Fracture of the body of an implant and its management – a case history

K. Gibney¹

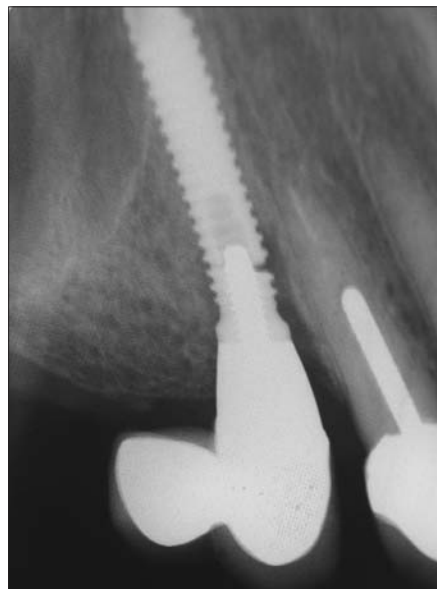
Fig. 1 Initial periapical radiograph showing fracture

A periapical radiograph (Fig. 1) revealed a fracture in the body of the implant at the position of the end of the prosthetic screw. The loose bridge was removed under local analgesia together with the implant fragment (Fig. 2) and a panoramic radiograph was taken (Fig. 3).

Implant body fracture is a rare complication of implant treatment occurring in only about 0.6% of fixtures. An *in vivo* study analysing the mechanism of fracture of implants concluded that fatigue stress fracture occurs with repeated loading.⁴ In this case the re-cementation of the post crown at UR3 (13) may well have altered the occlusion causing excessive

loading of the implant bridge resulting in a fatigue stress fracture. Rangert *et al.*⁵ found that partial bridges with cantilever designs accounted for 83% of implant fractures and that 90% of fractures occurred in the posterior regions. It has been shown in animal studies that crater-like bone loss will occur around implants with excessive dynamic loading⁶ and this loss of bone support will allow flexing of an implant under loading and possibly contribute to a fatigue stress fracture. In the past prosthetic screw loosening sometimes leading to screw fracture has occurred⁷ when occlusal overload is present but improvements to screw designs, allowing higher preloads has made screw loosening much less common. However this may perhaps lead to failure elsewhere in the system such as fracture of the body of the implant. Such fractures can be difficult to manage as patients invariably expect a fixed solution and therefore will not accept a removable partial denture. Care must be taken during treatment planning to minimise the risk of implant body fracture by designing a prosthesis, which allows for axial loading where possible and a favourable distribution of

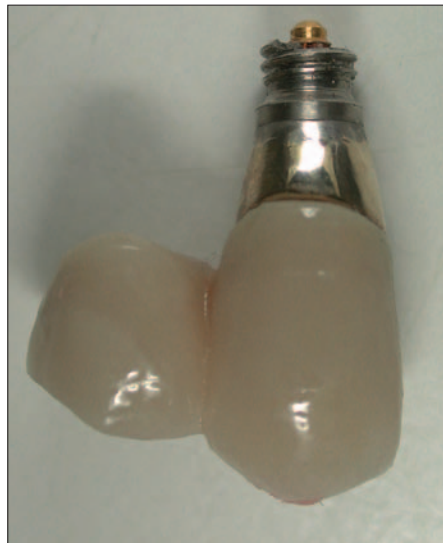
Fig. 2 Bridge and fixture fragment after removal

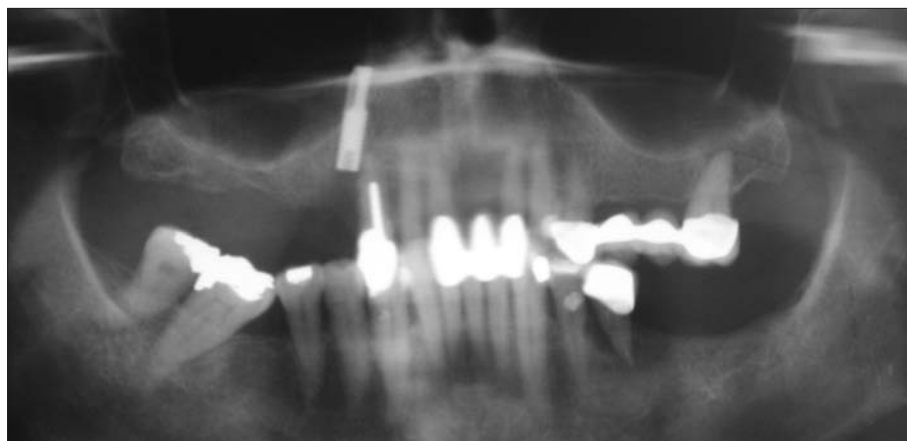
Fig. 3 Initial panoramic radiograph showing remaining fixture fragment

The remaining implant fragment was below the crest of the bone and so it is likely that the bone would remodel around this possibly covering it completely. The full thickness flap raised for the placement of the implants was closed over the site and as can be seen in Figure 5 healing was uneventful and complete.

This option was chosen as being most likely to provide a long-term stable solution that was acceptable to the patient. Two implants can be safely used to support a three-unit bridge to replace UR345 (13-15) and UR3 (13) was a failing post crown with a poor prognosis.

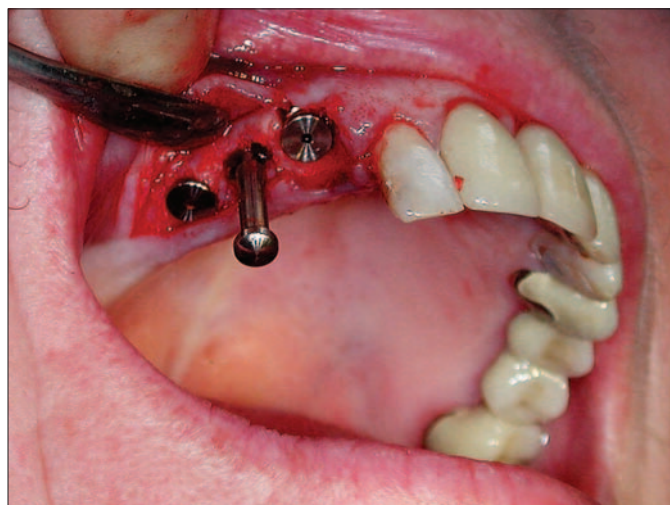
Fig. 4 Guide pin in fixture fragment during surgery to aid implant placement

An immediate, temporary, removable partial denture was constructed to replace UR345 and UR3 was extracted. About 6 weeks later two implants were placed at UR3 and UR5 using the standard Brånemark protocol. They were both Brånemark implants being Mark IV TiUnite® implants of 15 mm and 11.5 mm lengths respectively. As the implant fragment was not visible a guide pin was screwed into the remaining implant fragment to mark its position during surgery (Fig. 4). A two-stage approach was to be used and therefore cover screws were placed and the wound closed. After

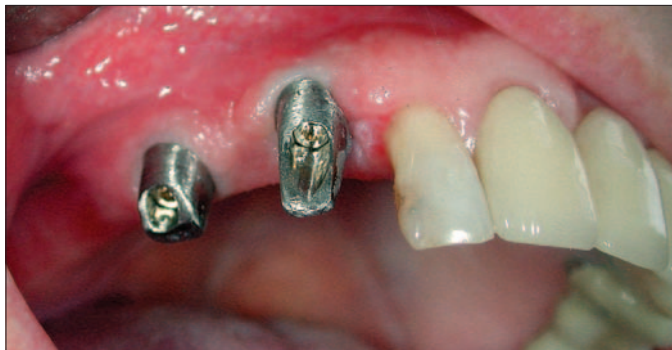
Fig. 5 Procera titanium abutments

Fixture head impressions were taken 2 months later and two Procera (Nobel Biocare, Gothenburg, Sweden) titanium custom abutments constructed. A 3-unit ceramo-metal bridge was constructed and cemented over these with a temporary cement (Improv, Nobel Biocare, Gothenburg, Sweden) (Figs 5, 6).

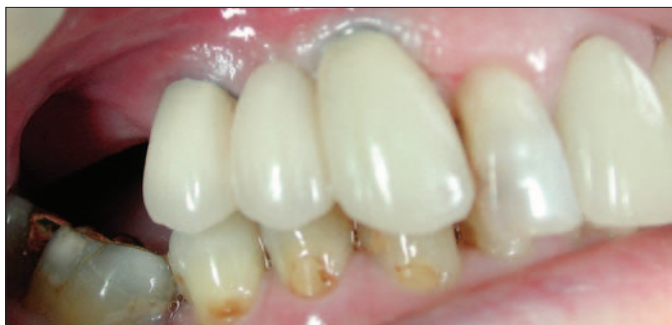
Fig. 6 Final bridge in place

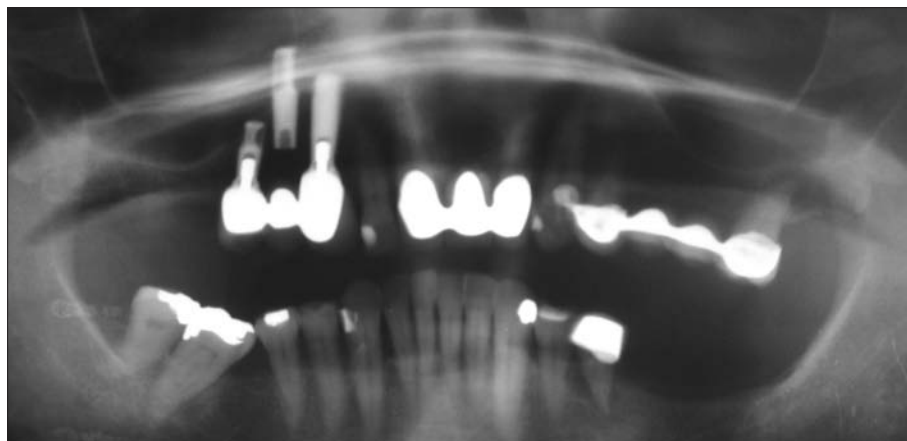
Fig. 7 Post treatment panoramic radiograph
