Fracture of the body of an implant and its management – a case history

K. Gibney¹

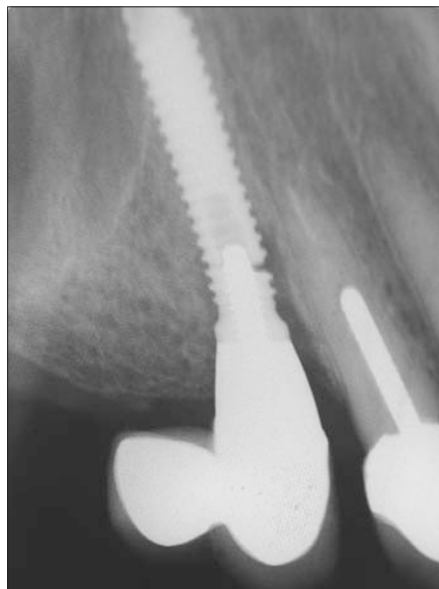
Fig. 1 Initial periapical radiograph showing fracture

A periapical radiograph (Fig. 1) revealed a fracture in the body of the implant at the position of the end of the prosthetic screw. The loose bridge was removed under local analgesia together with the implant fragment (Fig. 2) and a panoramic radiograph was taken (Fig. 3).

Implant body fracture is a rare complication of implant treatment occurring in only about 0.6% of fixtures. An *in vivo* study analysing the mechanism of fracture of implants concluded that fatigue stress fracture occurs with repeated loading.⁴ In this case the re-cementation of the post crown at UR3 (13) may well have altered the occlusion causing excessive

loading of the implant bridge resulting in a fatigue stress fracture. Rangert *et al.*⁵ found that partial bridges with cantilever designs accounted for 83% of implant fractures and that 90% of fractures occurred in the posterior regions. It has been shown in animal studies that crater-like bone loss will occur around implants with excessive dynamic loading⁶ and this loss of bone support will allow flexing of an implant under loading and possibly contribute to a fatigue stress fracture. In the past prosthetic screw loosening sometimes leading to screw fracture has occurred⁷ when occlusal overload is present but improvements to screw designs, allowing higher preloads has made screw loosening much less common. However this may perhaps lead to failure elsewhere in the system such as fracture of the body of the implant. Such fractures can be difficult to manage as patients invariably expect a fixed solution and therefore will not accept a removable partial denture. Care must be taken during treatment planning to minimise the risk of implant body fracture by designing a prosthesis, which allows for axial loading where possible and a favourable distribution of

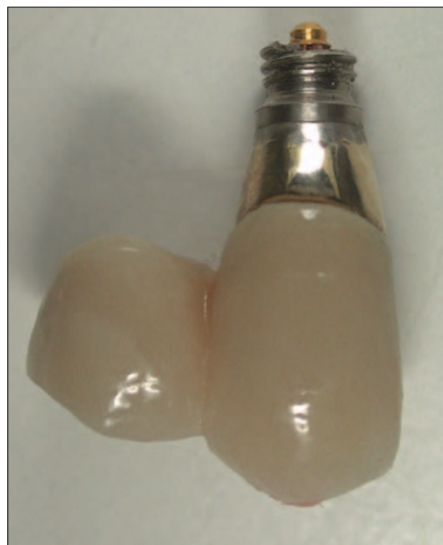
Fig. 2 Bridge and fixture fragment after removal

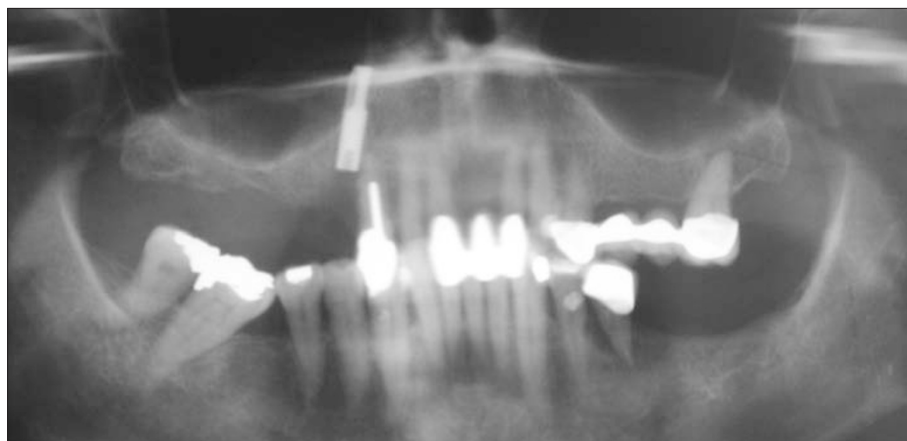
Fig. 3 Initial panoramic radiograph showing remaining fixture fragment

This option was chosen as being most likely to provide a long-term stable solution that was acceptable to the patient. Two implants can be safely used to support a three-unit bridge to replace UR345 (13-15) and UR3 (13) was a failing post crown with a poor prognosis.

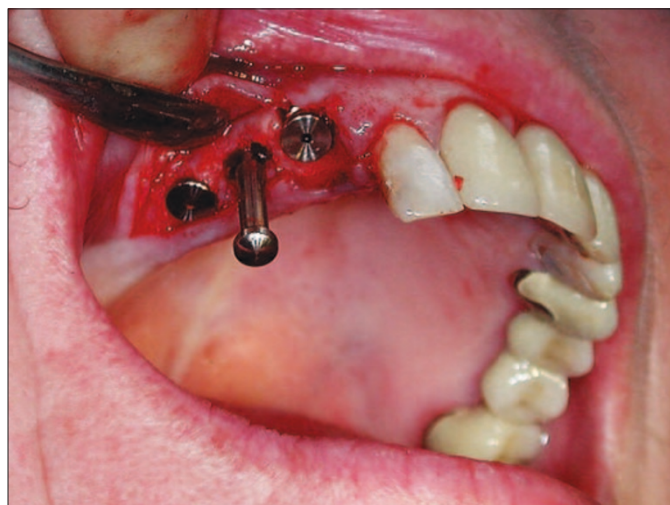
Fig. 4 Guide pin in fixture fragment during surgery to aid implant placement

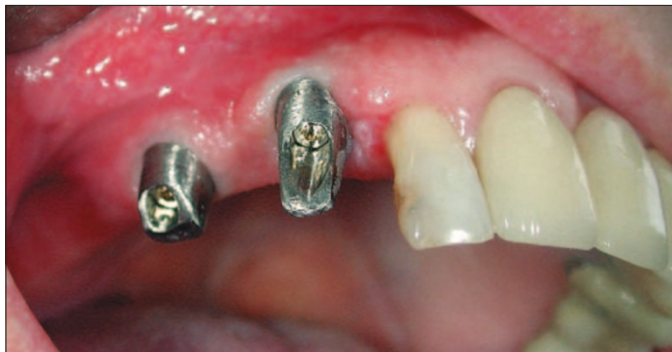
Fig. 5 Procera titanium abutments

Fixture head impressions were taken 2 months later and two Procera (Nobel Biocare, Gothenburg, Sweden) titanium custom abutments constructed. A 3-unit ceramo-metal bridge was constructed and cemented over these with a temporary cement (Improv, Nobel Biocare, Gothenburg, Sweden) (Figs 5, 6).

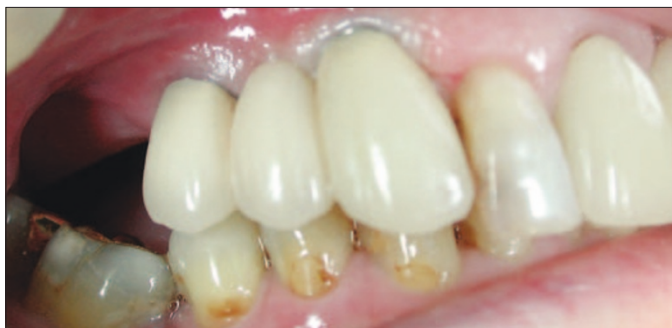
Fig. 6 Final bridge in place

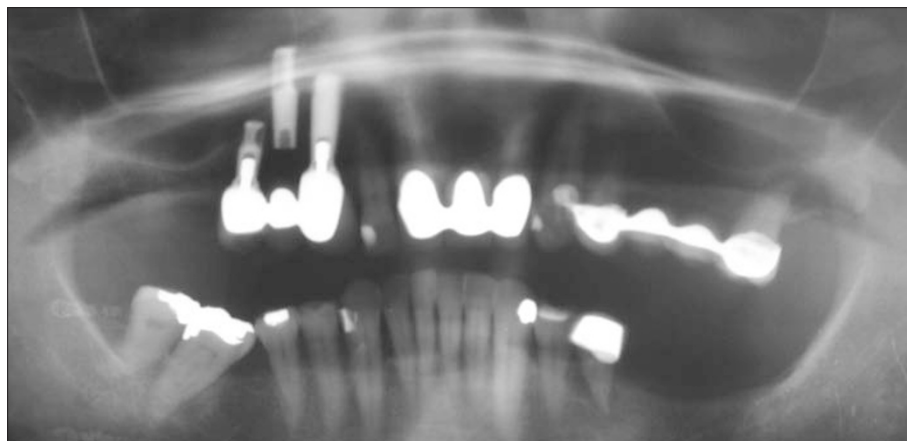
Fig. 7 Post treatment panoramic radiograph
