An investigation of intraocular lens damage and foreign bodies using an injectable hydrophilic acrylic lens implant

Eye (2010) 24, 152–157; doi:10.1038/eye.2009.3; published online 27 February 2009

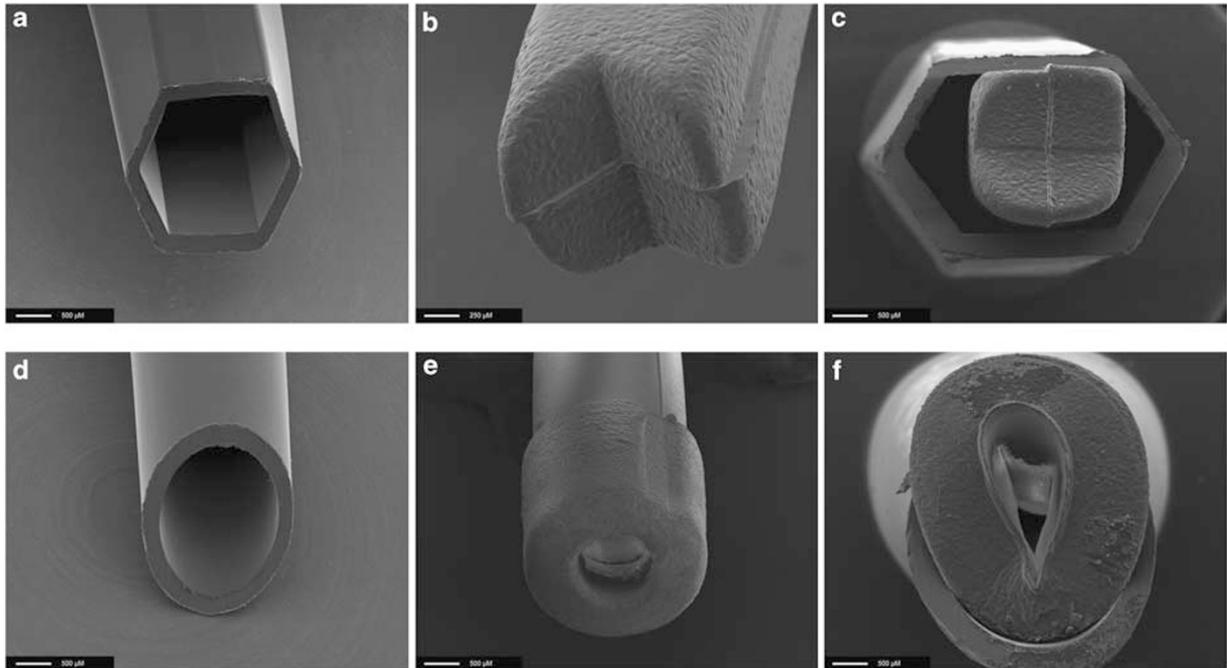
rigid plunger (Figure 1a–c), and the newer oval injector and soft compressible plunger (Figure 1d–f). Note that the rigid plunger (Figure 1b) is composed of two halves welded together. These halves were frequently poorly aligned, potentially leaving sharp edges.

Figure 1 Scanning electron micrographs of the old hexagonal nozzle (a) and plunger (b) showing how much space there is between components (c). The new oval nozzle (d) and soft compressible plunger (e) are a tighter fit (f).

causing entrapment of the haptics when closing the loading bay, and thereby fracturing the haptics on attempted injection. While there were no haptic fractures in the small number of IOLs that we used in this study, scanning electron micrographs of the injector reveal another possible cause of this problem. Owing to the relatively small size of the rigid plunger in relation to the nozzle, particularly at the wider proximal end of the tapered nozzle, it would be quite possible for the plunger to over-ride the haptic or lens during injection. Even at the narrowest point of the injector, at the tip of the nozzle (Figure 1c), one can see that there is ample room for the haptic to become trapped between the plunger and nozzle. Indeed, such a mechanism has been described in the literature previously.⁶ In contrast, the new injector uses a larger soft compressible plunger that completely fills the loading bay and proximal nozzle. As the IOL is injected the plunger is compressed to conform to the shape of the nozzle tip (Figure 1f). Our clinical impression with this new injector is that the incidence of haptic fractures is reduced.

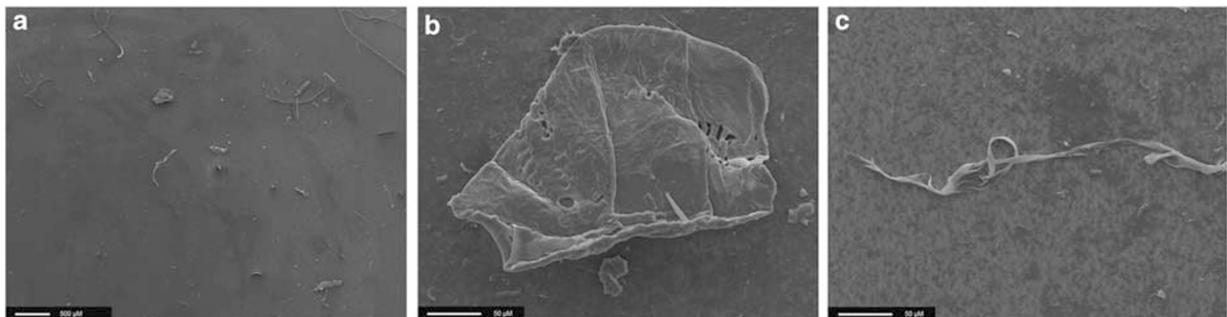
Before loading the lenses, the unopened blister pack containing the IOL was inspected with the operating microscope. This revealed that 17 out of 18 blister packs contained fine particulate matter floating in the solution. The largest particles were visible with the naked eye if examined closely. The blister pack supernatant was therefore collected, centrifuged, and examined by SEM. This revealed a combination of small irregular filaments and sheets of material (Figure 2).

Figure 2 Scanning electron micrographs of debris found in fluid taken from blister packs at low (a) and high power (b, c) showing a mixture of irregular sheets (b) and fibrils (c).

Before this study, intraocular foreign bodies were occasionally seen clinically after lens injection. This study suggests two possible sources of this material. Firstly, high-magnification operating microscope images of the unopened IOL blister packs clearly showed small foreign bodies floating freely within the saline solution. After discussion with the manufacturers about the origin of this material, one possible explanation was abnormal storage conditions causing crystals of saline to form. However, SEM shows that these foreign bodies were not crystalline in nature (Figure 2). Further, X-ray microanalysis of debris from the blister packs showed it to be composed of carbon, hydrogen, and oxygen. Their origin remains obscure.

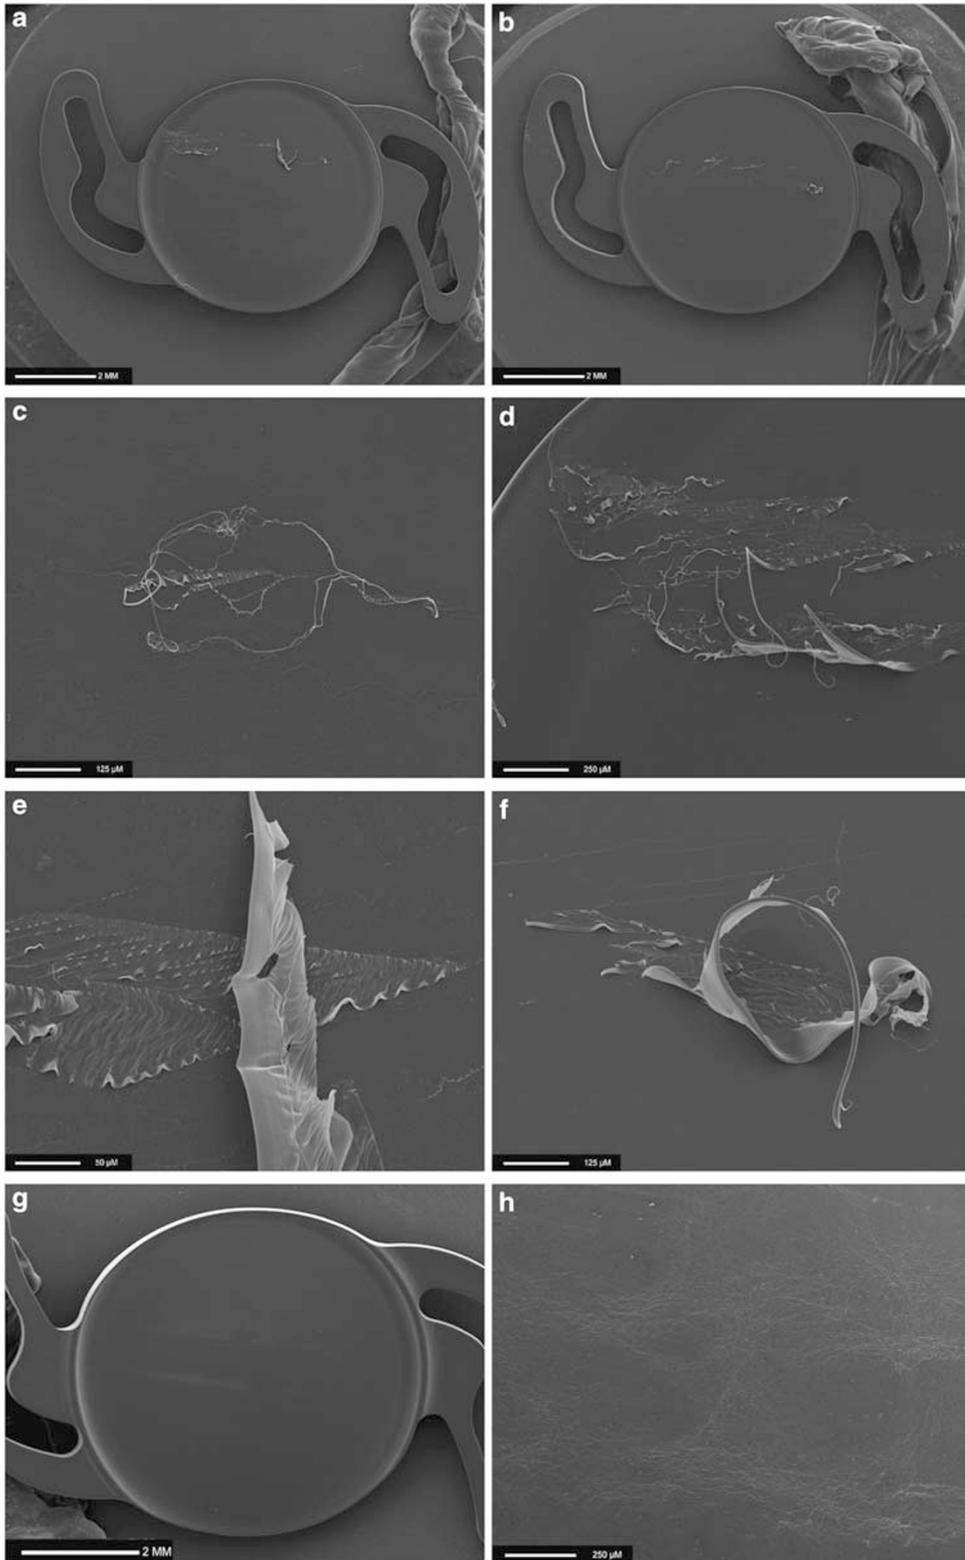
When injecting lenses through the original injector with the hexagon-shaped nozzle and the small hard plunger, eight of nine lenses had identifiable surface abnormalities visible at high magnification, with both the operating microscope and the SEM (Figure 3). All surface abnormalities were linear, on the posterior surface of the lens, and in the direction of injection. The appearance of defects did not correlate with either the IOL power or the quantity of Healon used. Four lenses had significant abnormalities (Figure 3a and b), two had minor surface abnormalities (Figure 3c), two had what appeared to be imprints or crease marks on the posterior surface (Figure 3g and h), and only one lens was completely unscathed. At high power these surface abnormalities appear to be of three types: fine irregular wavy filaments (Figure 3c), triangular surface abnormalities, with the apex nearer the leading haptic, and the base towards the trailing haptic (Figure 3d). These tended to curl as they lengthened and could break free to resemble foreign bodies (Figure 3d and e). Finally, large curls that had partially broken free from the IOL could be seen (Figure 3e and f). All three abnormalities can in fact happen on the same lens in a linear fashion (Figure 3a and b).

Figure 3 Scanning electron micrographs of IOLs showing linear posterior surface abnormalities at low power (a and b). At high power the surface of the lens can be seen to break up into fine wavy filaments (c), triangular-shaped rippled sheets (d), which break off to form foreign bodies (e), which may form curls (f). Some IOLs had linear surface impression (g), which at high power is actually a wrinkling of the surface (h).

In this study, the hexagonal injector produced surface abnormalities on eight of the nine IOLs. High-power SEM strongly suggested that these abnormalities were surface defects or scratches rather than exfoliations. We identified three morphological types of abnormality: fine wavy filaments, triangular areas of rippled or corrugated lens surface, and large curled shavings, which resemble foreign bodies (Figure 3). We suggest that these three types most likely represent a spectrum going from mild superficial to deeper surface abrasions. Mild superficial abrasions tend to free tiny filaments of acrylic polymer from the surface of the lens, which subsequently lie randomly on the surface (Figure 3c). Deeper abrasions, on the other hand, tend to start at a leading point and cause a triangular downstream rippling of the lens surface, rather like an avalanche. The deepest scratches, however, cause thick shavings to be lifted from the surface, and these are thrown into curls by friction (Figure 3f). We compare this with the decorative curling of ribbon, that is, running a length of ribbon, on stretch, over the edge of scissors to create curls. Consistent with these defects being IOL material, light and scanning electron microscopy of all plungers and nozzles showed no evidence of damage from injection.

With the redesigned injector, surface abnormalities were very much reduced. With SEM only three of the nine lenses had occasional wavy filaments and mild impressions. We attribute this improved performance to the shape of the nozzle tip. One other study has described a similar phenomenon, whereby injections through a hexagonal tip caused the nozzle to fracture and linear posterior surface abnormalities to appear on the IOL optic, whereas injection through a round tip did not.⁸ The relatively minor surface abnormalities that were seen on three IOLs (Figure 3g) may represent impressions that possibly would have disappeared with the fullness of time *in vivo* as described earlier.¹⁰

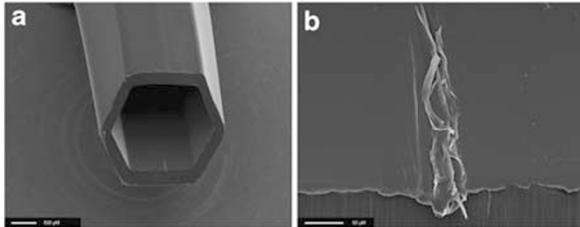
Only one injector nozzle had any visible defect after injection. It was a linear deep groove centrally on the inner surface, at the end of the tip, in the direction of injection (Figure 4). This defect precisely corresponds to where the welded edges of the plunger sit (Figure 1c).

Figure 4 Scanning electron micrograph of a hexagonal nozzle (a) that has a deep gouge at the tip that can be seen clearly at high power (b).

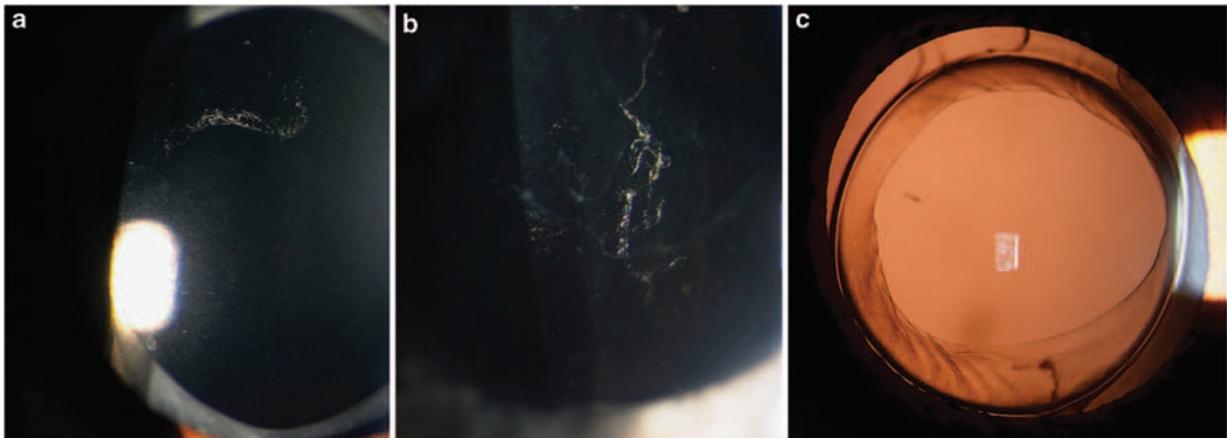
Figure 5 Anterior segment photographs of IOL surface abnormalities (a and b) and an IOL foreign body (c) 3 months after surgery.

To reinforce that our surface abnormalities were not onlays, we recalled five patients who were identified in our audit as having pronounced lens abnormalities visible at the time of surgery. In all cases, the surface abnormalities were still present 3 months postoperatively (Figure 5a–c). One patient had mildly prolonged postoperative uveitis, but no patient in this study expressed dissatisfaction with their IOL, or had lens exchange. It is well known that lens defects may cause dysphotopsia, be more proinflammatory, and are associated with greater bacterial adhesion^{12,13} and should therefore not be taken lightly.
