The role of nano-sized intergranular phases on nickel alloy 725 brittle failure

Maria Sofia Hazarabedian¹ and Mariano Iannuzzi¹✉

npj Materials Degradation (2021)5:39; <https://doi.org/10.1038/s41529-021-00185-2>

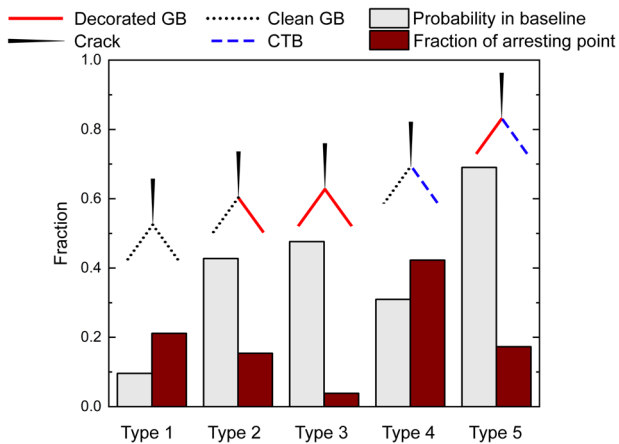
Figure 7 and Supplementary Table 1 summarize the statistical analysis of the crack arresting points. The crack arresting points were classified based on the presence of the intergranular phases (according to the optical micrographs) and the nature of the surrounding GBs, i.e., if the crack was connected to regular GBs or CTBs. Five types of arresting points were identified, as indicated in Fig. 7 and Supplementary Note. The count of each type was divided by the total of arresting points studied to calculate the fraction of each arresting point type. The probability of finding that type of junction in the baseline material was estimated according to Supplementary Note. The measured fraction of each type of arresting point and its probability to find the respective configuration of GBs in the base material are plotted in Fig. 7. Results showed that cracks arrested generally around clean GBs (Type 1 and 4). However, these types of junctions occurred less frequently in the baseline material microstructure. In contrast, the arresting points with adjacent intergranular precipitates (Type 3, 4, and 5) were uncommon, despite being more abundant in the base material. Therefore, results indicated that the decorated GBs offered low crack propagation resistance. The statistical significance of the detrimental effect of the decorated GBs was supported by P -values lower than 2.5×10^{-5} (Supplementary Note and Supplementary Table 1).

Fig. 7 Statistical analysis of main crack arresting points. The column chart shows, for each crack arresting point type, the measured fraction (red) along with the probability of that type GB junction in the baseline material (gray). The arresting points were classified based on the adjacent GBs' nature and decoration. Five categories were defined, depending on whether the crack tip was adjacent to (Type 1) two clean regular GBs, (Type 2) a clean and a decorated regular GBs, (Type 3) two decorated regular GBs, (Type 4) a clean regular GB and a CTB, and (Type 5) a decorated regular GB and a CTB.
