# The Punatsangchhu-I dam landslide illuminated by InSAR multitemporal analyses

Benedetta Dini<sup>1</sup>✉, Andrea Manconi<sup>1</sup>, Simon Loew<sup>1</sup> & Jamyang Chopel<sup>2</sup>

We use multitemporal analyses based on Synthetic Aperture Radar differential interferometry (DInSAR) to study the slope adjacent to the large Punatsangchhu-I hydropower plant, a concrete gravity dam under construction in Bhutan since 2009. Several slope failures affected the site since 2013, probably as a consequence of toe undercutting of a previously unrecognised active landslide. Our results indicate that downslope displacement, likely related to the natural instability, was already visible in 2007 on various sectors of the entire valley flank. Moreover, the area with active displacements impinging on the dam site has continuously increased in size since 2007 and into 2018, even though stabilisation measures have been implemented since 2013. Stabilisation measures currently only focus on a small portion of the slope, however, the unstable area is larger than previously evaluated. Highly damaged rock is present across many areas of the entire valley flank, indicating that the volumes involved

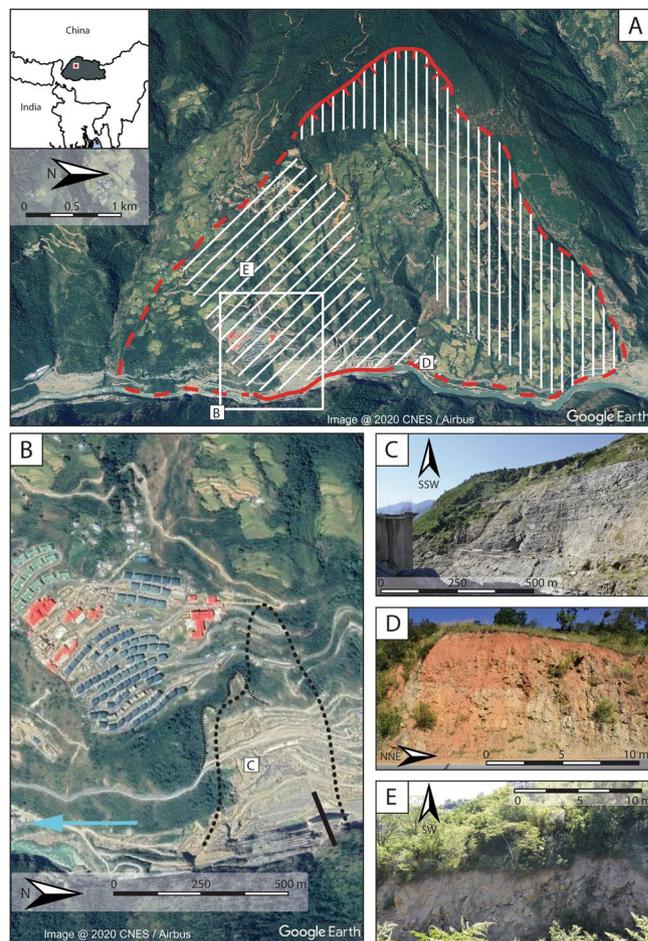
**Figure 1.** (A) Google Earth CNES/Airbus image of the area of study. Red lines with ticks represent the head scarp, presumed (red dashed) and known (red continuous) boundaries. Hatched area represents damaged rock (diagonal) and undisturbed residual soil (vertical). White square is the area in B. Inset shows the regional setting. (B) Google Earth CNES/Airbus image of white square in A. Black line represents the dam axis, thick dotted line indicates the 2013 failure area, thin dotted lines indicate scarps likely related to the 2013 failure. (C) Photo of the 2013 failure area. Given the angle from which the photo is taken, only the southern boundary is well visible, marked by scarps and the appearance of vegetation on stable ground. On the left of the photo, the construction of the left dam abutment is visible. (D,E) intensely damaged rock, location shown in A.

Analysis of the high-resolution DSM reveals the presence of an old head scarp, with heights varying between 30 and 100 m. The scarp can be followed for an arched path of 3 km, from 2030 m a.s.l. in the south, to 2430 m a.s.l. at its highest point below the ridge top, to 2080 m a.s.l. in the north. A convex profile is also present below 1600 m a.s.l., with bulging in the lower parts of the slope. Erosion at the toe, visible in a Google Earth image prior to 2009, indicates active river incision, particularly evident in the south; moreover, in the northern half of the slope a marked curvature in the river bed towards the opposite side of the valley is also present. An abundance of deeply incised channels, visible both in the DSM and in the optical images, suggests high erodibility of the material. This dense network of channels is coupled with high roughness of the topography, which confers an irregular morphology to the slope.

During a field visit in October 2017, we observed intensely damaged rock across a large part of the slope (Fig. 1). This extends from the area of the village, upslope to the smaller settlement on the southern flank of the slope at around 1800 m a.s.l. and then north into the middle of the slope. Outcrops along the farm road in the northern half of the slope show relatively undisturbed residual soils, with preserved parent rock structure (vertical hatches in Fig. 1A). Fresh scarps related to the 2013 slope reactivation are observed below the village at elevations going from 1250 m a.s.l. in the south, intersecting the road, to 1340 m a.s.l. at the highest point, to 1290 m a.s.l. in the north (Fig. 1B). These scarps, with an estimated height between 10 and 20 m, are also visible in Google Earth images (shown as thin dotted lines in Fig. 1B). A large deposition is also observed below the village, this possibly corresponding to the accumulation of the 2013 event (Fig. 1C). The lower parts of such deposits are intensely reworked by activity at the site.

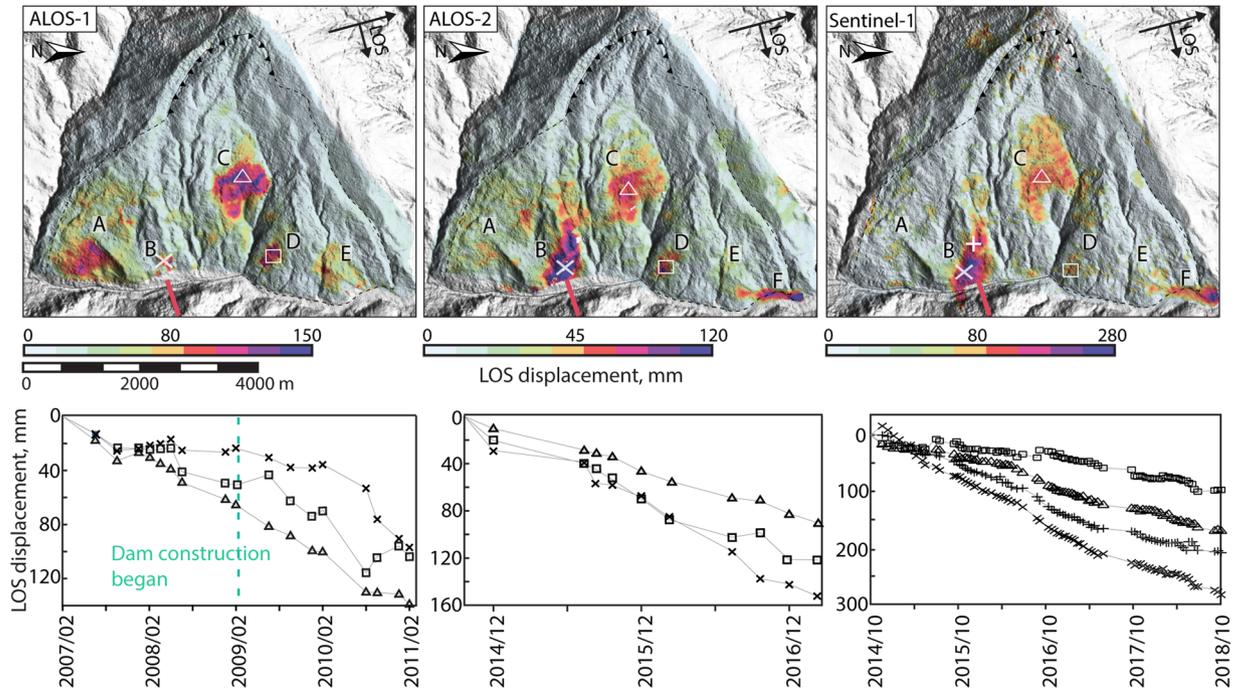
**Areas, cumulative displacements and average velocities for each sensor's period.** Sector A, as seen by ALOS-1, is characterised by an area of downslope cumulative displacements in the period February 2007 – February 2011 of >10 cm (with average velocity of roughly 3 cm/year estimated over the whole period) covering about 0.5 km<sup>2</sup>. A larger area of 2.3 km<sup>2</sup>, encompassing the zone of greater displacements and extending 1.2 km upslope from its upper margin, shows cumulative displacements between 5 and 10 cm (with average velocity of roughly 2.5–3.5 cm/year estimated over the whole period). This larger extent is well matched by the observations retrieved with ALOS-2, albeit cumulative displacements between September 2014 and February 2017 are on the whole lower than those shown by ALOS-1. The extent of the displacements in this sector becomes patchier in Sentinel-1 observations, between October 2014 and October 2018, and the boundaries less easily traced, with greatest displacements restricted to the toe of the slope and at around 1360 m a.s.l.

Sector B (immediately upslope of the dam site) in ALOS-1 shows two different areas with displacements largely above 5 cm (with average velocities around 1.5 cm/year), each roughly covering 0.1 km<sup>2</sup>. The upper one presents lower cumulative displacements with maxima around 7 cm (only faintly visible in Fig. 2 due to the scale,

**Figure 2.** The top three panels show LOS cumulative displacements in the three sensors. Colour scales are different and non-symmetrical to highlight areas of highest displacements, with high variability in different sectors and in the three sensors. Letters indicate the sectors described in section 2. Left and centre panels at the bottom show the time series of ALOS-1 and ALOS-2 of three points in sectors B, C, and D. Sentinel-1 panel at the bottom right shows the time series for the same points as in the other two sensors, with the addition of one point in sector B (cross). Points shown in the corresponding panels above. Dam axis in red. ALOS-1 and ALOS-2 SAR imagery obtained from JAXA (Dataset ©JAXA/METI ALOS PALSAR L1.0 2007, 2008, 2009, 2010, 2011, 2014, 2015, 2016, accessed through <https://auig2.jaxa.jp/openam/UI/Login>, 2016 and 2017). Copernicus Sentinel data [2014, 2015, 2016, 2017, 2018] accessed through the ESA Copernicus open access hub <https://scihub.copernicus.eu/dhus/#/home>, 2017, 2018. InSAR processing done with the software SARscape from Sarmap.

about 50 m upslope of point x, with average velocities around 2 cm/year). The lower one, at the toe of the slope, is characterised by larger cumulative displacements (visible in Fig. 2 around point x), reaching 15 cm by February 2011 (and average velocities exceeding 2.5 cm/year). ALOS-2 shows a fivefold areal increase by February 2017, the overall extent reaching 1 km<sup>2</sup>, comprising the two areas observed with ALOS-1. Displacements are largely above 8 cm and reach up to 22 cm in the lowest half (with average velocities largely around 2.5 cm/year and up to 8 cm/year in the lowest half). Although the boundaries are more jagged in the upper parts in Sentinel-1 data, the area is comparable to that seen in ALOS-2 and displacements exceed 30 cm in the lower half by October 2018 and similar average velocities to ALOS-2.

**Time series.** Time series are analysed and described here for sectors B, C and D, and are shown in the lower panels in Fig. 2.

In sector B, the ALOS-1 time series of a point at roughly 1320 m elevation (x in Fig. 2) shows a non-linear trend. In the first half of the period, from February 2007 to February 2009, the trend is on the whole shallow (though higher displacement rates characterise the period up to October 2007), followed by two acceleration phases during the second part of the period, from February 2009 to February 2010 and then more markedly from February 2010 until February 2011. The trend for the same point as seen with ALOS-2 and Sentinel-1 shows a roughly twofold increase in velocity in comparison to the period February 2009–February 2011 (see section 2.3 and Fig. 3) and linearity between September 2014 and June 2017. Sentinel-1 shows then a decrease in the displacement velocity after June 2017, though linearity is again seen through this last period. Velocities in this sector and their variations in time are described in detail in section 3.3.

On the whole, the time series in the centre of sector C show linear trends. The cumulative displacements observed over the different periods of observation of the three sensors show that the velocity remained similar throughout the whole period, lying relatively steady between 32 mm/year (ALOS-1) and 37 mm/year and 45 mm/year (ALOS-2 and Sentinel respectively). Some small deviation from a linear trend may be observed ALOS-2 images and in Sentinel-1 time series.

The time series of a chosen point in sector D generated with ALOS-1 images is more strongly non-linear. An initial phase with a lower velocity is visible up to end of June 2009. After that, a period of acceleration is observed until August 2010. We observe a change in average velocity from 20 mm/year, to 70 mm/year for ALOS-1 in the periods identified, and to around 50 mm/year as observed with ALOS-2 and then decreasing again to 30 mm/year through the rest of the period.

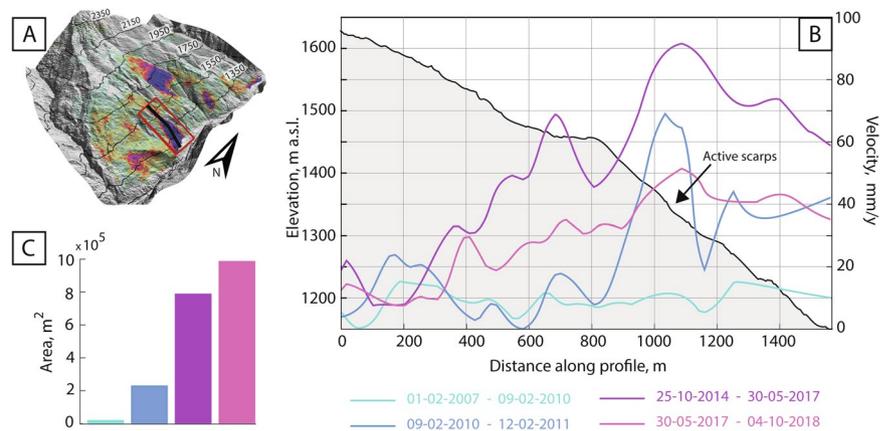
**Figure 3.** (A) 3D map inset shows the sum of cumulative displacements (stack) of all sensors over the entire slope, in red polygon the area of sector B and in black the profile are shown. (B) Velocities along the profile intersecting sector B. Slope profile shown in black. The different colours represent four periods over which velocities are calculated. (C) Histogram of the active displacements area size. (ALOS-1 and ALOS-2 SAR imagery obtained from JAXA (Dataset ©JAXA/METI ALOS PALSAR L1.0 2007, 2008, 2009, 2010, 2011, 2014, 2015, 2016, accessed through <https://auig2.jaxa.jp/openam/UI/Login>, 2016 and 2017). Copernicus Sentinel data [2014, 2015, 2016, 2017, 2018] accessed through the ESA Copernicus open access hub <https://scihub.copernicus.eu/dhus/#/home>, 2017, 2018. InSAR processing done with the software SARscape from Sarmap).

**Velocities along a profile in sector B.** Velocities were calculated along a profile crossing sector B, in the immediate proximity of the dam site, from west to east and from 1620 to 1150 m a.s.l., using ALOS-1 and Sentinel-1 data, given the partial overlap between ALOS-2 and Sentinel-1. Figure 3 shows the velocity calculated assuming linear displacement rates over four different periods, the latter defined by changes in the observed trends (as seen in the lower panels in Fig. 2). Between February 2007 and February 2009, the velocity remained relatively constant along the profile, at around 20 mm/year or less. From February 2009 the velocity increased remarkably between 1450 and 1350 m a.s.l. from less than 20 mm/year to over 60 mm/year, and below 1250 m a.s.l. it increased to over 30 mm/year. A further acceleration is observed from October 2014 to May 2017. During this period, we observe that between 1600 and 1450 m a.s.l. the velocity shows a downslope increase, reaching 70 mm/year. Moreover, after a 100 m wide, flat section at 1450 m a.s.l., the velocity increases downslope up to about 90 mm/year at 1350 m a.s.l. Although downslope of 1300 m elevation the velocities appear lower than in the upslope sections during this period, we still observe an overall increase from the previous period. Only in the last period, from May 2017 to October 2018 we observe a decrease in velocities: even though there are still parts of the slope with increasing downslope gradients, the overall velocities along the profile are lower in comparison to the previous interval, but higher in comparison to the beginning of the observations.

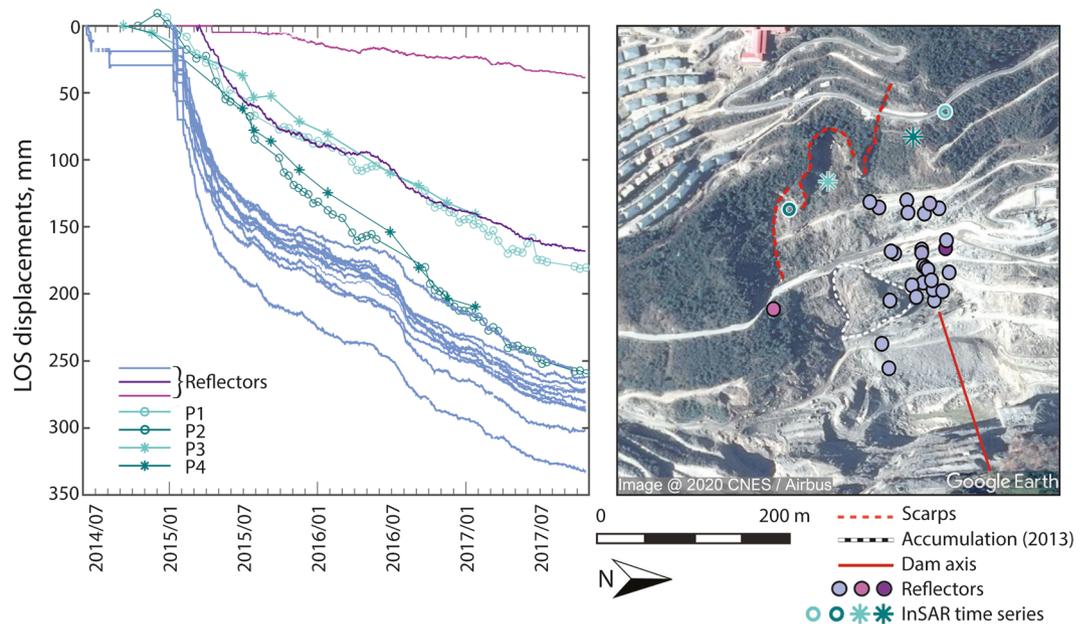
**Figure 4.** Left: comparison between *in-situ* data (solid lines) and satellite-based time series (lines with markers). Right: area of 2013 and 2016 failure with location of total station reflectors and sampling points of satellite observations (Background Google Earth CNES/Airbus imagery).

***In-situ* data as validation for InSAR measurements.** A total station installed at the site on the left abutment on the dam has recorded the movements of reflectors placed within the 2013 failure area. 39 reflectors were installed between the deposit of the 2013 failure and the scarps below the village, these covering an area 300 m wide and 400 m high. The data from these reflectors were converted into the line of sight of the satellites for comparison. In Fig. 4, the corrected time series of 24 of these reflectors are shown together with two ALOS-2 and two Sentinel-1 time series of points sampled in the area. The points chosen for the satellite data are approximately 50 to 200 m upslope from the reflectors, due to low coherence and loss of correlation in the area immediately around the reflectors. From December 2014 to June 2015 a very fast downslope displacement is recorded by all reflectors and such acceleration is not fully captured by the satellites. This may be caused by a combination of different factors: (i) the points of the time series do not correspond perfectly to the area reflectors, this likely leading to high variability in the local vertical to horizontal components ratio of the displacements, due to the high roughness of the terrain and high slope angle variability in the area of the 2013 failure, (ii) the total station reflectors are the representation of the displacement at a particular location, whilst the InSAR pixel in our processing is ~15 m, (iii) there are large return periods in the first part of the ALOS-2 time series and gaps in the Sentinel-1 time series (see

connection graph in Supplementary Fig. 2) over which the velocity is interpolated. However, from June 2015, the velocity shown by the reflectors decreases and the time series obtained with the satellite data reproduce this trend very well. An acceleration in June 2016 is shown by the reflectors and captured by ALOS-2 time series.
