## Evolution process and failure mechanism of a large expressway roadside landslide

Site investigation, deformation monitoring, laboratory test, and theoretical calculations were used to analyze the evolution details of a large expressway roadside landslide during the start-up sliding process. The monitoring results show that the initial deformation and failure occurred on the protective wall at the slope toe, then gradually developed to the upper part of the slope, and finally led to tensile cracks at the slope trailing edge. Accelerated deformation of the slope support structures, such as the protective wall at the slope toe, the anti-slide pile, and the anchor cable, were observed during the continuous extreme rainfall. The infiltrated rainwater can change the weight, the osmotic pressure, the anti-sliding force, the sliding force of the sliding mass, and further soften the fully weathered tuff soil and reduce its strength, resulting in the landslide occurrence. Block the slope surface runoff is an effective measure to reduce the landslide risk. The current analysis will be helpful to the prevention, control, and emergency disposal of similar landslides.

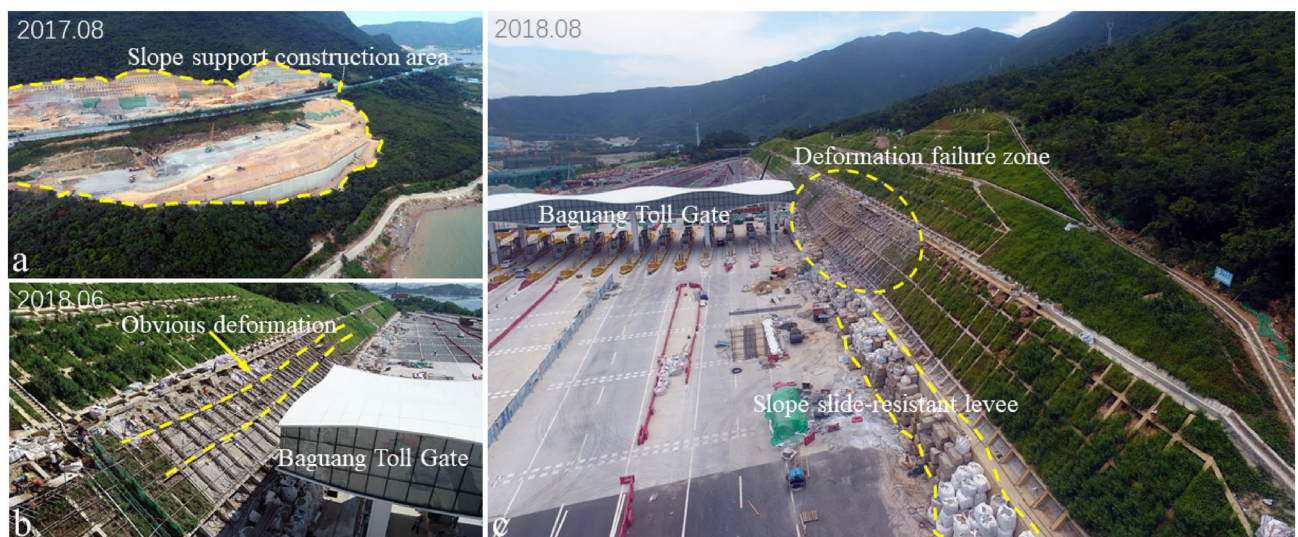
**Landslide description.** The excavation and construction of the Baguang toll gate slope started in August 2017 (Fig. 2a). It is a typical landslide caused by extreme rainfall and engineering construction (excavation of the mountain foot). The construction of this cutting slope was completed in January 2018, and obvious deformation was observed since May 2018. After two heavy rains (June 7 and August 28, 2018), the slope deformation was accelerated, which threatened the overall safety of the expressway and the toll station (Fig. 2b,c). On June 7, 2018, due to the influence of Typhoon “Aiyuni”, the maximum daily rainfall intensity reached 159 mm/day, and the cumulative rainfall in three days reached 489.3 mm. On August 28, 2018, a continuous extremely heavy rainstorm occurred, lasting about a week. The peak rainfall intensity reached 112.4 mm/h, the maximum daily rainfall reached 417.2 mm/day, and the cumulative rainfall reached 1926.4 mm. The field survey results show that: the entire landslide region was about 440 m long and 120 m wide (Fig. 1), with the area about 48,400 m<sup>2</sup>. The bottom sliding surface developed along the weak structural plane (mainly completely weathered tuff). The thickness of the landslide mass was uneven, with an average thickness of about 20 m. The total landslide volume was about  $6.8 \times 10^4$  m<sup>3</sup>. The main sliding direction was about SE 151°. Owing to the above reasons, Baguang Toll Landslide can be categorized as a large landslide with a middle-level depth. Based on the “Cruden and Varnes’ classification”<sup>34</sup>, typical category of this slope failure is “Translational sliding”.

**Figure 2.** Typical stages before the formation of the Baguang Toll Landslide: (a) excavation of the Baguang toll station slope in the initial construction stage; (b) large deformation threatening the toll station safety; (c) slope supporting structure appears obvious deformation and failure area for suffering typhoon.

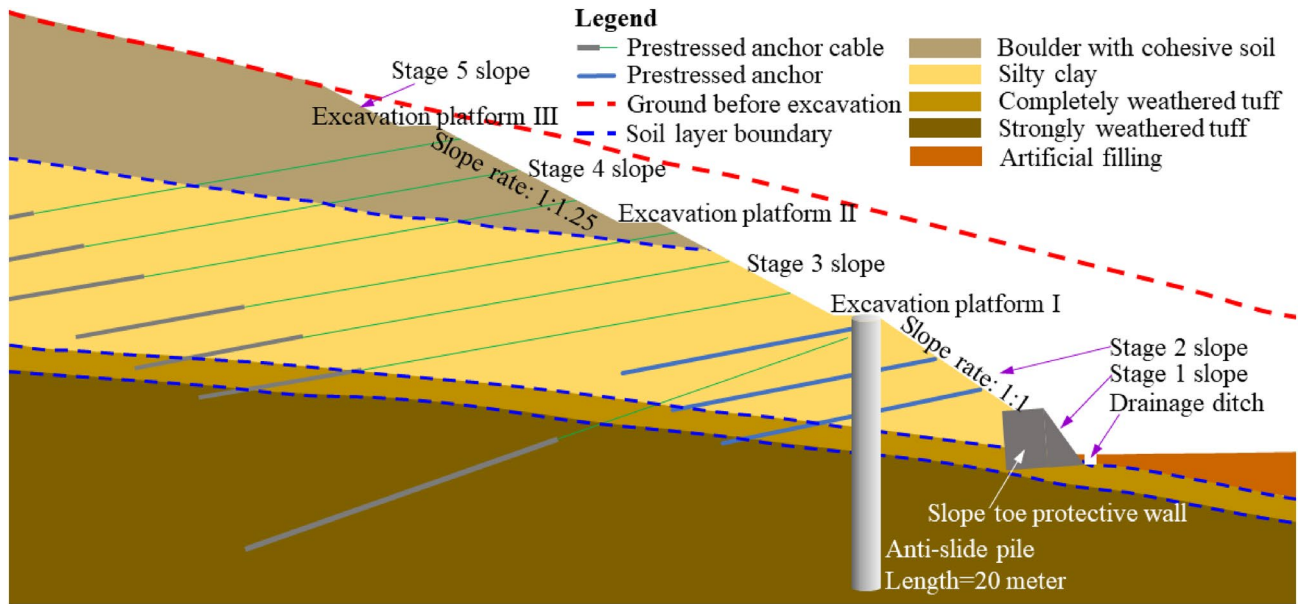
soil, silty clay, and completely weathered siltstone (Fig. 3). Among them, artificial fill has loose structure and good water permeability. The soil layers, e.g., silty clay containing breccia, silty clay, and completely weathered tuff, have poor water permeability. The Quaternary artificial filling layer, slope diluvium, eluvium and completely weathered layer are all water bearing rock formations.

**Figure 3.** Typical geological cross-section and support measures during the slope construction.

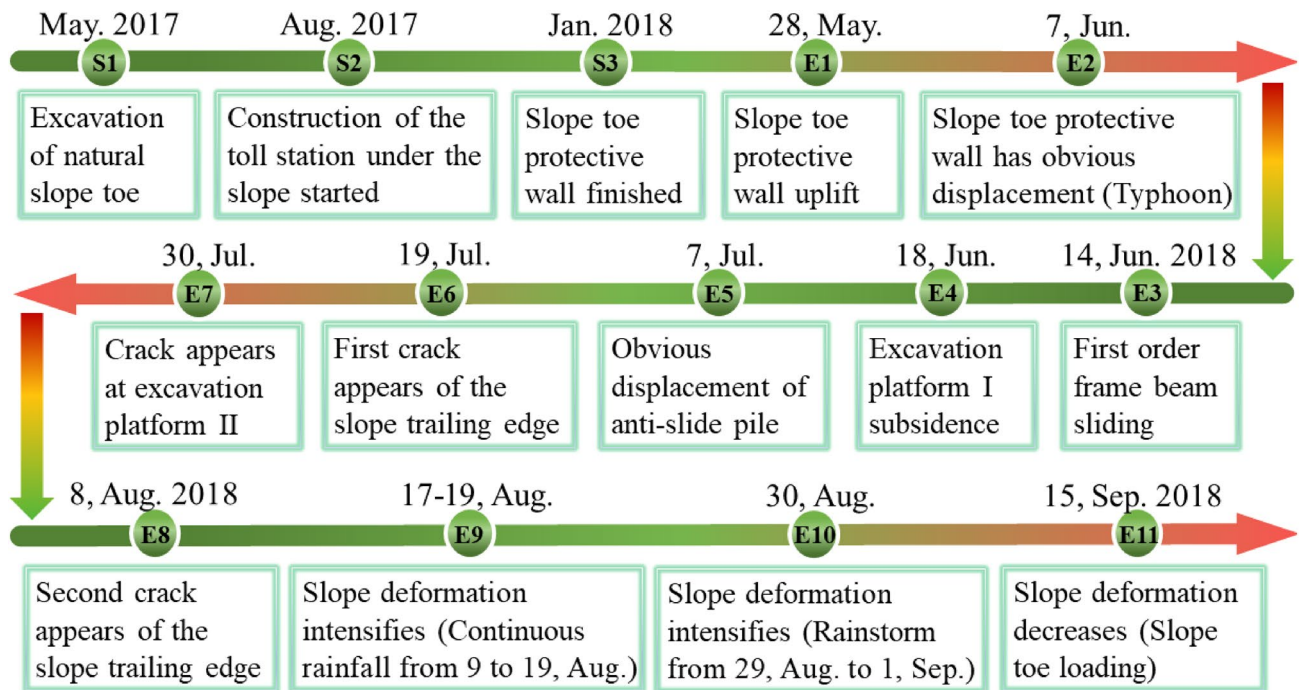
**Characteristics of slope starting slip.** For the expressway construction, excavation engineering of the natural slope at the location of Baguang toll gate began in May 2017. Construction of Baguang toll gate began in August 2017 and was completed by January 2018. During the construction of the toll gate and roadside slope support, there was hardly any rainfall.

After May 2018, extreme rainfall occurred continuously, with a large amount of rainwater penetrating the slope. Rainwater softened the underlying completely weathered tuff layer, resulting in the internal sliding surface. High-risk of sliding at any time poses a threat to the traffic safety. Typical events that trigger the slope gradual transition from stable state to critical sliding state are shown in Fig. 9. The events recorded in Fig. 9 are the results of the site investigation at different time nodes. Some observed conditions on site are shown in Figs. 10 and 11.

**Figure 9.** Evolution process and typical events timeline of the Baguang toll gate landslide from May 2017 to September 2018 (S1, S2, S3 represents the time nodes in the construction process, E1-E11 represents the time node when the slope gradually tends to instability after construction).

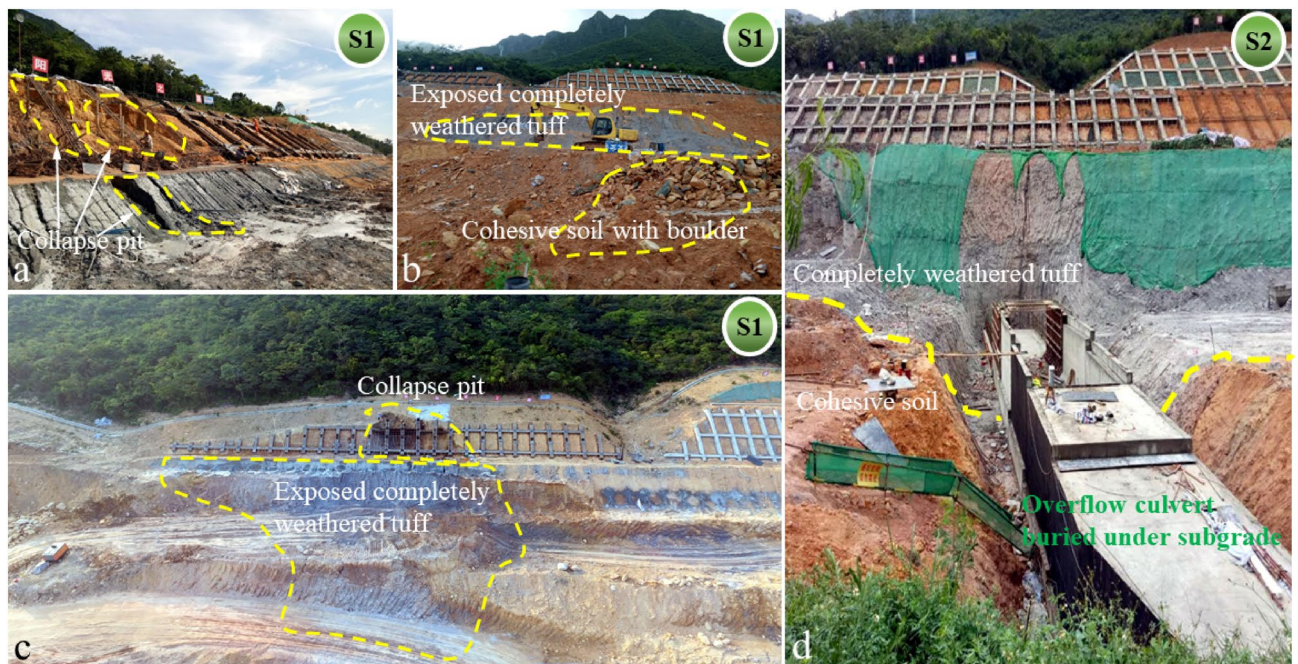
**Figure 10.** Excavation during construction of the roadside slope and toll gate (S1 and S2 correspond to the time nodes in Fig. 9). (a) Collapse pit caused by roadside slope excavation. (b) Distribution of weathered tuff on roadside slope and cohesive soil containing boulder. (c) Completely weathered tuff exposed during excavation. (d) Construction of the overflow culvert buried under subgrade.

Figure 10 shows the soil excavation during construction. The main characteristics of shallow soil including: The fully weathered tuff layer had an obvious boundary with cohesive soil layer; The natural cohesive soil easy collapsed under the rainwater runoff action, resulting in collapse pit; Some boulders were mixed in cohesive soil, and the uneven distribution of boulders may affect the soil strength. There is a direct causal relationship between the complex structure of the soil layers and the sliding phenomenon of the reinforced slope under the extreme rainfall action.

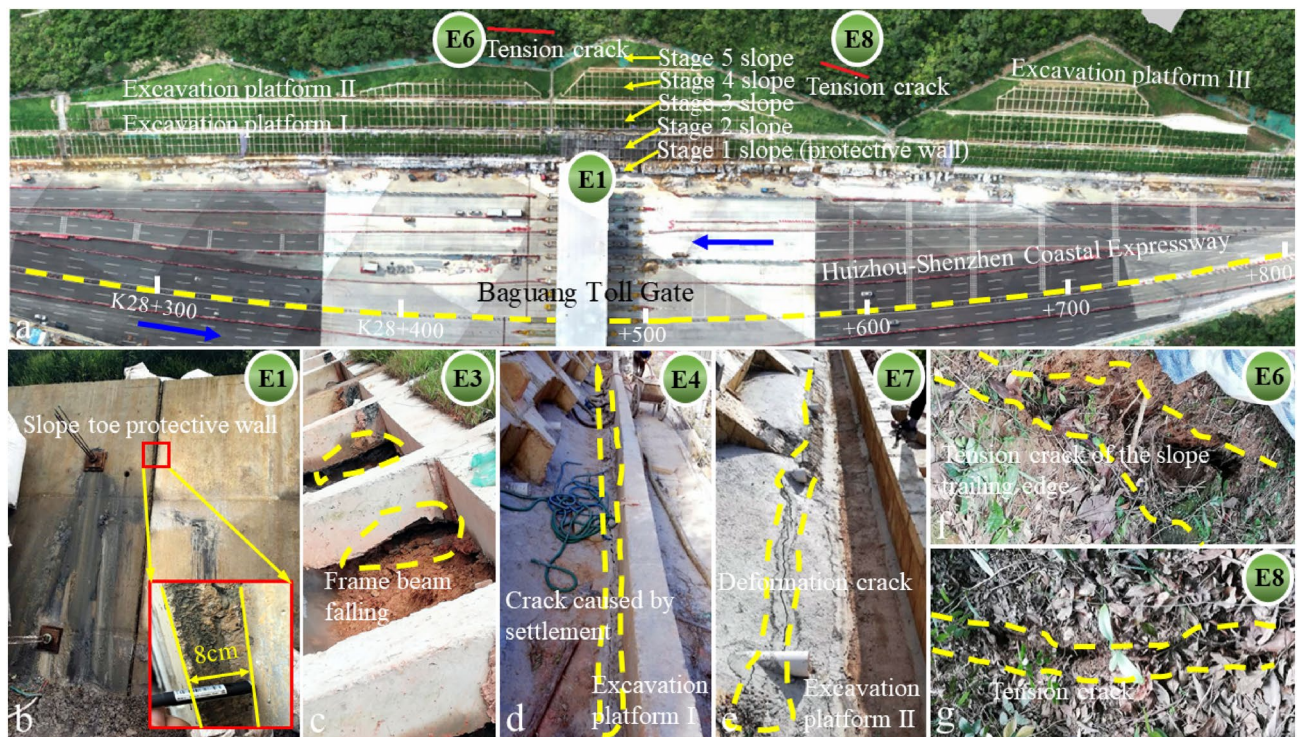
**Figure 11.** The panoramic photo of the supported slope, and the damage phenomenon in the deformation and failure evolution process (E1–E8 correspond to the time nodes in Fig. 9). (a) Supporting structure of slope; (b) deformation characteristics of the slope toe protective wall; (c) the first order frame beam deformed, damaged and out of ground contact; (d,e) drainage facilities cracking caused by the slope deformation; (f,g) tension cracks at the slope trailing edge.

Figure 11 shows the panoramic view after the construction completion, as well as the damage of different parts of the slope at different time nodes. There are five stage slopes and three excavation platforms after the slope support engineering finished (Fig. 11a, design parameters and construction distribution are shown in Fig. 3). Early observed slope deformation and failure occurred in the slope toe protective wall, and the anchored slope toe protective wall gradually produced large deformation under the strong thrust of the sliding mass (Fig. 11b). Then (Jun. 14, 2018), the first-order frame beam appeared deformation and suspension, which indicate that the slope deformation increased, and the slope stability deteriorated gradually (Fig. 11c). After 4 days, cracks appeared on the excavation platform I due to subsidence (Fig. 11d). After 40 days, deformation cracks were found on the excavation platform II (Fig. 11e). Tension cracks appeared one after another at the trailing edge of the slope (Fig. 11a,f,g). After the above deformation, the slope experienced two major storms, which directly brought the slope to the critical state of impending slip. High intensity emergency response measures were applied since September 2018. From the deformation phenomenon mentioned above, that the slope front edge damaged firstly, and the tension crack gradually appeared at the slope rear edge, this landslide can be regarded as atypical “Translational sliding” landslide<sup>34</sup>.

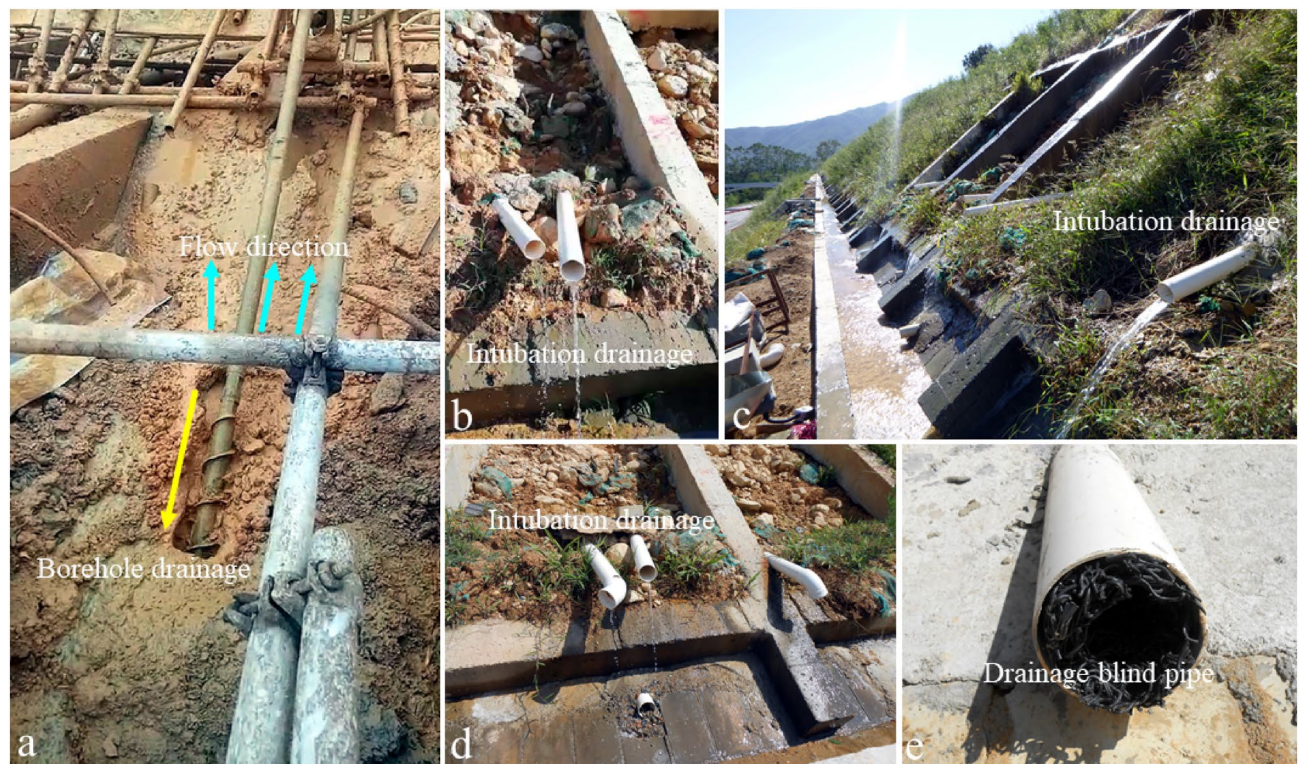
**Figure 12.** Drainage measures were taken to reduce landslide risk. (a) Borehole drainage (construction of deep horizontal drain hole); (b–d) slope insert tilted drainpipe; (e) buried drainage blind pipe.

Field observation also found that since August 2018, after heavy rainfall, the intercepting ditch was investigated and found that there was almost no water flowing into the intercepting ditch. This phenomenon indicates that a large amount of rainwater seeped into the slope and the surface runoff disappeared. Literature shows that this is the precursor of large-scale landslide<sup>38,39</sup>. To minimize the impact by the landslide, various drainage measures taken by the emergency response team are shown in Fig. 12. Artificial drilling and drainage were carried out at the slope seepage part (Fig. 12a). During the drilling process, the water flow in the slope would occasionally spray out, indicating that there was a large water pressure in the soil. After a heavy rainfall, a large amount of water could also be drained out using the inserted PVC pipe (Fig. 12b–d), indicating that a large amount of rainwater was contained in the slope soil. To drain the rainwater infiltrated into the soil in time, blind drainage pipes were directly buried in the soil during the emergency rescue process (Fig. 12e).

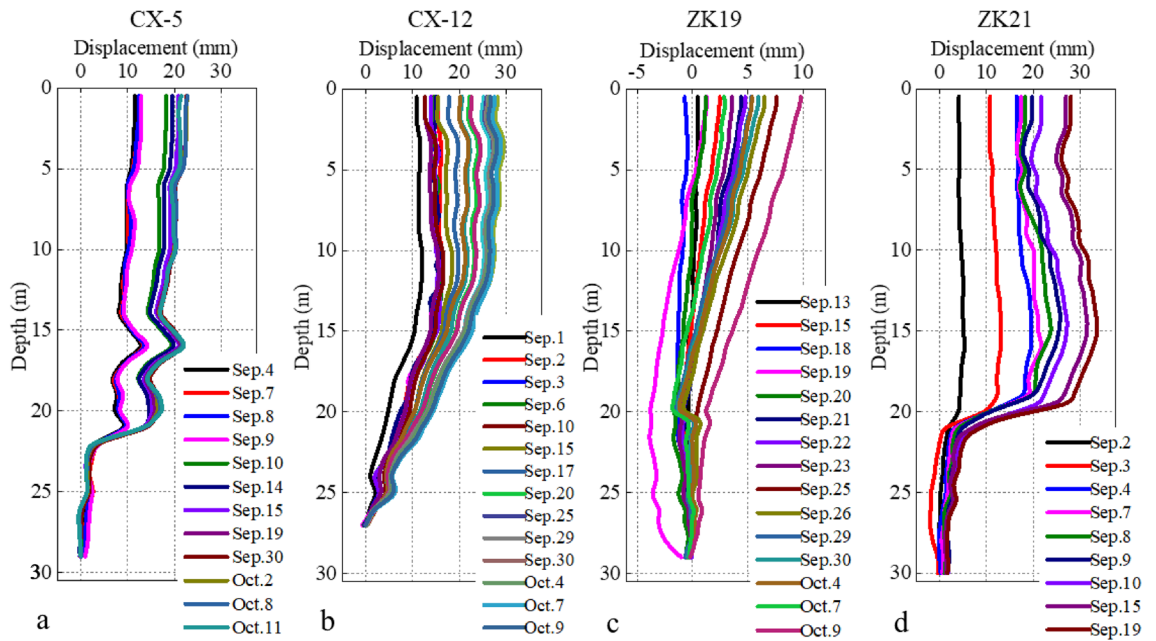
**Monitoring results.** *Inclinometer results.* Figure 13 shows the inclinometer results of some boreholes after September 2018. A positive displacement indicates that the deformation direction is the same as the sliding direction, and a negative displacement indicates that the deformation direction is opposite to the sliding direction. According to Fig. 9, the slope experienced heavy rainfall around September 1. Inclinometer results of borehole CX-5 (Fig. 9a) showed that the slip surface depth was about 21.5 m. There was “seesaw” in the depth range of 15 m to 22 m. There was an obvious “step” phenomenon in the inclinometer results during Sep. 9–10. The inclinometer results of borehole CX-12 (Fig. 9b) showed a convergence trend, the slip surface depth was about 27 m. It indicates that slope was in a “creep” state. Inclinometer results of borehole ZK19 (Fig. 9c) showed that the slip surface depth was about 28 m. At the depth of 20 m, there was an obvious “Z” type mutation of the displacement curve. The deformation curves at Sep. 9, Oct. 7 and Oct. 9 showed that the displacement curve at this borehole had obvious “oscillation” characteristics. Inclinometer results of borehole ZK21 (Fig. 9d) showed that the slip

**Figure 13.** Incliner results of some boreholes after September 2018 (the borehole position is shown in Fig. 6).

surface depth was about 20 m. Compared with the displacement at CX-5, CX-12 and ZK19 boreholes, ZK21 had no obvious gradual displacement change above the slip surface. This phenomenon indicates that the slope had slipped at ZK21 borehole location.

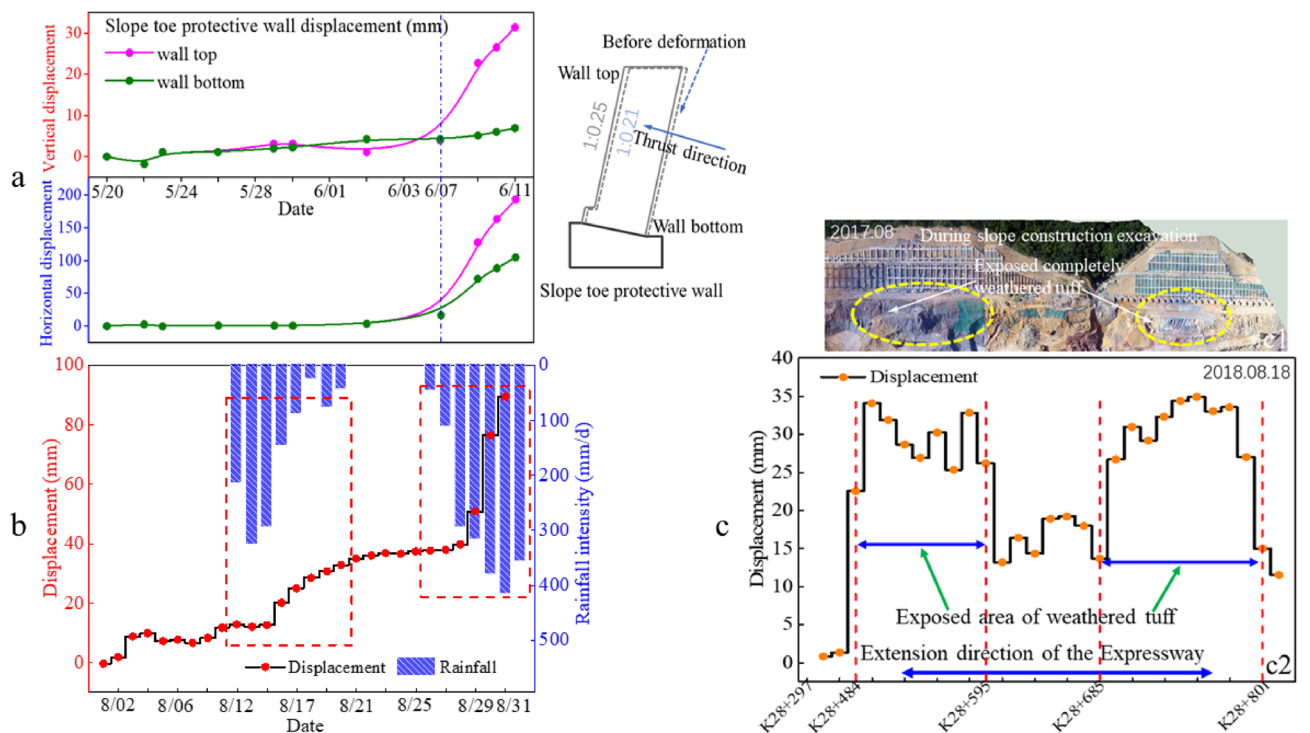
*Slope toe protective wall deformation.* Figure 14a shows the displacement variation of the slope toe protective wall (see Fig. 3) at K28 + 595 section in the horizontal and vertical directions, and the schematic diagram of stress

**Figure 14.** Typical deformation characteristics of slope toe protective wall: (a) location at K28 + 595 section; (b) (horizontal displacement) of slope toe protective wall (top) at K28 + 544 section after rainfall; (c) slope toe protective wall (top) deformation (horizontal displacement) in the extension direction of the Expressway on August 18, 2018, (c1) soil layer distribution during slope excavation, (c2) the displacement distribution.

and deformation ratio of the slope toe protective wall. Wall displacements showed that after June 7, 2018, the vertical displacement of the wall top increased significantly, and the horizontal displacement of the wall top and bottom also increased significantly. This phenomenon was directly related to the rainfall. The deformation and failure state of the protective wall was shown in Fig. 2c. In the slope slide evolution process, rainfall had obvious influence on the slope toe protective wall deformation. Figure 14b shows the influence of typical heavy rainfall on the slope toe protective wall deformation at the section K28 + 595. Each heavy rainfall could lead to a sharp increase in the displacement of the slope toe protective wall. The influence of rainfall on the slope toe protective wall deformation could gradually accumulate, and eventually led to the deformation aggravation and the slope stability deterioration.

Figure 14c shows the deformation characteristics of the slope toe protective wall along the expressway under the same observation standard. There were two areas with large deformation, namely K28 + 484 to K28 + 595 and K28 + 685 to K28 + 801. These two areas were also exposed area of the completely weathered tuff. This shows that rainfall infiltration has an obvious weakening effect on the soil strength in the completely weathered tuff distribution area. The water softening effect on the completely weathered tuff soil is also one of the fundamental reasons for the slope deformation and sliding. In addition, obvious delay phenomenon about the influence of the completely weathered tuff soil physical properties (water on its strength parameters) on the slope stability could be found clearly.

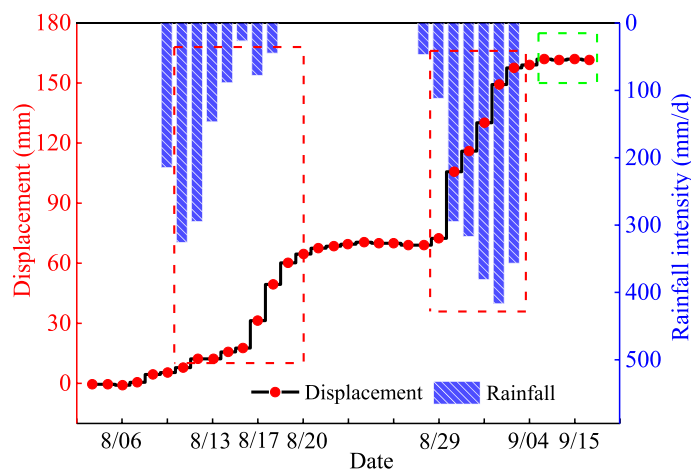
**Anti-slide pile deformation.** The deformation of the anti-slide pile (see Fig. 3) caused by rainfall is illustrated in Fig. 15. There was a rainfall started around August 10 and lasted nearly a week. The anti-slide pile showed obvious deformation of accelerating and tilting outwards at the end of the rainfall. The deformation of the anti-sliding pile had a delay relative to the rainfall process. Around August 30, the slope also experienced a heavy rainfall. However, the anti-slide pile had obvious deformation at the beginning of the rainfall. The deformation of the anti-slide pile continued but decreased gradually during the rainfall process. These phenomena show that the effect of rainfall on slope deformation had a cumulative effect. After the slope deformation develops to a certain extent, the rainfall event has a high probability to directly trigger the slope sliding. After September 15, the deformation of the anti-slide pile stopped (green frame line in Fig. 15), mainly due to the support measures taken by the emergency team.

**Figure 15.** Displacement of anti-slide pile top (excavation platform I, near the section K28 + 426) during and after rainfall.

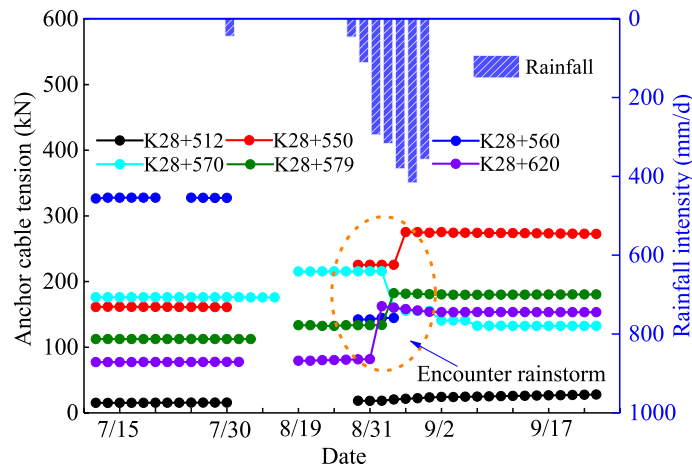
**Anchor cable tension.** The distribution of anchor cables in a typical slope profile is shown in Fig. 3. A certain density of anchor cables is distributed in the slope of the excavation platform I and above. Anchor cables are only installed in part of the slope with large excavation areas. Figure 16 shows the tension variation with time of some anchor cables in the slope at different positions along the extension direction of the expressway. The curve discontinuity is due to data acquisition failure in some time periods when emergency support was adopted for the slope safety. Between August 31 and September 2, 2018, heavy rainfall occurred in the slope area due to typhoon. Some anchor cables tension had changed significantly. Among them, anchor cable tension at K28 + 550, K28 + 579 and K28 + 620 sections increased significantly, and the anchor cable tension at K28 + 570 section decreased significantly. This phenomenon proves the adverse effect of heavy rainfall on slope stability. The variation difference of anchor cable tension reflects that the slope is not overall sliding.

**Figure 16.** Changes of anchor cable tension at different positions before and after rainstorm.

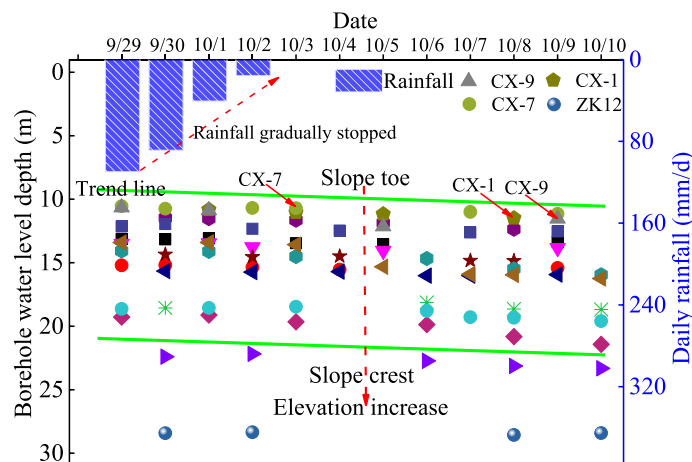
**Groundwater level change.** The groundwater level in a borehole is an important field monitoring index. The change of groundwater level in boreholes before and after rainfall can affect the slope stability directly, and its change after the rainfall reflects the comprehensive permeability of the soil layer. Figure 17 shows the groundwater level change with time in some boreholes on the site. As the rainfall gradually ceasing, the groundwater level

**Figure 17.** Groundwater level (relative to the ground at the borehole location) change in boreholes after rainfall. (Borehole location is shown in Fig. 6).

in the borehole slowly decreased within 2 weeks. The groundwater level change caused by the rainfall process showed a fluctuating trend. This phenomenon was closely related to the geological conditions at the landslide location. The relative groundwater level of boreholes at the slope toe was low. With the increase of elevation, the relative groundwater level of boreholes gradually increases. The groundwater level in the landslide region was in the range of 10 to 30 m below the ground.

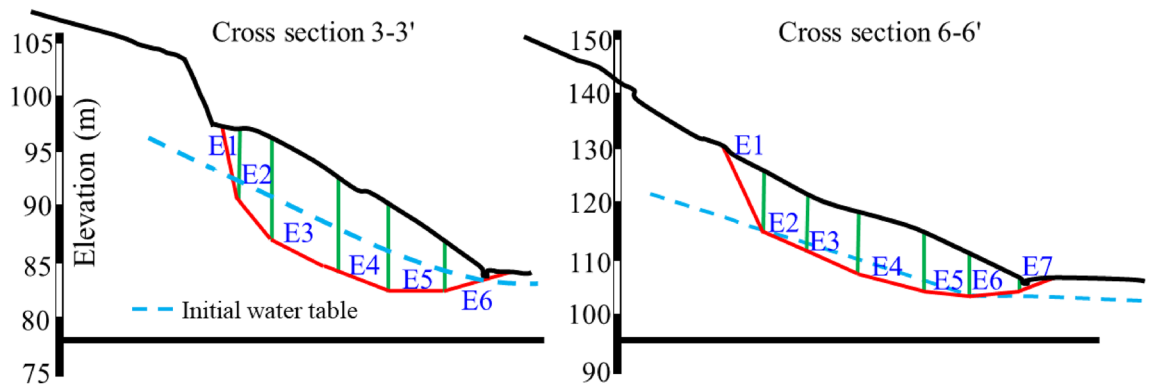
Table 3 shows the calculation parameters and results of each strip of cross section 3-3' without considering rainfall. It is assumed that the natural bulk density, saturated bulk density, cohesion and internal friction angle of each strip are the same in the calculation. The interaction force between strips is gradually accumulated from E1 to E6 through the transfer coefficient. From the calculated results, it can be seen that only the FS of E5 and E6 is greater than 1, and the FS of E6 is greater than 1, which indicates that the slope is generally in stable state. Table 4 shows the scenario considering transient continuous rainfall (rainfall intensity is 300 mm/day). Calculation parameters are kept the same as the scenario without considering rainfall. Rainfall can cause obvious changes in the strip weight, the osmotic pressure, the anti-sliding force, the sliding force, and the reaction force, which are reflected in the calculated FS. Compared with the FS obtained in Table 3, the FS of the same strip in Table 4 is significantly reduced. The FS of E6 strip is 0.943, indicating that landslide has happened.

**Figure 18.** Schematic diagram of soil strip division in cross section 3-3' and 6-6'.

respectively. Similar to the scenario of cross section 3-3', transient continuous rainfall will significantly reduce the FS of each strip. For the case of without considering rainfall, the FS of strip E7 is 1.081, while considering rainfall, the FS of E7 decreases to 0.849. If the influence of rainfall infiltration on the shear strength parameters of rock and soil is considered, the influence of rainfall events on the FS of each strip will be more significant. Therefore, rainfall infiltration plays an important role in this landslide event.

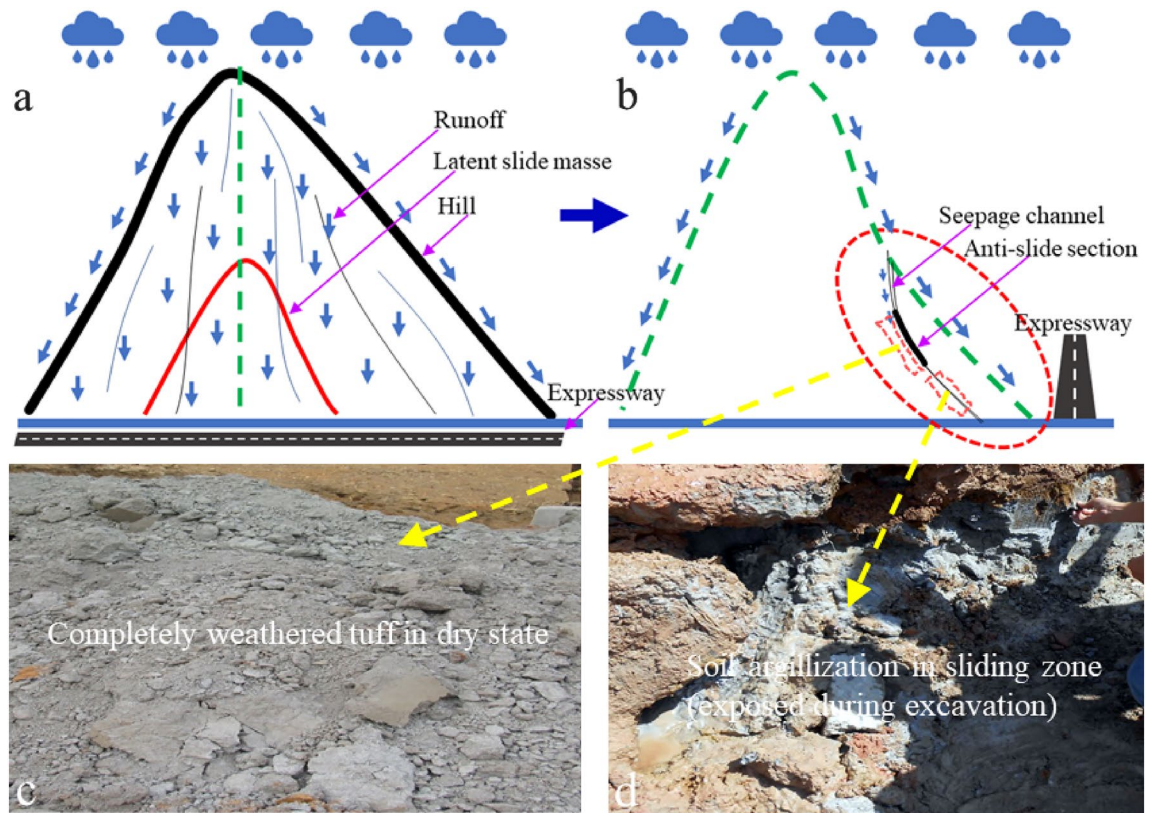
Figure 19 shows the occurrence mechanism of slope sliding triggered by rainfall. A key factor is the seepage channel. Preventing rainwater infiltration from seepage channel is the fundamental measure to eliminate the large-scale sliding risk. To achieve this goal, emergency team tries to find the seepage channel in the direction of the mountain top and prevent the runoff from flowing into the slope using intercepting and drainage ditches (Fig. 20). Figure 20 also shows the working path of seeking the seepage channel at different time node. To eliminate the large-scale sliding risk, the emergency team finally adopted the treatment of excavating part of the sliding mass and intercepting the runoff (Fig. 20b,c).

**Figure 19.** Occurrence mechanism of slope sliding caused by rainwater infiltration. (a) Schematic diagram of the sliding mass; (b) profile of the sliding mass (lateral view); (c) completely weathered tuff in natural dry state; (d) mudding state of the slip zone soil mixed by completely weathered tuff and silty clay.

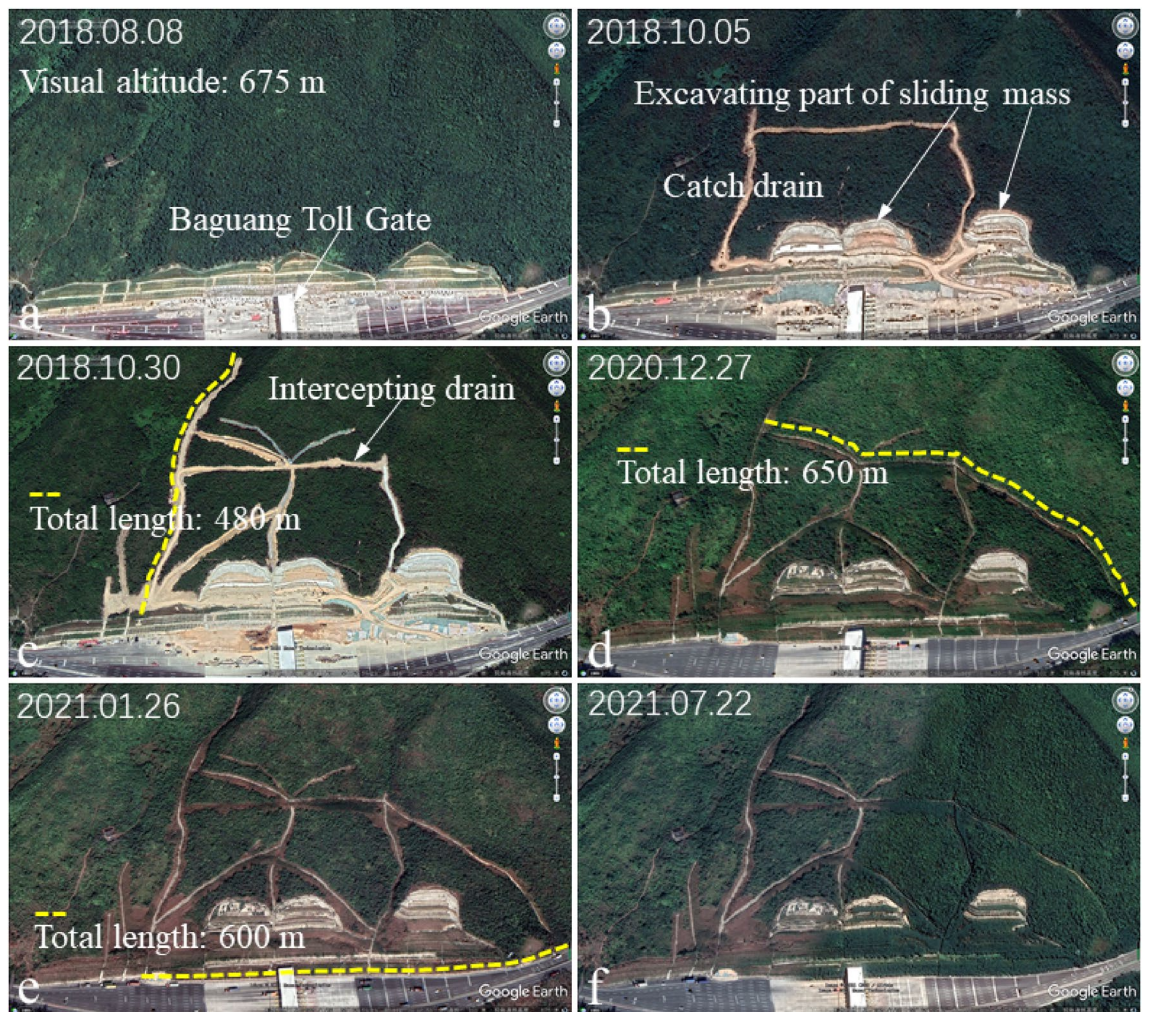
**Figure 20.** Setting and current situation of intercepting ditches and drainage ditches that block the runoff on slope surface at different time nodes. (a) The slope in a critical sliding state after extreme rainfall; (b,c) drainage ditch and intercepting ditch set on the mountain above the slope top; (d) excavation area covered by vegetation gradually; (e,f) current status of the Baguang Toll Landslide.
