Mercury vapour release from a dental aspirator

Objective To investigate the release of mercury vapour from a dental aspirator which vented its waste air through its base directly into the surgery environment.

REFEREED PAPER

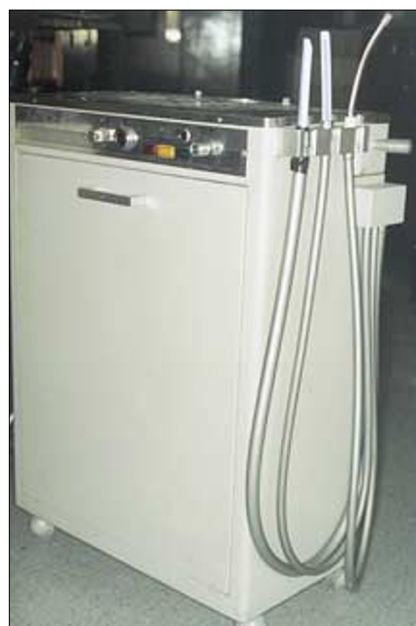
The aspirator under investigation was a model Tridac Aspiraide 2, serial number 1846H; year of manufacture 1978 (Figure 1). It had been purchased from a dental equipment dealer in April 2000 and had reportedly been removed relatively recently from a clinic in the South London area. This aspirator was in working order and on cursory examination did not appear to be unduly contaminated; the clinical tubing and internal separator canister being relatively clean. In this particular device waste aspirated air is expelled through four holes in the base directly into the surgery.

Fig. 1 Photograph of the aspirator under investigation. This particular model was of the self contained and semi-mobile trolley type that is designed to be plumbed-in next to the dental chair. This aspirator expelled its waste air through four holes in the base of the unit and consequently released mercury vapour into the breathing zone.

Venting of aspirated waste air to the outside is clearly desirable in view of the findings of this report. The particular device under test was not designed to have its exhaust vented to the outside although its modern equivalent has the option to do this. Guidelines do exist which recommend that dental vacuum exhaust should be vented outside at roof level away from air intakes and opening windows.⁸ The guidelines are not mandatory and appear to be made in the main with regard to bacterial contamination rather than to the possibility of mercury vapour exposure.

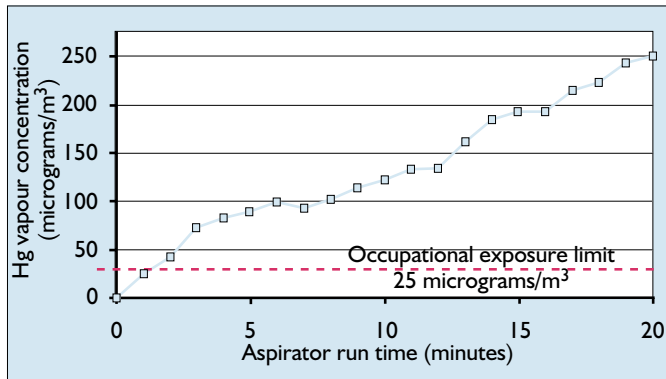
Fig. 2 Mercury vapour in the breathing zone of the dentist with aspirator run time. The aspirator was switched off after about 20 minutes as mercury vapour levels of ten times the occupational exposure limit had been reached.

At the breathing zone of the dentist mercury vapour levels increased steadily with aspirator operating time. The test was terminated after 20 minutes as room concentrations had already reached 250 µg/m³ or ten times the occupational exposure limit. Figure 2 shows the rise in mercury vapour concentration in the breathing zone as the aspirator is left running on full power, the small fluctuations were probably caused by air currents within the laboratory.

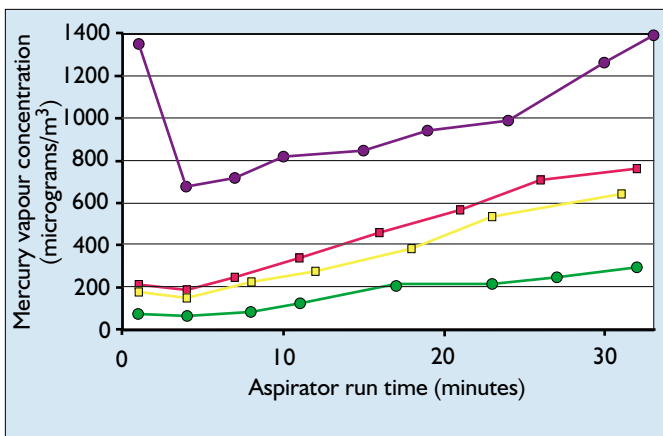
Figure 3 shows mercury vapour concentrations at the exhaust

Fig. 3 Mercury vapour concentration of emissions at the aspirator exhaust vent. Blue, contaminated aspirator; red, internal tubing and canister cleaned; yellow, internal tubing, canister and air exhaust filter cleaned; green, internal tubing, canister and air filter cleaned and old vacuum motor replaced.

vent. In the aspirator's contaminated condition an initial spike in mercury vapour emissions to 1400 µg/m³ is seen before falling back to 700 µg/m³ and then rising steadily back up to 1400 µg/m³ again after 30 minutes of continuous operation.

Cleaning of the internal and external pipe work and canister produced almost a 40% reduction in mercury vapour emissions at the exhaust port. The same pattern of an initial spike in mercury levels as the machine was switched on followed by the linear rise with temperature increase was still observed.

Further reductions of 10% in vapour emissions were observed when the old blackened amalgam dust contaminated foam bacterial air filter was cleaned.

Subsequently replacing the old vacuum motor with a new uncontaminated one further reduced mercury emission by approximately 25%.

Approximately 40% of the mercury vapour emissions from this aspirator resulted mainly from amalgam contamination of the internal pipe work. The flexible corrugated plastic tubing appeared to offer a good surface for gross amalgam deposition to occur.

The foam bacterial air exhaust filter also contributed to mercury vapour emissions by acting as a trap for particulate amalgam through which hot air from the vacuum motor passed before venting into the room.

The vacuum motor itself also acted as a significant source of mercury vapour because of amalgam dust particulates trapped within the motor housing and armature. The vapour pressure of mercury rises exponentially with temperature and consequently as the vacuum motor heated up with run time mercury vapour release increased.

The initial spike in mercury vapour emission as the aspirator was turned on can be explained by a build up of vapour within the casing released by amalgam dust contamination after the aspirator had been turned off.

Even after the old motor was replaced with a new 'clean' one it was not possible to completely eliminate all mercury vapour emissions. The vacuum motor was surrounded by sound insulating material, which had become contaminated with particulate amalgam dust, as was the whole of the internal casing. Heat from the operation of the vacuum motor warmed the surrounding amalgam contaminated insulation and metal casing propagating the release of mercury vapour.

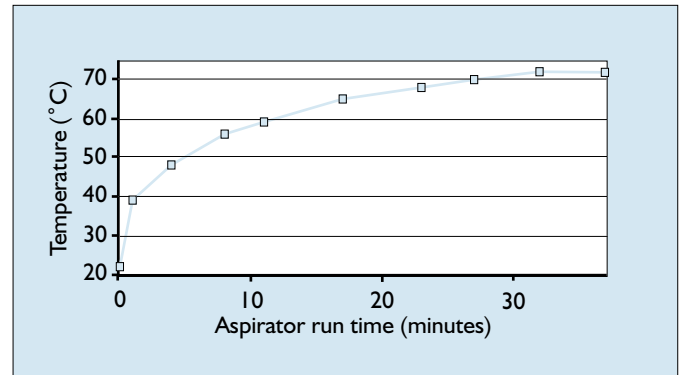
Figure 4 shows the increase in air exhaust temperature as the electric vacuum motor heats up with run time.

Fig. 4 Increase in aspirator exhaust air temperature as vacuum motor heats up with run time.

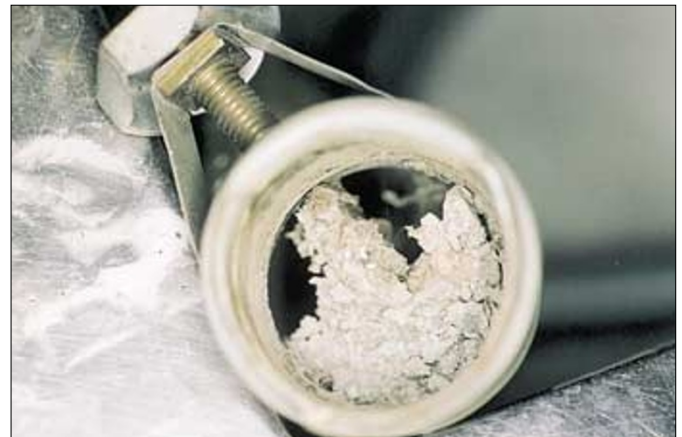
Visual examination of the internal pipe work following the initial tests revealed gross amalgam contamination in the internal pipe work. Heaviest contamination being visible as a build up of an amalgam concretion in the corrugated plastic pipe leading from the clinical suction tube manifold to the top of the separator canister (Figure 5.) Similar gross amalgam concretions were also visible in the suction manifold. By comparison the external clinical suction tubing and internal canister were relatively clean.

Fig. 5 Photograph of amalgam contamination within corrugated internal tubing of aspirator.

Although cleaning the internal pipe work of the aspirator led to a 40% reduction in mercury vapour emission, caution should be exercised whilst carrying out this procedure as readings taken inside

the aspirator cabinet above the canister and vacuum motor whilst hot were sometimes off the scale of the analysing instrument. It is recommended that this procedure should be carried out only with adequate ventilation and use of a mercury vapour absorbent mask and then only when the vacuum motor has cooled. As mercury crosses the placenta, pregnant workers should avoid cleaning contaminated parts of aspirators such as the separator canister.
