## CASE REPORT

# Erosion of urethra by malleable penile prosthesis in a spinal cord injury patient with diabetes mellitus and repeated misplacement of Foley balloon in the urethra: lessons we learn: a case report

*Spinal Cord Series and Cases* (2022)8:12; <https://doi.org/10.1038/s41394-022-00481-2>

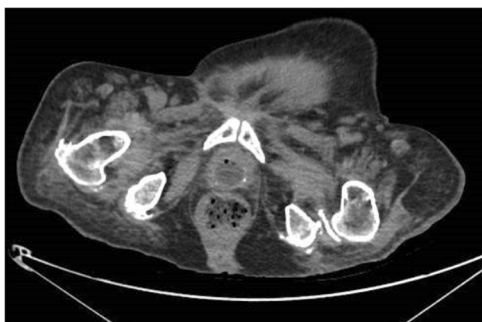
**Fig. 1 CT Pelvis.** CT of pelvis (axial section) performed on 28 August 2020 shows the Foley balloon located in the prostatic urethra.

In August 2020, CT of pelvis showed no evidence of gas locules in the penile soft tissues. The implants were present in both corpora cavernosa with no obvious migration of the prostheses. The balloon of the Foley's catheter was present in the prostatic urethra. (Fig. 1) The catheter was changed in the community.

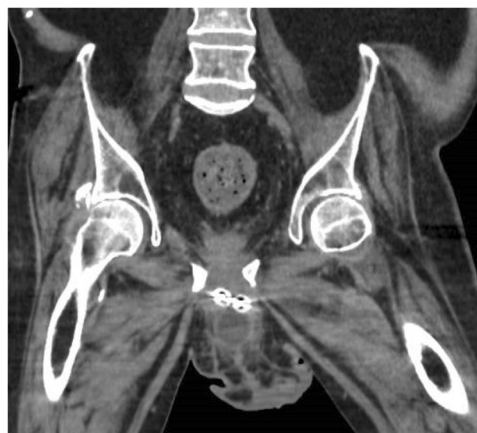
**Fig. 2 CT pelvis.** CT of pelvis (coronal section) done on 24 November 2020 shows the Foley balloon, which has been inflated in the prostatic urethra, is abutting the penile prostheses (located cephalad to the Foley balloon).

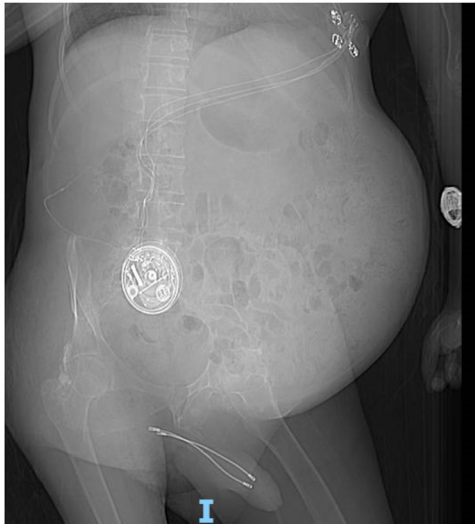
CT of urinary tract with contrast was performed on 11 December 2020. The scout film showed the two prostheses in the penis (Fig. 3). CT revealed that the urethral catheter balloon was currently at level of membranous/prostatic part of urethra, rather than within the urinary bladder. There was fluid attenuation collection measuring  $8 \times 1.7 \times 1$  cm (L x W x D), extending from the anterior inferior aspect of symphysis pubis, to between the corpus cavernosus penile implants, up to the perineum (Fig. 4). Gas locules were present within the more cranial aspect of the fluid collection, which indicated secondary infection (Fig. 5). Corpus cavernosus penile implants were in situ, with the distal tip of left implant abutting the skin surface. This CT revealed fluid collection and evolving fistula tracking and draining to the perineum.

**Fig. 3 Scout film of CT.** Scout film of CT (11 December 2020) shows penile prostheses in situ. The baclofen pump is seen in the centre and the sacral root stimulator at the top right.

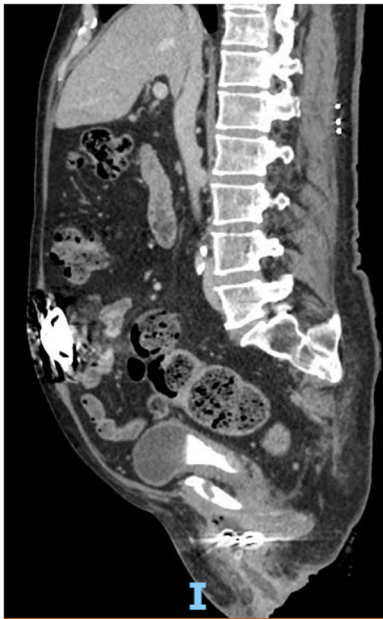
**Fig. 4 CT abdomen and pelvis.** CT of abdomen and pelvis (sagittal section) performed on 11 December 2020 shows fluid attenuation collection measuring  $8 \times 1.7 \times 1$  cm (L x W x D), extending from the anterior inferior aspect of symphysis pubis, to between the corpus cavernosus penile implants, up to the perineum. Gas locules were present within the more cranial aspect of the fluid collection.

Cystoscopy revealed large posterior false passage in bulbar urethra connecting to perineal wound. Both implants were exposed in the urethra at the verumontanum. Urinary bladder showed chronic reaction to catheter. Suprapubic cystostomy was done. Through a penoscrotal incision, bilateral longitudinal corporotomies were performed. Both prostheses were removed intact. The corpora cavernosa were closed with 3-0 Prolene interrupted sutures. The patient was left with urethral and suprapubic catheters to maximise urine drainage away from the fistula.

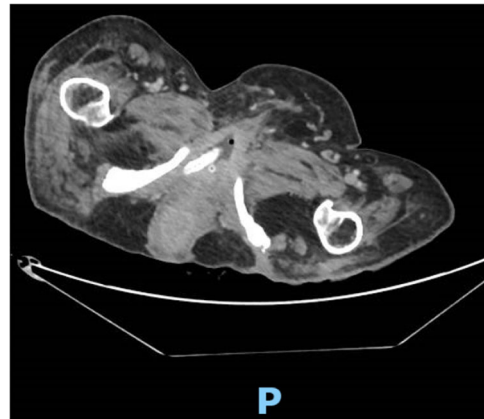
**Fig. 5 CTAbdomen and pelvis.** CT of abdomen and pelvis done on 11 December 2020 (axial section) shows fluid collection (containing a gas locule) around the anterior aspect of the penile implant.
