Investigating defects and annual degradation in UK solar PV installations through thermographic and electroluminescent surveys

Mahmoud Dhimish¹ and Ghadeer Badran¹

npj Materials Degradation (2023)7:14; <https://doi.org/10.1038/s41529-023-00331-y>

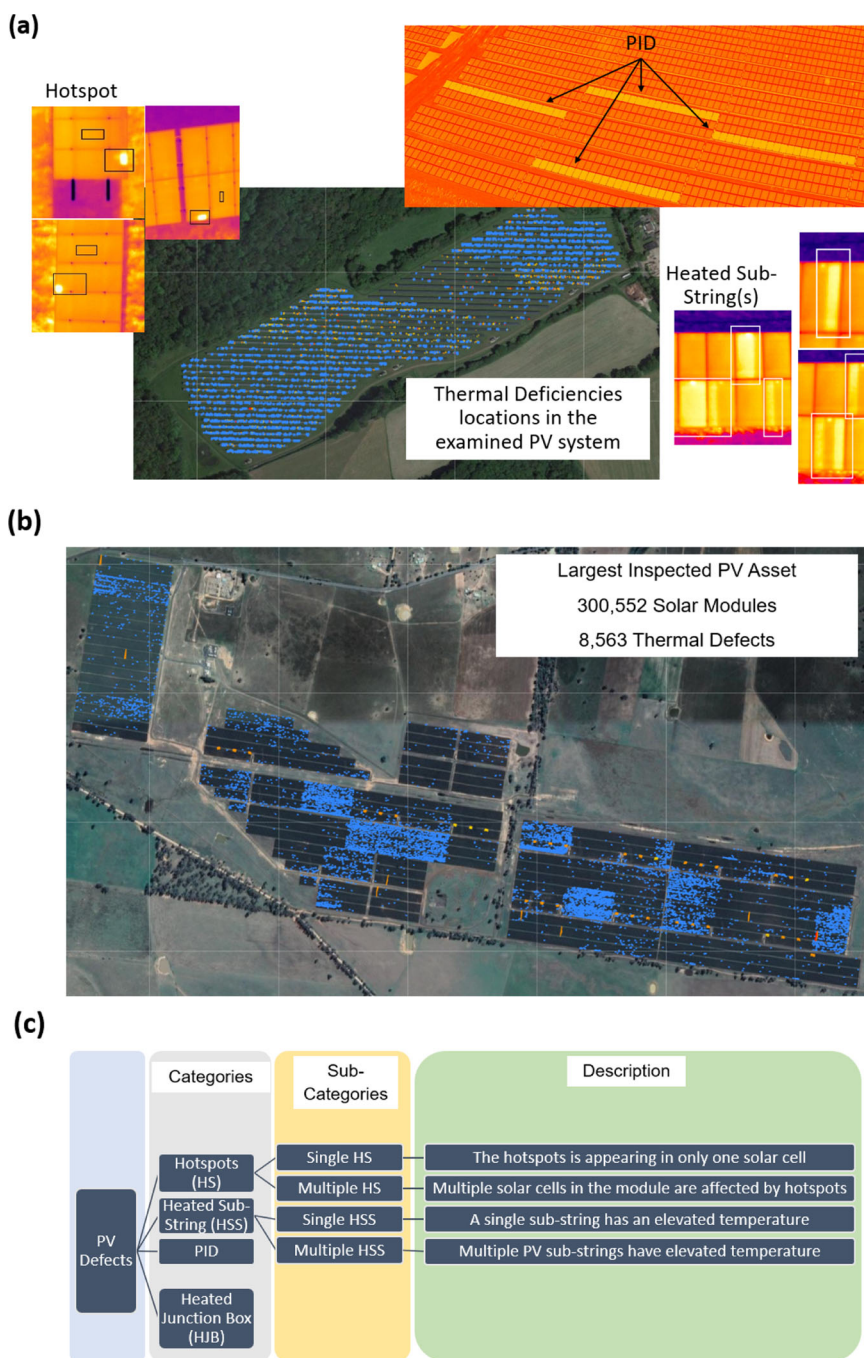
Fig. 1 Example of the analysis of the thermal efficiencies for two different PV assets. **a** A PV asset with 20,570 solar modules containing 4993 thermal defects. In this installation, hotspots, PIDs, and heated sub-strings are examples of thermal problems. Thermal defects are indicated by red, yellow, and blue dots. According to the “confidentiality agreement” with the PV asset owners, the precise geographical location of these assets is confidential. **b** Here is another example showing the locations where thermal anomalies were detected in one of the largest PV assets inspected, with 300,552 solar modules and 8563 thermal defects found. **c** Categories of the PV thermal anomalies investigated/analysed in this work.

Two different examples of the thermal defects of PV assets are shown in Fig. 1. The red/yellow/blue dots represent the location of the thermal deficiency, which is identified and analysed using the thermal camera. For example, in Fig. 1a, A total of 4993 thermal defects were found in all 20,570 solar modules available for this PV asset (24.27% defective cases). Installation of this PV system is approximated at a title of 37° and a azimuth of -7°. Figure 2b shows our largest inspected solar asset, comprising 300,552 solar modules with 8563 thermal defects. PV modules in this installation have different azimuths (+13° to -25°) and titles (27° to 33°). Due to prior agreements with local authorities, the precise locations of PV assets are kept confidential.

A summary of PV defect categories/subcategories can be found in Fig. 1c. We analysed all PV system defects, including hotspots (Single HS or Multiple HS), heated substrings (Single HSS or Multiple HSS), PID, and heated junction boxes (HJB). To compare and analysed data, these defects were populated for each inspected PV installation.

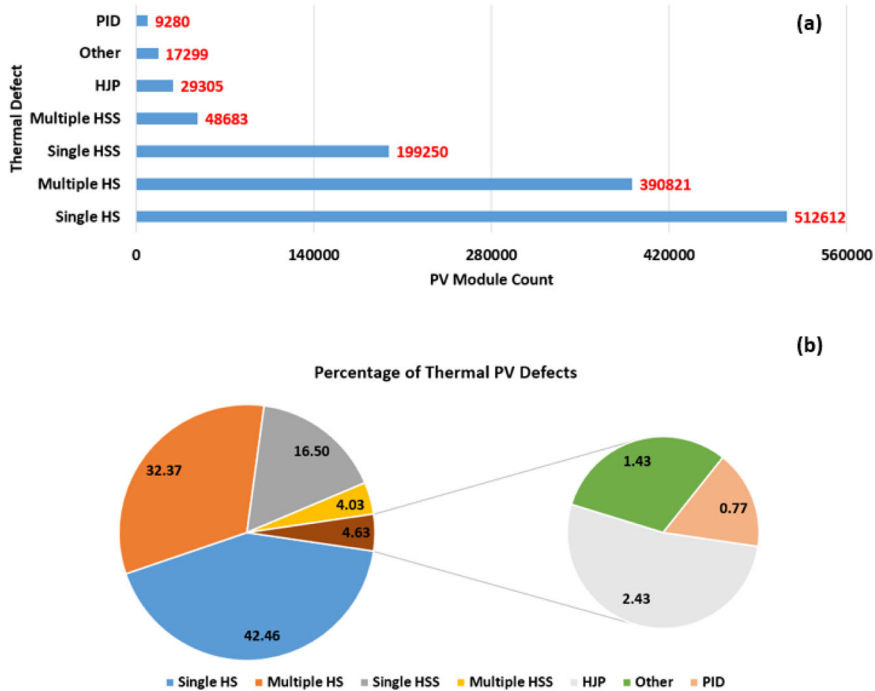
Fig. 3 Summary of the thermal efficiencies of the inspected PV modules. **a** PV count of thermal defects. **b** Percentage of PV defects.

A summary of all thermal defects found in inspected PV modules can be found in Fig. 3. According to the inspection, 36.6% of 3,300,000 modules were defective, while 63.4% were defect-free. As shown in Fig. 3a, with 512,612 reported cases, the single HS is the most common thermal defect. PID is the least common thermal fault; however, previous research^{29,30} has demonstrated that it can adversely affect PV modules and lead to 25–50% power losses. Compared with single HS, which are most likely to affect PV

According to Fig. 3b, 42.46% of all thermal defects are caused by a single HS, and 32.27% by multiple HS. A remarkable observation is that 16.5% of all faults are caused by one HSS. Consequently, defective bypass diodes or soldering defects are likely to cause PV module failures. A second interesting observation is that only 2.43% of PV modules are affected by an HJB. In light of recent papers³¹, it is surprising that this result emerged,

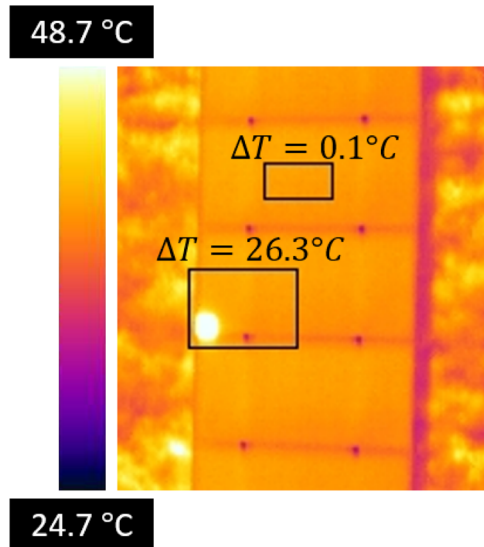
Fig. 4 An example of a thermal image taken for PV modules with different ΔT variations. In the example, we show that a PV module without hotspots has $\Delta T = 0.1^\circ\text{C}$ while it is equal to $\Delta T = 26.3^\circ\text{C}$ when a module is affected by a single HS.

For example, Fig. 4 shows two PV modules with recorded ΔT . For the upper PV module with no hotspots, the $\Delta T = 0.1^\circ\text{C}$, whereas the single HS in the lower PV module shows an elevated

temperature of $\Delta T = 26.3^\circ\text{C}$. The operating voltage loss, V_{loss} , of the PV module with $\Delta T = 0.1^\circ\text{C}$ is 0.03 V , and for the module with $\Delta T = 0.1^\circ\text{C}$ is equal to 30.7 V . The operating voltage of the thermally defective module is found using (4), where $V_{non-defective}$ and $V_{defective}$ represents the operating voltage of the adjacent non-defective PV module, and the module with thermal defect, respectively:

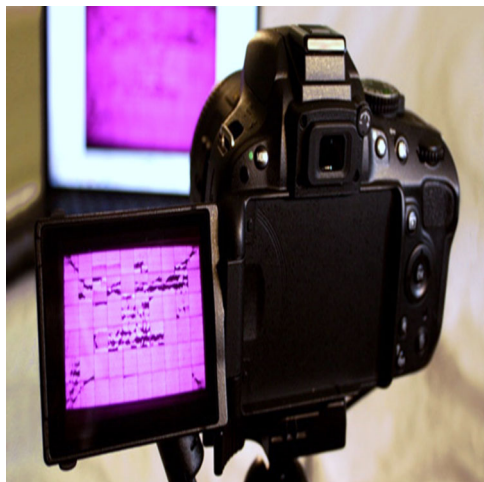
Fig. 6 EL imaging setup used to test the PV module. The EL camera is brought by Brightspot Automation, USA-based company.

In this section, we discuss the correlation between thermal and EL imaging for PV modules. Thermal images are known to aid in identifying PV faults^{32,33}, but EL images can also be used for determining solar cell health. Therefore, we have used an EL testing setup, as shown in Fig. 6 to test PV modules with different thermal defects.

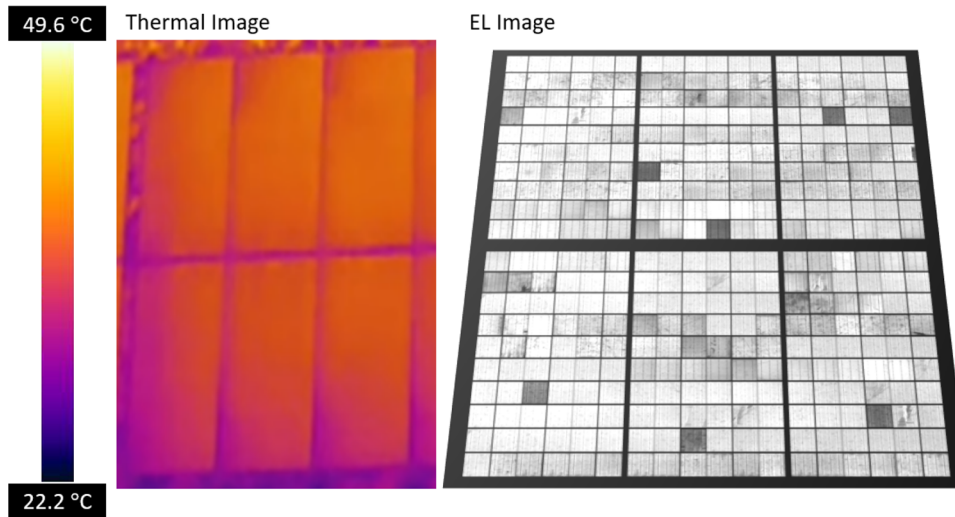
Fig. 8 Another two examples of thermal vs. EL images of PV modules. In spite of the fact that the EL images show that the PV modules have multiple cracks, there is no thermal defect in the modules (the solar cells are not becoming hotter).

Another comparative example of PV thermal vs. EL image is shown in Fig. 8. When observing the thermal image, no anomalies can be detected. However, almost all six PV modules developed cracks after completing the EL inspection. In addition, multiple solar cells exhibit low EL intensity, which could be due to early PID, shunting, or breakdown regions in the cells. As a result, the EL image assures that if these modules keep operating under field conditions, the cracks will deteriorate, creating hotspots, and thus reducing their power output.
