Experimental study on the properties of modern blue clay brick for Kaifeng People's Conference Hall

This article presents building assessment research comprising on-site inspections, indoor scientific tests, and material performance studies on the wall blue clay bricks in the Kaifeng People's Conference Hall, objectively developing an enhanced scientific understanding to renovate modern buildings. Using X-ray diffraction (XRD), scanning electron microscopy (SEM), alongside a parametric study of density, moisture content, water absorption, void ratio, frosting, compressive strength, and softening coefficient in assessing the material health of the blue clay bricks and its non-key parts, in developing "appropriate and compatible renovation" to repair contemporaneous buildings. The composition, pore characteristics, weathering degree, and mechanical properties of the blue clay brick samples were analyzed. These parameters showed that blue clay brick fired at less than 1000 °C; the main mineral composition as quartz, followed by albite, mica, and anorthite. Its density was 1.573 g/cm³, less than the 1.70 g/cm³ of ordinary clay brick. According to the standards, the water absorption wa

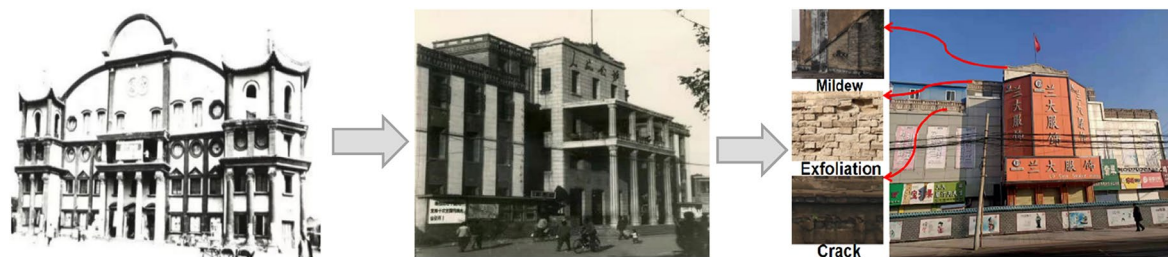
Figures 1–3. **Figure 1** Early completion of construction. **Figure 2** Transformation by posterity. **Figure 3** Expansion of shops outwards.

Note: Fig. 1 and Fig. 2 are obtained from Kaifeng Archives. Figure 3 is obtained by the author personally on site.

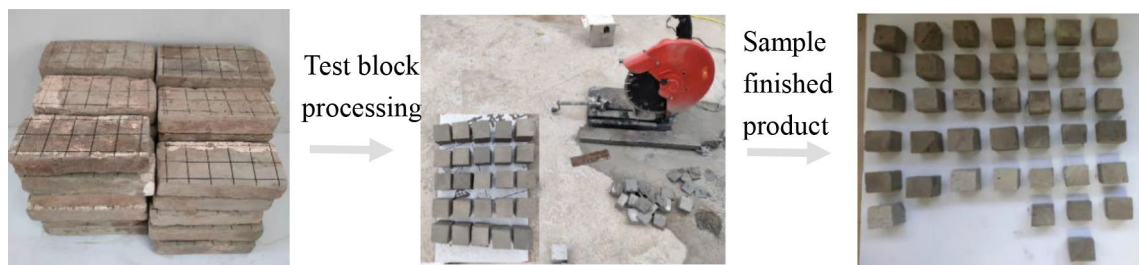
Figures 4–6. **Figure 4** Brick samples. **Figure 5** Specimen cutting and grinding. **Figure 6** Sample finished product.

Preparation of the test samples. The samples came from partially blue clay bricks on the walls of the Kaifeng People's Conference Hall. Before performing various basic performance tests, the blue clay bricks were pretreated, and Fig. 4 shows some of these bricks. First, we removed the floating dust and mortar remaining on the brick surfaces, and then using a marker, drew a small grid of 50 mm × 50 mm on the cleaned surfaces. Then, following "Material for maintenance and conservation of historic architecture—Grey brick" (WW/T 0049-2014), the blue bricks were cut along the small grid drawn, using a cutting machine (see Fig. 5). Finally, cut and polished the blue bricks to make 50 mm × 50 mm × 50 mm cube samples (as seen in Fig. 6).

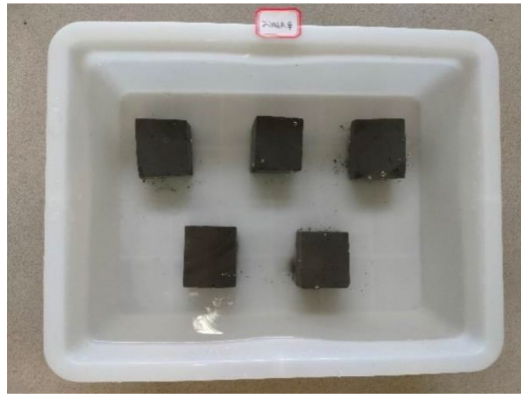
Figure 7. Samples soaking for 24 h.

Experimental method. According to the specifications in “Test Methods for Wall Bricks” GB/T 2542-2012, we took five pieces of 50 mm × 50 mm × 50 mm cube samples, cleaned the samples’ surface with a brush, and numbered them; the numbers were A₁–A₅, respectively. First, we weighed the mass m_0 of each sample in the natural state. Next, placed the sample in a blast drying box set to 105–110 °C to dry to a constant mass m_1 after drying. Next, immersed the dried sample in water at 10–30 °C (as shown in Fig. 7) and took it out after 24 h for repetitive weighing until the difference between three consecutive measurements was less than 0.2% (as shown in Fig. 8), and recorded its mass m_{24} .

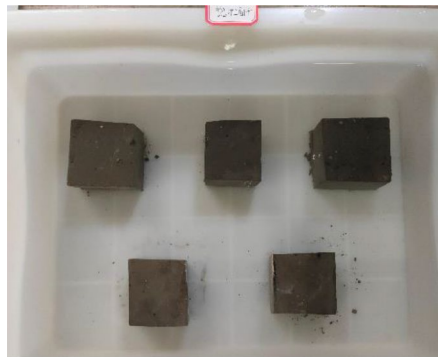
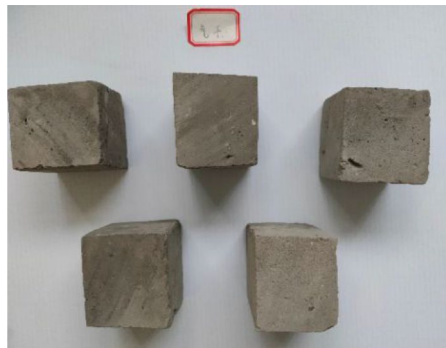
Figure 9. State of dry saturated samples.

Figure 10. State of air-dried samples.

Experimental method. Ten 50 mm × 50 mm × 50 mm cube samples were taken; five samples were used for the strength test in a saturated dry state, and the other five were used for the strength test in the air-dry state. First, five samples were immersed in water (at 15–25 °C); the water surface was maintained 20 mm higher than the sample surface, and took the samples out after 4 days of soaking. Next, placed the removed samples on a wire mesh rack to drain the free water for 1 min, and then wiped off the excess water on the sample surface with a damp cloth. At this time, the samples were saturated but dry (as shown in Fig. 9). Next, put the other five samples in a non-ventilated room set at a temperature of less than 10 °C for 72 h; the samples were air-dried (as seen in Fig. 10). Finally, the saturated dry and air-dried samples were tested using the aforementioned compressive strength test. The compressive strength ratio in the dry form of the saturated sample to the strength in the air-dry state was the value determined as the softening coefficient.

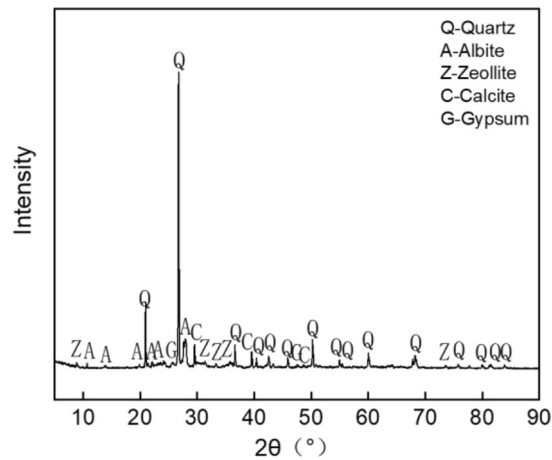
Figure 11. XRD pattern of ordinary sintered red brick.

Phase analysis. We combined the drawing tools to draw the mineral composition diagram (as shown in Figs. 11, 12). Figure 11 indicated that the main mineral composition of ordinary sintered red bricks was quartz, but it also contained albite, zeolite, calcite, and gypsum. Similarly, the annotated Fig. 12 (for blue clay brick) illustrates that quartz's diffraction peaks were 20.8°, 26.6°, 36.5°, 39.4°, 40.3°, 42.4°, 47.5°, 50.1°, 55.3°, 60.9°, 64.0°, 68.1°, 68.3°, 73.5°, 77.6°, 81.2°, 81.5°, and 84.972°. The diffraction peaks for albite were 22.1°, 23.5°, 27.9°, 28.7°, and 29.4°. The diffraction peaks for anorthite were 31.2° and 45.4°. The diffraction peaks for mica were 8.8° and 24.1°. Hence, the main mineral composition of the blue clay brick was also quartz. In addition to quartz, it also contained albite, mica, and anorthite. There were no high-temperature sintered products of mullite and cristobalite; hence the sintering temperature did not exceed 1000 °C^{44–51}.

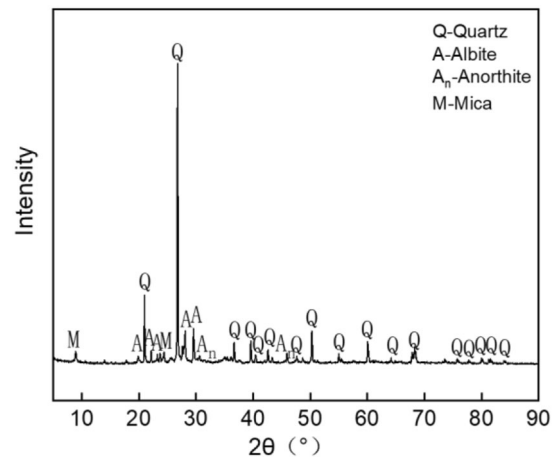
Figure 12. XRD pattern of clay blue brick sample.

- (1) The main mineral composition of the blue clay brick materials in the People's Conference Hall walls was quartz, followed by albite, mica, and anorthite. There were no high-temperature sintered products of mullite and cristobalite. Therefore we inferred that the sintering temperature of this batch of bricks did not exceed 1000 °C. It was crucial to pay attention to the preparation of blue clay brick materials with similar material properties.

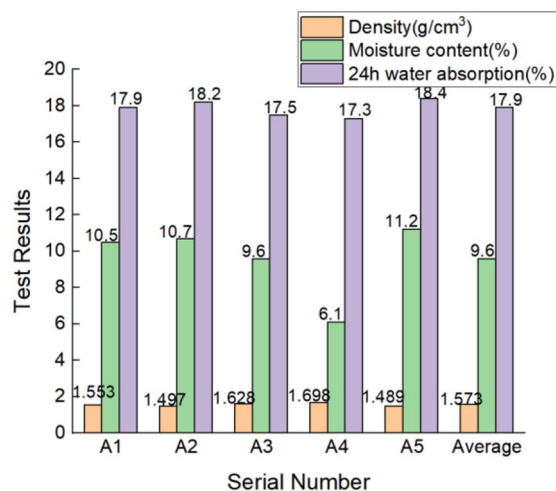
The calculated results for each sample's density, moisture content, and 24 h water absorption are shown in the bar charts in Fig. 14; A1–A5 are the five sample numbers.

The test results in Fig. 14 show that the density for the five samples ranged from 1.489 to 1.698 g/cm^3 , with an average value of 1.573 g/cm^3 . The density of the five samples and the average result was lower than the density value of 1.70 g/cm^3 of standard clay bricks. Under the natural environmental forces on the wall for nearly a 100 years, affected by weathering, there were many pores in the brick body so that the compactness of the sample had slightly reduced. The water content of the five samples was 6.1 – 10.7% , and the water absorption was 17.3 – 18.4% . The water absorption of five samples was partially lower than the average value of “Sintered Ordinary Brick” (GB/T 5101-2017) (18%), but some of them reached more than 18% , with an average value of 17.9% . Although it was close to the average value (18%) of “Sintered Ordinary Brick” (GB/T 5101-2017), the water absorption was slightly higher. In addition, from the bar charts, it was seen that the higher the density for the same sample, the lower the water content and water absorption, which reflected that the denser the material and the smaller the internal porosity of the material.

Figure 14. Bar charts of density, moisture content, and water absorption of each sample.

The density, moisture content, and water absorption depended on the brick's size and the number of pores. The number and size of the internal pores are some of the main factors that affect the durability of the wall that cause the wall deterioration. Kaifeng is rainy in summer, and the water absorption of the blue bricks on the wall is relatively large. After the wall bricks were saturated with water, they become easily affected by temperature^{52–54}. Due to thermal expansion and cold contraction at high temperatures, the blue clay brick will crack and peel off

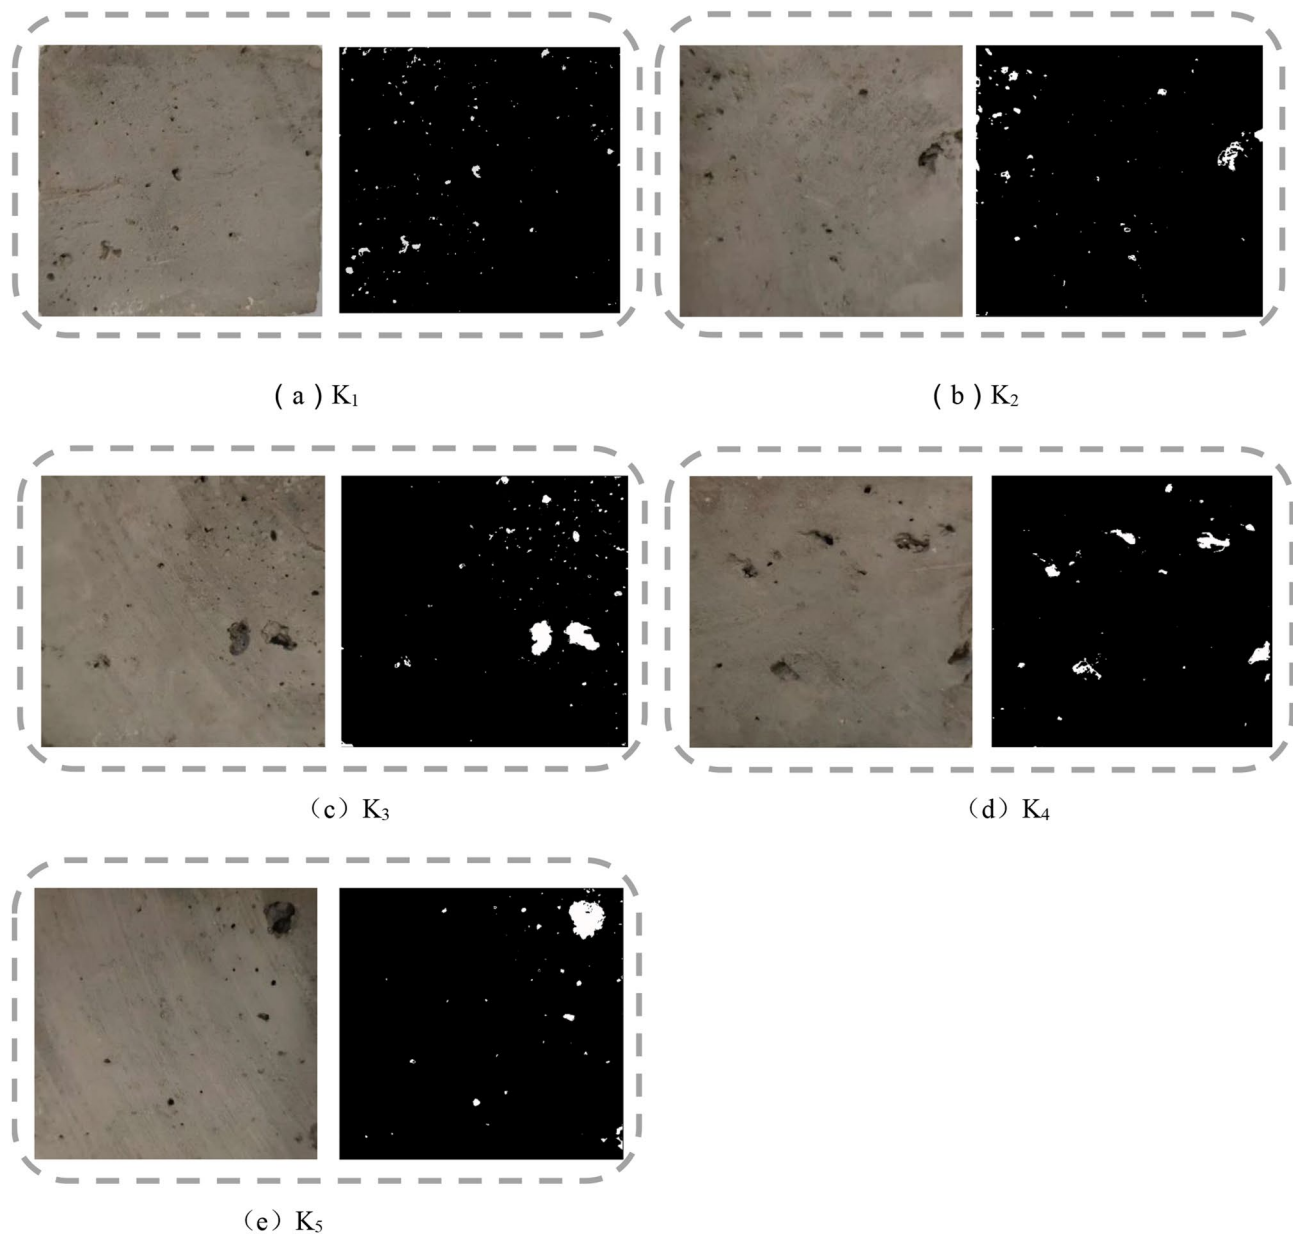
The measured results were summarized (as shown in Table 1). In addition, the internal pore diagram of the sample (as shown in Fig. 15) are respectively the samples of K₁–K₅. The calculated result of the void ratio for each sample was represented by a bar chart (as shown in Fig. 16).

Figure 15. Hole inside the sample.

The first picture shows the surface of the brick sample in Fig. 15a–e. In order to make readers see the holes on the surface of the brick more clearly, the second picture outlines the surface of the brick, highlighting the position and shape of the holes in white.

Due to the limitations of the test instrument, we used the vernier caliper to measure the size of hole. Accurate to mm. The results in Table 1 showed that the void ratio of the brick sample lay between 3.59 and 3.75%, and lower than the void ratio of standard solid clay bricks (25%). In conjunction with the local Kaifeng environmental conditions and with the long-term groundwater migration, salt erosion, freeze–thaw cycles, and alternating cold and heat, the blue clay bricks of the Kaifeng People’s Conference Hall produced internal pores that were invisible to the naked eye^{56–60}. This kind of blue brick with relatively large sand content is easily affected by the environment. Located beside the Yellow River, Kaifeng is cold in winter and rain in summer, so its cultural relics are more vulnerable to damage caused by freeze–thaw cycles. In the process of repeated freezing and melting, the phase state of the water between the pores of the blue bricks in the wall constantly changes, resulting in the internal pores being constantly in microscopic expansion force, and finally leading to the expansion of the pore structure. The expansion of internal pores not only leads to the decrease of the density of blue bricks on the wall, but also increases the water absorption, and slowly expands the hole visible to the naked eye, so that the number of brick surface holes in the original bricks have caused holes.

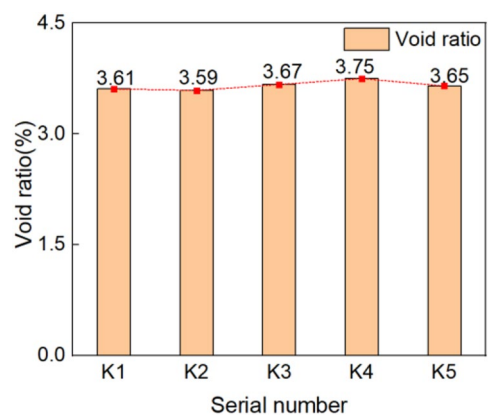
Figure 16. Void ratio histogram.

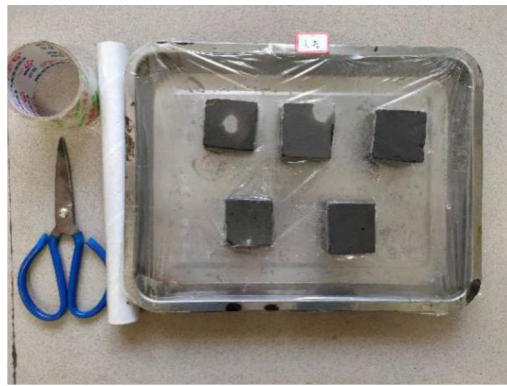
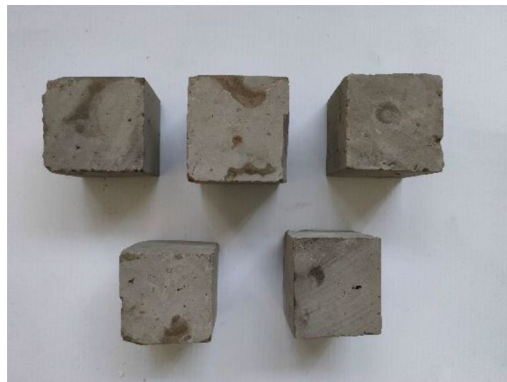
Figure 17. Frost testing process.

Figure 18. Evidence of sample frosting.

Frost test results and analysis. The frosting test process and test samples are seen in Figs. 17 and 18. According to the “Test Method for Wall Bricks” (GB/T2542-2012), the evaluation standard of the degree of frosting, combined with the test results, we noticed small but yet noticeable frost film appeared on the sample surface, but the surface of the sample was still seen; hence the sample frosting was assessed as ‘slightly frosted’.

The degree of frosting of the blue clay bricks was related to the internal material composition and pore characteristics, and also the groundwater migration with the dissolution of salt also playing a key role^{63–65}. Due to the brick’s porous nature, surface water and groundwater permeate the wall through the capillary pores, simultaneously promoted salt migration. The salt dissolved in the brick wall penetrated the wall after the water evaporated. The apparent salt would accelerate the powdering of the wall on interacting with moist air. Under long-term environmental effects, the chalking intensified to encroach into the wall’s interior. If these continue, it will cause foundation instability. In addition, the Kaifeng soil is relatively alkaline, and the groundwater level is relatively high. Based on the experimental results, the influence of the local conditions in Kaifeng on the brick walls should not be ignored. Given this situation, traditional desalination must be encouraged. The soluble salt on the wall surface was washable with distilled water and removed, and the insoluble salt was removed by scrubbing with 2% dilute hydrochloric acid. This was very necessary for the scientific protection of the people’s meeting place.

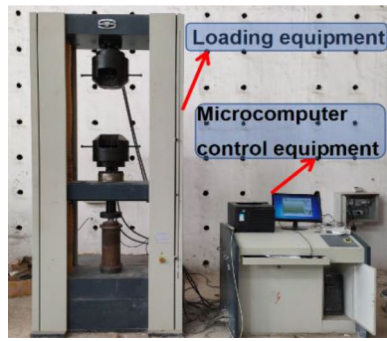
Figure 19. Microcomputer controlled testing machine.

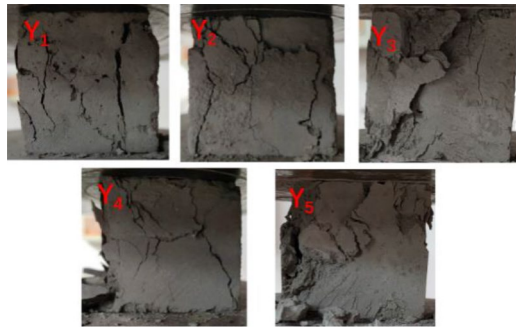
Compressive strength test results and analysis. *Experimental phenomenon.* At the commencement of loading, slight cosmetic cracking appeared at the edges and corners of the test samples. The initial crack direction was mainly vertical or slightly oblique. With the continued increase of the vertical load, the internal stress in the sample concurrently increased, the width of the micro-cracks formed at the initial stage of loading increased, the cracks continued to extend along the direction of the initial cracks, and simultaneously new cracks were gradually formed. When the load was approaching the ultimate load, the vertical surfaces of the specimen began to fall off locally. When the load reached the limit load, the crack width of the sample further increased, the sample’s surface is locally peeled off, the load-bearing capacity dropped rapidly, and the sample failed. The test equipment is seen in Figs. 19 and 20. During the loading process, the sound of the specimen being crushed was audible.

Figure 20. The sample failure forms at ultimate load.

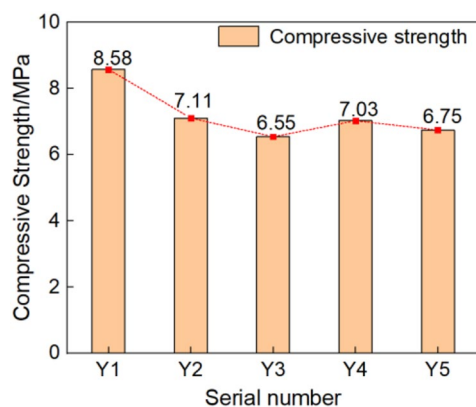
The compression test results are in Table 2 and further illustrated as a bar chart in Fig. 21. The stress σ of blue brick material was the load value divided by the cross section area of the sample. That's the forced per unit area. The strain ε of blue brick material was obtained by passing a strain gauge on the side of blue brick. The strain gauge was connected to the strain tested by a half-bridge connection, and the micro-deformation can be obtained through the signal acquisition and data processing of the strain tested. The specific method was that the material strain gauge was respectively arranged at the lateral center point of the uniaxial compression sample. In the process of sample loading test, the relationship between the force and deformation of the brick material was obtained by real-time monitoring. The curve of specific test results is shown in Fig. 22.

Figure 21. Bar chart of compressive strength of each sample.

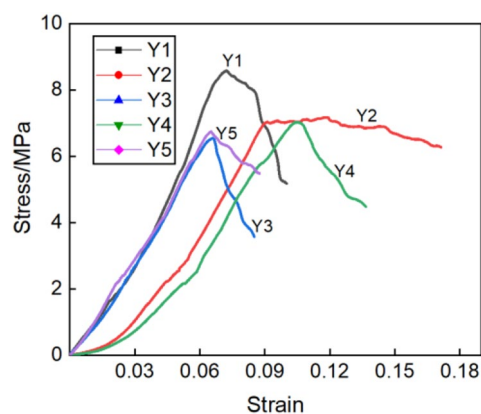
Using the slope of the two points on the graph corresponding to 0.6 times the ultimate strength and 0.3 times the ultimate strength in the stress–strain curve, the elastic modulus of the sample was calculated as 789.8 MPa. Test results in Fig. 21 show that the strength grade of the blue clay brick was less than MU10 for standard sintered brick, and the strength did not meet the relevant requirements specified in the current masonry code, nor did it meet the criteria in the masonry seismic code. The current compressive strength value did not indicate the initial mechanical performance indicators of the blue clay brick. The brick-making technology of a hundred years ago was known to be exquisite, but the blue clay brick tested was severely weathered through the long-term

Figure 22. Stress–strain curves of test samples.

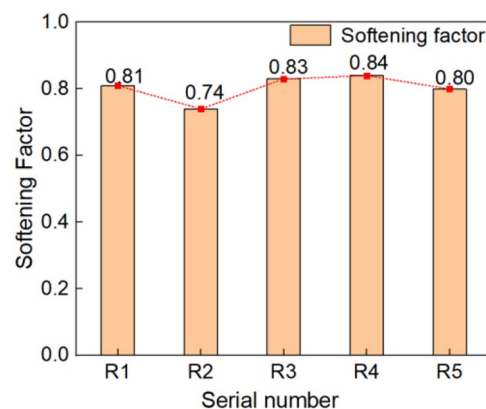
Softening coefficient test results and analysis. The results of the softening coefficient of the blue clay brick samples are given in Table 3. The results of the softening coefficient of each test sample were illustrated as a bar chart in Fig. 23. It was evident from the test results that the average softening coefficient of the blue clay brick sample was 0.80, and results ranged between 0.70 and 0.85. Therefore, the water-resistance of the blue clay brick was good. Kaifeng is located in the Central Plains, with rainy summers and cold winters. After nearly a hundred years of wind and rain erosion, the water-resistance of the blue clay brick had remained good. Although the cur-

Figure 23. Histogram of softening coefficient of each sample.
