## Preliminary report on the landslide early warning on August 20, 2021, in Nangqian County, Qinghai Province, China

Based on an analysis of the formation mechanism, stability state and development trend, this paper focuses on monitoring key indicators, such as surface deformation and rainfall, to realize the early warning of landslides and provide some guidance for landslide disaster prevention and avoidance in the alpine mountainous area of Nangqian, Qinghai Province. The landslide of the Baima Elin Monastery has the topographic and geomorphological conditions of landslide formation and has the basic characteristics indicating that it can be influenced by rainfall and climate, so a landslide warning should be comprehensive. At the same time, the landslide is currently in an unstable state, and the seasonal freeze–thaw cycle will cause it to become more unstable. Based on macroscopic signs, it is predicted that the deformation of the Baima Elin Monastery landslide will continue to intensify without abatement, the stability will be further reduced after winter, developing in an unfavorable direction, and engineering measures should be taken as soon as possible to manage the landsl

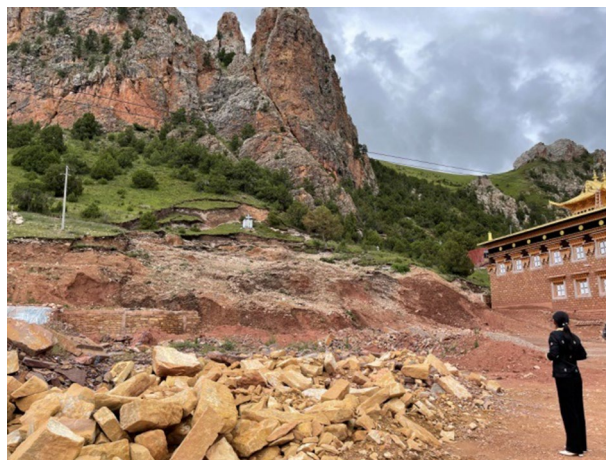
**Figure 2.** Panorama of the landslide.

The landslide reached 25 m<sup>3</sup>, causing different scales of damage to the monk's retreat and the wall of the great hall, but the landslide did not cause direct economic losses and casualties. The panorama of the landslide is shown in Fig. 2. After the landslide, at 11:00 AM on August 20, 2021, technicians of the Qinghai Coal Geo-engineering Co. LTD visited the site and investigated the landslide. The landslide is approximately 35 m long, 85 m wide, 4 m thick, 1.2 × 10<sup>4</sup> m<sup>3</sup> in scale and 5.2 × 10<sup>4</sup> m<sup>3</sup> in volume. At present, the landslide's extensional crack along its back edge tends to widen and deepen. Heavy rainfall and earthquakes may cause local landslides or collapse disasters, which pose a threat to the monastery.

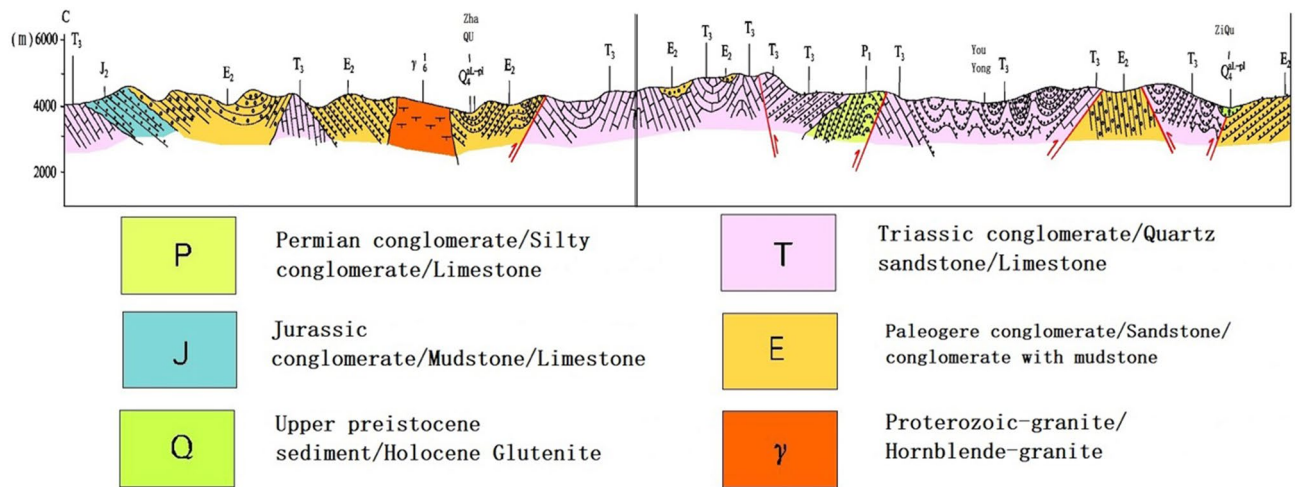
**Figure 3.** Geological profile (this figure is taken from 7 references: <China Geological Survey, Ministry of land and resources. Detailed investigation of geological hazards in Qinghai>).

area is Quaternary broken gravel<sup>4,5</sup>. The lithology is yellow–brown conglomerate, gray–purple conglomerate, medium- to fine-grained quartz sandstone, quartz siltstone, purple–red mudstone, and gray–white gypsum; the stratigraphic section is shown in Fig. 3<sup>6</sup>. The back edge of the landslide is located on the south side of the steep sinking bump under the landslide, which is a potential landslide area, and this area has elevations of 3658 to 3670 m. The slope is rather complete, no obvious signs of deformation are present, and the average slope is 22

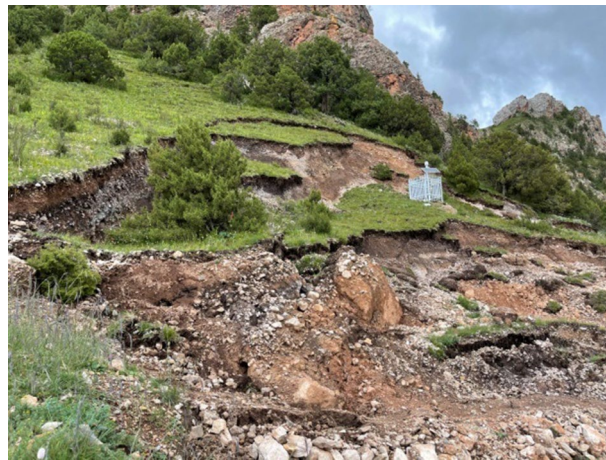
**Figure 4.** Tensile cracks in the trailing edge (2015.07).

On-site investigations reveal that the landslide is a small moving earthen landslide with a trailing edge elevation of 3704 m, leading edge elevation of 3683 m, landslide height of 21 m, slope of 45 degrees, and landslide sliding direction of 155 degrees. The landslide is in the stage of peristaltic deformation, and field inquiries and investigations reveal that the landslide's expansion cracks formed in two stages, which were directly related to rainfall. The first stage was in mid-July 2015; on mainly the north side of the landslide's back edge, two tensile cracks formed, which were approximately 3–5 m and had crack widths of 0.2–0.3 m but less than 0.3 m and a maximum observed depth of 0.5 m. It was a semicircular distribution, as shown in Fig. 4.

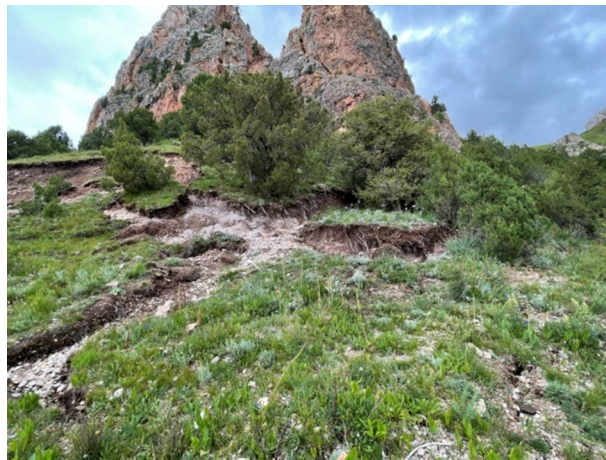
**Figure 5.** Landslide tensile cracks (2021.08).

The second landslide occurred at 4:00 AM, August 20th, 2021. Ten tensile cracks formed on the upper slope; their lengths ranged from 2 to 8 m, widths ranged from 0.15 to 0.5 m, total sinking depths ranged from 1 to 3 m, and visible depths ranged from 0.5 to 1.5 m. The cracks were in an east–west orientation, as shown in Fig. 5.

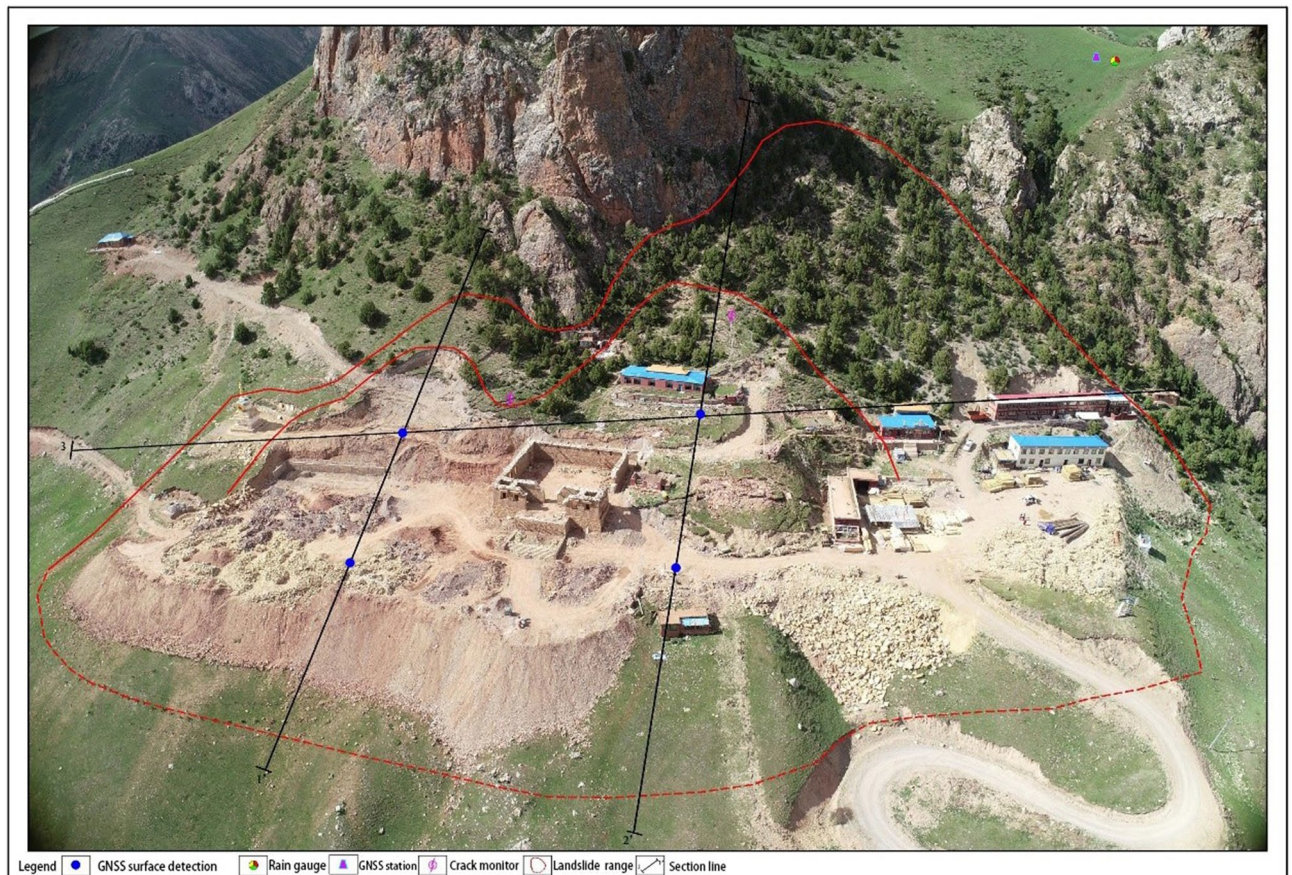
**Figure 6.** Landslip monitoring setup.

For the prevention of landslide geological disasters, the local government jointly undertook prevention research with the State Key Laboratory of Geohazard Prevention and Geoenvironment Protection (Chengdu University of Technology) and Qinghai China Coal Geological Engineering Co., Ltd. in January 2021. The disaster location, four earth movement monitors, one GNSS base, two fissure meters, and one rain gauge were established, according to Fig. 6, and the geological disaster 2–2 survey line profile is shown in Fig. 7.

The surface displacement meter/GNSS is a space-based radio navigation and positioning system that provides all-weather three-dimensional coordinates, speed and time information at any location on the earth's surface or

near-earth space by using the pseudo-range, ephemeris, satellite launch time and user position clock difference of a group of satellites. The parameters are as follows: relative positioning accuracy in the horizontal direction:  $\pm (5 \text{ mm} + 1 \text{ ppm})$ ; RMS in the vertical direction:  $\pm (10 \text{ mm} + 1 \text{ ppm})$ ; RMS sampling interval: 1 h; crack meter measuring range: 0–50/100//200/500 cm; measurement accuracy:  $\pm 0.1\%$  F·S; and sampling interval: 1 h.

The tipping bucket rain gauge measures the natural rainfall and converts the rainfall into a digital information output in the form of a changing value to meet the needs of information transmission, processing, recording and display. The 0.2 mm tipping bucket rain gauge adopted this time uses 2/3/4G transmission. The parameters are as follows: measurement range of the system: 0–8 mm/min; resolution: 0.2 mm; and sampling interval: 1 h.

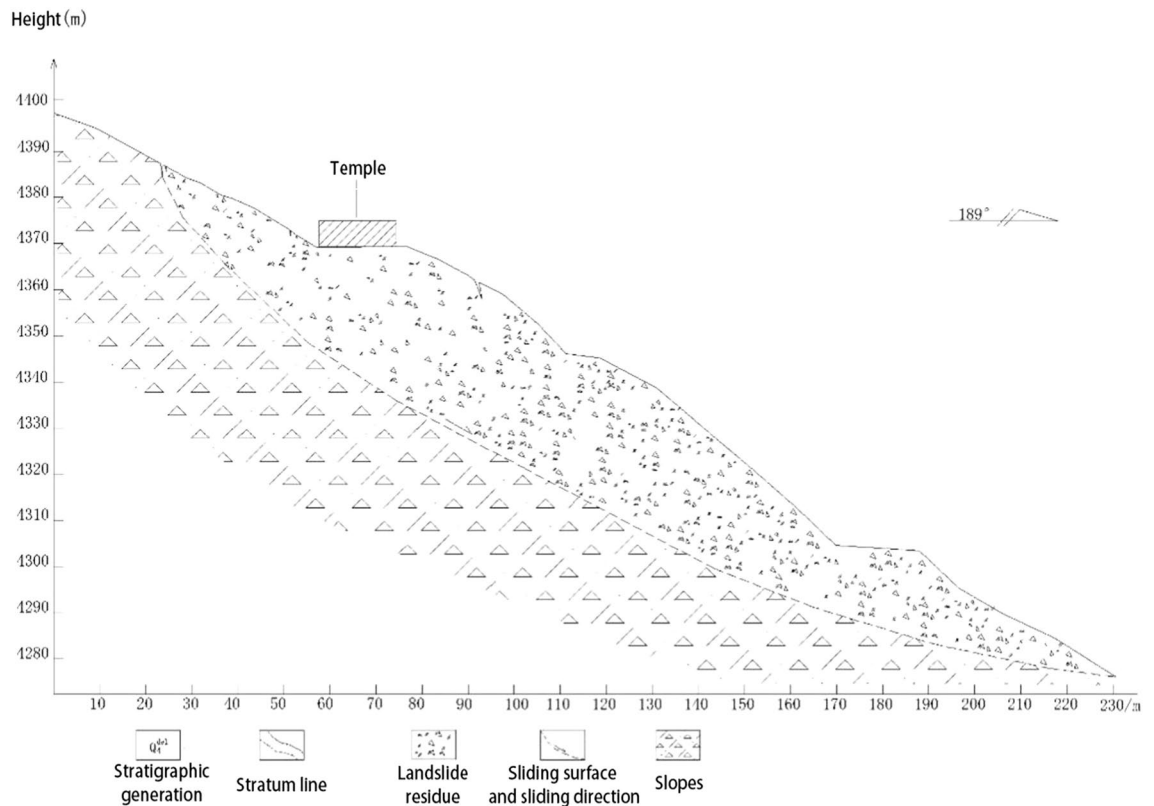
**Figure 7.** Geological disaster profile 2-2.

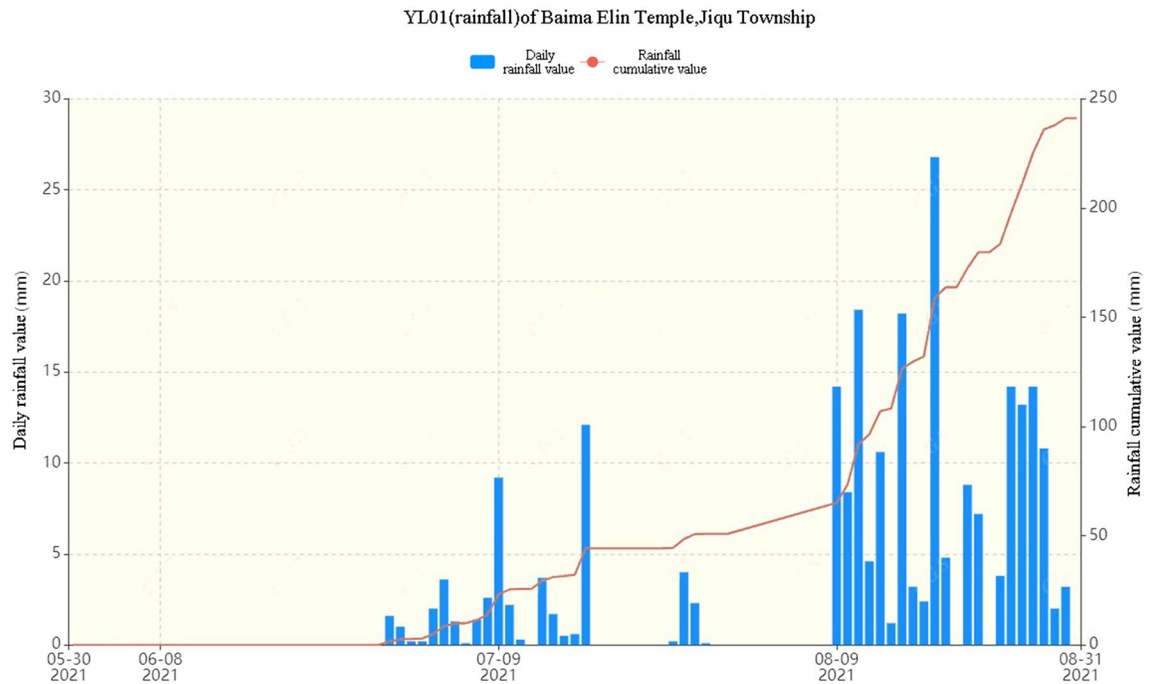
**Figure 8.** Rainfall on a single day and accumulated rainfall from May 31st to August 31st, 2021.

The rain gauge data of the Baima Elin Monastery of Jiqu Township show that starting on August 10th, the rain gauge data increased, and the rainfall reached 8 mm per hour on August 19th, with an accumulated rainfall of approximately 100 mm (the rainfall capacity is shown in Fig. 8). Continuous heavy rainfall caused rain to soak into the loose layer and existing cracks, thereby increasing the weight of the slope and lowering the shear strength, which is the direct cause of landslides<sup>4,5</sup>. At 4:00 AM, August 20th, in the Baima Elin Monastery, Jiqu Township, Nangqian County, Yushu, Qinghai Province, the 02GP01 surface displacement meter triggered a single parameter warning, the 11GP01 surface displacement meter triggered an orange alert (surface movement data are shown in Fig. 9), and the landslide observation system triggered an orange alert; an orange alert means that the slope is in the stage of accelerated deformation, and the probability of a landslide within a few days is very high.

A comparison of Figs. 8 and 9 shows that when continuous rainfall occurs, the horizontal displacement and vertical displacement of the crack increase, and the displacement of the crack changes stably within a certain period of time. The stable growth of the single-day displacement recorded by the displacement meter before the landslide occurred lasted approximately 10 days, the stable value of the vertical displacement was approximately 2.5 mm, and the stable value of the horizontal displacement was approximately 7.6 mm. The length of the stabilization period with increasing displacement is basically proportional to the time required for the rainwater to completely soak the rock mass until the rock mass becomes saturated with water. According to the statistics of multiple landslide points in the study area, landslides of different sizes occur when the daily rainfall reaches more than 22 mm and the cumulative continuous rainfall reaches more than 112 mm.

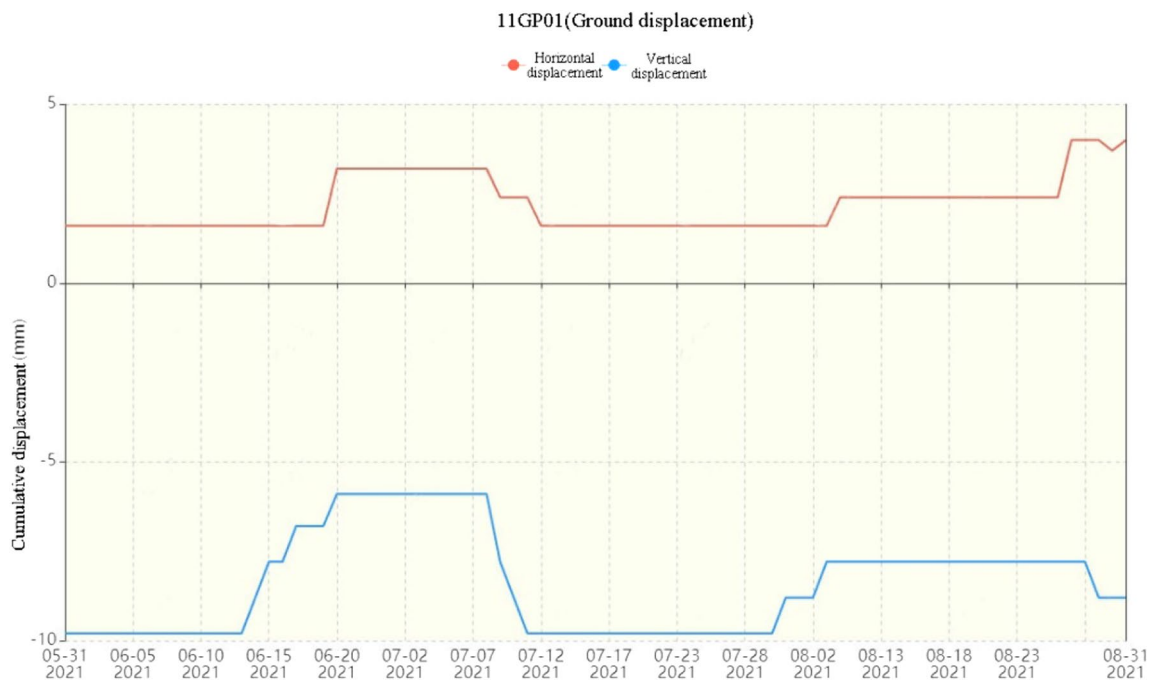
**Figure 9.** Accumulated horizontal and vertical movement from May 31st to August 31st, 2021.
