Rapid testing on the effect of cracks on solar cells output power performance and thermal operation

This work investigates the impact of cracks and fractural defects in solar cells and their cause for output power losses and the development of hotspots. First, an electroluminescence (EL) imaging setup was utilized to test ten solar cells samples with differing crack sizes, varying from 1 to 58%. Our results confirm that minor cracks have no considerable effect upon solar cell output, and they develop no hotspots. However, larger cracks can lead to drastic decreases in the output power, close to -60%. Furthermore, as the crack area increased, there was a further increase in the cell's temperature under standard test conditions. On the contrary, no hotspots were found for the solar cells affected by significant crack areas (crack percentage > 46%) because there were insufficient areas to develop a hotspot. Last, a comparative analysis with solar cells affected by potential induced degradation (PID) was made. We found a strong relationship in the output power losses, and the PID test critically impacted the cells by developing localized hotspots at a temperature level close to 50 °C.

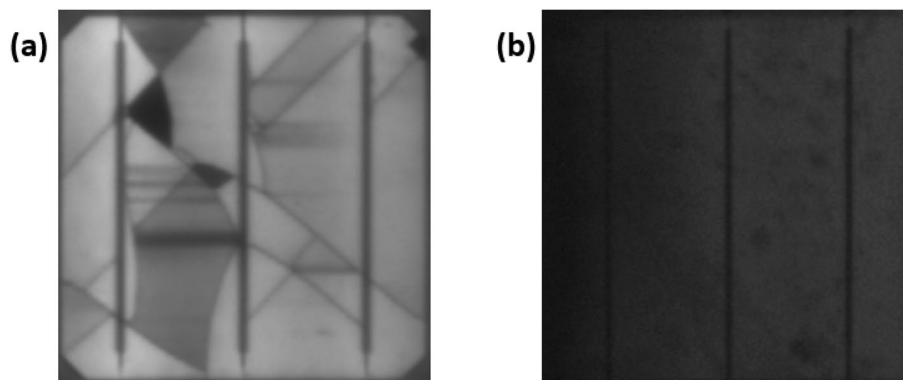
Figure 1. EL image of solar cells (a) Affected by cracks and structural defects, (b) affected by PID.

Cracks are often invisible to the bare eye; the current standard cracks detection method uses Electroluminescence (EL) imaging^{18–20}. In Fig. 1, the EL image of two different solar cells is presented. Here we show the difference between the EL image when a solar cell is affected by cracking and structural defects (Fig. 1a) and when the cell is affected by PID (Fig. 1b). There has been a limited explanation of the behaviour of these cracks on the actual degradation of the output power and their correlation to the presence of hotspots. In addition, to date, there is a lack of understanding of whether all types (or crack percentages) can lead to a significant drop in the output power generation of solar cells.

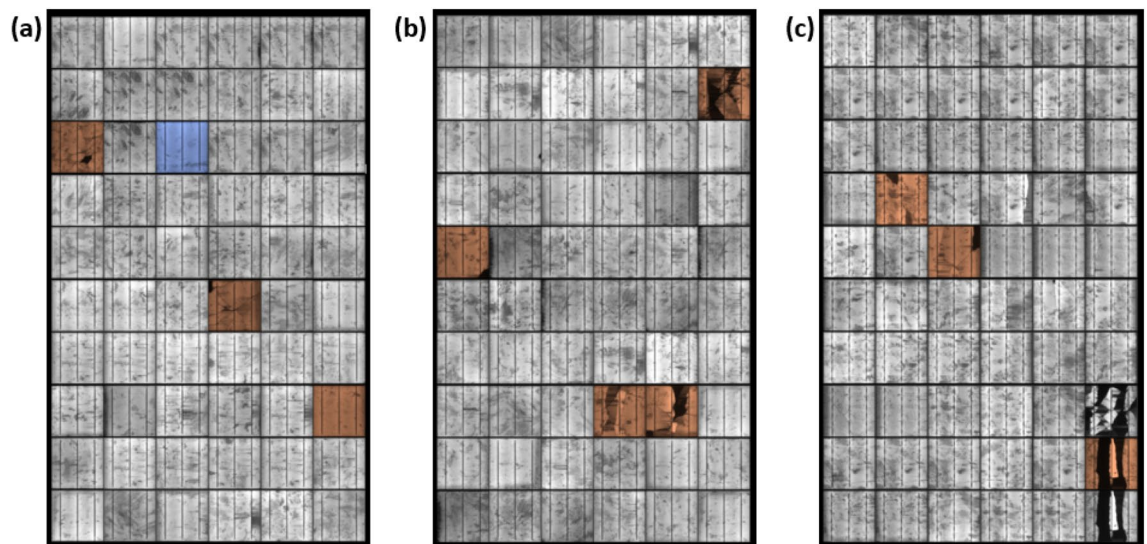
Figure 3. Original EL image for the PV modules before the dismantling process (a) PV module #1, (b) PV module #2, (c) PV module #3.

the crack was computed by subtracting a cracked vs crack-free image; this was performed using MATLAB script. The solar cell samples were deliberately dismantled from an original three different PV modules; this process was handled by Solar UK Ltd, an international PV recycling company located in the UK. The EL image of the PV modules before the dismantling process had to happen is shown in Fig. 3. There is no difference in the crack size and orientation before and after the dismantling process was completed. The PV modules examined in this work were exposed to outdoor conditions; therefore, we cannot precisely define the source of the cracks (i.e., caused during the PV installation phase, rapid damage due to hailstorm, snow, etc.).

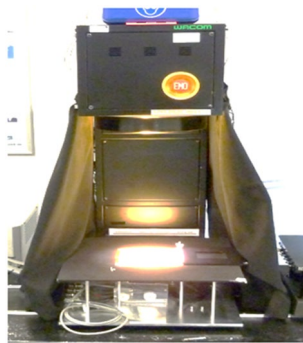
Figure 4. PVcomB solar simulator.

The solar simulator tested the performance of the cells, and the output power vs irradiance was taken at each analysed condition. The class A+ solar simulator, shown in Fig. 4, has been used to facilitate the testing of the examined solar cell samples. This instrument has a maximum illumination area of $155 \times 155 \text{ mm}^2$, a homogeneity of illumination $\pm 2 \text{ W/m}^2$ at irradiance intensity range $0\text{--}1000 \text{ W/m}^2$. In addition, the solar cell temperature can be controlled from 15 to $200 \text{ }^\circ\text{C}$ via the PVcomB software to maintain a specific temperature level during the experiments. A thermal camera is placed on the back sheet of the solar simulator (solar cell holder) to aid the thermal measurements of the examined samples. The camera has a thermal sensitivity of $\pm 0.1 \text{ }^\circ\text{C}$.

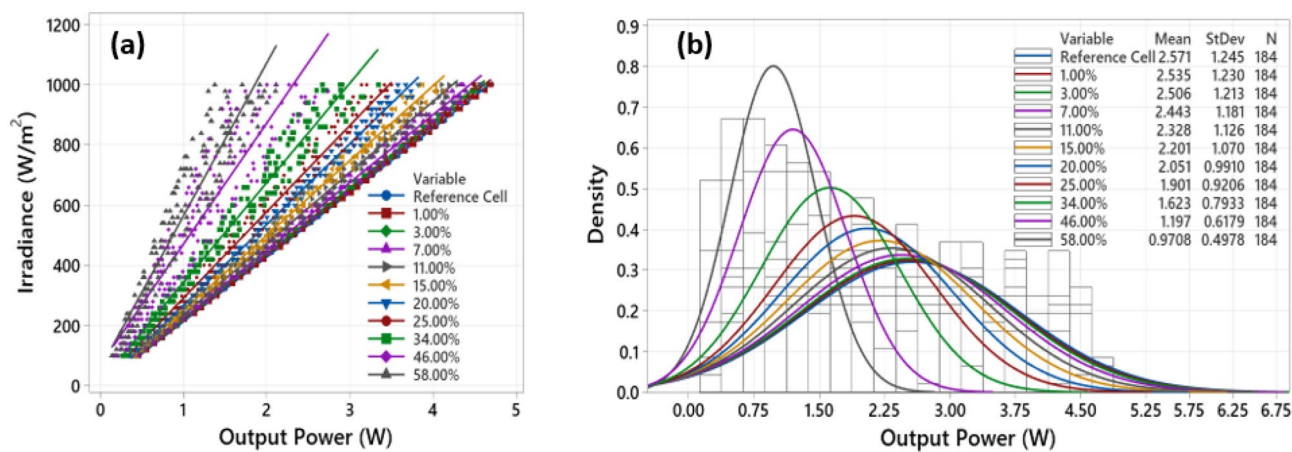
Figure 5. (a) Output power vs irradiance for the examined solar cells, (b) Density and the calculated parameters of the collected data; N = 184 represents the number of samples of every experiment.

Output power measurements. The tested solar cell samples, including the reference cell, were all subjected to solar illumination under varying irradiance, 100–1000 W/m², the temperature of the cells was maintained at STC conditions, 25 °C. The output power measurements taken from the solar simulator is shown in Fig. 5a. The step-change in the irradiance level is 20 W/m², and for precision targets, we took four different measurements for every irradiance level. Next, we have distributed the measured output power as in histogram (Fig. 5b), and a normal distribution function was selected to observe the mean and the standard deviation (StDev). In this figure, the y-axis denotes the density, which corresponds to the relationship between the observations/measurements and their probability of occurrence. Hence, 0.9 resembles a high probability of occurrence than 0.1, which corresponds to a low probability of occurrence. Using this parameter in the y-axis helps find the rectified mean value of the output power of each tested solar cell, therefore, eliminating any errors in the measurements.

As can be observed in Fig. 5b, there is a significant correlation between the output power of the reference cell and the solar cells affected by 1%, 3%, 7% and 11% crack percentages. The mean output power is approximately equal to the reference cell, 2.571 W. In contrast, we observe a significant decay in the mean of the output power while the crack percentage in the solar cell increases. For example, the solar cell affected by 20% has a mean output power of 2.051 W, compared with 0.9708 W identified from the last solar cell sample with a crack percentage of 58%.

In addition, as the crack percentage increase in the solar cell, it is anticipated that the standard deviation of the output power measurements decreases. A low standard deviation indicated that the values are clustered close to the mean. Hence, even though the irradiance increased while experimenting, there were no significant changes in the output power of the critically cracked solar cells (i.e., 46% and 58% crack percentages).

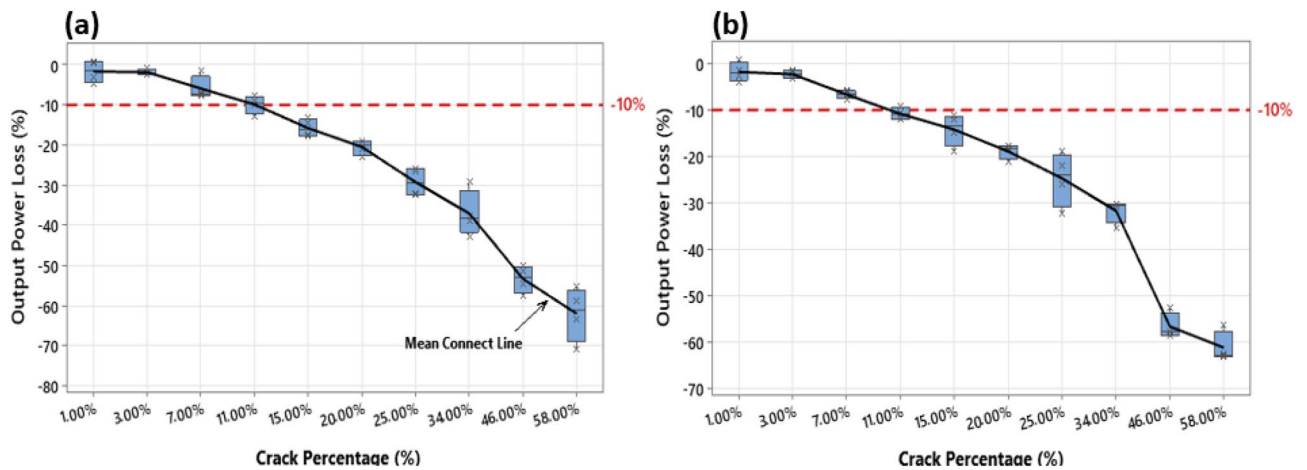
Figure 6. Calculation of the output power loss for the tested cracked solar cell samples (a) at 1 Sun, (b) at 0.5 Sun.

The output power loss is calculated using (1), where P_{ref} is the output measured power of the reference healthy solar cell, the value of P_{ref} is taken from the manufacturer datasheet, and the P_{sample} is the output measured power for the selected solar cell samples. The results of the output power loss at 1 Sun (1000 W/m²) and 0.5 Sun (500 W/m²) are presented in Fig. 6.

According to Fig. 6a, the solar cells with crack percentage below 15% are above the -10% baseline. This result suggests that the output power losses for the solar cells with crack percentages of 1%, 3%, 7%, and 11% is insignificant. We confirm the same outcome while testing with the solar samples at 0.5 Sun, as shown in Fig. 6b. Accordingly, these results enable us to understand that not all cracks in solar cells could induce output power losses. Small cracks, i.e., below 10%, unlikely influence the output power generation and are relatively equivalent to non-cracked cells. In a comparative evaluation, the output losses (or degradation) are likely to transpire due to other predicaments such as encapsulation, arcing-faults, or PID.

Furthermore, we compared the degree of similarity of the results obtained by the PID experiment against the cracked solar cell samples (Fig. 6). The outcome of this comparison is presented in Fig. 11. According to both Sun levels (1 and 0.5), that the solar cell samples subjected to the PID test are comparable to those with crack percentages of 20–34%. Consequently, the output power loss estimation ranges from –20% to as low as –35%. These results confirm to a certain degree that cracks in solar cells are a form of PID; they affect the output power performance and are unlikely to be mitigated. In summary, this section demonstrates that PID can rigorously

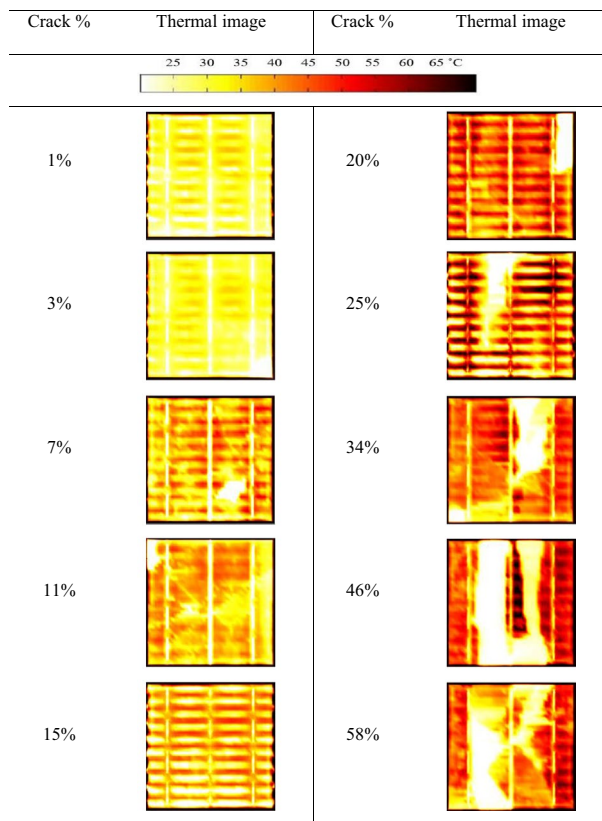
Table 2. Thermal images of the examined solar cell samples under STC conditions.

Thermal performance and hotspots development. The thermal images of the solar cells, shown in Table 2, have been taken under STC conditions. These images have been captured approximately 2-min when applying the illumination to make sure that the hotspot develops, if any.

Considering the results in Table 2, it is clear that the crack area has no increase in the temperature, always 25°C or below. This is because the crack represents an inactive state. Hence, no absorption of electrons can be achieved, in other words, the inactive area has a temperature similar to the back or front sheet of the solar cell. Nevertheless, because of the uneven distribution of the current flow in the busbars due to the presence of the cracks, a localized heat (hotspot) can develop. For example, the surface temperature of the solar cell with a 20% crack percentage has increased to approximately 40°C .

We have discovered that whenever the crack area increase, it is not necessary to develop a hotspot. A good example is given in Table 2 by the last two solar cell samples, 46% and 58%. Because there is a significant inactive area in the cells, the localized heat can be critical, yet there is not enough area to develop a hotspot. Therefore, in this condition, and as seen in Fig. 7, there is assuredly an increase in the temperature in some parts of the cell, yet the average cell surface temperature is below 30°C .

As we have shown earlier in Table 2, some solar cells do not develop hotspots. In this regard, the PID experiment allows us to confirm another compelling conclusion. We have observed that the solar cell samples subjected to the PID test have developed severe hotspots, as can be seen in Fig. 10. The surface temperature of both cells is approximately 50 °C; these images were taken at STC conditions. In comparison, the worst case of an increase in the cell temperature for cracked cells was observed at nearly 43 °C (Fig. 7) when the cell is affected by a 25% crack percentage. Therefore, unlike solar cracking, a PID can critically influence the thermal performance of affected solar cells.

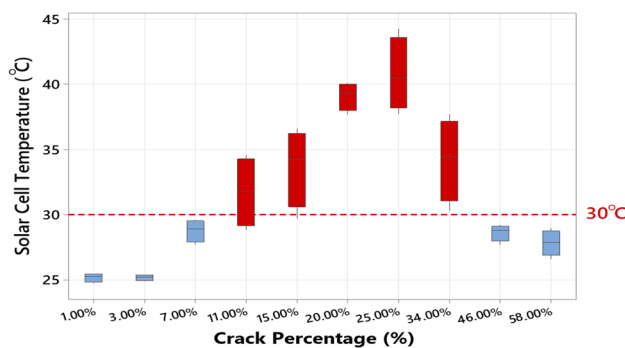
Figure 7. Solar cell samples temperature vs crack percentage.

The average surface temperature of the solar cells is then recorded using FLIR software and summarized in Fig. 7. It is recognized that a hotspot is to develop if the crack percentage, which is essentially representing an inactive area in the solar cell, is in the range between 11 and 34%. Considering the IEC61215/61646 standard, all other solar cells affected by either 7% crack size or below, or 45% crack size or more, are below the baseline of 30°C ; hence, these samples considered not correlate the crack and presence of hotspots.

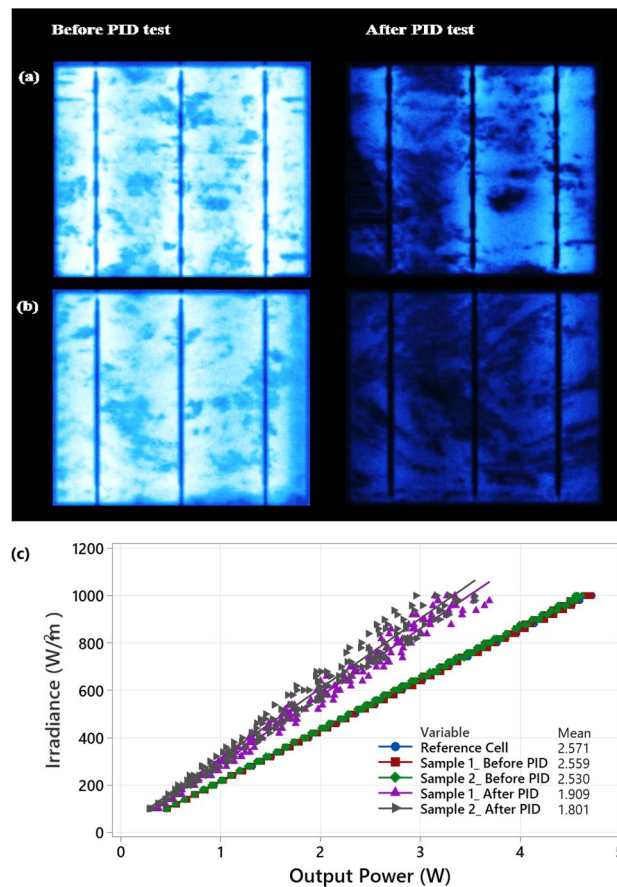
Figure 9. PID test output results (a) Sample #1, (b) Sample #2, (c) Output power measurements before and after the PID test was performed.

The PID test was performed using the PIDcon instrument. We have applied the standard PID testing conditions, where the temperature is maintained at 85 °C, the voltage is set to negative 1000 V, and the PID test ran over 96 h²⁸. This procedure was performed on two solar cell samples that presents no cracks, shown in Fig. 9a,b. These figures also contain the EL image taken before and after performing the PID test. Apparently, the PID had a significant impact, as expected, toward developing shunted areas in the cells. Furthermore, the output power measurements for the solar cell samples before and after the PID test are presented in Fig. 9c. After the PID experiment was completed, it is seen that the mean output power has significantly dropped for both samples, 1.909 and 1.801 W.
