Field study on the severity of photovoltaic potential induced degradation

Ghadeer Badran & Mahmoud Dhimish

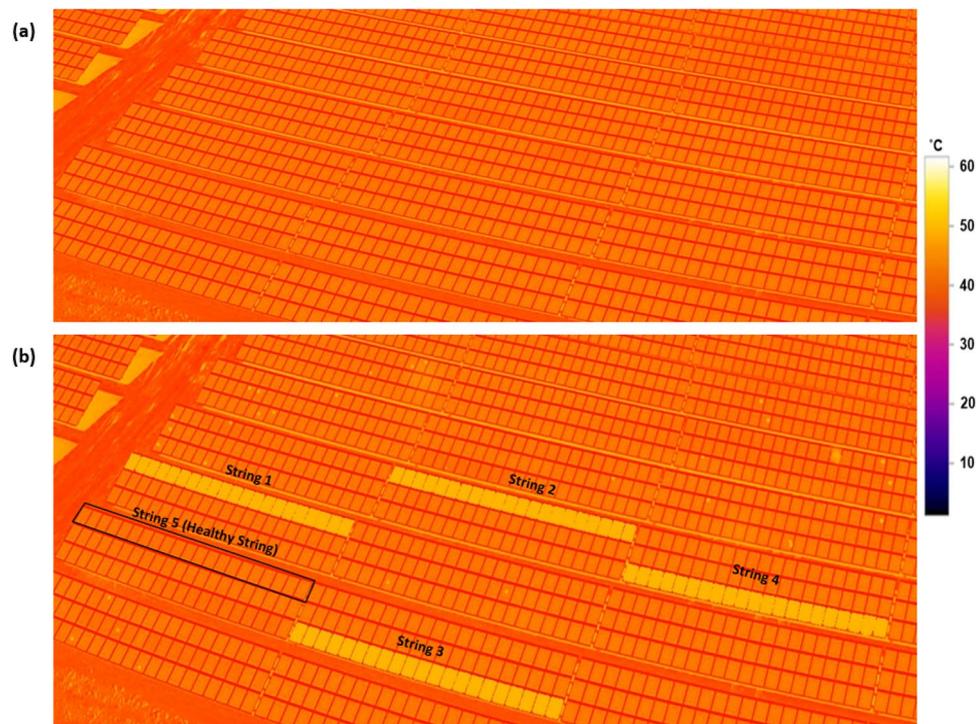
Figure 1. Thermography image of the tested PV strings during night-time. (a) Image taken on 01/08/2019, first day of PV operation (ambient temperature 34 °C). (b) Image taken on 03/08/2020, after 1-year of operation (ambient temperature 35 °C). The thermal image is taken using DJI Mavic 2 Enterprise Advanced drone with thermal sensitivity ± 2 °C.

The PV site was under construction in 2019 and was operational on 01/08/2019 when the thermal image was taken (Fig. 1a). We took these thermal images during the day when solar radiation was 712 W/m², and the ambient temperature was 35 °C. No anomalies or faults were found. One year later, however, four PV strings were affected by PID, as shown in Fig. 1b. PID is characterized by an increase in PV module surface temperature to nearly 55–60 °C, compared with healthy PV strings which have a surface temperature of almost 37 °C.

Each PV string's log of measurements was analyzed and compared with a healthy PV string (string 5, Fig. 1b). Unfortunately, the current–voltage and power–voltage curves of the individual PV strings were not measured during the thermal inspection. The healthy PV string, string 5, was carefully selected as other PV strings had already developed hotspots and other mismatching conditions. We calculated the output performance ratio (PR) for each month. The PR ratio would indicate when the PID developed in the PID-affected PV strings and how much deterioration in output power developed compared with the healthy PV strings.

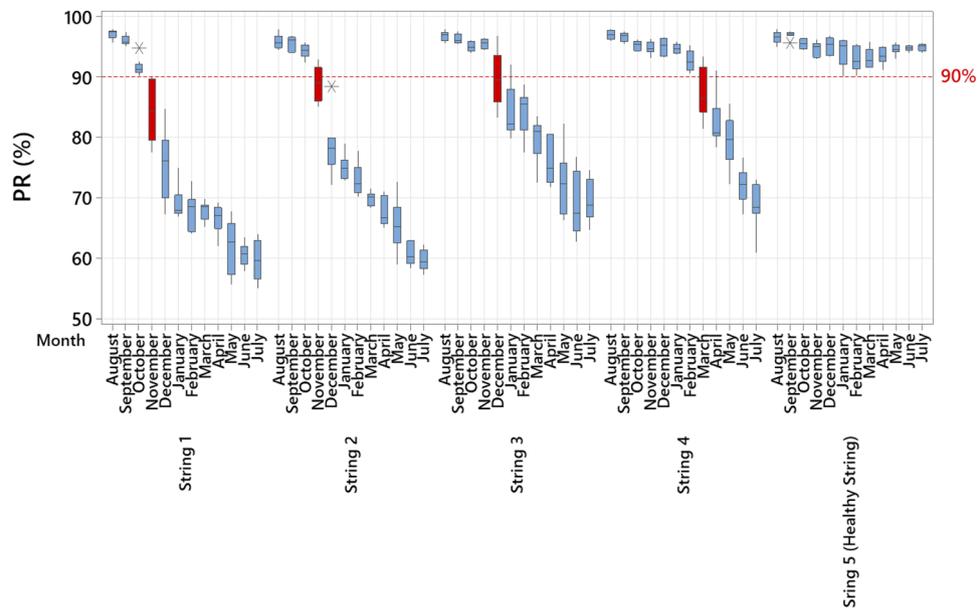
Figure 2. Performance ratio of the tested PV strings. The y-axis presents the PR ratio, and the baseline of 90% was selected to indicate low performance; the x-axis gives the month. This chart shows the PR ratio for the PV strings during their first year of operation and the red labelled boxplots for the individual PV strings believed to be the starting month of the PID.

The results of the monthly calculated PR ratio are presented in Fig. 2. The healthy PV string has no monthly PR ratio below 90% during the entire year of operation. However, the decline of the PR ratio of the other PV strings has been seen at different times. For example, in PV string 1, the monthly PR drop started in November (4-months after field operation); the same observation is valid for PV string 2. The third PV string has a slight decline in the PR starting from December; this suggests that PID has occurred after 5-months of field operation. In contrast, PV string 4 has no significant drop in the PR ratio during the first 7-months of field operation. However, a fast decline in its performance is evident in March, due to PID.

- (1) PID can have an instantaneous reduction in the output power of the PV strings. For example, in PV string 2, after 4-months of field operation, the PR has dropped from nearly 90% in November to 77% in December.
- (2) PID develops in the PV strings at different periods. This implies that the early thermal inspection (day one) is insufficient to detect PID abnormalities.

It is also clear from Fig. 2 that PIDs can accelerate during relatively hot months, May through July. Prior to our examination, there was inadequate information on whether the PID effect could still have an effect on PV modules during these months due to the lower differences between PV surface and ambient temperature. The opposite has been proven by our experiment. In addition, Table 1 shows the PR ratio difference in the first month compared with last month. The PR difference ranges from 27.9 to 39.9% for the PID-affected PV strings, while the PR difference for the healthy PV strings is only 0.3%. These results are consistent with those obtained by laboratory testing^{9,12}.

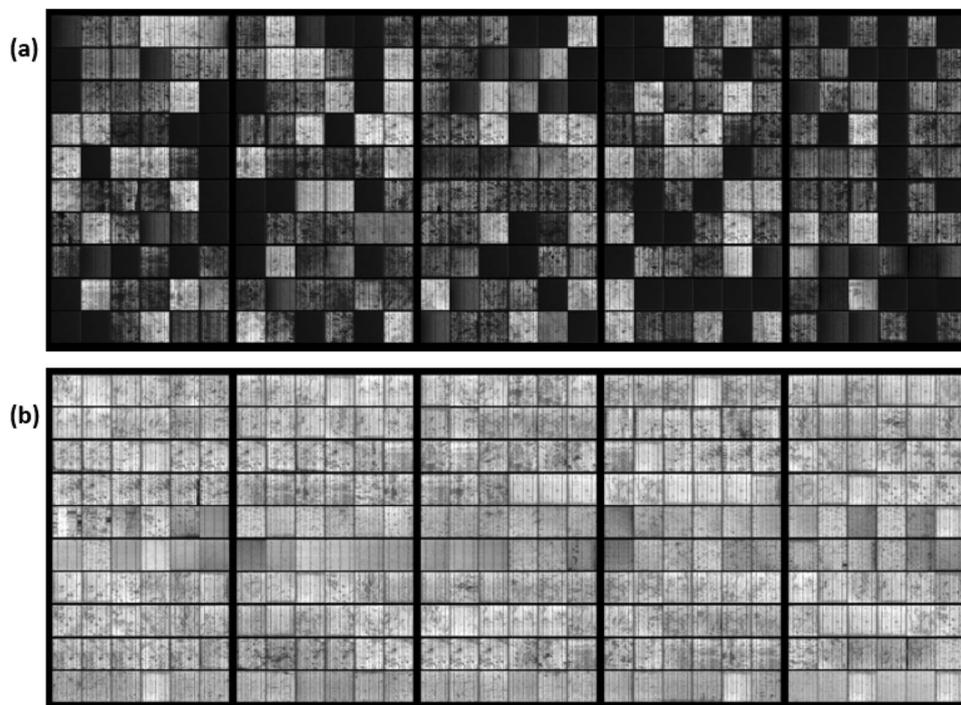
Figure 3. Electroluminescent image of two PV modules. (a) Modules located in a PID affected PV string (string 1). (b) Modules located in the healthy PV string (string 5). The electroluminescent images were taken during night-time, under an ambient temperature of 26 °C, and the modules were running at 90% of their short circuit condition.

PID examination using electroluminescent imaging. The confirmed PID case in the PV strings was also supported by examining several PV modules under EL testing. For example, the output image of five PV modules from PV string 1 vs in the healthy PV string is shown in Fig. 3. Through EL detection, it is clear that the affected modules by PID, Fig. 3a, has low EL intensity compared with the healthy PV modules, Fig. 3b. In addition, the PID affected modules show shunting (blackout) cells that are likely to degrade the module's performance. However, unlike the healthy PV modules with homogenous EL intensity across the solar cells, these only have some micro cracks. Despite that some solar cells in the healthy PV modules have some cracks or minor

shunting, these are typically normal to occur during the first year of operation and they have insignificant impact on the performance of the modules^{22,23}.

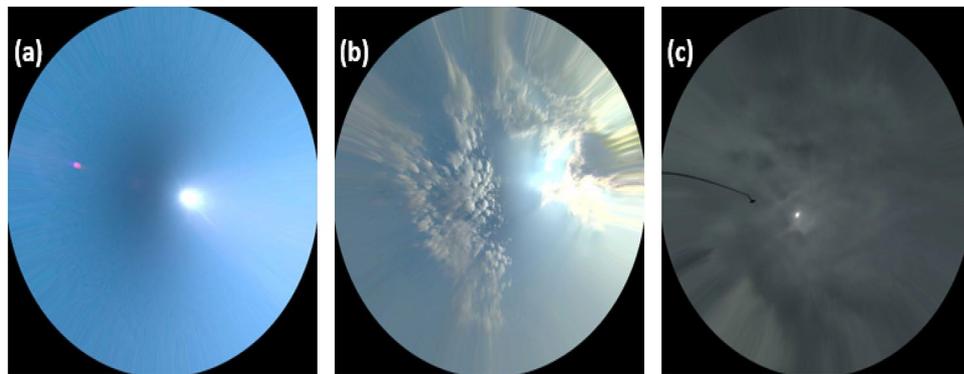
Figure 4. Sky image for the PV operation condition. (a) Clear sky. (b) Partial shading. (c) Overcasting. These images were taken using TSI 440A total sky imager. The temperature of the PV modules at these conditions is 26, 23 and 19 °C, respectively; and the solar radiation is 730, 677, and 408 W/m².

A series connection of PV modules in Fig. 3 was used to test the I-V curve under a variety of field conditions. Figure 4a shows the modules under no shading (cloud-free skies), while Fig. 4b shows them under partial shading (some clouds). Last but not least, the modules are evaluated when operating under overcast conditions (Fig. 4c).

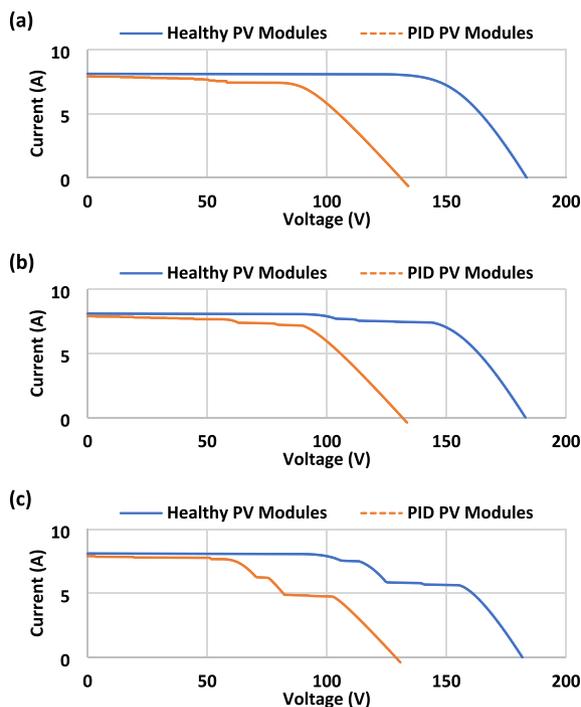
Figure 5. Current–Voltage (I–V) curve measurements of the examined PV modules. (a) Clear sky. (b) Partial shading. (c) Overcasting. The I–V curve tracking accuracy is $\pm 0.5\%$. The blue curves show the healthy PV modules (free PID), and the orange curves show the PID PV modules.

The I-V curves were taken for both the healthy and the PID PV modules during each different sky conditions (Fig. 5). In PID affected modules, I-V curves dropped steeply because PID has a significant impact on output voltage. According to Fig. 5a, the open-circuit voltage dropped from 183.6 V for the healthy modules to 134.1 V for the PID modules. PID-affected PV modules do not show a significant drop in short circuit current. In spite of this, the maximum current that can be extracted from the PID affected modules is less than that from healthy modules. As a result, the PID modules will generate less output power due to the voltage and current drop.

Table 2 summarizes the electrical output parameters (compiled from Fig. 5) for the tested PV modules. Due to the reduced current and voltage, the PID modules had a significant drop in power at maximum power point (MPP). PID accelerates the power decrease (−39.69%) due to reduced shunting resistance at lower irradiance conditions (overcast, 408 W/m²). During clear sky and partial shading conditions, respectively, the output power of the PID-affected modules decreases by −37.15 and −36.29%. The I-V curve tracer endeavoured to track approximately the same current at I_{MPP} for the PID compared with the healthy modules at the clear sky and partial shading because the modules are relatively affected by high irradiance (> 650 W/m²). However, at low irradiance

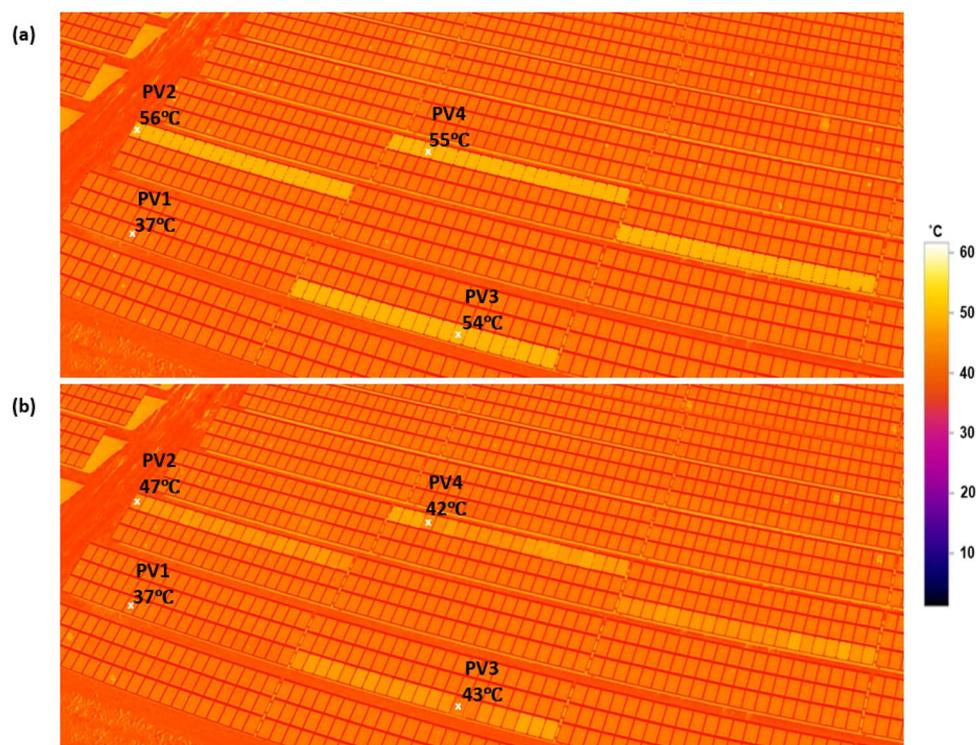
Figure 6. Thermography image of the tested PV strings during night-time. (a) Image taken on 03/08/2020, after one year of PV operation (ambient temperature 35 °C). (b) Image taken on 10/08/2021, after 1-year of fitting the anti-PID box on the PV strings (ambient temperature 35 °C). The thermal image is taken using DJI Mavic 2 Enterprise Advanced drone with thermal sensitivity ± 2 °C, the selected points on the figure are rounded to the nearest integer.

Figure 6 shows thermal images of PV strings after PID was confirmed (Fig. 6a) and after fitting the anti-PID box for a year (Fig. 6b). During the daytime, both images were taken under relatively the same ambient temperature.

As shown in Fig. 6b, the anti-PID box has partly improved the thermal performance of the PV modules. Three different instances were emphasised, where the PV surface temperature has dropped by nearly 9–13 °C; a summary of the results is presented in Table 3.

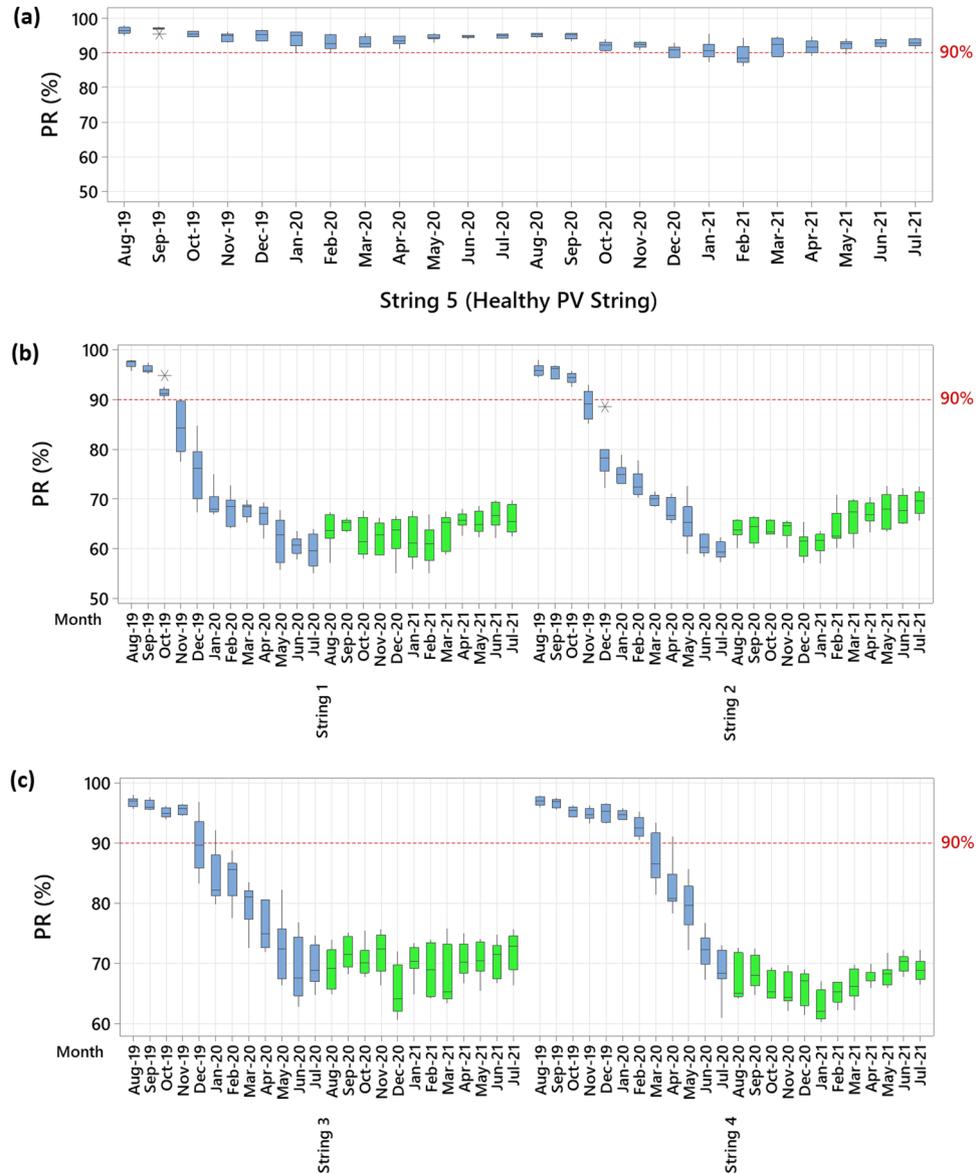
Figure 7. Performance ratio of the tested PV strings. (a) Healthy PV string (PV string 5). (b) PV strings 1 and 2. (c) PV string 3 and 4. The y-axis presents the PR ratio, and the baseline of 90% was selected to indicate low performance; the x-axis gives the month and the PV string number. This chart shows the PR ratio for the PV strings during their two years in the field, as well as the PR ratio after the anti-PID box is fitted.

Fig. 7, you can see the monthly PR ratio of the PV strings for each month. As shown in Fig. 7a, the healthy PV module maintains a superior performance over a period of two years, with a PR ranging from 88 to 96%. PV strings (1, 2, 3 and 4) that were confirmed to have PID had exactly the same PR ratio, even when the anti-PID box was installed, their PR remained consistently below 75% even after the anti-PID box was installed, as shown in Fig. 7b,c.

The anti-PID recovery, however, stops the acceleration of power losses for the affected PID modules. Figure 7b,c demonstrate a virtually constant PR ratio after fitting the anti-PID box (see green highlighted boxplots), and no further reductions (i.e., below 50% PR ratio) have been observed. The results suggest that the anti-PID box has a positive impact on already PID-affected modules, which delays the recycling of the modules when a suitable detection mechanism is in place.

Figure 7 illustrates another conclusion about the long-term impact of PID on PV modules. The study shows that PID can severely affect modules, resulting in a 25% to 40% reduction in output power. Sadly, unidentified PIDs can cause rapid power losses, and we see this frequently in large industrial PV assets. Thus, our results highlight the importance of regularly inspecting PV systems to avoid system complications, particularly those related to PID.

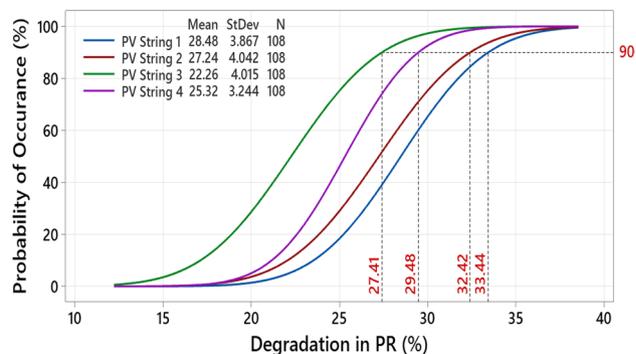
Figure 8. Plot of probability distribution functions for PV strings affected by PID. Probability of occurrence (in percentage) is represented by the y-axis, and degradation (in percentage) is represented by the x-axis. Plotting this figure requires data from Figs. 7b,c. N stands for the number of samples, and StDev for the standard deviation.

CDF is a widely used statistical analysis function that describes the probability of discovery of an investigated variable^{27,28}. To explore the degradation in PR, we plotted the CDF for the affected PID PV strings as shown in Fig. 8. There is a 90% probability that a PV string affected by PID will have a PR degradation between 27.41 and 33.44%. Nevertheless, this assumption is only valid if the PID affected the modules for at least six months, as our previous data shows.

Also shown in Fig. 8 is the standard deviation (StDev) and the mean of the samples. According to the PR, the mean degradation ranges from 22.26 to 28.48%. A low StDev (3 to 4) indicates that the data are clustered around the mean. In summary, the CDF plot shows a degradation in PR for PV strings with affected PIDs. The probability of accelerated power losses in a PV string affected by at least 6-months of PID is approximately 27% to 33% with 90% confidence. Due to the location of our investigated PV system in Spain, Barcelona, these results may also be more accurate during hot summers and cold winters.
