Anthropogenic interventions on land neutrality in a critically vulnerable estuarine island ecosystem: a case of Munro Island (India)

M. K. Rafeeqe^{1,2}✉, T. R. Anoop¹, M. K. Sreeraj¹, R. Prasad¹, L. Sheela Nair¹ & A. Krishnakumar¹

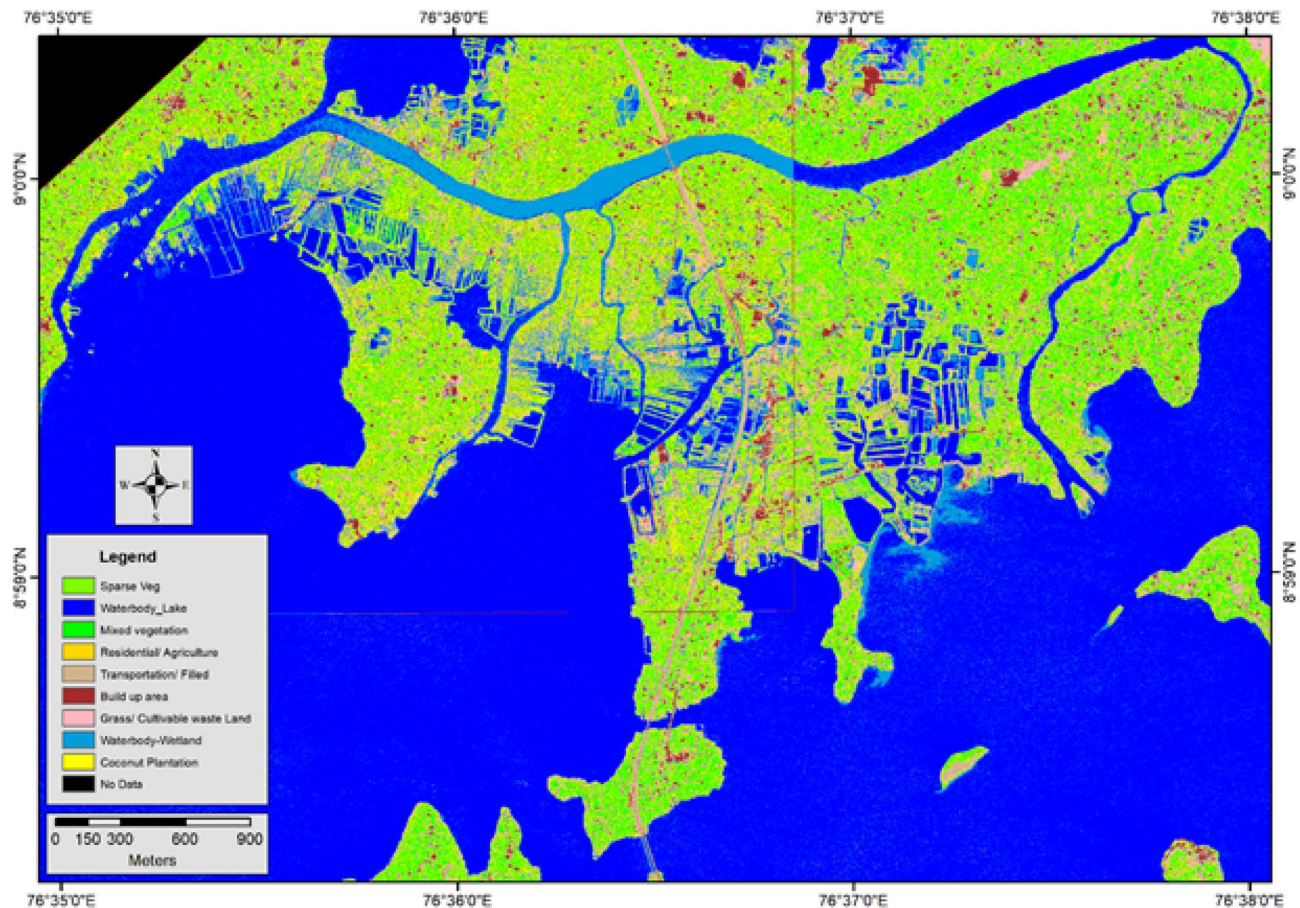
Figure 4. Land use pattern—supervised classification of World View—II images (figure was generated by Arc GIS 10.6 & ERDAS IMAGINE 2015).

the inhabitants. The 3.36 km long railway line, passing through the island's heart, splits the island into the easily accessible east and less accessible west sides (Fig. 4). The western part of this railway line is an underdeveloped region and does not have any better transportation facilities except waterways.

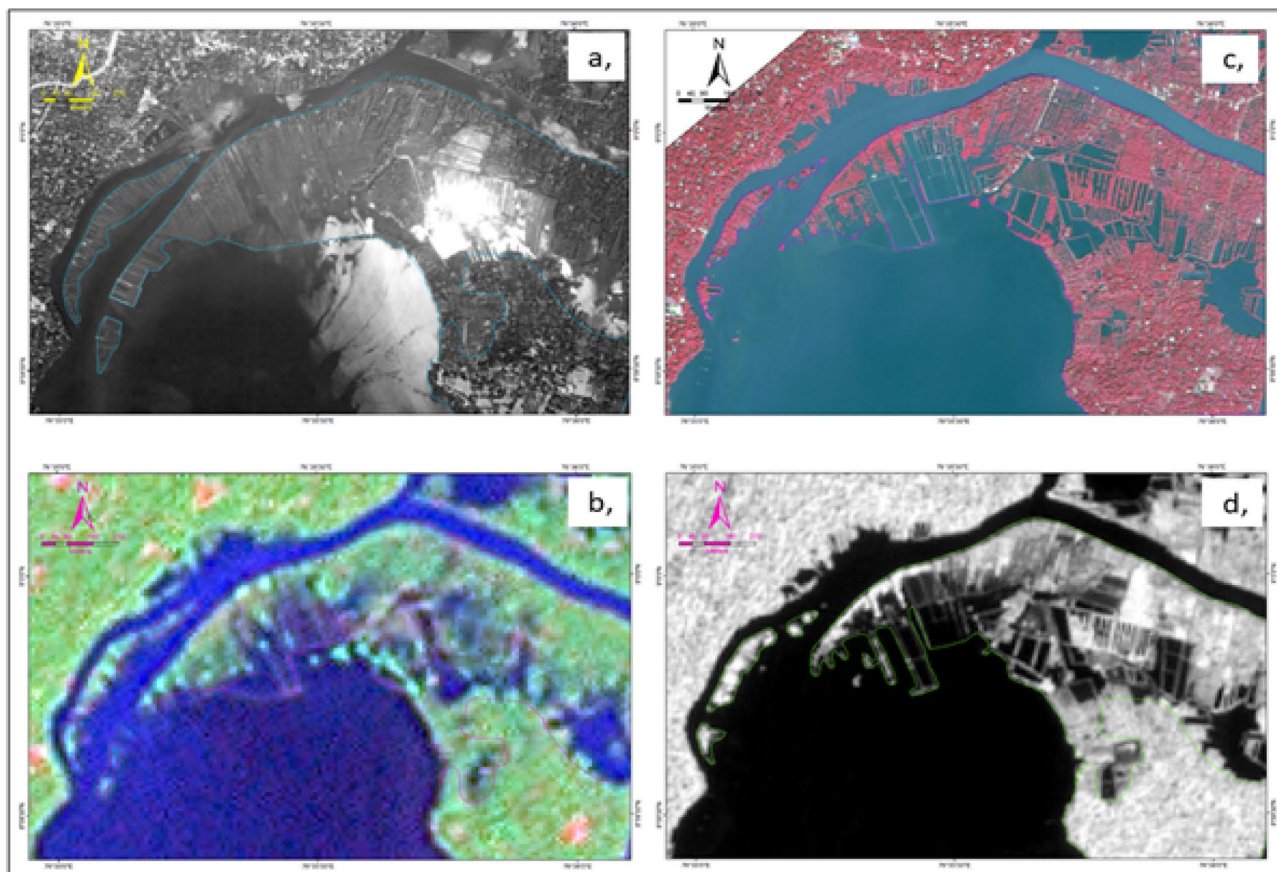
Figure 8. Morphological changes in the study area from the satellite images (a) 1989 (aerial photograph); (b) 2000 (Landsat); (c) 2011 (World View—II); (d) 2021 (Sentinel) (the modified maps of (a) is obtained from National Remote Sensing Centre (NRSC), Hyderabad, (b) is downloaded from <https://earthexplorer.usgs.gov/> (c) is obtained from Digital Globe through NRSC and (d) is downloaded from <https://scihub.copernicus.eu/>. Figures were generated using Arc GIS 10.6).

Over the study area the most affected alluvial plain of the *Peringalam* and *Cheriyakadavu* island are taken separately to study the morphological changes over the decades. This area is named *Puthan Yekkalpuram* (which means new alluvium land), and the north side of the Kallada river (the northward extension in the *Mundrothuruth* GP) is demarcated as old alluvium land (*Pazhaya Yekkalpuram*) as per the revenue department’s cadastral map. The study shows that total 38.73 acres of land has lost from the *Peringalam* and *Cheriyakadavu* Islands during the last 32 years, which is equivalent to 11.78% and 46.95% of the total geographical area of the *Peringalam*

and *Cheriyakadavu* Islands, respectively. The land degradation details over the last three decades are given in the Table 2. Many other locations, such as *Nenmeni* and *West Pattamthuruth*, are also severely affected by land degradation. However, these areas are landlocked and less affected by running water or floods. Hence, the land degradation experienced is the settling of the topsoil and subsidence of structures such as houses and bridges. The sinking of basements of many houses and even the subsidence of railway platforms are well observed during field visits, indicating the alarming land degradation issues (Figs. 1 and 10) to be addressed its deserving importance. There are also clear indications of the gradual formation of new waterlogged areas in the islands, which may further deteriorate and forms the part of the backwater system which eventually affects total land area of the Munroe Island.

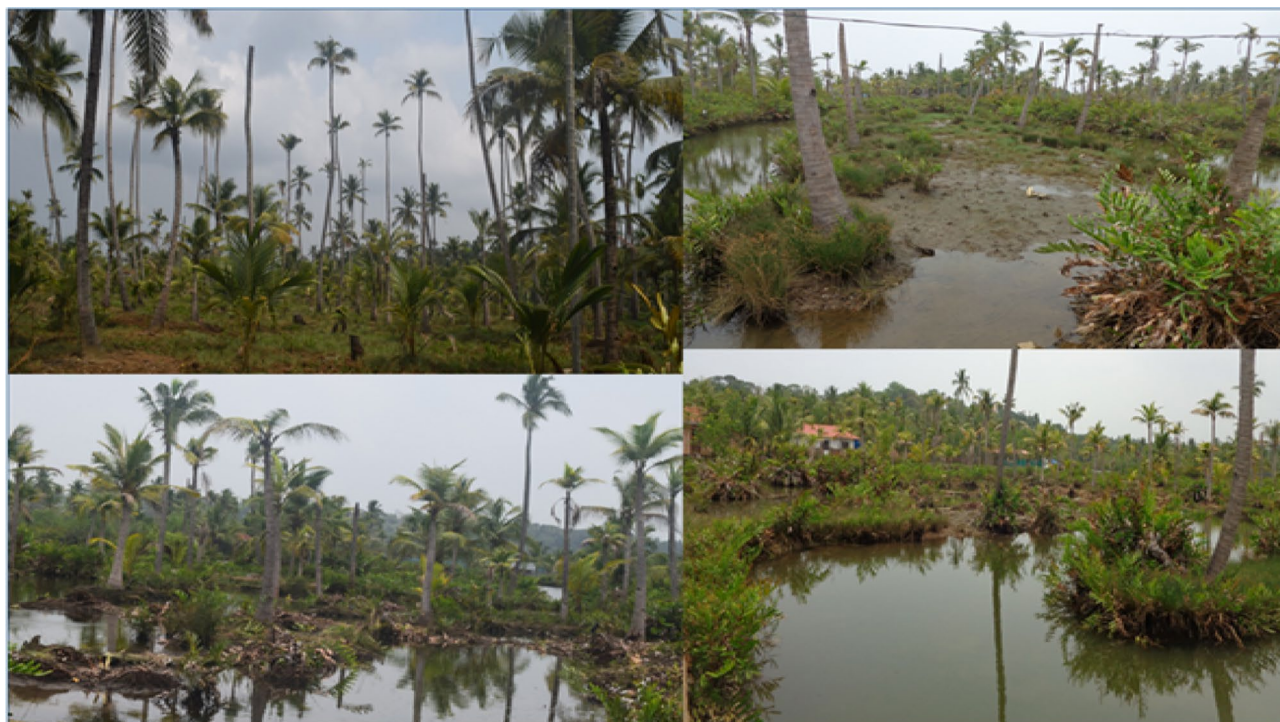
Figure 9. Threatened coconut plantations indicating the low productive regime. Photographs taken by Rafeeque MK.

Land degradation: a morphological analysis. To decrease the impact of the monsoon floods and to distribute the alluvium to the southern part of the island, Canol Munroe, the then Diwan of the Thiruvithamkoor Dynasty, made an artificial man-made canal during the 1820s connecting the Kallada river with the eastern extension of Ashtamudi lake, and this river is known as “Puthanar” (meaning a new river). During the last few decades, (after 1980s) the estuarine island ecosystem of Munroe Island has faced several structural deformities. The natural sedimentation and flooding happening in the Islands were very limited and hence, the normal events happened over the past several decades disturbed and significantly affected the land neutrality. These islands, once known as the region’s rice bowl, now devoid of any paddy cultivation mainly because of the increased soil salinity. According to the Cadastral map prepared by the revenue department (1960s) there were many paddy fields, locally named as *Mathirampalli Vayal* (Vayal is the local name for paddy field), *Thekke Kothappalam Vayal*, *Mattil Vayal*, *Kottuvayal*, *pallaykattu Vayal*, *Konnyail Vayal*, *Vadakke Kundara Vayal*, *Thachan Vayal*, *Thekke Kundara Vayal*, *Kizhakke Oveli Vayal*, *Thekke Oveli Vayal*, *Odiyil Vettukattu Vayal*, *Nedumala Vayal*, *Madathil Vayal*, *Karichal Vayal*, *Moonumukkil Vayal*, *Arupara Vayal*, *Kaniyampalli Vayal*, *Manakkadavu Vayal*, *Panampu Vayal*, *Pattamthuruth Vayal* etc. The recent satellite images shows that no paddy cultivation exist now, which is further confirmed by the field observations conducted through our study. The annual report published by Gramapanchayat³⁹ indicate that the paddy field of region was reduced from 227 to 8 acres (from 1950 to 1995) and now about in 2 acres only (2018). Most of the paddy fields of northern and northwestern regions are severely affected by land degradation due to erosion, saline water intrusion and flooding and are entirely or partially buried under the backwater system. Figure 8 depicts the morphological degradation of the severely affected areas of Munroe Island from 1989 to 2021 through different satellite images. Some paddy fields are converted into filtration ponds to take the benefit of frequent tidal flooding. The coconut plantations were later introduced in place of paddy fields, and they eventually replaced the paddy fields. However, during the last decades, it has been observed that these coconut plantations are also under threat mainly because of degradation of the soil fertility, which directly bears the quality and quantity of production (Fig. 9).

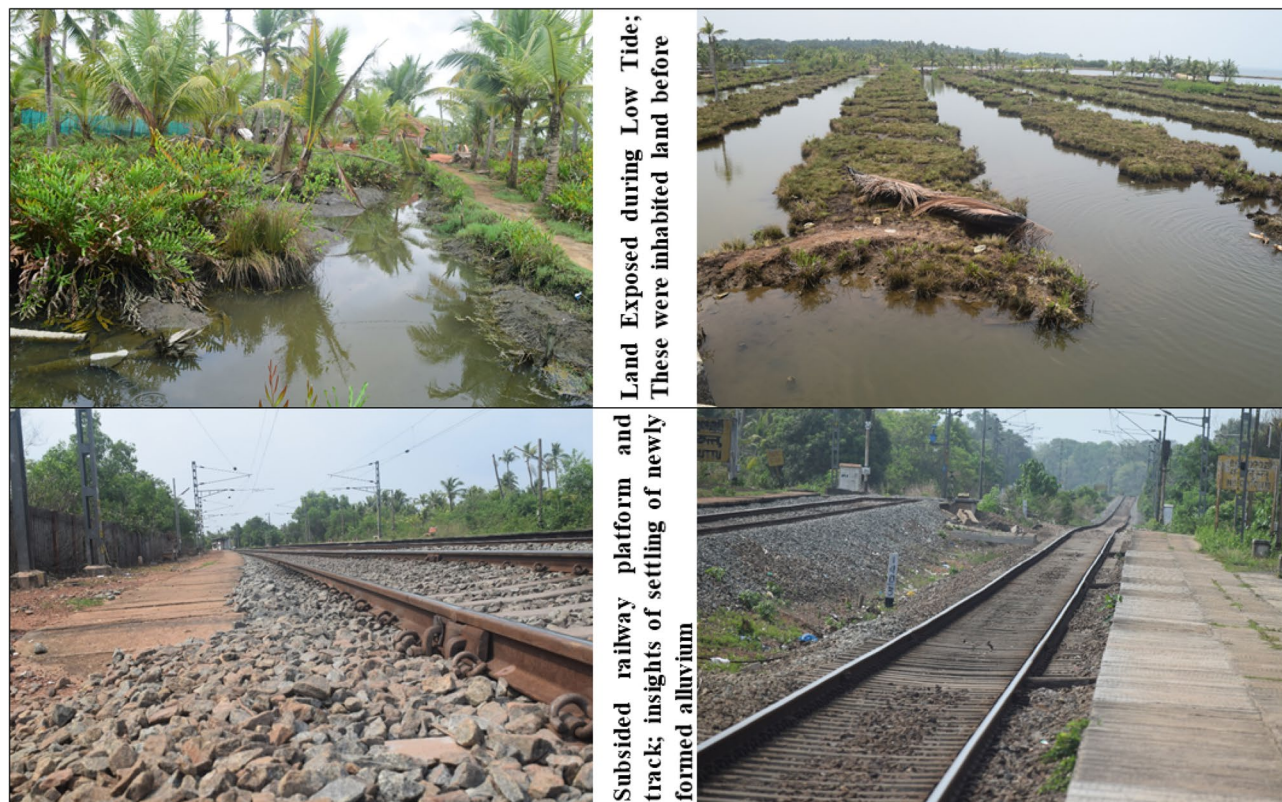
Figure 10. Various environmental degradations in Munroe Island. Photographs taken by Rafeeqe MK.

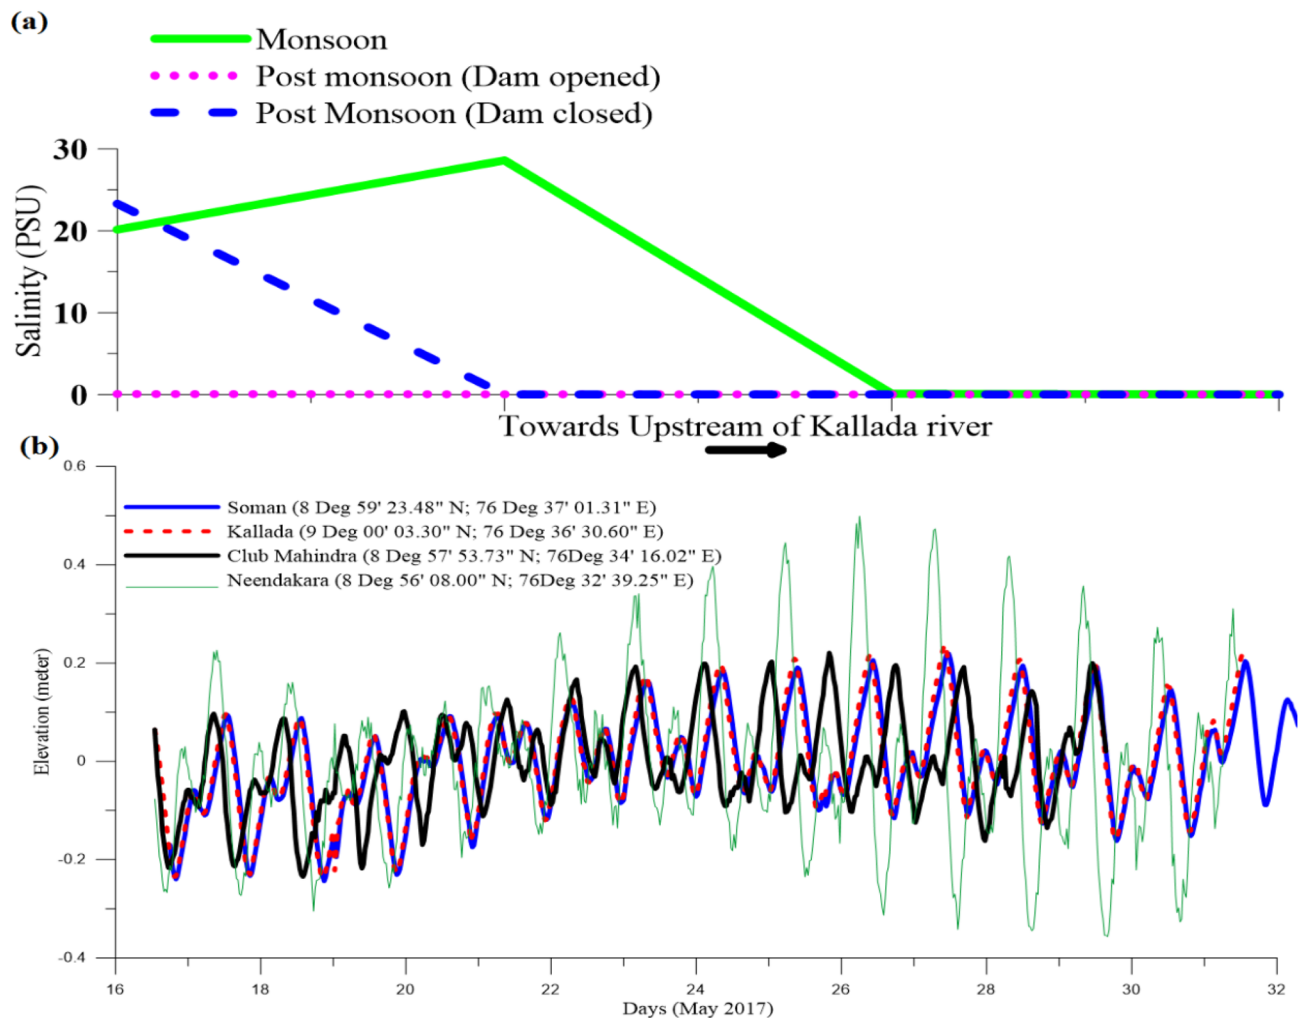
Figure 11. (a) Salinity variation of bottom water at selected locations in Kallada river during monsoon and post monsoon. (b) Observed tide during pre-monsoon months.

during the field study, which corroborates with the acquaintance of local people as well, is that the flooding on Munroe Island is not related to the spring tide of the open ocean. The disappearance of the semidiurnal tide in the central lakes occurs due to frictional resistance and the time lags for the tide to travel across the estuary⁶¹. At the shorter semidiurnal period of approximately 12 h, the tide is more dissipated than the more extended constituents of 24-h duration. The survey conducted with the island inhabitants also reiterates these views.

The water quality analysis for three time periods, during the year of the cyclonic storm, Okhi (2017), was conducted to understand river run-up impact on salinity in and around Munroe Island (Fig. 11). The riverbed is lowered below the baseline of erosion, and dense saline water is trapped in the deeps during high tide. This has been confirmed during the bathymetric survey of the Kallada river and Ashtamudi backwaters, which showed a significant increase in water depth, particularly within the river channel. The high-density saline water is
