## Model experiment research on HPTL anchoring technology for coal-rock composite roof in deep roadway

Zhengzheng Xie<sup>1</sup>, Yongle Li<sup>1</sup>✉, Nong Zhang<sup>1,2</sup>, Zhe He<sup>1</sup>, Chuang Cao<sup>1</sup> & Wei Li<sup>3</sup>

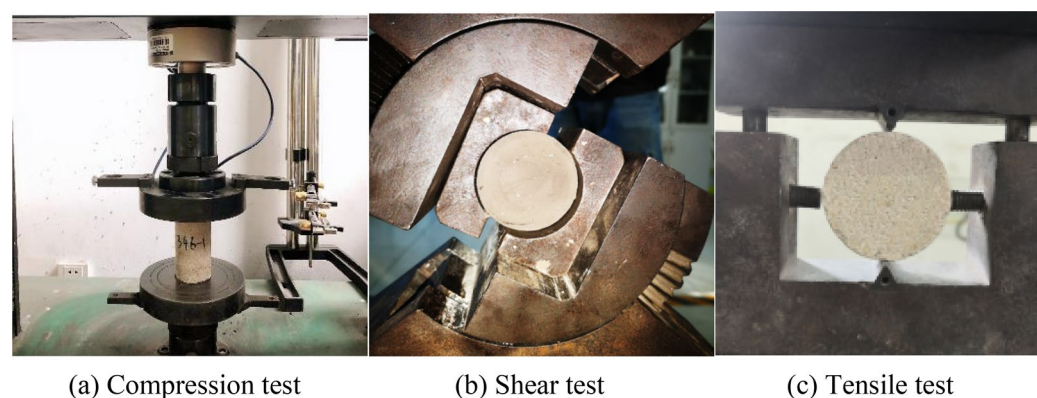
**Figure 1.** Experiment on mechanical properties of similar materials.

To prepare samples with different strength, four sand-to-binder ratios (3:1, 4:1, 5:1, 6:1 and 7:1) and three cement-to-gypsum ratios (3:7, 4:6 and 5:5) were applied pursuant to the scope of simulated strength of different rock strata. Specifically, 15 groups of standard cylindrical samples of  $\Phi 50 \times 100 \text{ mm}$ , 15 groups of standard cylindrical samples of  $\Phi 50 \times 50 \text{ mm}$ , and 15 groups of standard cylindrical samples of  $\Phi 50 \times 25 \text{ mm}$  in size were prepared for independent compression test, shear test and tensile test, respectively, with each group containing three samples for the test (Fig. 1). According to comparisons between different groups in the experiment, the proportioning ratio of similar materials among coal, siltstone, sandy mudstone, and fine sandstone were eventually decided as 737, 646, 637 and 755 (for instance, the proportioning ratio of 737 represents a sand-to-binder ratio of 7:1 and a cement-to-gypsum ratio of 3:7). Table 1 presents the mechanical parameters of the similar materials selected in the experiment.

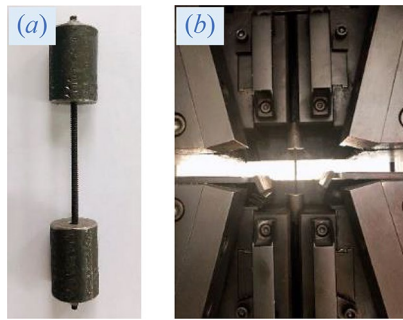
**Figure 2.** Mechanical property test of experimental bolt: (a) experimental bolt and pattern die, (b) detail of bolt drawing test.

Therefore, stainless steel screws and carbon steel screws were adopted for the test, with the test photos shown in Fig. 2 and the specific properties and specifications in Table 2. It was concluded that the  $\Phi 3$ -mm stainless steel screw had an average peak load of 3839 N and an elongation of 19.7%, which was consistent with the characteristics of the bolt; and the  $\Phi 3$ -mm carbon steel screw possessed an average peak load of 4727 N and an elongation

Type	Specifications	Peak force/N	Average peak force/N	Average elongation/%
Stainless steel screw	$\Phi 3 \times 250$ mm	3995/3667/3855	3839	19.7
Carbon steel screw	$\Phi 3 \times 250$ mm	5019/4601/4562	4727	2.8

of 2.8%, fitting the characteristics of the high-strength long bolt and the cable. As a result, the  $\Phi 3$ -mm stainless steel screw was used as the bolt, with the  $\Phi 3$ -mm carbon steel screw as the high-strength long bolt and the cable.

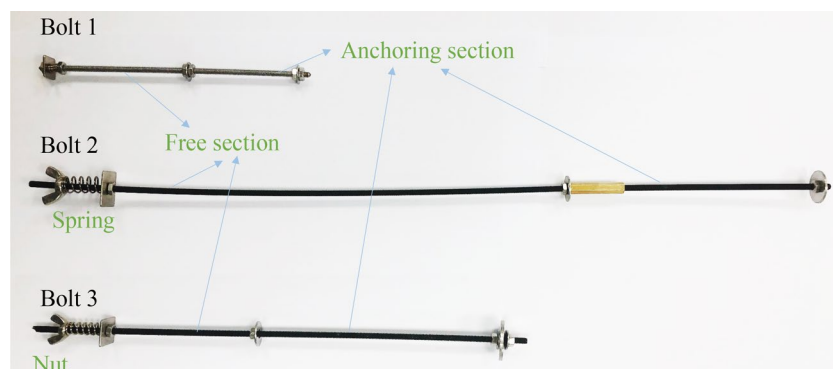
**Figure 3.** Experimental bolt.

A similar bolt comprised a screw, a gasket, a compression spring, and a bolt nut. As shown in Fig. 3, it consisted of a bolt, a cable, and a high-strength long bolt, all of which were measured as 125 mm, 325 mm and 225 mm, respectively, in length from top to bottom. Each bolt extended 25 mm externally for easier exertion of the pre-tightening force by the bolt nut. The length of the anchoring section of the experimental bolt was determined by the gasket, and the gap between the gaskets was anchored by cement mortar.

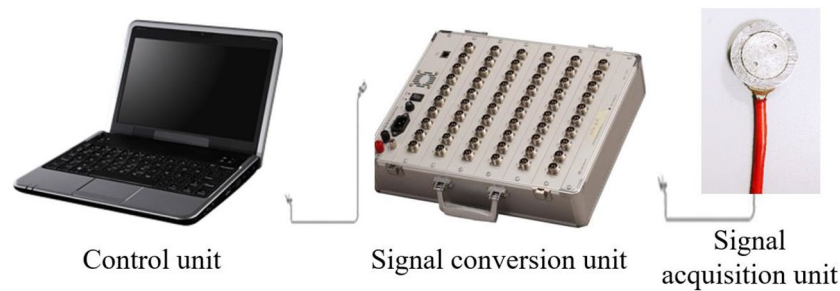
**Figure 4.** Static strain test system.

*Surrounding rock stress monitoring system.* The evolution characteristics of the internal pressure of the model was monitored using the DH3816N static strain test system produced by Donghua Test, with the experimental system presented in Fig. 4. The static strain test system was composed of the control unit, the signal conversion unit, and the signal acquisition unit, serving as the software system, the static resistance strain indicator, and the pressure sensor, respectively. In addition, the static strain test system covered a total of 60 channels that could conduct real-time monitoring of 60 measuring points at the same time.

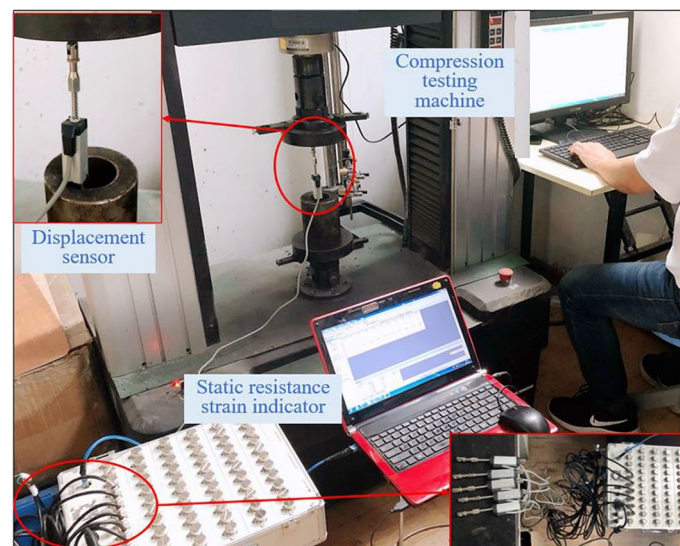
**Figure 5.** Displacement sensor and its calibration experiment.

**Roadway surface deformation monitoring system.** Real-time monitoring of roof subsidence of the roadway and convergence of the coal wall was conducted using a KTR2 displacement sensor, which had the maximum traveling distance of 15 mm and a measurement accuracy of  $\pm 0.1\%$  (Fig. 5). The displacement sensor and the static resistance strain indicator functioned together as the roadway surface deformation monitoring system, which was capable of converting displacement signals into digital signals. As presented in Fig. 6, roadway surface deformation was measured in an accurate manner by calibrating the quantitative relationship of the displacement sensor in the laboratory.

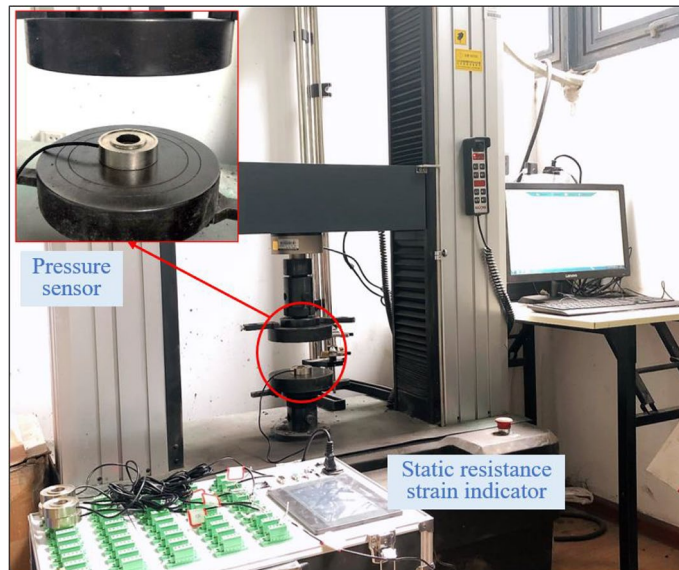
**Figure 7.** Force sensor and its calibration experiment.

**Bolt load monitoring system.** Real-time monitoring of the axial load of the similar bolt was performed using a force sensor (Fig. 7). The pressure sensor had a measuring range of 0–1 T with a measuring accuracy of  $\pm 0.2\%$ . The force sensor was calibrated using a pressure tester to acquire the corresponding relationship between the output digital signal and the load. Figure 8 presents the calibration experiment.

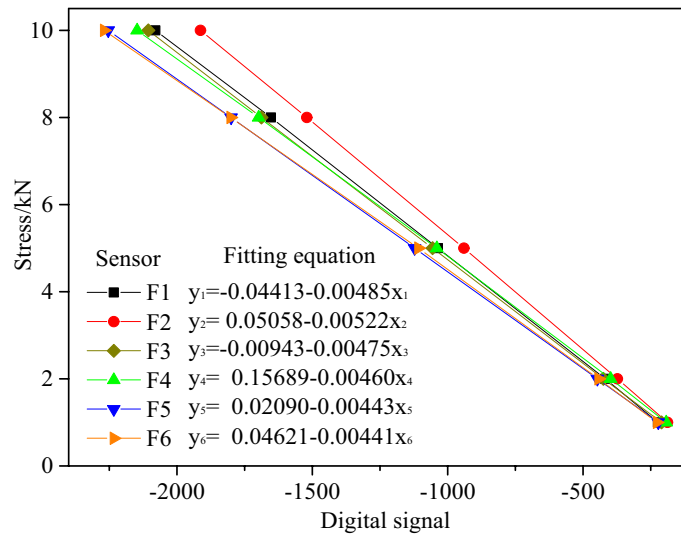
**Figure 8.** Data linear fitting and regression equation.

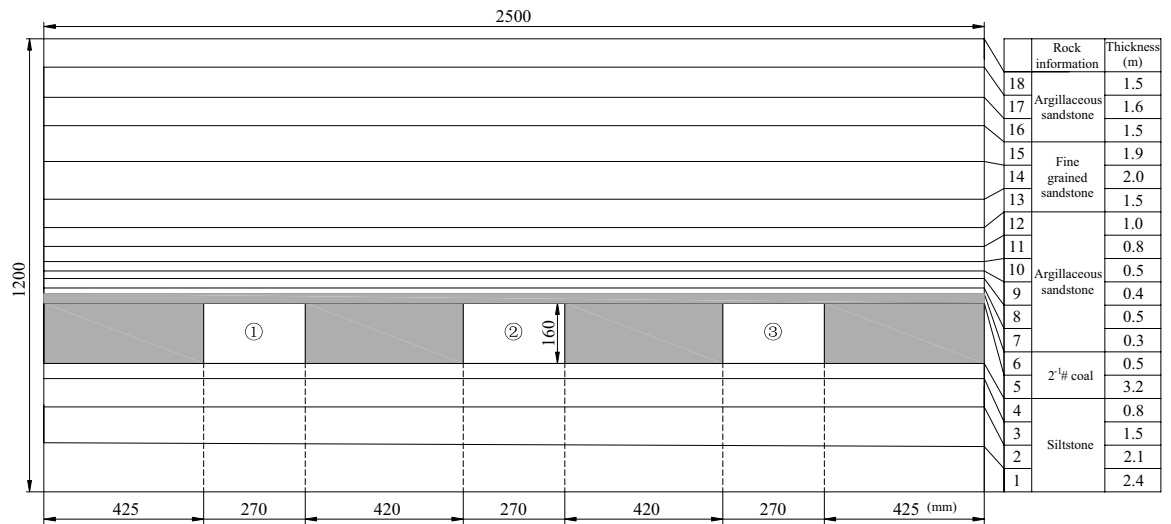
**Figure 9.** Model map of strata distribution.

**Experimental model and program.** *Experimental model.* Figure 9 presents the relations between the size of the experimental model, the distribution of the coal measure stratum and the location of the roadway. Three identical roadways, 270 (width)  $\times$  160 (height) mm in size, were arranged in the 2–1 coal seam, with a spacing of 420 mm between adjacent roadways. A 425-mm large coal pillar was reserved for the roadway on each side to mainly prevent stress interference and guarantee similar boundaries. Weak planes with cleavages

The stress environment of the model was designed in line with the occurrence conditions of Haulage Roadway 21,205. Since the mining coal seam is typical of 2–1 coal and buried at a depth of 620 m, the in-situ rock stress of this layer stood at 15.5 MPa, and the actual in-situ rock stress of the boundary above the model was tested as 15.2 MPa. Therefore, the in-situ stress field above the experimental model was calculated as 0.5 MPa based on the stress similarity ratio of 1000:33.

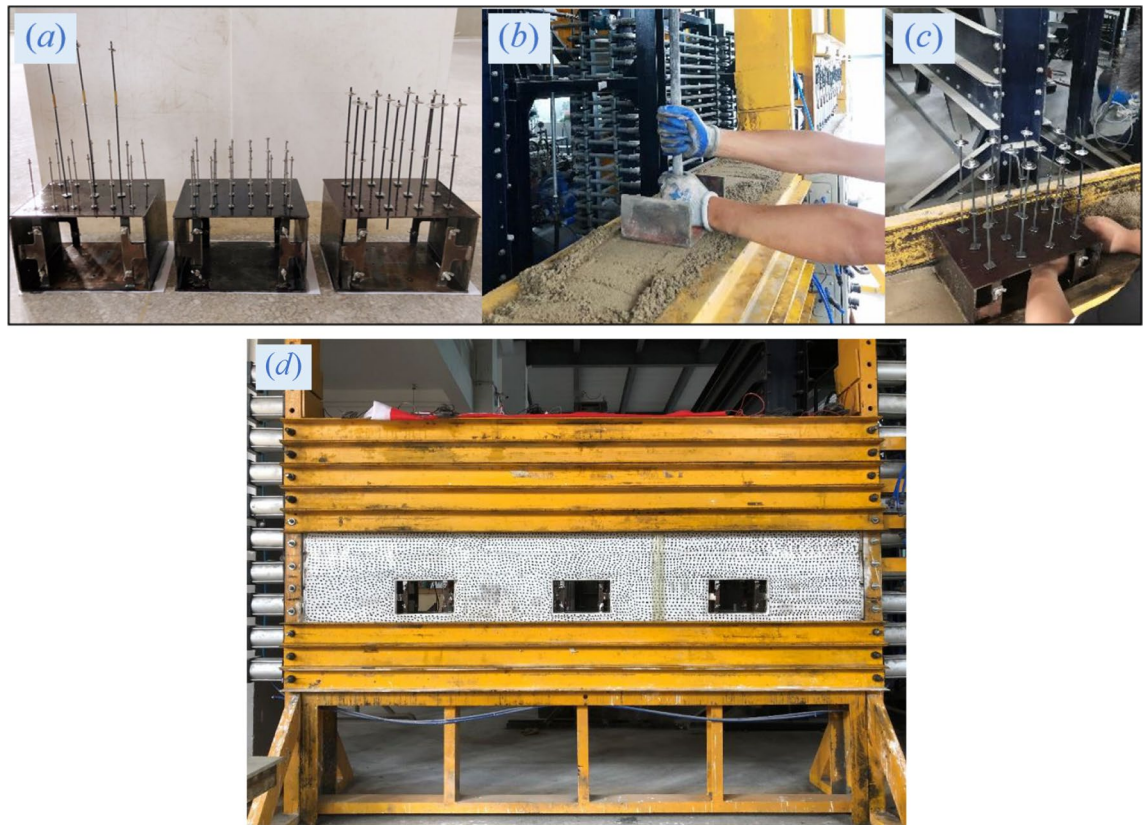
**Figure 12.** Main steps of model making.

*Process of model making.* The making of the experimental model mainly covered the following 6 steps: (a) The experimental bolts were assembled and installed into the model of the roadway in advance after the assembly. (b) Similar materials for various rock strata were prepared pursuant to the proportioning ratio listed in Table 1, and were poured into the model frame for tamping in line with the distribution of rock strata after they were prepared. (c) Roadway models and pressure sensors were embedded into the experimental model in accordance with their locations planned. (d) The baffle boards at the front and rear of the model were removed 7 days after

the laying of the model; then the model was subjected to natural drying for another 20 days, followed by the treatment of whitewashing and painting with black spots on the model surface. (e) Baffle boards were installed at the front and rear of the model, and the observation areas around the roadways were extruded with transparent acrylic plates to apply stress constraints on the observation areas. Figure 12 presents the main steps of model making.

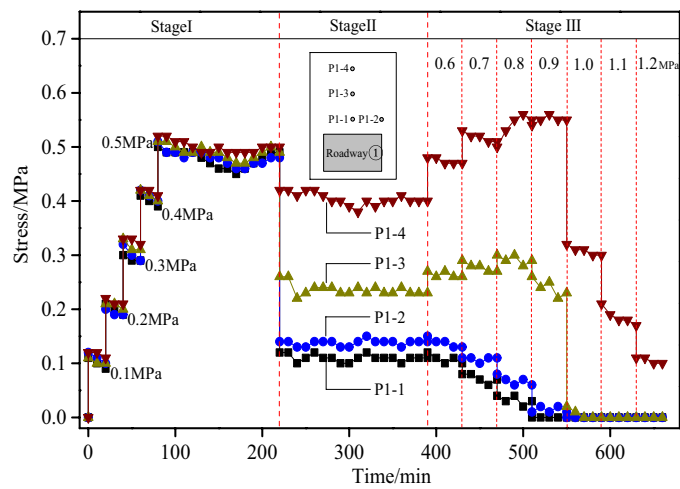
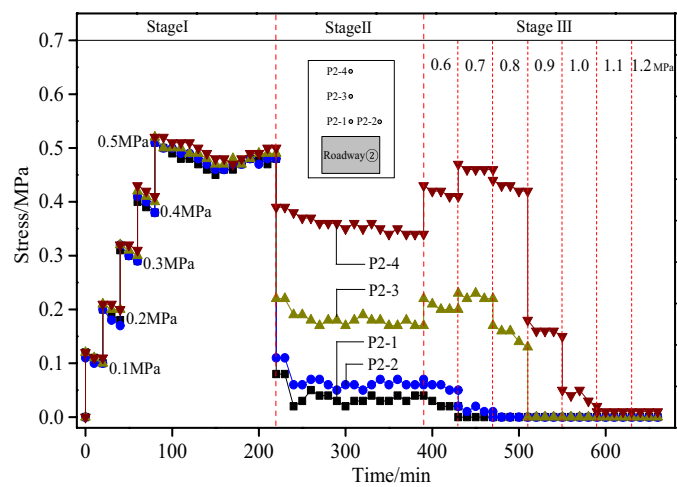
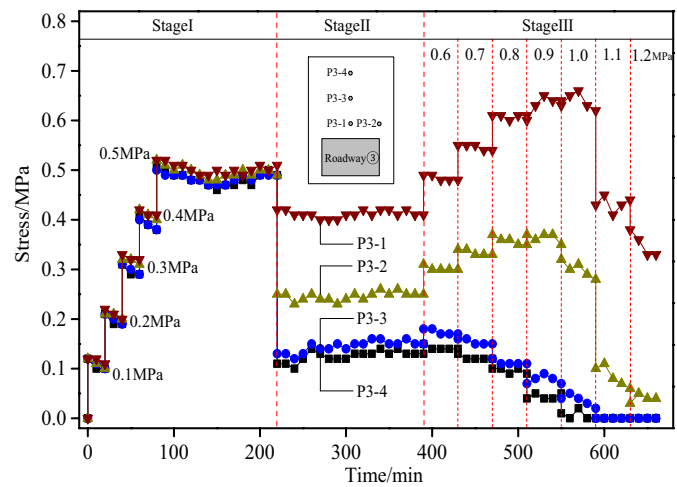
**Figure 14.** Stress evolution curves of roadway surrounding rocks.

**Evolution of the stress of roadway surrounding rocks.** Figure 14 presents the stress evolution curves of roadway surrounding rocks, revealing that as roadway excavation and model loading carried on, the evolution laws of the stress of surrounding rocks in each roadway exhibited both similarities and differences. The first stage witnessed similar stress evolution curves of the three roadways, all of which indicated a trend of gradient increase. the surrounding rock stress of each roadway dropped slightly with a tendency of remaining stable when the surrounding rock stress reached 0.5 MPa. In the second stage, the surrounding rock stress decreased sharply when the roadway was initially excavated, with the pressure sensors closer to the roof witnessing a larger drop while those further from the roof experiencing a smaller drop in stress value. Furthermore, the surrounding rock stress rose slightly and was subjected to dynamic adjustments after the bolt support was applied. In the third stage, significant differences occurred in the evolution of the stress of different layers as the loading pressure increased gradually. The evolution of the stress on the roofs of the three roadways will be discussed in independent sections.

The roof of Roadway ① was co-supported by short bolts and long cables. The sensors P1-1 and P1-2 were located within the bolt anchorage zone, while the sensors P1-3 and P1-4 were installed outside the bolt anchorage zone but still within the cable anchorage zone. According to Fig. 14a, the stress of P1-1 and P1-2 decreased gradually when the loading pressure rose slowly to 0.8 MPa, revealing the appearance of crack abscission layers firstly in the top coal during this process; but the sensors P1-3 and P1-4 witnessed the rise of the stress, indicating that no cracks developed outside the bolt anchorage zone under this pressure and only elastic–plastic deformation occurred in the deep surrounding rocks. The stress in the bolt anchorage zone almost dropped to 0 when the pressure rose to 0.9 MPa, implying the generation of comparatively large abscission layers in the bolt anchorage

zone and the separation of the top coal from the deep rock strata; at this moment, the stress of the sensor P1-3 had begun to drop with a descending trend, indicating the appearance of abscission layer damages in the tail area of the bolt, as well as the occurrence of crack propagation outside the bolt anchorage zone; moreover, the stress of the sensor P1-4 started to fluctuate. The entire bolt anchorage zone collapsed when the loading pressure reached 1.0 MPa, resulting in a sudden drop of the stress of roof surrounding rocks; at this moment, the stress of the sensor P1-3 dropped to 0 while that of the sensor P1-4 still remained above 0, indicating that the deep rock mass still retained its bearing capacity to some degree.

In Roadway ②, the roof was under single support of short bolts. The sensors P2-1 and P2-2 were located within the bolt anchorage zone, while the sensors P2-3 and P2-4 were installed outside the bolt anchorage zone. According to Fig. 14b, the stress of both sensors P2-3 and P2-4 rose when the loading pressure reached 0.6 MPa and 0.7 MPa, respectively, with the sensor P2-4 exhibiting a larger amplitude of increase. The stress of the sensors P2-1 and P2-2 dropped, however. The stress of the sensor P2-1 decreased to 0 directly at a pressure of 0.7 MPa, denoting that the cracks between the top coal and the upper rock stratum had run through to form abscission layers. Given a pressure of 0.8 MPa, the surrounding rock stress of the sensors P2-3 and P2-4 both dropped slightly, indicating the propagation of the cracks to deeper strata at this moment. The bolt anchorage zone instantly collapsed when the loading pressure reached 0.9 MPa, due to which the stress in the deep stratum was suddenly released. Consequently, the stress of the sensors P2-3 and P2-4 dropped in a gradient manner.

The roof of Roadway ③ was under single support of high-strength long bolts, for which the sensors P3-1, P3-2 and P3-3 were installed within the bolt anchorage zone while the sensor P3-4 outside the bolt anchorage zone. As shown in Fig. 14c, when the loading pressure rose to 0.9 MPa in a gradual process, the sensors P3-1 and P3-2 witnessed a slight decrease while the sensors P3-3 and P3-4 a gradual increase in stress. This indicated that though cracks had started to develop in the top coal area of the bolt anchorage zone as the pressure rose, the bolt anchorage zone still functioned with effective bearing capacity at this moment. This further proved that thick anchoring layers of the roof were able to resist a large amount of load. The development of surrounding rock cracks became active when the loading pressure reached 1.0 MPa, with the sensor P3-3 witnessing a drop

while the sensor P3-4 not yet a decline in stress. This indicated that the cracks had not yet developed to this location. The walls were crushed at a loading pressure larger than 1.0 MPa, resulting in the overall subsidence of the roof and the generation of abscission layers between rock strata. Consequently, the stress of surrounding rocks dropped in a gradient manner. At this moment, however, the roof still remained comparatively intact, with the existence of safety spaces in the roadway to some degree.

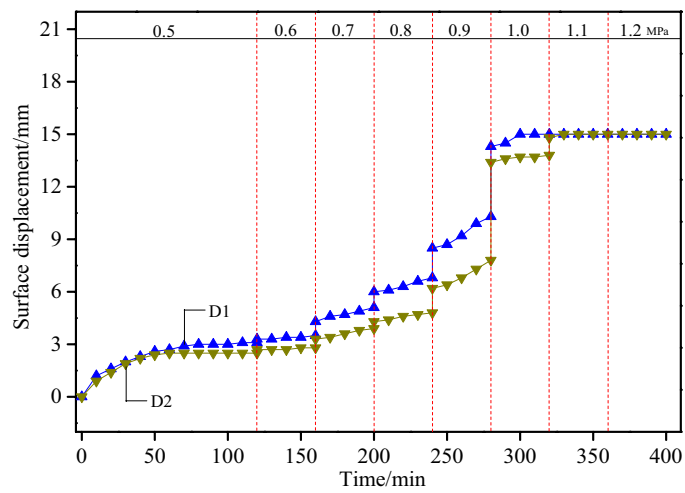
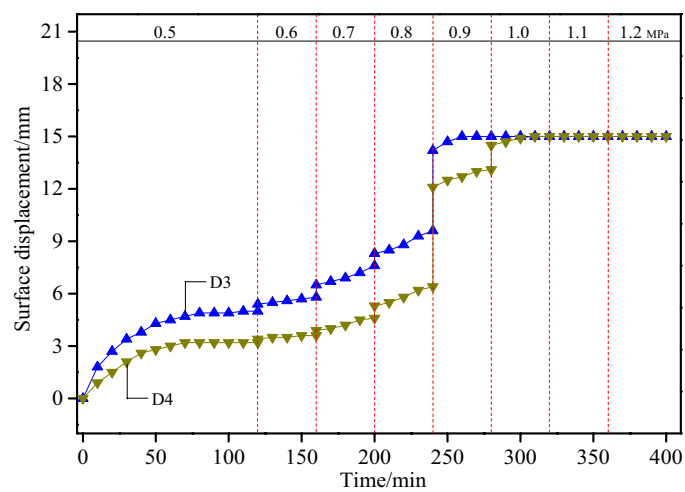
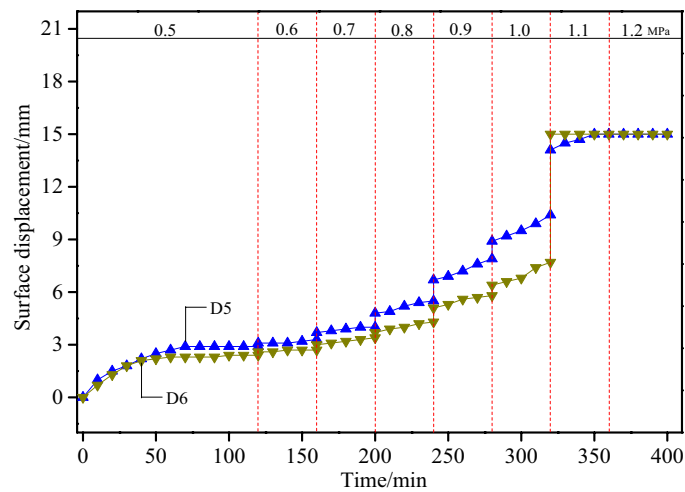
**Figure 16.** Surface displacement variation curves of roofs and walls of various roadways.

**Evolution of roadway surface displacement.** Figure 16 presents the surface displacement, evolution curves of the roofs and walls of various roadways, based on which different evolution characteristics of each roadway are revealed.

According to Fig. 16a, the displacement of the roof and the coal wall of Roadway ① was measured by the displacement sensors D1 and D2, respectively. At a loading pressure of 0.5 MPa, the roadway surface displacement increased rapidly and then slowly and finally became stable. The subsidence of the roof and the convergence of the coal wall amounted to 3.1 mm and 2.5 mm, respectively. Little deformation occurred in surrounding rocks when the loading pressure reached 0.6 MPa, with an increase of roof subsidence and coal wall convergence only by 0.4 mm and 0.3 mm, respectively; at a loading pressure of 0.7 MPa, 0.8 MPa and 0.9 MPa respectively, the deformation of surrounding rocks was featured with a rapid increase by leaps, with the roof subsidence amounted to 5.1 mm, 6.8 mm and 10.3 mm and the relative displacement to 1.6 mm, 1.7 mm and 3.5 mm, respectively, at each stage. Collapse occurred in the bolt anchorage zone of the roof at a pressure larger than 0.9 MPa, with the roof displacement reaching the maximum range of the sensor (15 mm) in an instant.

As shown in Fig. 16b, the sensors D3 and D4 were adopted to measure the displacement of the roof and the coal wall of Roadway ②, respectively. When the loading pressure reached 0.5 MPa, the surrounding rocks exhibited similar deformation characteristics with those of Roadway ①, except for a degree of variation that was more dramatic. During this process, the amount of roof subsidence was larger than the amount of coal wall deformation, which stood at 5.0 mm and 3.2 mm, respectively. At a loading pressure of 0.6 MPa, 0.7 MPa and 0.8 MPa, respectively, the roadway deformation presented an evolution characteristic of progressive increase, with the roof subsidence at each stage reaching 5.8 mm, 7.6 mm and 9.6 mm, respectively. When the loading pressure was at 0.9 MPa, the shallow rock mass of the roadway instantly collapsed, due to which the roof subsidence promptly reached the maximum range of the sensor. The coal wall convergence also reached 15 mm given a loading pressure of 1.0 MPa, implying that the deformation of the roof was larger than that of the coal wall under the short bolt support.

According to Fig. 16c, the sensors D5 and D6 were used to measure the displacement of the roof and the wall of Roadway ③, respectively. The roof subsidence was very close to the coal wall convergence at a loading pressure of 0.5 MPa, which were measured as 2.9 mm and 2.4 mm, respectively, after stabilization. When the loading pressure stood at 0.6 MPa and 0.7 MPa respectively, comparatively small deformation occurred in surrounding rocks, and the deformation of the roof and the coal wall only reached 4.0 mm and 3.4 mm, respectively. Given a loading pressure of 0.8 MPa, 0.9 MPa and 1.0 MPa respectively, comparatively active deformation took place in surrounding rocks, with the amount (in roof subsidence, for instance) reaching 5.5 mm, 7.9 mm and 10.4 mm, respectively. When the load reached 1.1 MPa, the coal walls were crushed and collapsed, due to which the coal wall convergence reached the maximum range of the sensor in an instant. Moreover, the overall roof sank as a result. This indicated that the deformation of the roof was significantly smaller than that of the coal wall under the high-strength long bolt support.

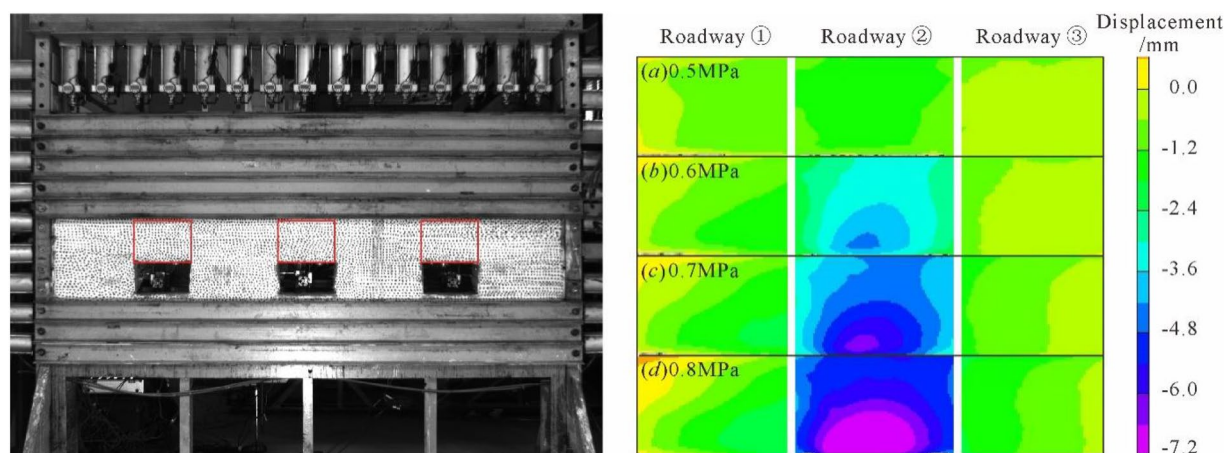
**Figure 17.** Evolution characteristics of displacement field of surrounding rock of each roadway under progressive loading.

**Evolution of roadway surface displacement field.** Figure 17 presents the displacement field evolution diagram of the surrounding rocks of the roofs of the roadways under the mode of progressive loading. The digital speckle correlation measurement system was adopted to collect grayscale photos, which are shown as the images on the left in Fig. 17. The cloud chart characteristics of the roadway displacement fields were acquired after the input of the grayscale images into the software system for calculation, which are shown as the images on the right in Fig. 17.

According to Fig. 17a, the surrounding rock displacement fields of the roofs of all roadways remained relatively uniform when the loading pressure reached 0.5 MPa, without no concentration of displacement fields. Figure 17b reveals that the concentration of displacement fields occurred in the top coal area of Roadway ② and propagated into deeper strata when the loading pressure was at 0.6 MPa. On the contrary, however, no obvious changes were spotted in Roadway ① and Roadway ③ in this regard. As shown in Fig. 17c, the displacement field of the roof surrounding rock in Roadway ② continued to increase and propagated into deeper strata when the loading pressure reached 0.7 MPa. As shown in Fig. 17d, the displacement of the roof surrounding rock in Roadway ② distributed widely when the loading pressure was at 0.8 MPa, with the displacement of shallow surrounding rocks amounting to 7.2 mm. Nevertheless, no apparent concentration of displacement fields was observed in Roadway ① or Roadway ③. Further analysis of the roadway failure characteristics in Fig. 18 revealed extremely dramatic development of the cracks in surrounding rocks of Roadway ②, which not only generated inclined cracks and a lateral abscission layer but also caused the inclined cracks at the roadway humeral angle to intersect with and run through the abscission layer; the abscission layer was approximately located at the tail area of the bolt anchorage zone, falling into the tensile stress area between the bolts and the surrounding rocks and categorized as a weak surface. Therefore, it was easy for cracks to appear in this area under this load. At this moment, lateral cracks occurred between the top coal and the immediate roof of Roadway ①, while Roadway ③ only experienced minor deformation with the absence of apparent crack propagation.

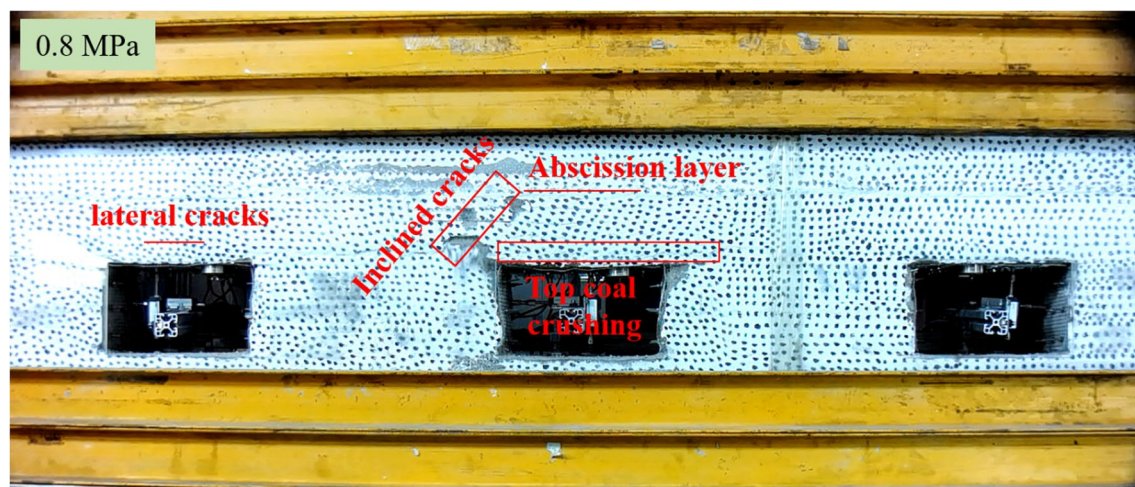
**Figure 18.** Failure characteristics of surrounding rock of each roadway at a loading pressure of 0.8 MPa.

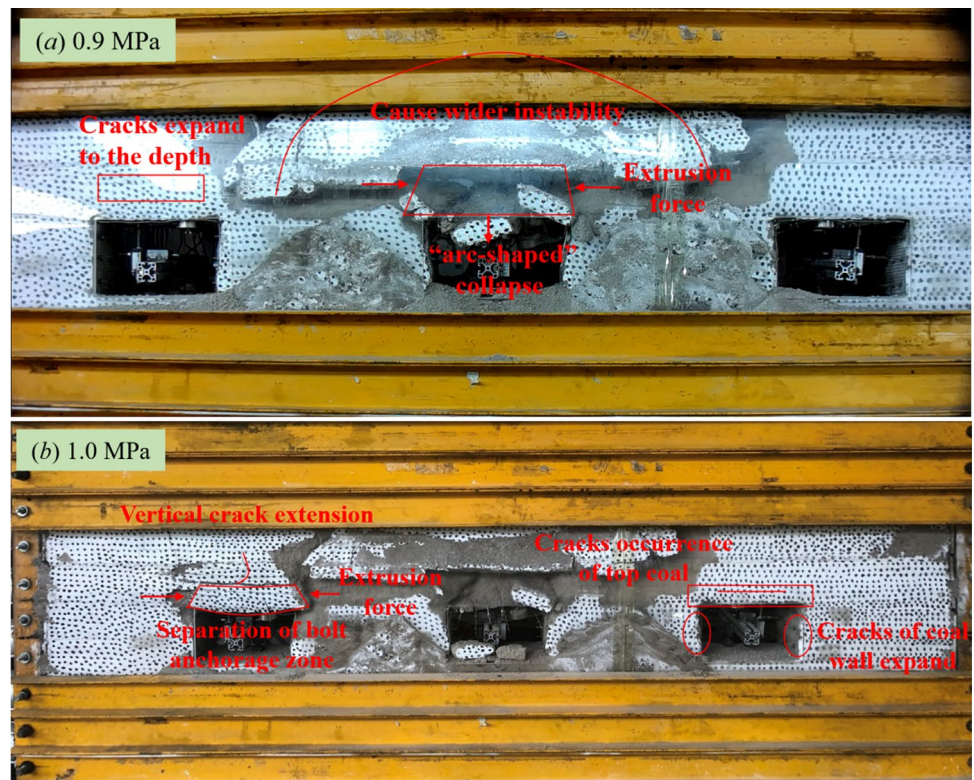
**Figure 19.** Failure characteristics of surrounding rocks of each roadway at a loading pressure of 0.9 MPa and 1.0 MPa.

**Difference analysis of progressive failures of surrounding rocks of different roadways.** Figure 19 presents the deformation failure diagrams of each roadway at a load of 0.9 MPa and 1.0 MPa, respectively. The failure mechanisms of the roofs anchored by different support systems were analyzed based on comparisons between failure characteristics of each roadway. As shown in Fig. 19a, overall collapse took place in Roadway ② when the load reached 0.9 MPa, subsequently resulting in instability of rock masses in a wider range. At this moment, though the cracks in shallow strata of Roadway ① had already propagated into deeper strata, the cracks were only confined to the bolt anchorage zone. On the contrary, however, Roadway ③ had witnessed no apparent deformation yet. The bolt anchorage zone of Roadway ② fell off further at a load of 1.0 MPa. In Roadway ①, the bolt anchorage zone was separated from the rock stratum of the immediate roof to cause complete failure of the bolt support. During this process, the cable only functioned to hang up the bolt anchorage zone. In the meanwhile, the vertical cracks in the immediate roof also propagated into deeper strata, so there was the risk of systematic collapse. At this moment, Roadway ③ also witnessed obvious deformation that mainly concentrated in the following two locations: firstly, the top coal and the connecting area between the top coal and the coal wall, where a lot of cracks appeared; and secondly, in the coal wall, where a great number of penetrating cracks occurred.

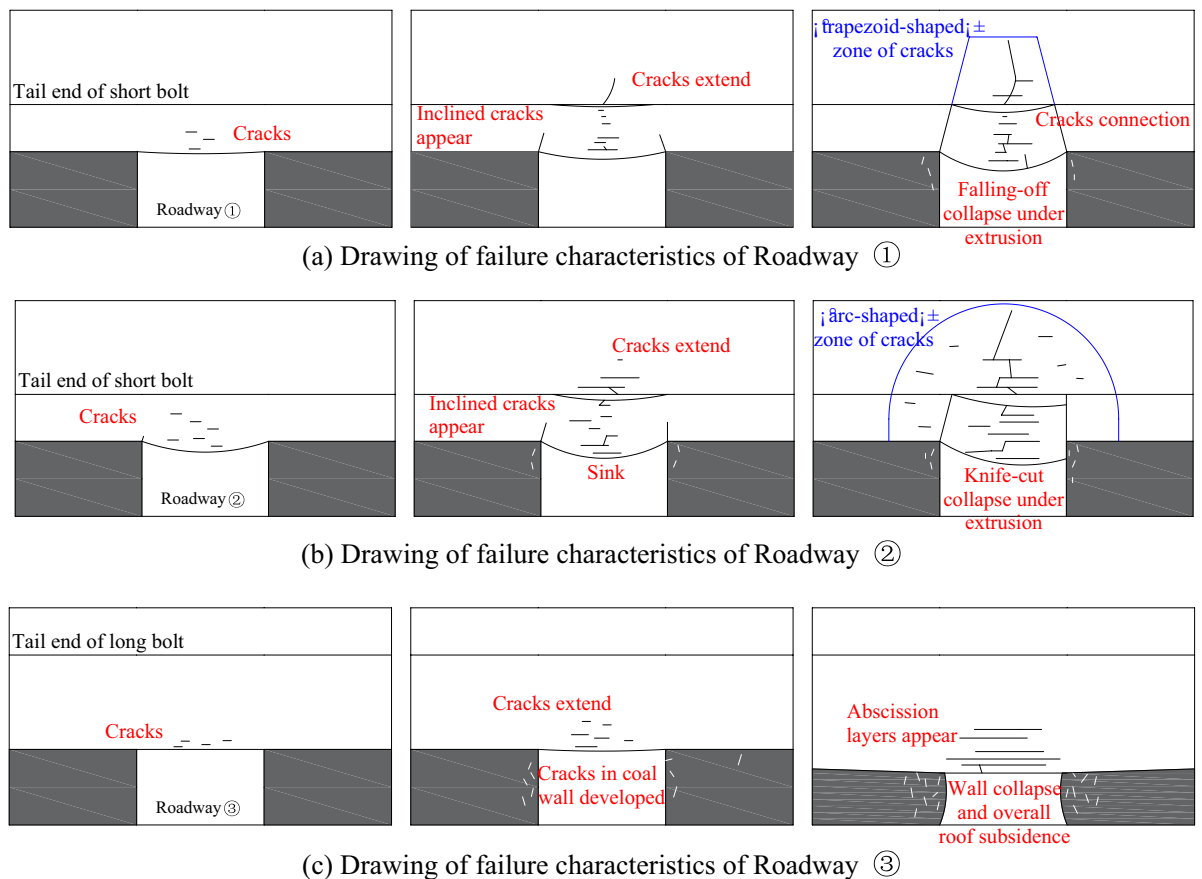
**Figure 20.** Drawings of failure characteristics of each roadway.

Figure 20a presents the drawing of the progressive failure of Roadway ①, which mainly consisted of the following processes: the cracks in the top coal started to emerge before the appearance of inclined cracks at the humeral angle in the connecting area between the top coal and the coal wall. As the lateral and longitudinal cracks in the anchorage zone ran through the strata, the overall bolt anchorage zone sank as a result and eventually fell off and collapsed under the action of the horizontal pressure force. This kind of failure is categorized as the “falling-off collapse under extrusion.” At this moment, the cracks had already propagated into the rock strata outside the bolt anchorage zone to form a “trapezoid-shaped” zone of cracks.

Figure 20b presents the drawing of the progressive failure of Roadway ②, which mainly covered the following processes: Cracks developed firstly in the top coal. Then, the cracks in the top coal propagated beyond the boundary to the entire bolt anchorage zone. In the meanwhile, the cracks at both the two humeral angles of the roadway started to develop upward, with inclined cracks formed on the left while vertical cracks on the right. Over collapse occurred in the bolt anchorage zone under the action of the horizontal force. This kind of failure is categorized as the “knife-cut collapse under extrusion.” At this moment, the cracks had already propagated beyond the bolt anchorage zone to form a wide “arc-shaped” zone of cracks.

Figure 20c presents the drawing of the progressive failure of Roadway ③, which mainly involved the following processes: The cracks on the top coal propagated into the immediate roof under high pressure. In the meanwhile, the cracks in the coal wall developed dramatically to trigger the collapse of the roadway and the

overall subsidence of the roof. This is a failure typical of “wall collapse and overall roof subsidence.” During this process, the roadway still had safety spaces to some degree except for the appearance of multiple abscission layers in rock strata of the roof.

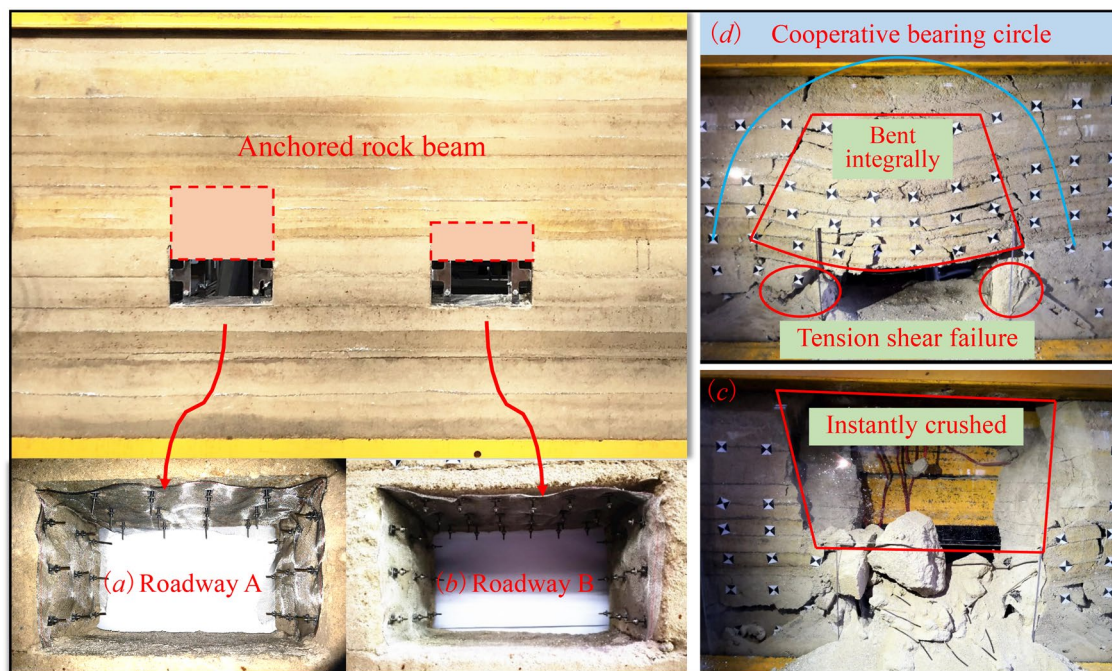
**Figure 21.** Roadway failure characteristics based on similarity model and impact dynamic load.

After the supports for the roadways in the model were installed, the model was subjected to an instantaneous loading of 1.0 MPa to simulate the instantaneous high dynamic pressure under impact. The experimental results revealed significant differences in failure characteristics between the two roadways. According to Fig. 21c, the thin-layer anchored rock beam supported by short bolts in the roof of Roadway B collapsed in an instant under the action of the instantaneous high load, displaying the failure of “knife-cut” collapse in general. In the

meanwhile, collapse outside the anchorage zone was also triggered. As shown in Fig. 21d, though the coal walls of Roadway A were instantaneously crushed under the action of high load, the thick-layer anchored rock beam in the roof only experienced “fan-shaped” subsidence as a whole. During this process, wide distribution of multiple horizontal and vertical cracks occurred between rock strata of the roof. At this moment, the failure of the roof was mainly attributed to the lack of bearing force from the coal wall.

Based on further analysis, the thickness of the anchoring layer played a key role in determining the bearing structure of the roof, thus further affecting the forms of the failures of the roadway. The thick-layer anchoring structure in the roof, supported by high-strength long bolts, could mobilize the rock masses in a wider range to bear the load together. In this manner, the rock masses functioned jointly to resist high load. Despite of the occurrence of wall collapse, the surrounding rocks of the roof could still bear the load effectively to guarantee necessary safety spaces for the roadway. Since the bearing capacity of the thin-layer anchoring structure supported by short bolts was weak, it could only mobilize the rock masses in a smaller range to bear the load. Consequently, it would instantaneously collapse under impact load at higher odds. This indicated that when a thick-layer anchoring structure has been established in the roof, it is able to effectively mobilize the rock masses in a wide range to form a huge bearing circle. In this way, the anchoring layer will be substantially improved in rigidity to perform better in impact resistance.

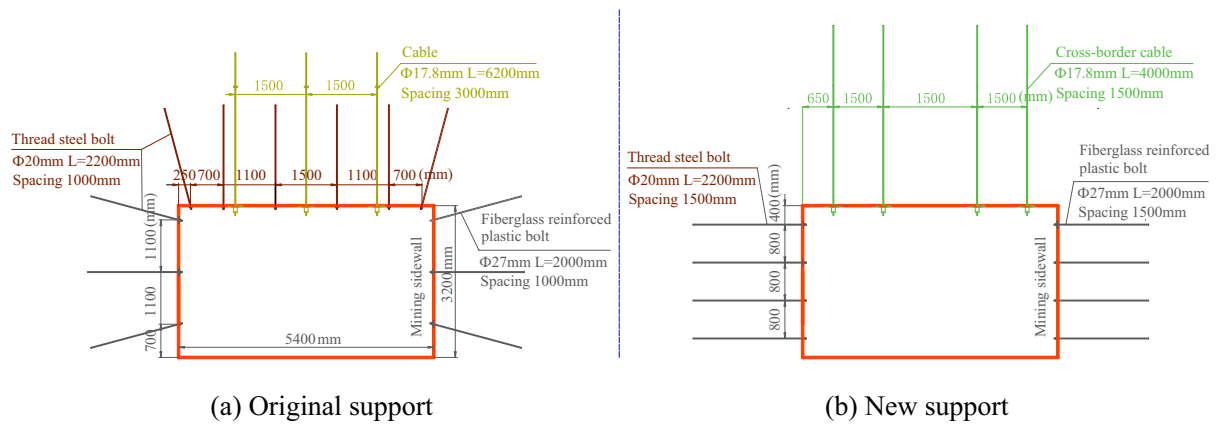
**Figure 22.** Comparison of support parameters between original and new schemes.

The original support scheme was a combination of bolt and cable support, with the specific parameters presented in Fig. 22a. Six thread steel bolts (specification:  $\Phi 20 \times 2200$  mm) were installed in each row in the roof, for which an arched steel supporting tray (150 × 150 × 10 mm) was equipped at a row spacing of 1000 mm. Three cables were installed (specification:  $\Phi 17.8 \times 6200$  mm) in each row, for which an arched steel supporting tray (300 × 300 × 12 mm) was arranged at a row spacing of 1500 × 3000 mm. On top of that, the installation of a steel bar mesh (specification:  $\Phi 6.5 \times 3400 \times 1100$  mm) was also required. The pre-tightening force of the bolt and the cable was measured as 30 kN and 80 kN, respectively. Thread steel bolts (specification:  $\Phi 20 \times 2200$  mm) were adopted for the coal pillar, for which a steel supporting tray (150 × 150 × 10 mm) and a rhombic metal mesh (2800 × 1200 mm) were equipped. Fiberglass reinforced plastic bolts ( $\Phi 27 \times 2000$  mm) were adopted for the stopping wall, for which a fiberglass reinforced plastic supporting tray and a steel plastic mesh (2900 × 1200 mm) were equipped.

The new support scheme was a design of cross-boundary single support by cables, with the specific parameters presented in Fig. 22b. Cross-border cables (specification:  $\Phi 21.8 \times 4000$  mm) were adopted for the roof, with each row consisting of 4 such cables vertically at unequal spacing and a row spacing of 1500 mm. An arched steel supporting tray (300 × 300 × 16 mm) was equipped for each cable. A  $\Phi 6$ -mm steel bar mesh (5400 × 1600 mm) was also arranged to protect the surrounding rock surface of the roadway. The pretension force of the cable was measured as no less than 160 kN. Dextral high-strength thread steel bolts (specification:  $\Phi 20 \times 2200$  mm) and the alike were adopted for the coal pillar and the coal wall, for which a rhombic mesh (3300 × 1800 mm) was equipped to protect the surrounding rock surface of the roadway. Fiberglass reinforced plastic bolts ( $\Phi 27 \times 2000$  mm) were

used for the stopping wall, for which a steel plastic mesh ( $3300 \times 1800$  mm) was installed for protection of the surrounding rock surface of the roadway. Four bolts were installed in each row at a row spacing of  $800 \times 1500$  mm. The pre-tightening force of the two types of bolts was measured as no less than 40 kN.

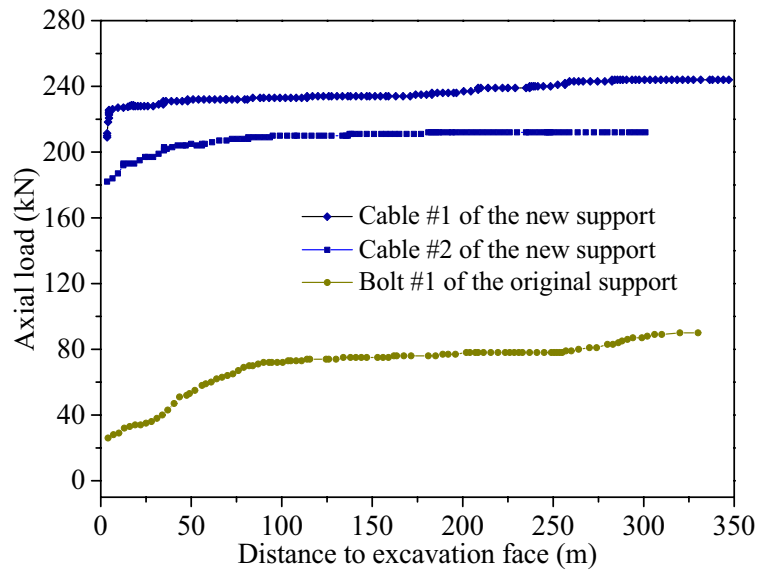
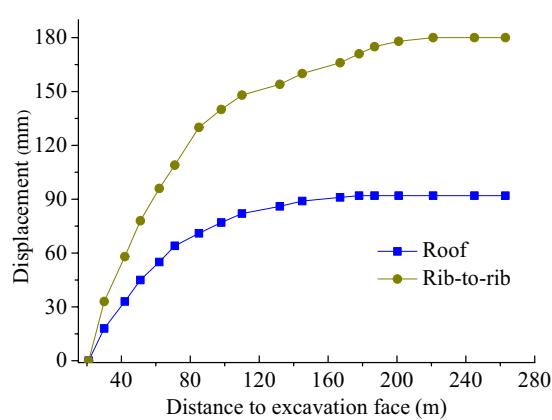
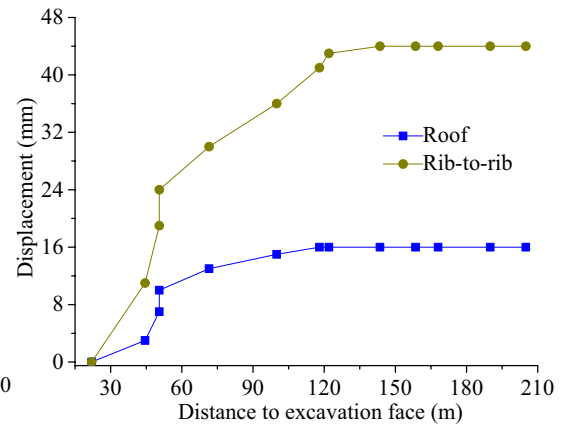
(a) Comparison of axial load of the bolt and the cable

(b) Surface displacement evolution curves of roadways under the original support

(c) Surface displacement evolution curves of roadways under the new support

**Figure 23.** Monitoring data under the original support and the new support.

The roof subsidence and the convergence of both walls of the roadway under the original and new support schemes were monitored based on the cross-section method, with the monitoring results presented in Fig. 23b,c. The total influence scope resulting from excavation was about 200 m under the original support scheme. The final deformation of the roof and both walls was measured as 92 mm and 180 mm, respectively, with the scope subjected to severe influences being approximately 80 m. At this moment, the roof subsidence and the convergence of both walls accounted for 74% and 68% of the total deformation, respectively. It could be seen that the roadway experienced comparatively large surface deformation, and the roof sank to varying degrees. The top coal particularly witnessed severe deformation typical of broken expand. Moreover, a large area of fractured fissures occurred in the coal walls to result in the enlargement of roadway span and further aggravate the subsidence of the roof. The stress scope under the influence of excavation after adjustment was about 120 m under the new support scheme. In times of stable load, the roof subsidence and the convergence of both walls were measured as 15 mm and 44 mm, respectively. The first 50 m was the section where the excavation stress was adjusted dramatically. At this moment, the roof subsidence and the convergence of both walls stood at 11 mm and 25 mm and accounted for 73.3% and 56.8% of the total deformation, respectively. The roadway under the new support scheme generally witnessed not too much surface deformation. This was because the thick-layer bearing circle of the roof substantially inhibited the roadway from deformation, which not only adapted to energy absorption and alleviated the pressure from the roof on the coal wall but also controlled the problem of large-scale fragmentation of the coal wall<sup>23,24</sup>.
