# Experimental study on strength and failure characteristics of sandstone rock mass with complex cataclastic structure using 3D printing models

Shan Dong<sup>1,2✉</sup>, Zhichun Lu<sup>3</sup> & Xi Hu<sup>1,2</sup>

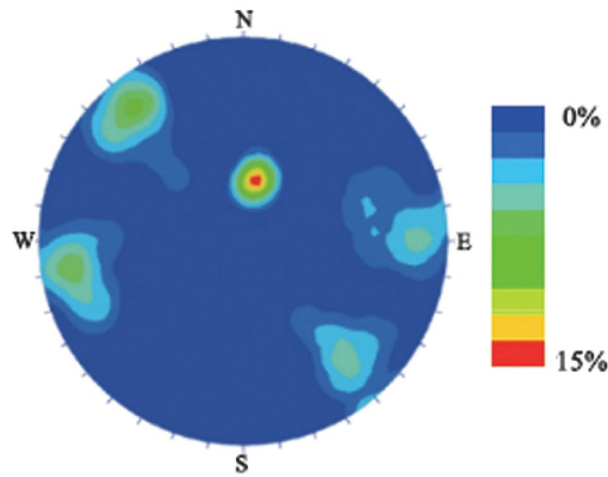
**Figure 1.** Statistical diagram of structural plane distribution of the Daguangbao landslide.

**Model design of network models of intersecting rock mass joints.** The model proposed in this paper can be mainly considered as a cataclastic rock mass, which is combined, intersected, and surrounded by two sets of intersecting joints. The Longmenshan fault zone is a common seismic zone in China<sup>17,18</sup>. Due to tectonic stress and superficial transformations, numerous cataclastic rock masses are formed, which are of significant representativeness and research significance<sup>19</sup>. Field investigations and statistics were conducted on the rock mass joints of the Daguangbao landslide in Longmenshan fault zone, and three main structural aspect groups of research point development (Fig. 1) were identified: I,  $350^{\circ}\text{--}15^{\circ}\angle 25^{\circ}\text{--}45^{\circ}$ ; II-①,  $61^{\circ}\text{--}100^{\circ}\angle 61^{\circ}\text{--}90^{\circ}$ ; II-②,  $240^{\circ}\text{--}280^{\circ}\angle 61^{\circ}\text{--}90^{\circ}$ ; III-①,  $120^{\circ}\text{--}150^{\circ}\angle 61^{\circ}\text{--}90^{\circ}$ ; III-②,  $300^{\circ}\text{--}326^{\circ}\angle 61^{\circ}\text{--}90^{\circ}$ .

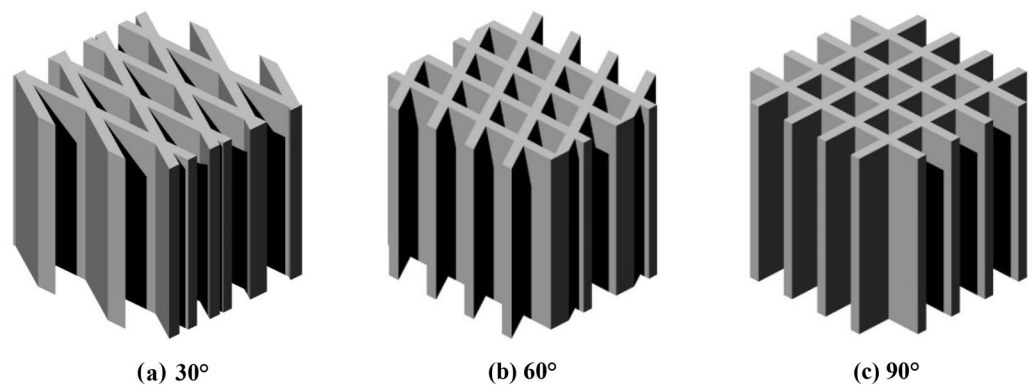
**Figure 2.** The network models of rock mass joints developed using ANSYS software.

Using the plane unit normal vector to transform the occurrence of the joints, the intersection angles of Group I and Group II joints were mainly in the range of  $38.13^{\circ}\text{--}58^{\circ}$  and  $58^{\circ}\text{--}90^{\circ}$ ; the included angles of Group I and Group III joints mainly ranged from  $21.72^{\circ}\text{--}61^{\circ}$  and  $61^{\circ}\text{--}90^{\circ}$ ; and the included angles of Group II and Group III joints were mainly in the range of  $17.29^{\circ}\text{--}64^{\circ}$  and  $64^{\circ}\text{--}90^{\circ}$ . In this study, the method of averaging was used to determine the lower critical point, middle critical point, and upper critical point of the intersection angle of the joints, which were  $26^{\circ}$ ,  $61^{\circ}$ , and  $90^{\circ}$ , respectively. Furthermore, considering the representativeness of the sample and the convenience of sample preparation, the final intersection angles of the two groups of intersecting joints were  $30^{\circ}$ ,  $60^{\circ}$ , and  $90^{\circ}$  respectively. Thereafter, using Analysis of Systems (ANSYS) software, network models of the rock mass joints with intersection angles of  $30^{\circ}$ ,  $60^{\circ}$ , and  $90^{\circ}$  were established (Fig. 2).

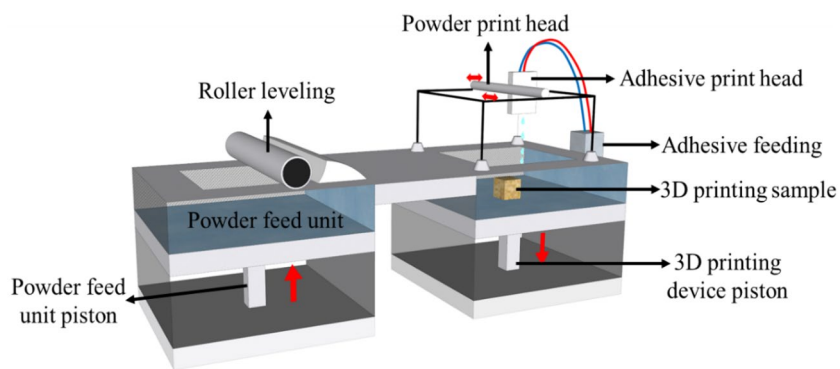
**Figure 3.** Printing mechanism of 3D printer.

**Three-dimensional printing joint network model.** In this experiment, the S-Max Pro™ 3D printer was used to print the joint network entity model. The S-Max Pro™ 3D printer, which uses an efficient print head and a full-automatic recoat machine, can print different materials and achieve a maximum printing speed of 1351/h (with a printing layer thickness of 0.26–0.38 mm). The S-Max Pro™ 3D printer uses the feeding cylinder to provide the powder particles of the printing material, spreads the printing particles in a layer on the printing work area via the printing nozzle, and then sprays a layer of adhesive on the solid part of the printed specimen to bind the material particles. When the powder particles of the previous layer are cohesive, the powder feeding piston rises by one printing layer height to start printing the subsequent layer. This process is then repeated until the solid model is printed (Fig. 3).

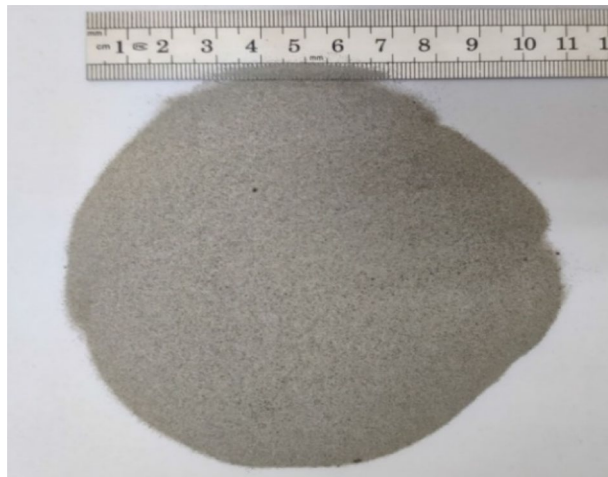
**Figure 4.** The 3D printing of sand particles.

In this study, for the 3D printing of the plane network model of rock mass structures, artificial sandstone powder particles with particle sizes of 0.1–0.3 mm were used as aggregates (Fig. 4), which were bonded with no-bake adhesive (furan adhesives). The rock mass discontinuity network model developed using ANSYS software was imported into the S-Max Pro™ 3D printer, which automatically printed the 3D network model of the cataclastic rock mass joint (Fig. 5). Due to the extremely low strength of the printed hollow rock mass joint network model, the voids of the joint and fissure network after printing were filled with fine sand to prevent damage to the joint network model during transportation.

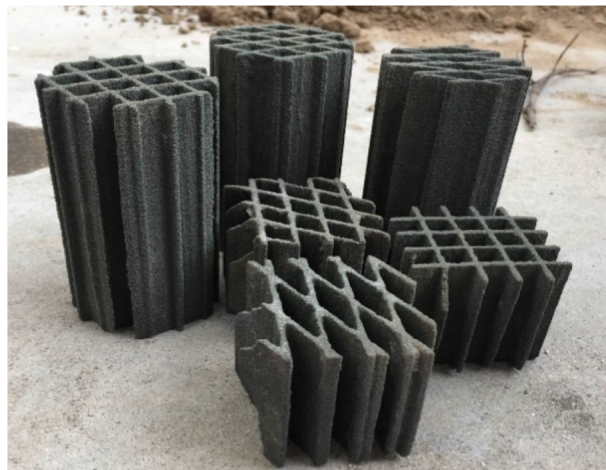
**Figure 5.** The 3D printing of the structural plane network model sample.

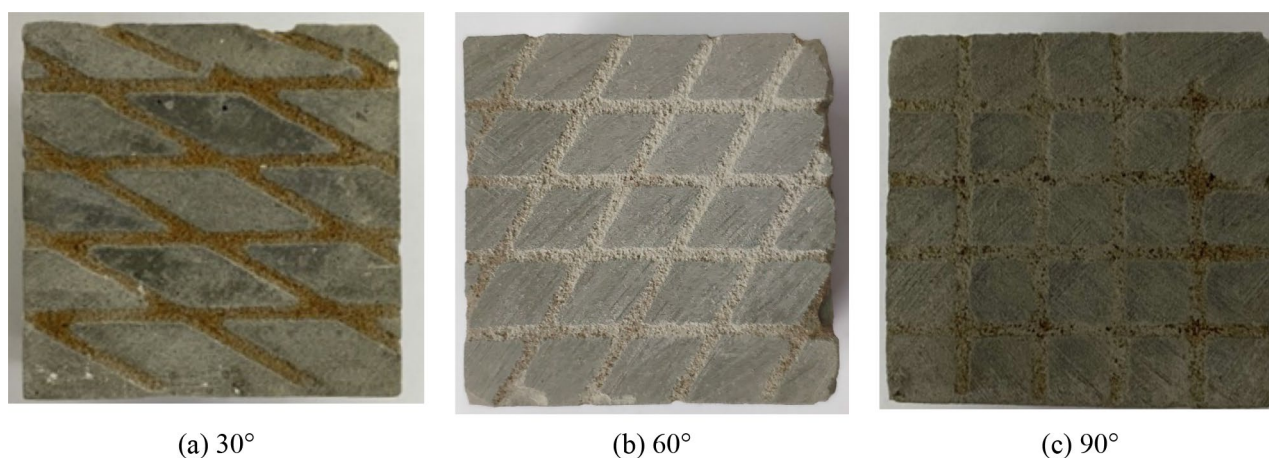
**Figure 6.** Poured cataclastic rock mass sample.

surface network model was placed into a cube model box with dimensions of 50 mm × 50 mm × 50 mm for pouring. After repeated tests, it was found that after 1/3 of the cement slurry was injected into the model box within which the 3D printed structural surface network model was placed, with pouring continued thereafter, the obtained samples demonstrated the highest integrity. After a sample was poured, it was demoulded after 3 days of air drying in ambient air and cured for 28 days. The final pouring sample is shown in Fig. 6. To simplify the following description, the cataclastic rock mass samples containing 30°, 60°, and 90° intersecting joint network models were denoted as the Type-1, Type-2, and Type-3 samples, respectively.

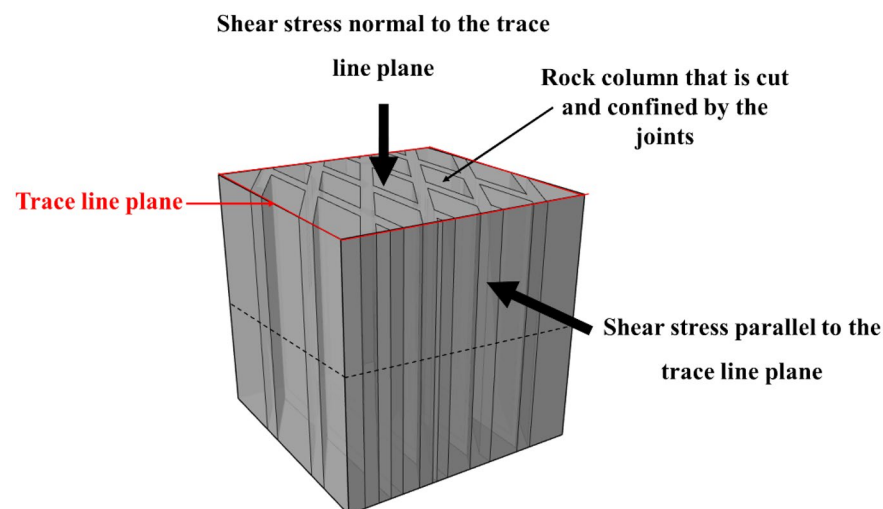
**Figure 8.** Schematic diagram of test shear direction.

respectively. The intersection plane of the joint was defined as the trace line plane (Fig. 8). The design scheme of the direct shear test included the shear stress parallel to the plane of the trace line plane, and the shear stress normal to the trace line plane (Fig. 8). During shearing, the normal stress was first applied at a constant value, and then the shear load was gradually applied. Simultaneously, the shear and normal displacement under each level of shear load were measured and recorded.

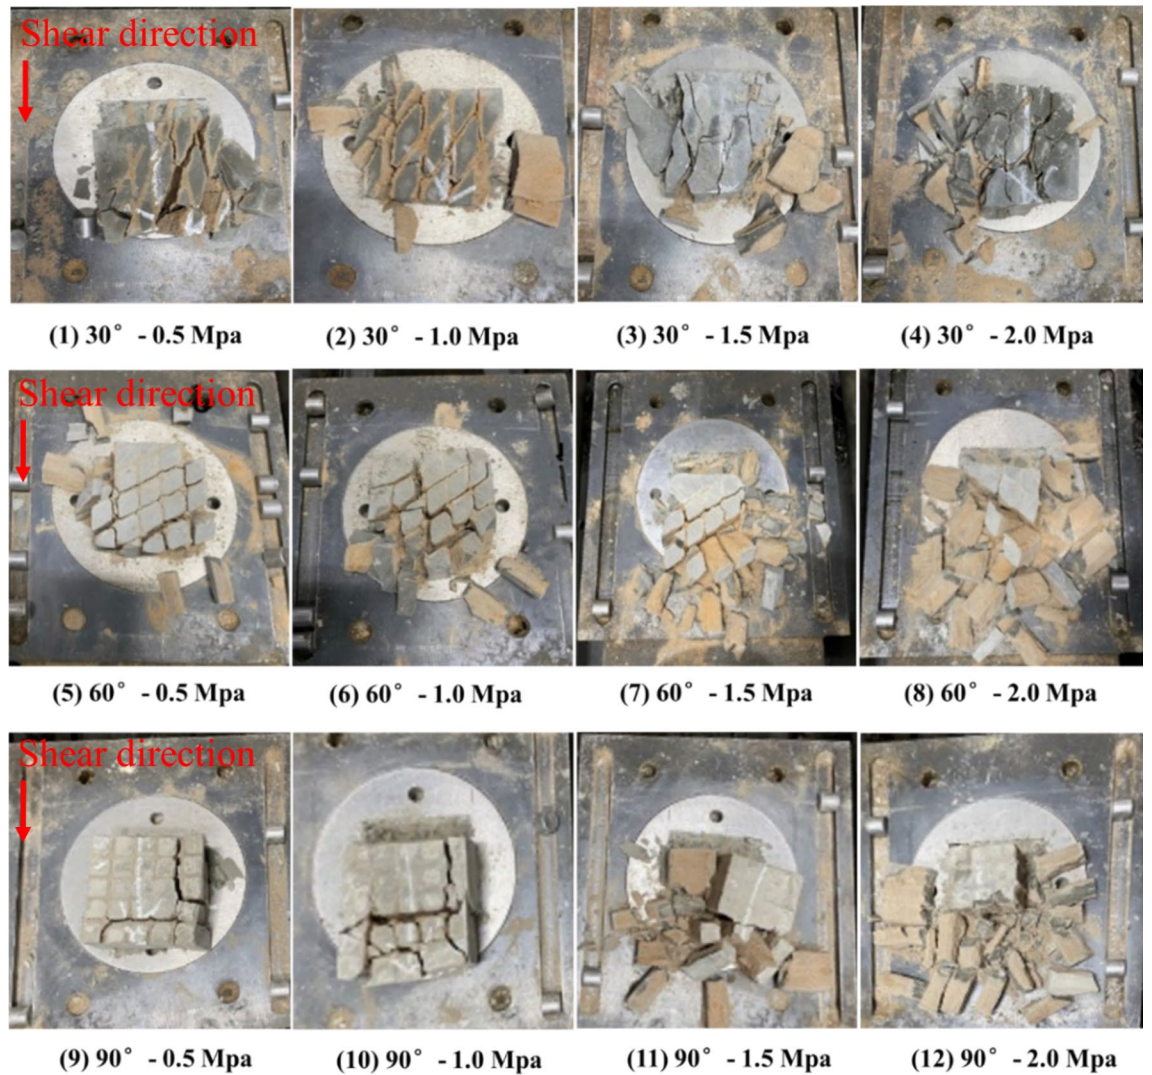
Figure 9. Shear failure phenomenon of the upper blocks of the samples.

**Analysis of shear failure phenomenon (for shear stress parallel to joint plane).** *Upper block.* Based on the test results, under different normal stresses, the upper halves of different samples exhibited different degrees of relaxation and fragmentation along the shear failure plane (Fig. 9). Based on the failure phenomenon of the upper block after shearing, the failure phenomenon of the upper block was divided into two failure modes: (1) vertical splitting failure along the joint, i.e., the upper block cracked along the columnar joint surface; and (2) rock column splitting failure, i.e., the rock column split along the joint and rock column. Both failure modes were accompanied by significant volume-expanding phenomena, and the main difference was with respect to whether or not the rock column underwent fracturing damage. As observed from the shear failure phenomenon of the upper block, when the normal stress was 0.5 MPa, the failure of the rock mass under the normal stress was vertical splitting failure along the joint; and when the normal stress exceeded 0.5 MPa, the rock column splitting failure was gradually promoted.

In particular, the fracture of rock column is a characteristic of brittle material failure. He et al.<sup>21</sup> verified the extreme value of the minor tension stress at the crack tip under normal compressive load based on Griffith theory, which revealed that splitting failure occurs during the compression process corresponding to the gradual characteristics of rock failure. Furthermore, the criterion of the occurrence of rock splitting is as follows: the value of the longitudinal load should be high, and the value of lateral stress should be low or zero. In addition, there should be short-term application of loads or no subsequent loads. The theory proposed by He et al.<sup>21</sup> can explain the phenomenon observed in this test. By analysing the shear pattern after the shear test, it was found that the splitting failure of the rock column mainly occurred along the vertical direction, which demonstrated that the splitting failure of the rock column was mainly formed in the application of the initial normal stress. In the shear test, during the initial normal load application process, the side pressure of each rock mass sample was almost zero. In particular, under short-term normal load application, the rock column underwent splitting failure, and with an increase in the normal load, the impact increased, and the splitting failure of the rock column was more significant.

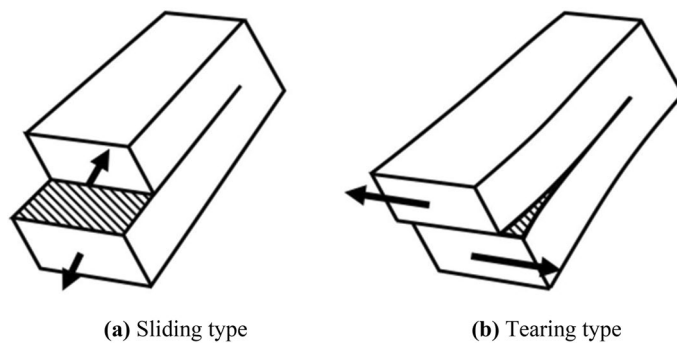
Figure 10. Schematic diagram of shear crack.

*Shear failure plane.* Irwin<sup>22</sup> classified two types of shear cracks: (1) sliding type, where the displacement of particles is parallel to the crack surface and perpendicular to the crack front (Fig. 10a); and (2) tearing type, where the particle displacement is parallel to the crack surface and crack front (Fig. 10b). Hence, Irwin<sup>22</sup> proposed the shear crack intensity factor, which can be expressed as follows:

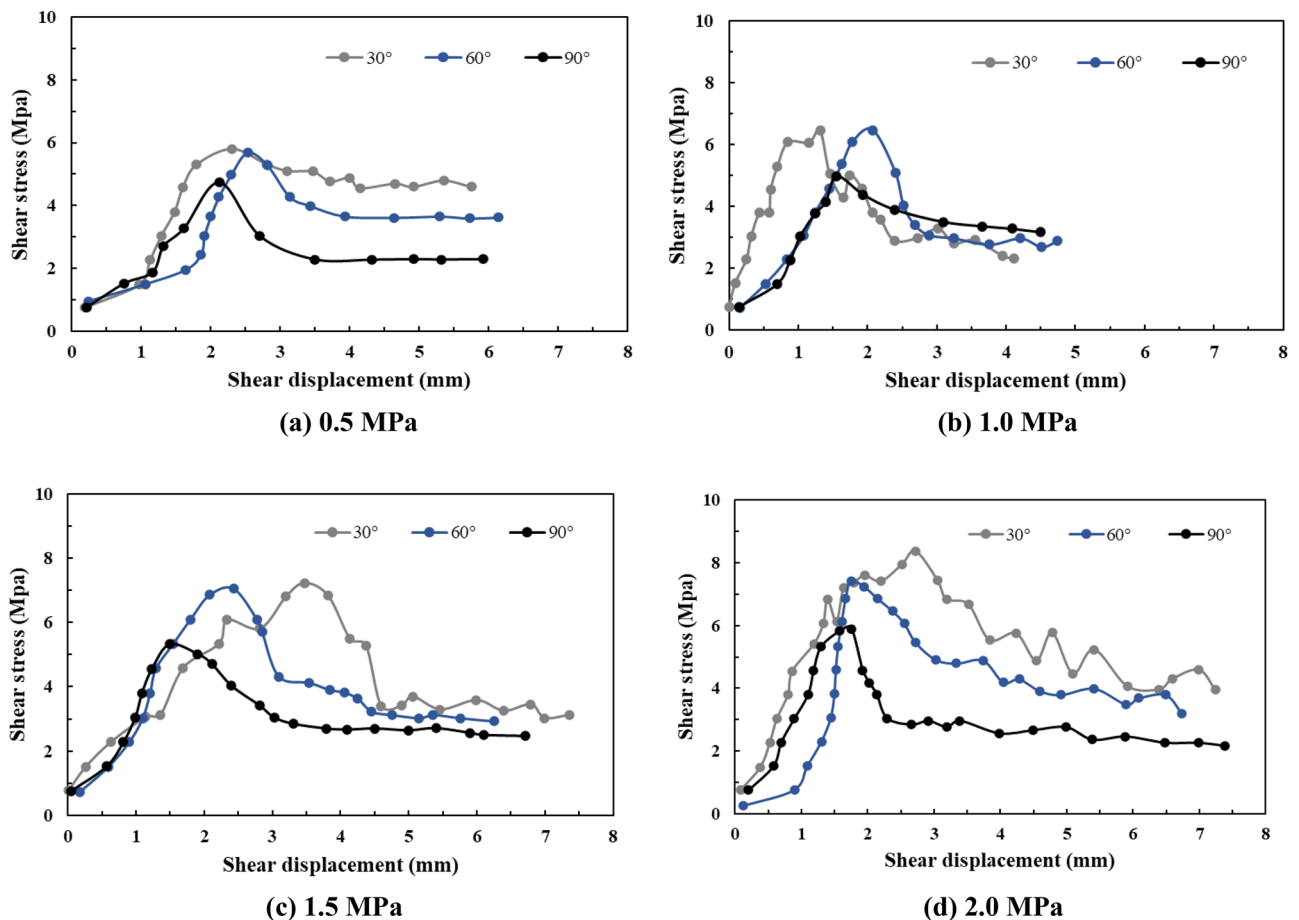
**Figure 12.** The shear stress–shear displacement curves of different samples.

**Shear stress and shear displacement characteristic curve analysis.** Based on the test results, the shear stress–displacement curves of different samples were all peak-type curves that can be classified into three stages, namely, the pre-peak elastic stage, post-peak softening stage, and residual stage. Given that the post-peak curve can indicate the variation trend of the deformation and failure of the shear failure plane to an extent, based on the smoothness of the curve, we divided the curve into three categories as follows. I. The post-peak curve was relatively flat and regular, and the residual stage was relatively stable, thus reflecting that the shear failure plane of the sample after shearing was relatively straight; II. slight fluctuations were observed in the post-peak softening stage or the residual stage, thus reflecting that the shear failure plane after shearing of the sample exhibited slight

fluctuations; and III. there were large fluctuations in the post-peak softening stage or residual stage, and a “stress plateau” was observed, thus reflecting that the shear failure plane of the sample after shearing exhibited a greater degree of roughness and fluctuations.

As can be seen from Fig. 12, with an increase in the normal stress, the shear stress–displacement curves of the different samples all transitioned from Category I to Category III. Under the same normal stress conditions, the shear stress displacement curve of the Type-1 sample was significantly different from that of the Type-1 and Type-2 samples, and the shear stress displacement curve of the Type-2 sample was slightly different from that of the Type-3 sample, which mainly indicates that the fluctuations of the Type-1 sample curve were more significant than those of the Type-2 and Type-3 samples, and the fluctuations of the Type-2 sample curve were more significant than those of the Type-3 sample. This indicates from that the roughness of the shear failure plane of the Type-1 sample was significantly greater than that of the Type-2 and Type-3 samples, and the roughness of the shear failure plane of the Type-2 sample was slightly greater than that of the Type-3 sample.

**Shear stress.** As can be seen from Fig. 12, although the failure curves of the Type-2 and Type-3 samples were highly similar, the peak shear strength of the Type-2 sample was closer to that of the Type-1 sample and larger than that of the Type-3 sample. Furthermore, the peak shear strength of the Type-1 sample was slightly larger than that of the Type-2 sample. From the analysis of the cataclastic rock mass samples, the main difference between the Type-1, Type-2, and Type-3 samples was with respect to the different shapes and sizes of the confined and cut blocks in the cataclastic rock mass. Among them, the shapes of the confined and cut blocks of the Type-1 and Type-2 samples were similar, and the block sizes were significantly different. However, the peak strength difference was not significant, which indicates that the size of the confined and cut blocks in the unit area is not the main factor influencing the peak strength of cataclastic rock mass. The sizes of the confined and cut blocks in the Type-2 and Type-3 samples were highly similar; however, the shapes were completely different, and the peak strengths were significantly different, which indicates that the main influencing factor of the cataclastic rock mass strength is the shape of the confined and cut blocks in the cataclastic rock mass per unit area.

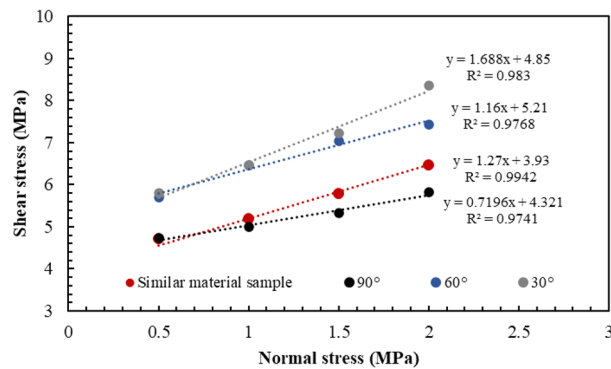
**Figure 13.** Fitting results of normal–shear stress curves.

Furthermore, based on the analysis of the fitting test results (Fig. 13 and Table 3), the cohesion values of the Type-1, Type-2, and Type-3 samples were 4.85 MPa, 5.42 MPa, and 4.32 MPa, respectively; and the friction angle values were 59.38° and 45.98° and 35.75°, respectively. With an increase in the intersection angle of the joints, the cohesion exhibited an increasing trend followed by a decreasing trend. The internal friction angle exhibited a decreasing trend. In addition, the shear stresses of the Type-1, Type-2, and Type-3 samples were compared with

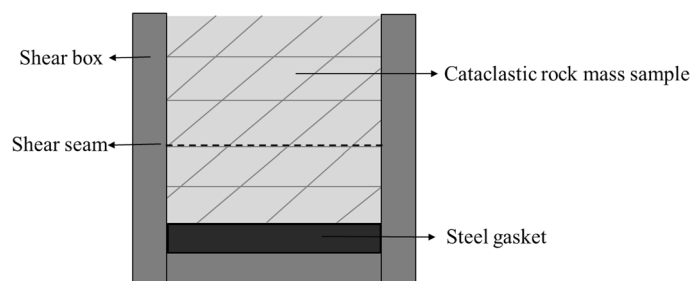
**Figure 14.** The shear mode of the shear test with shear stress perpendicular to the joint plane.

**Shear stress perpendicular to the joint plane.** *Analysis of the shear failure phenomenon.* The shear mode of the shear test with shear stress perpendicular to the trace line plane is shown in Fig. 14. During the shear test, the joint surface of the sample was placed at the position of the shear seam by positioning a gasket under the sample to ensure that the sample was sheared along the joint surface during the shearing process. The samples after shearing are shown in the Fig. 15, where the upper and lower rock blocks and the shear failure plane exhibited high integrity after shearing under the condition of low normal stress. With an increase in the normal stress, the rock block gradually underwent fragmentation, and the degree of fragmentation of the shear failure surface increased. Based on the shear test results analysis, there were two main failure phenomena; i.e. the upper block of the sample the cemented rock column breaks along the joint surface, and the shear failure plane underwent significant compression shear failure. Images of these two typical phenomena, as observed in the test, are shown in Figs. 16 and 17.

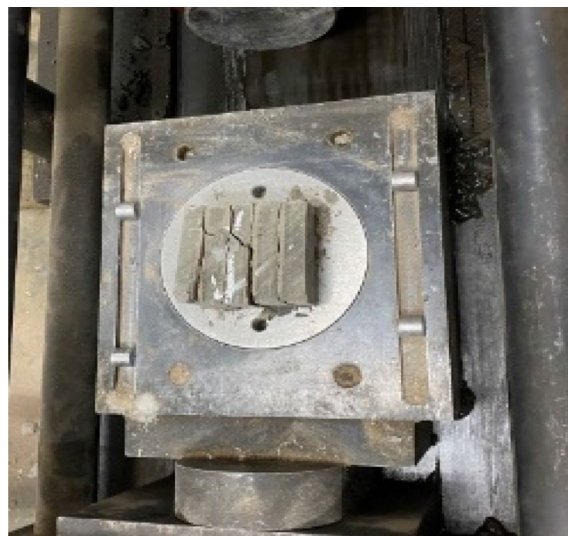
Figure 16. Breakage of the cemented rock column along the joint surface.

during normal stress application, the cemented rock column underwent breakage along the joint surface, which led to the cracking of the rock wall structural bulk. Thus, the closing stage of the rock mass in the shear process was not significant. This indicates that in the initial stage of the joint surface shearing of the cataclastic rock mass, the compaction deformation under low normal stress conditions is dominated by the closure of shear joint planes; and in the initial stage of deformation under high stress conditions, the deformation of the rock mass structure is dominant.

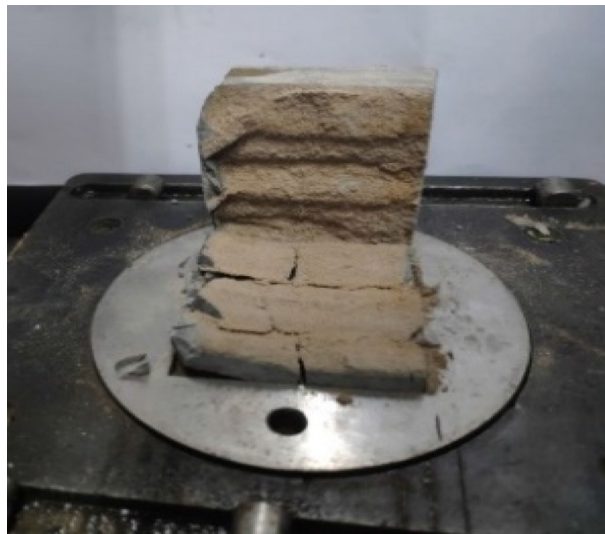
**Figure 17.** Significant compression failure of the shear failure plane.

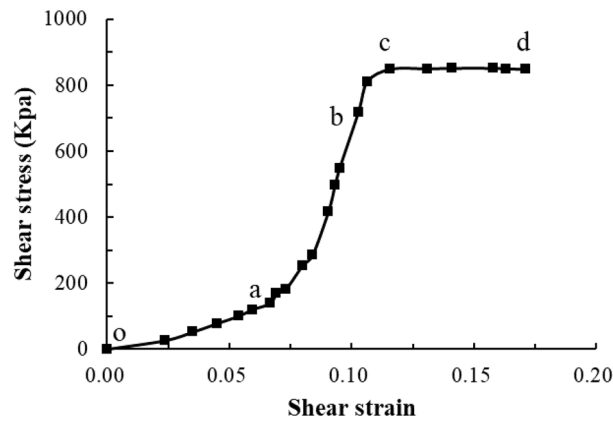
**Figure 18.** Shear stress characteristic curve of single joint surface for plastic deformation.

*Shear stress and shear strain characteristic curve analysis.* In general, the shear stress characteristic curve of the single joint surface of the plastic deformation can be divided into four stages (Fig. 18), as follows. (1) Closure of existing cracks (o–a): in this phase, the density of filler increases, the shear deformation is nonlinear, and the stress–strain curve is concave. (2) Elastic deformation (a–b): the joint of rock mass transitions from a discontinuous medium to a nearly continuous medium, the matrix deforms, and the material exhibits intact rock behaviour characterized by constant stiffness. (3) Fracture development (b–c): inelastic deformation and plastic behaviour can be observed, in which the curve loses its linearity with a significant increase in strain as microfrac-

tures propagate in a stable manner. (4) Fracture coalescence (c–d): fracture propagation, coalescence, and interaction induce the degradation of the mechanical properties, in addition to damage to the joint of the rock mass.

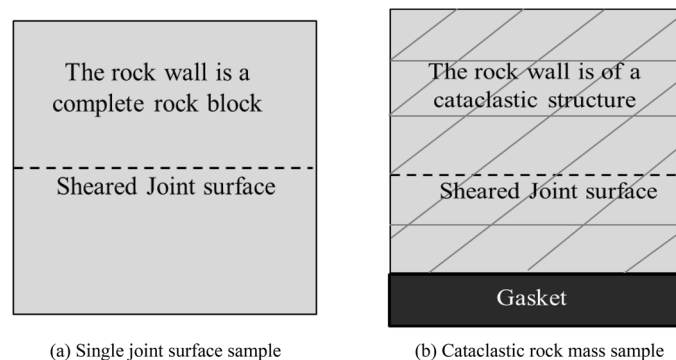
**Figure 19.** Comparison between the single joint surface rock mass sample and cataclastic rock mass sample.

elastic stage. This may be because the cataclastic rock mass sample in the test was different from the conventional single joint surface sample. The rock wall of the single joint surface sample was complete (Fig. 19a), and the rock wall had a slight influence on the deformation and damage of the joint plane in the shear process. In the test, the rock wall of the sample was controlled by the joints, and the structure of the rock wall could be considered as the cataclastic rock mass (Fig. 19b). In the above damage phenomenon analysis, under a higher normal stress,

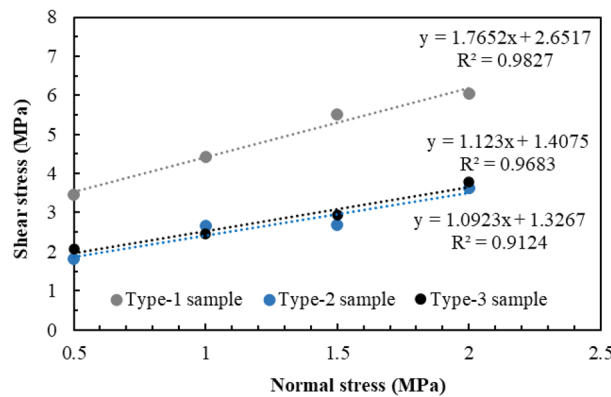
Figure 22. Fitting results of the normal stress–shear stress curves.

For a comparative analysis, a direct shear test was conducted on 3D printed intact samples with printing materials and printing methods consistent with the joint network model, and the test process was the same as previously mentioned. The test results of the sandstone samples were approximately equivalent to the shear strength of the structural plane of the complete rock wall sample. Based on the test results, the cohesion of intact sample was 2.28 MPa, and the internal friction angle was 37.2°. Furthermore, based on the fitting results of cataclastic rock samples and intact samples, the shear strengths of shear structural planes under different normal stresses were calculated, and the results are shown in Table 4. Irrespective of the normal stress, the shear strength of the Type-1 sample was greater than that of the intact sample; and with an increase in normal stress, the shear strengths of the Type-2 and Type-3 samples gradually increased until they exceeded that of the intact sample. Hence, in addition to the normal stress and roughness of the joint surface, as proposed in previous studies, the structure of the rock wall and the deformation characteristics in the shear process should be considered when calculate the shear strength of the rock mass.
