# Maintenance of crack with infilling polymer modified mortar for shear deficient of reinforced concrete beam

Being a developing country, Pakistan needs sustainable and cost-effective strengthening/ retrofitting solution to be adopted/ practiced in the construction industry. The research reported in this paper was aimed to study the effectiveness of PMM, an indigenous product, for repairing reinforced concrete beams, resulting more effective and cost benefiting repair and strengthening for restoration of pre-cracked RC structures. This article presents the research results of experimental investigation conducted for repairing of cracks in shear deficient reinforced concrete (RC) beams with locally available novel material polymer modified mortar (PMM). A total of 6 beams; divided in three groups i.e. short beams, medium beams and deep beams with varying depths and same mix design were tested to four point loading under monotonic loading conditions until failure loads. Afterwards, these beams were repaired with PMM and cured with water for 72 h for retesting until failure. Load at first crack and at failure, crack pattern and deflections were recorded for all specimens during testi

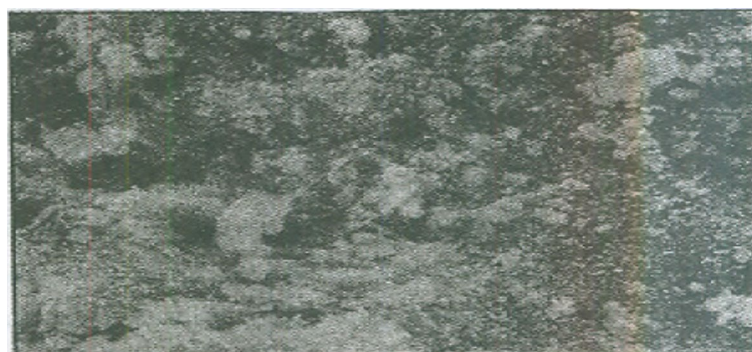
**Figure 1.** Electron micrographs of unmodified mortar.

Figure 1 shows that in the absence of polymer films, unmodified mortar is of poor quality. Figure 2 shows that due to presence of monolithic network of polymer films in PMM, its mechanical properties and durability are greatly improved in comparison to the un-modified mortar.

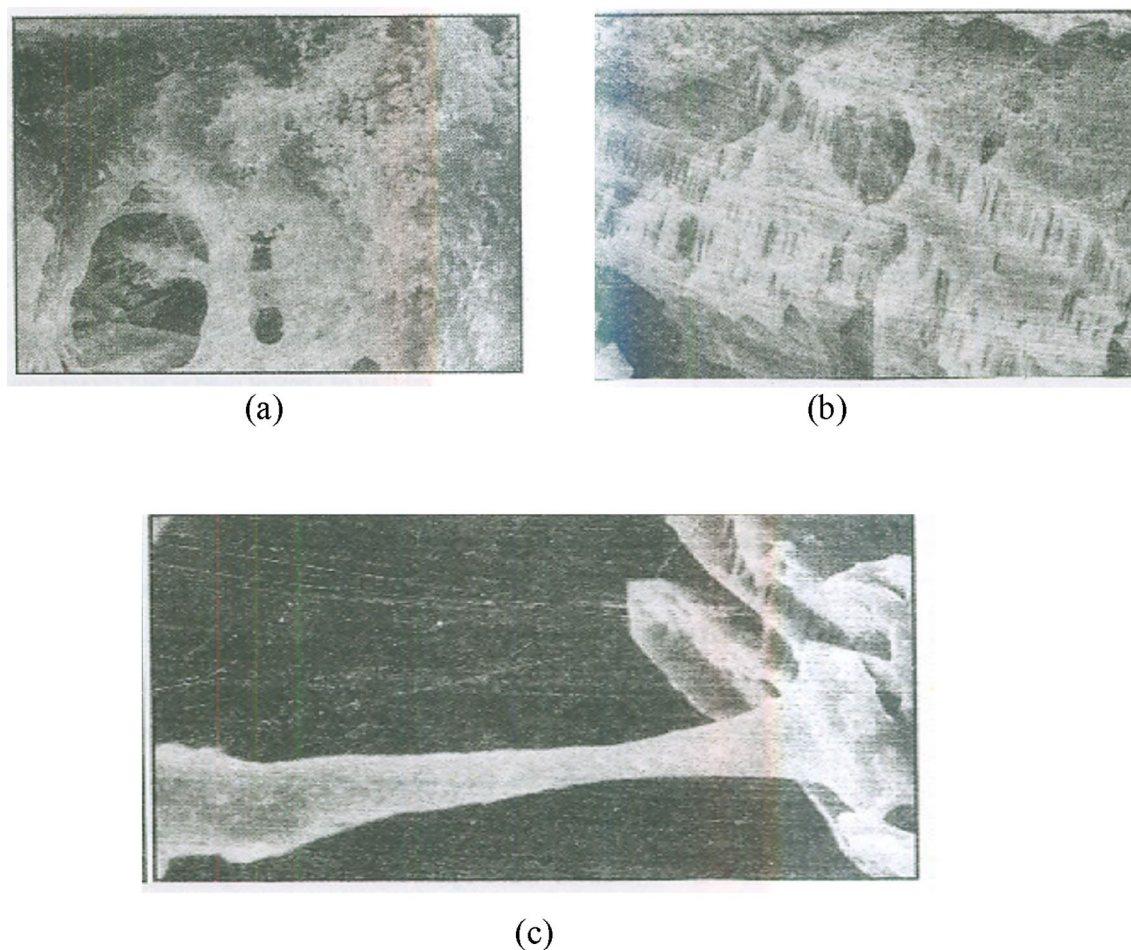
**Figure 2.** (a–c) Electron micrographs of PMM.

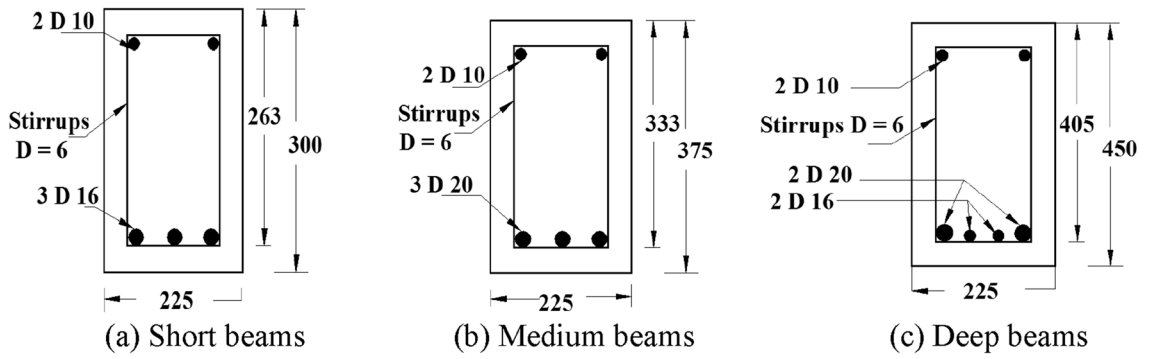
Figure 3. Transverse section of beams.

Total 6 full-scale RC beams were constructed. All specimens were designed as shear critical by ignoring the shear reinforcement. The beams were divided in three groups depending upon their depths designated as short beams for beams with depth of 300 mm, medium beams for beams with depth of 375 mm and deep beams for beams having depth of 450 mm. Each group consists of two beams with identical depths. Total span and width were kept same as 2750 mm and 225 mm for all specimens. The beam grouping, dimensions and reinforcement details are shown in Table 3.

Reinforcement ratio and  $a/d$  were kept constant in all specimens. All beams were tested until failure load and the results of the control model were compared with repaired beam models. The control beams' group is suffixed with letter 'C' in the beam group names. The specimens of short beams were named as SDS-1 and SDS-2, medium beams as SDM-1 and SDM-2, deep beams as SDD-1 and SDD-2. The cross sections, reinforcement and loading details of all beams are shown in Figs. 3 and 4.

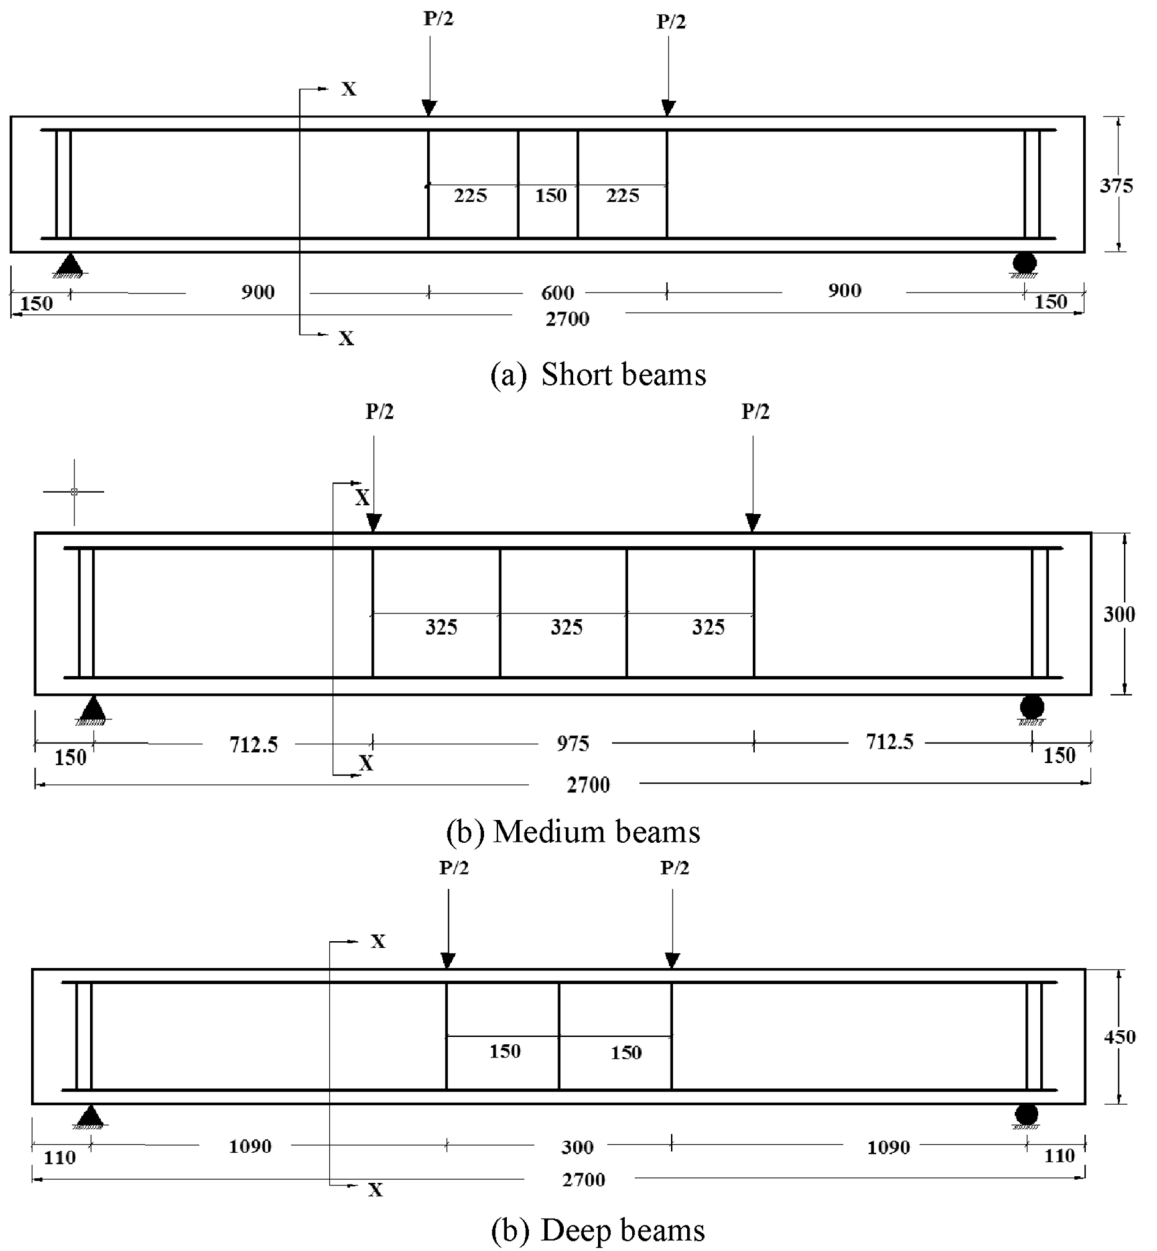
Figure 4. Longitudinal section of beams.

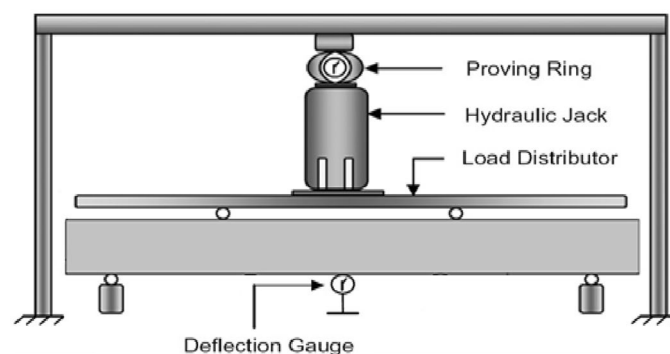
**Figure 5.** Detailed illustration of test setup.

All beams were tested to four-point monotonic loading under simply supported conditions as shown in Fig. 5. Load was applied in intervals at rate of 5 kN/min using a hydraulic jack having a capacity of 1000 kN. Load under the hydraulic jack was used as load distributor to generate the two-point loads. Deflection gauges were employed to determine the deflection of specimens. The deflection was recorded very carefully after the application of each load increment. To avoid the chance of error, two dial gauges were employed to measure the mid-span deflections. Dial Gauges are basic instruments that are used to measure accurately very small and diminutive liner distances. These instruments are reliable and are also used by the different researchers around the globe to measure the linear deflections in different structural elements as evident from number of published data.

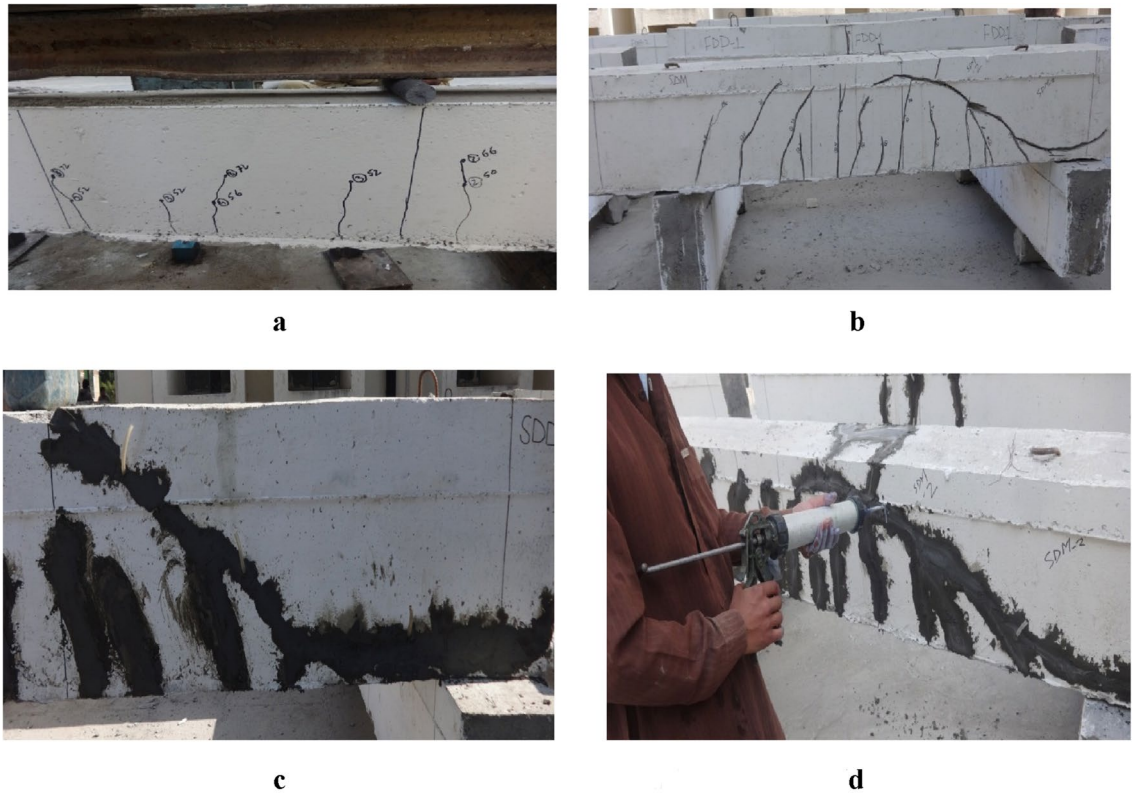
**Figure 6.** (a) Crack marking with respective load. (b) cleaning cracks and preparing for fill. (c) Sealing of cracks with PMM paste. (d) Injection of PMM into cracks.

This program was intended to repair cracks developed after initial testing in beams. Sudden brittle failure was observed in all beams due to wide diagonal tensile cracks. No diagonal shear crack was observed before failure. Only hairline vertical flexure cracks were noted. After initial testing all beams were repaired with PMM. Before applying PMM to Beams, all areas of damaged and cracked concrete were identified, delineated and clearly marked out prior to commencement of works. All traces of existing coatings, sand or cement rendering were removed from the damaged areas in order to properly assess the damage area as shown in Fig. 6b.

Water was then added to PMM to prepare a paste of enough consistency which was used to seal all the cracks as shown in Fig. 6c. After sealing the cracks, flow-able mix was prepared to inject the mixture into cracks through nozzles under pressure using a pressure gun as shown in Fig. 6d. Procedure of repairing of cracks with PMM is illustrated in Fig. 6 (a-d). After repairing process, these specimens were retested until failure and all data were recorded for each specimen including first crack load, failure loads, failure modes and mid span deflection.

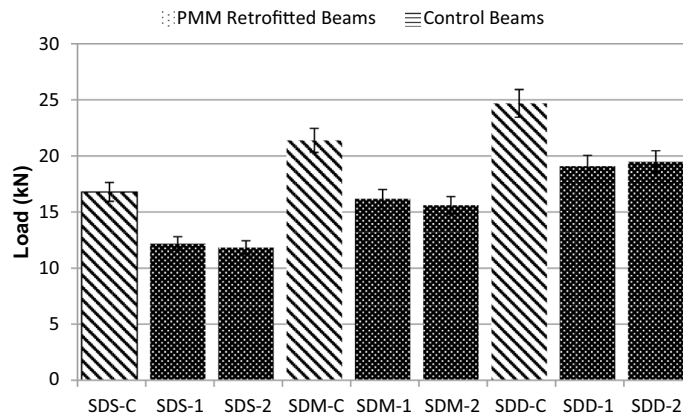
**Figure 7.** Comparison of loads at first crack of controlled and repaired beams.

Load required to generate the first crack was noted in each specimen. Figure 7 shows the comparison between loads at first crack of control and PMM repaired specimen. It can be seen from the Fig. 7 that deep beams tend to crack and eventually fail at relatively larger loads in comparison to medium and short beams. Also, loading values at first crack after repair in all beams were comparatively lower than controlled beams; concluding that the use of PMM as strengthening material could not restore the original strength of specimens.

On a detailed note, the percentage difference of first crack loads were higher for medium beams as compared to deep and short ones. For short beams, these were found to be 49.81% respectively lower than controlled beams. For medium beams these were 62.40% lower as compared to controlled beams. As far as deep beams are concerned, the percentage difference was found to be 59.64% and 51.21% respectively lower, in comparison to controlled beams.

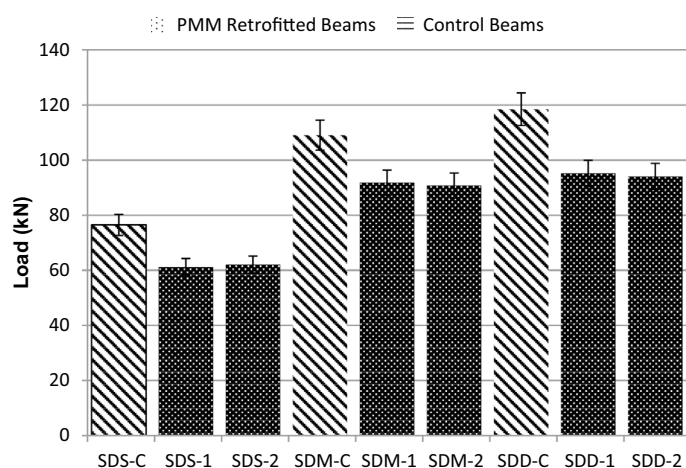
**Figure 8.** Comparison of failure loads for control and repaired beams.

The failure loads obtained from the experimental results along with relative strength as compared to control specimens are shown in Table 4 and Fig. 8 for short, medium and deep beams.

All control beams tested before the application of PMM were failed in shear with no sign of ductility due to absence of stirrups. At failure, wide shear diagonal cracks were observed in all specimens. Vertical flexure cracks were developed in the region where stresses exceeded the modulus of rupture.

All specimens, after repairing with PMM showed similar behavior at failure. All specimens were failed due to the cracks over the shear zone. The possible reason of this failure mode in all specimens of was the opening of repaired shear diagonal cracks which suddenly increased the stresses that lead to the sudden widening of repaired cracks. All specimens when reached about 80–90% ultimate load of control specimens, opening of the repaired shear crack occurred leading to failure of specimens. In short beams group, specimens, SDS-1 and SDS-2, failure occurred due to opening of shear cracks at applied load of 61.5 kN and 62.5 kN; both specimens restored about 80% strength of control beam SDS-C. Specimens of medium group beams, SDM-1 and SDM-2 failed at applied load of 98.8 kN and 96.8 kN due to reopening of shear crack. In both specimens, strength restored after PMM application was 90% and 88% of control beam SDM-C.

Specimens of deep group beams, SDD-1 and SDD-2 failed due to widening of shear crack followed by the crushing of concrete in compression zone at applied load of 95.2 kN and 94.1 kN. Both specimens regain about

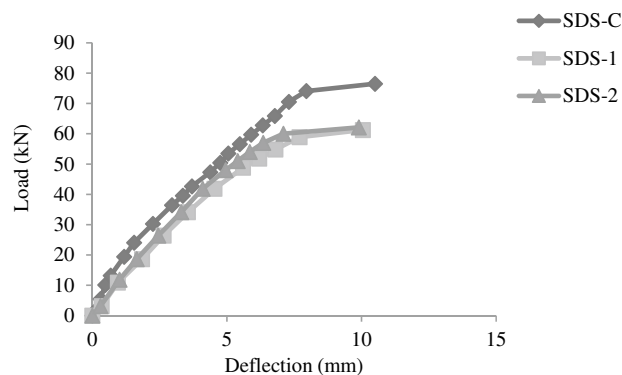
**Figure 9.** Load deflection plots for beams of SDS group.

For the case of short beams (SDS group), Initial load/deflection curve is much flatter in control beams. But as controlled beams move towards failure, enhanced deflection is observed until failure.

Load deflection plot of PMM repaired beams is less stiff as compared to control beams at the initial stages. But PMM repaired beams show a much smoother curve with smaller deflection at failure loads indicating improved stiffness of beams as compared to controlled beams at failure point. Short beams showed sudden increase in deflection after about 75% of ultimate load. Maximum ultimate load restored is 82% of that of control beam.

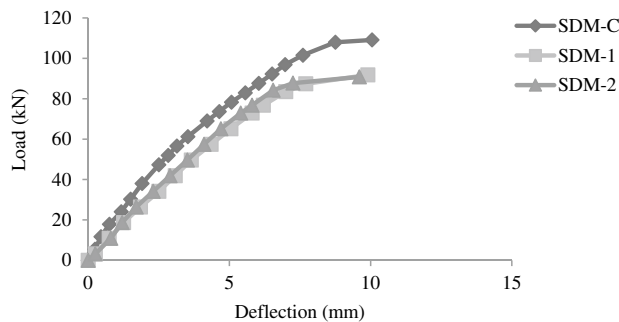
**Figure 10.** Load deflection plots for beams of SDM group.

As far as medium beams (SDM) group are concerned, smooth linear load deflection curve is observed in repaired beams until the point of opening of cracks. Both beams show 13% less deflection at failure with maximum ultimate load restored is 82% of that of control beam.

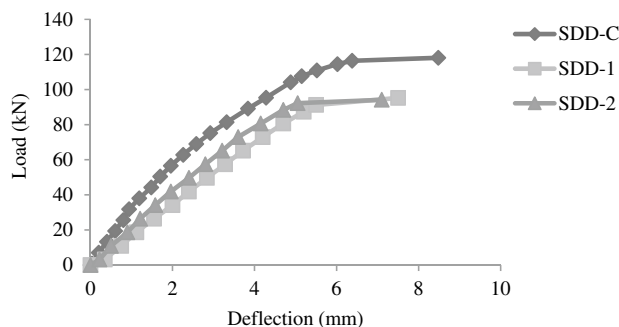
**Figure 11.** Load deflection plots for beams of SDD group.

For the case of deep beams (SDD) group, linear load deflection curve is observed in repaired beams. Linear load deflection trend is observed up to 70% of failure load. But sudden increase in deflection after about 75% of ultimate load is observed deep beams. The deflection at failure for deep group beams was lower for controlled beams. Both beams show 33% less deflection at failure compared to control beams indicating improved stiffness of beams as compared to control beams.
