Experimental study on the damage performance and forced response of concrete lining in fault-crossing tunnel

Understanding the adverse effects of tunnel crossing active faults on tunnel structures is crucial for ensuring their safe operation and construction. This paper presents the results of a series of model tests conducted at a scale of 1:40 using a fault sliding test box. Three sets of fault comparison tests were carried out, namely: (1) the tunnel does not cross the fault, (2) the spring stiffness is reduced, and (3) the model is not reinforced. The objective was to study the failure characteristics of tunnels crossing active faults. The findings reveal that when the hanging wall moves downwards, cracks appear on the surrounding rock surface of the hanging wall, specifically above the tunnel lining crossing the fault. The lining is significantly damaged within the range of -30 – $+30$ cm. All points of axial force exhibit an increasing compression trend. The section of axial force and bending moment near the fault fracture surface is notably larger than that far from the fault fracture surface. The safety factor of the entire structure decreases sharply after dislocation, ma

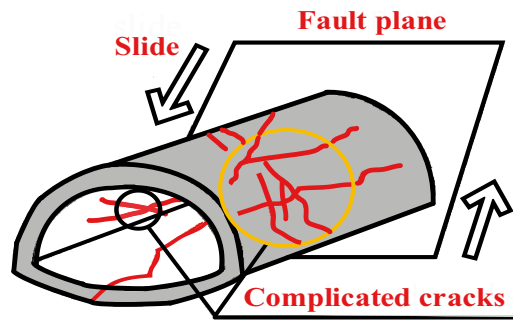
Figure 1. Tunnel damage pattern caused by fault slide.

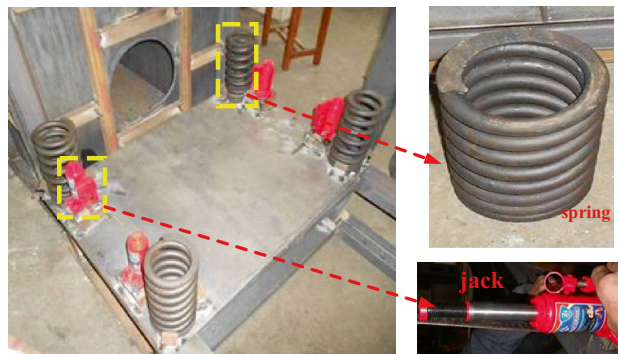
Figure 3. Spring and jack.

the gap formed by the jack. As shown in Fig. 3, the stiffness of the springs can be calculated to generate a compression of 3–4 cm after dislocation to simulate the final dislocation displacement. In this process, the hanging wall will reciprocate up and down under the action of the spring and interact with the foot wall to simulate the fault dislocation process.

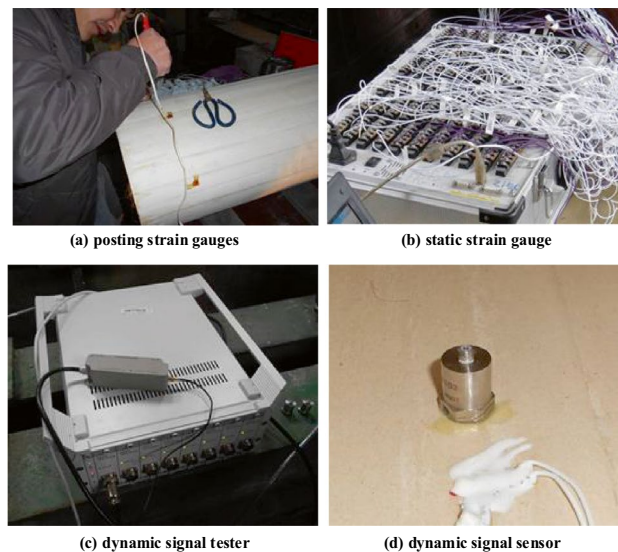
Figure 4. Static strain and dynamic signal acquisition.

The internal force of tunnel lining is mainly carried out by static strain gauges as shown in (a) and (b) in Fig. 4. After the lining model is cast, transverse and longitudinal strain gauges are posted at the test design position, and the distribution of wires is coordinated to ensure the intact rate of strain gauges during the test. The static strain gauge is used as shown in the figure. The vibration wave generated by fault dislocation is monitored by dynamic signal sensor as shown in (c) and (d) in Fig. 3. The instrument adopts DH3816 dynamic signal instrument, and the sensor probe is set at the inverted arch where the tunnel passes through the fault, and the sensor probe is set at the surrounding rock near the tunnel outside the fault, and the data are collected for comparative analysis.

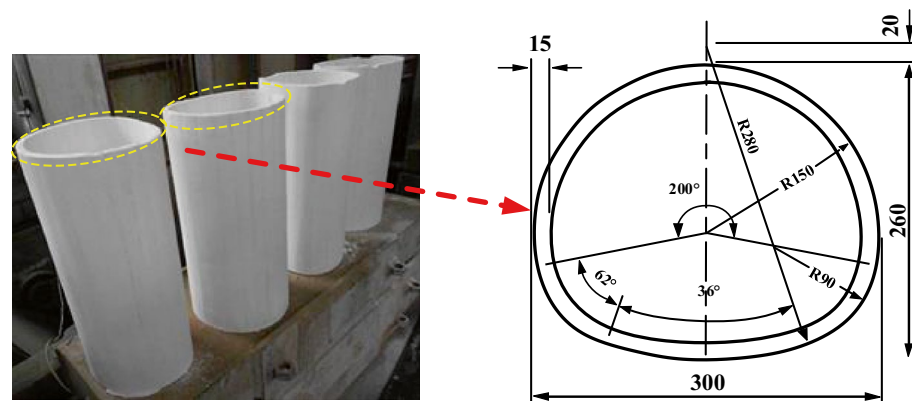
Figure 5. Lining section size.

materials, C25–C35 is used in the secondary lining of tunnel in practical engineering, and the elastic modulus is about 20–30 Pa. The secondary lining model used in the test is gypsum, and the elastic modulus is 300–500 MPa according to the material test. The tunnel is 60 cm in the longitudinal direction, and then the total length is 180 cm with gypsum after segmental pouring. The cross-sectional dimensions of tunnel lining are shown in Fig. 5.

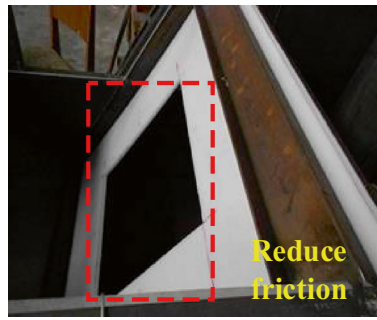
Figure 6. PVC plastic board.

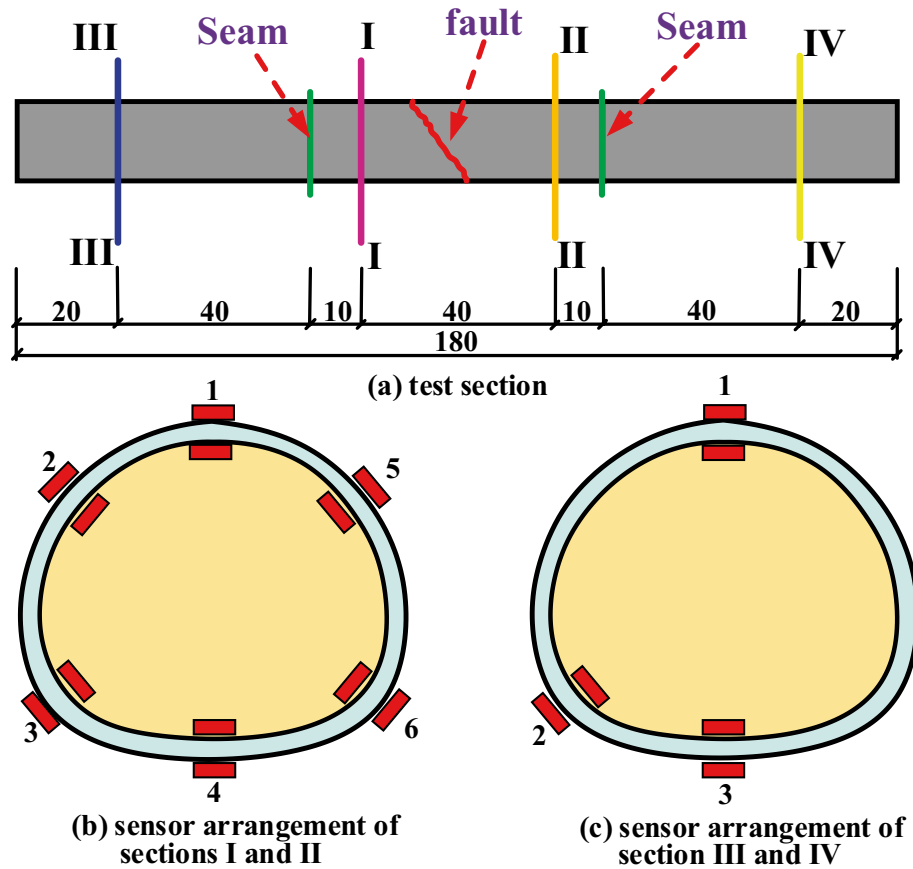
Figure 8. Layout of test section.

There are four sections along the longitudinal direction of the tunnel, of which I and II sections are close to the fault fracture surface, which are the key positions for testing. Each section is provided with transverse and longitudinal strain gauges inside and outside the vault, left and right arches, left and right arches and inverted arches, and the layout of test sections under various working conditions is set inside and outside the vault, arch foot and inverted arch of III and IV sections far from the fault fracture surface, as shown in Fig. 8.

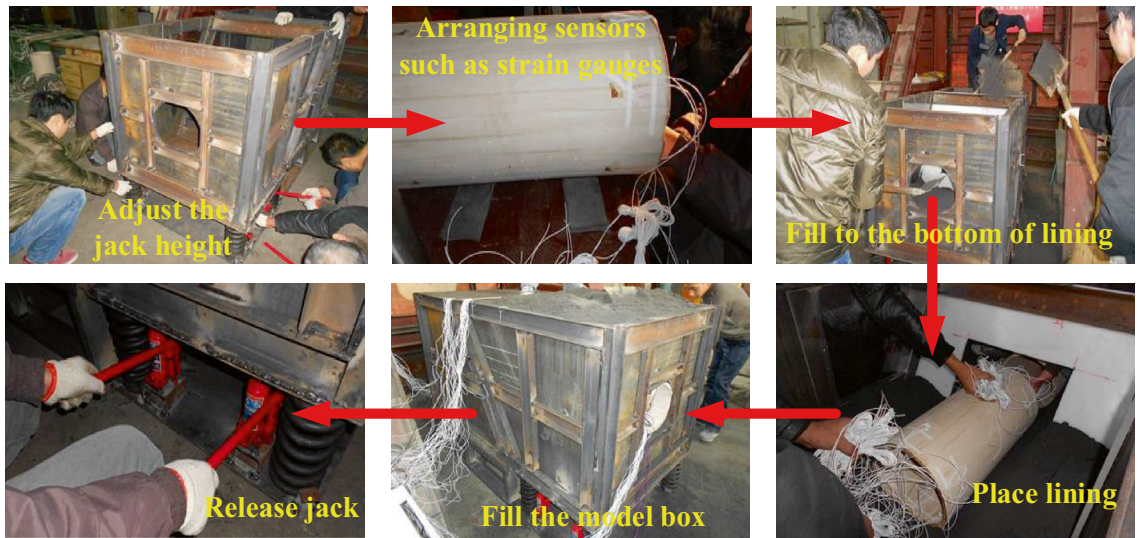
Figure 9. Test steps.

As shown in the Fig. 9, it is a concrete test step to simulate the failure characteristics of tunnel lining when the fault is dislocated without any anti-vibration measures. Four jacks are installed at the bottom of the upper plate part of the model box, and the stroke of the jacks is adjusted at the same time so that the upper plate and the lower plate are on a horizontal line, four springs are installed in the space formed after the jacks are pushed, static strain gauges and acceleration sensors are arranged at the key parts of the lining model, and the wires are treated as a whole, and similar materials of surrounding rock are started to be filled. Until the bottom of the preset lining position, the lining is placed, and the longitudinal joints are completed, so that the whole lining structure becomes a whole. The whole model box is filled with similar materials of surrounding rock, and compacted. During this period, pay attention to the protection of sensor data lines. After the filling is completed, the initial data of sensors are collected. At the same time, four jacks are put down, and the upper plate moves downwards and contacts the spring to generate vibration. Finally, it is connected with a computer display and the Internet to collect acceleration sensor data and lining strain data after dislocation.

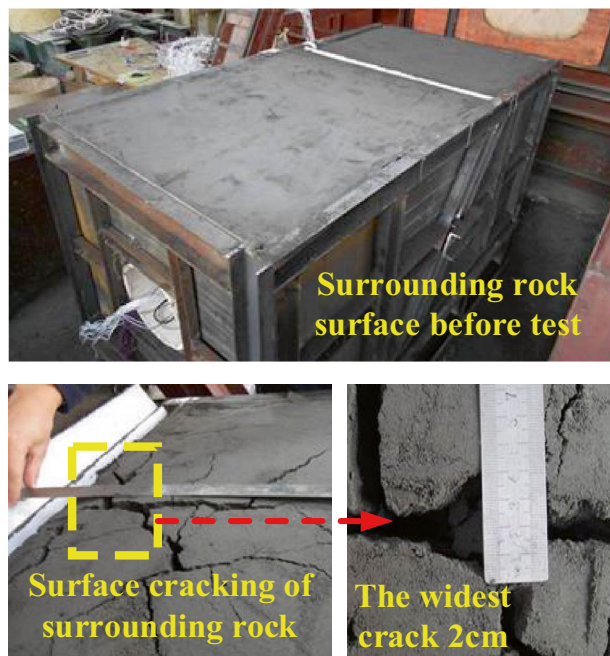
Figure 10. Surface condition of surrounding rock of hanging wall after test.

After the fault is dislocated, as shown in the Fig. 10, the surface of surrounding rock is compared before and after the test, and the hanging wall quickly slides down along the fracture surface and vibrates when it contacts the spring. After the vibration, the following changes have taken place in the model: there is an extended crack near the fault at the top of the surrounding rock of the hanging wall, with the widest point of 2 cm and the depth of 8 cm, and the crack area is directly above the tunnel lining crossing the fault.

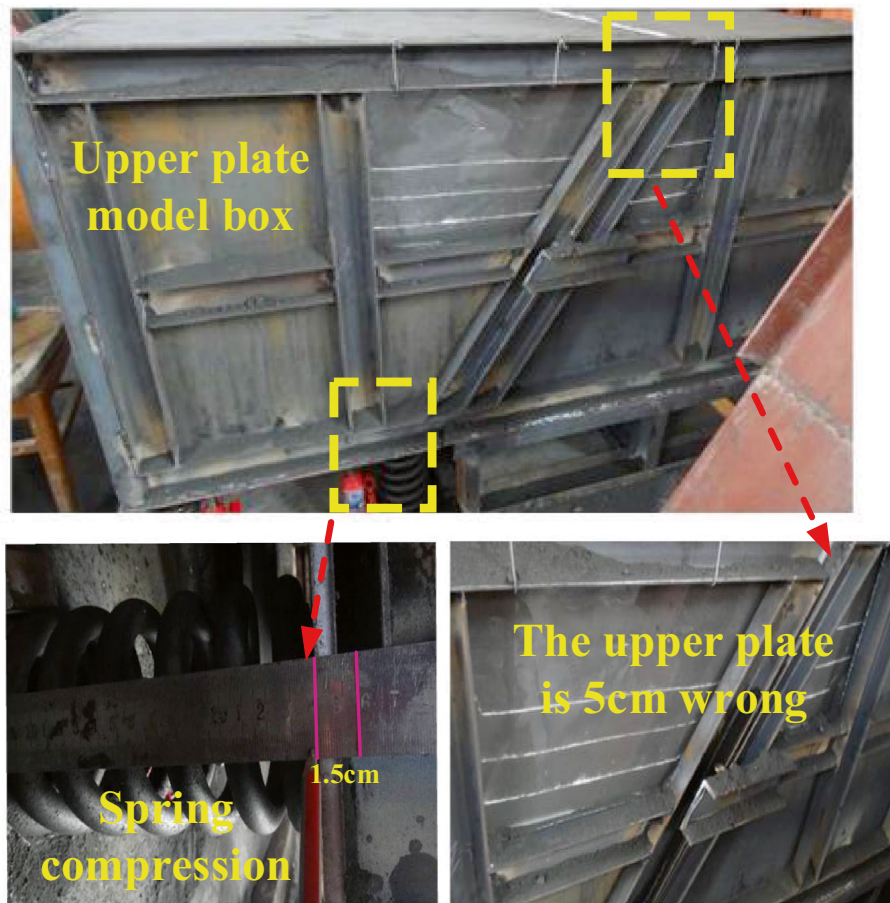
Figure 11. Spring compression and dislocation of upper plate model box.

The upper plate continued to oscillate until it was stable, and finally the upper plate was dislocated by about 5 cm, in which the spring was compressed by 1.5 cm. Before the two sets, the horizontal consistency changed to the top set and the bottom set, as shown in the Fig. 11.

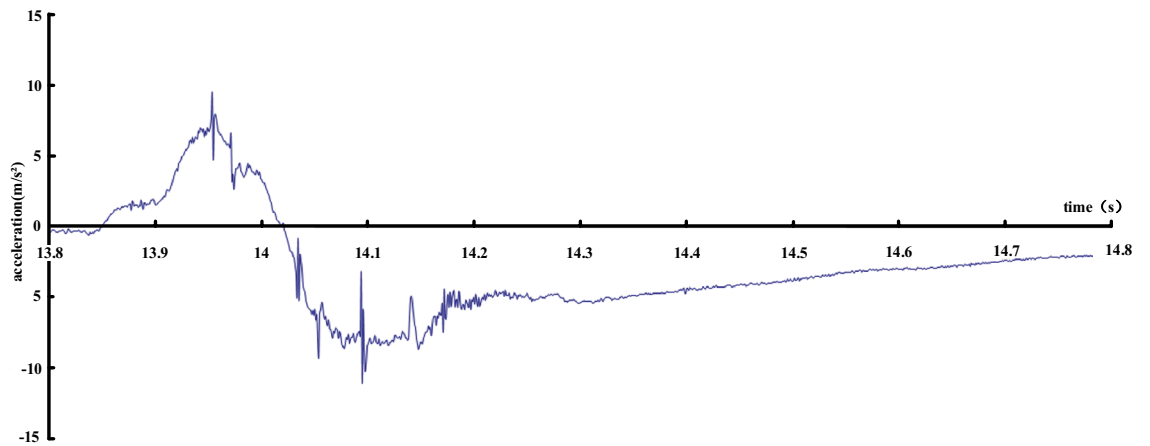
Figure 13. Acceleration record of surrounding rock near fault.

Figure 13 is a dynamic signal acceleration record set in the surrounding rock at the fault, and Fig. 14 is a dynamic signal acceleration record set on the lining inverted arch at the fault. As can be seen from Fig. 13, the surrounding rock and the box body are in an approximate free-fall state at the moment when the hanging wall is released, and the maximum acceleration is close to 1 g. After contacting the spring, the acceleration is reversed and continues to oscillate to stability due to the influence of the spring reaction. As can be seen from Fig. 14, the situation of lining is quite different from that of surrounding rock. Because the instantaneous acceleration of lining cracking is very large, the peak acceleration is obviously greater than that of gravity, and several large peaks appear, indicating that the lining has cracked in many places to varying degrees, and finally the acceleration continues to oscillate to stability.

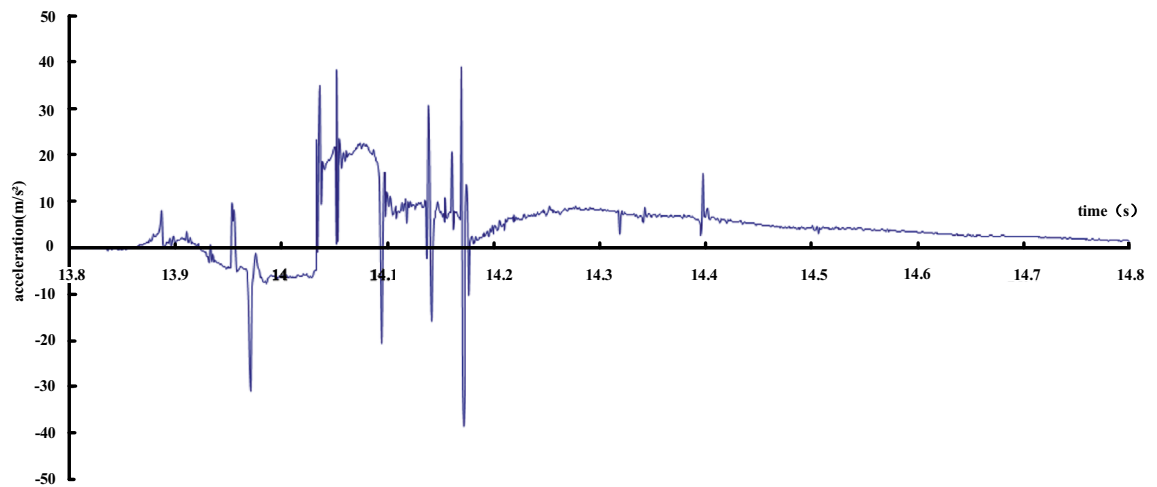
Figure 14. Acceleration record of lining near fault.

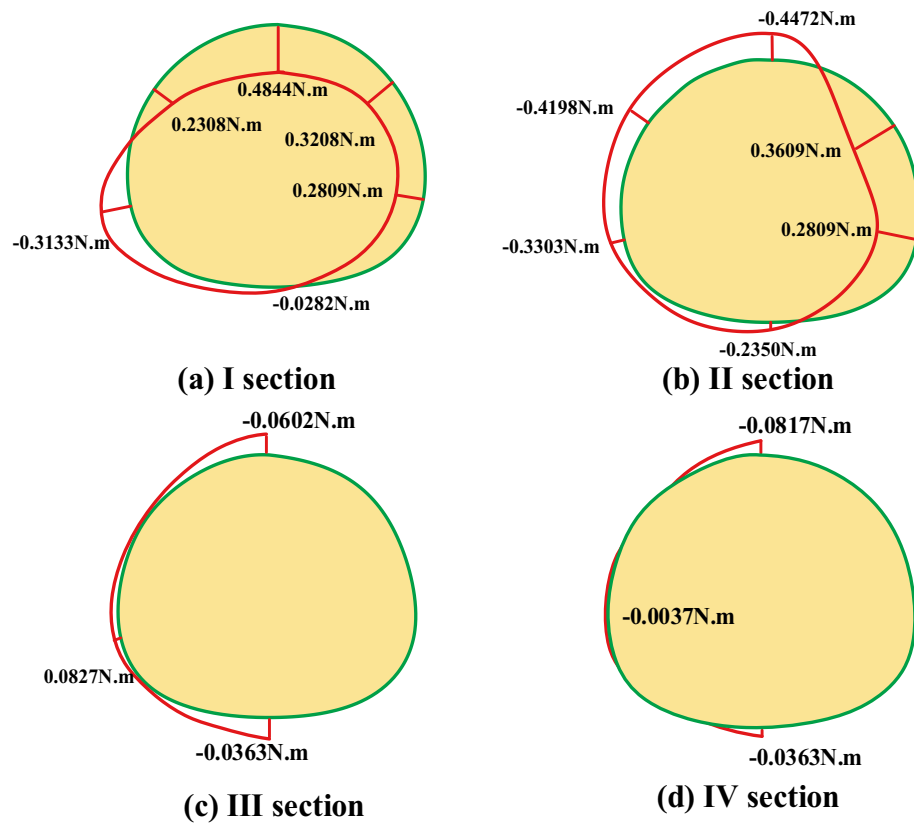
Figure 17. Moment increment after dislocation of fracture surface.

As shown in Fig. 17, the sections near the fault fracture surface (section I and section II) are obviously larger than those far away from the fault fracture surface, in which the maximum increment of the inner bending moment is 0.4844 N.m, which occurs at the vault of section I (footwall) and the maximum increment of the outer bending moment is 0.4472 N.m, which occurs at the vault of section II (footwall), far from the fault. From the comparison of the upper and lower plates, after the dislocation, the magnitude of the moment increment of the two sections is close, but the direction is different.

- (3) From the point of bending moment, the sections close to the fault fracture surface (section I and section II) are obviously larger than those far away from the fault fracture surface, in which the maximum increment of inner bending moment is 0.4844 N m, which occurs at the vault of section I(footwall) and the maximum increment of outer bending moment is 0.4472 N m, which occurs at the vault of section II (footwall), far from the fault. From the comparison of the upper and lower plates, after the dislocation, the magnitude of the moment increment of the two sections is close, but the direction is different.

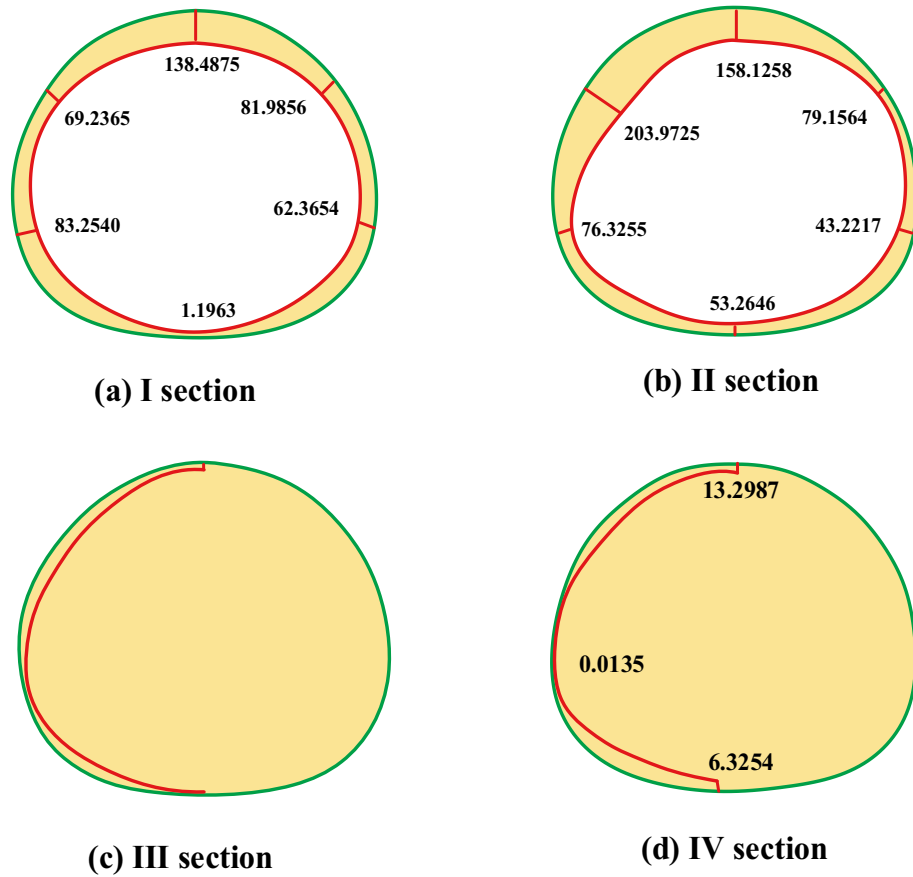
Figure 18. Reduction of safety factor after dislocation of fracture surface.

The change of safety factor reduction in different parts of each section before and after tunnel dislocation is shown in the Fig. 18. From the perspective of safety factor, the safety factor of the whole structure decreases sharply after dislocation, and the sections near the fault fracture surface (section I and section II) are obviously larger than those far away from the fault fracture surface, with the maximum decrease of 203, which occurs at the arch waist of section II (hanging wall). From the perspective of safety factor reduction values at each point, the tunnel is at the vault, arch waist and left and right arch feet. From the comparison between the upper and foot walls, the safety factor of the hanging wall is much lower than that of the foot wall after the dislocation occurs, and from the actual tunnel damage, the cracking of the hanging wall lining is more serious than that of the foot wall lining.

- (4) From the perspective of safety factor, the safety factor of the whole structure decreases sharply after the dislocation, and the sections close to the fault fracture surface (section I and section II) are obviously larger than those far away from the fault fracture surface, with the maximum decrease of 203 , which occurs at the arch waist of section II(the hanging wall). From the perspective of the safety factor reduction values of each point, the tunnel is more likely to crack at the vault, arch waist, left and right arch feet and inverted arch, It is in good agreement with the actual test structure. From the comparison between the upper and

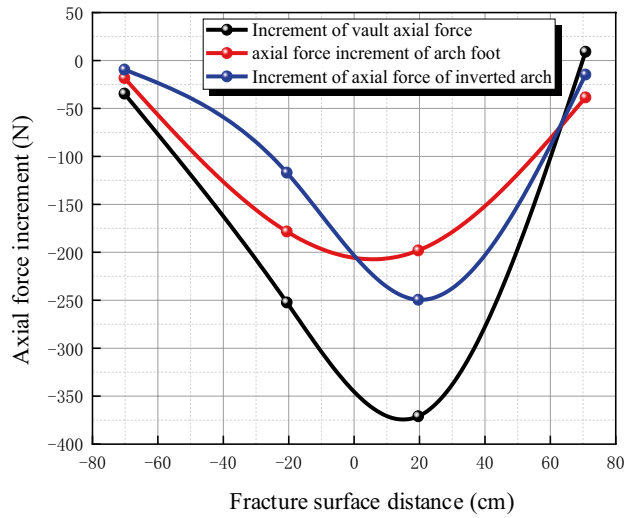
Figure 19. Relationship between axial force increment and fracture surface distance.

In order to reflect the relationship between the longitudinal internal force change and the location of the tunnel, the data are combined with the location of the fracture surface. The relationship between the axial force increment and the distance of the fracture surface is shown in Fig. 19, and the relationship between the bending moment increment and the distance of the fracture surface is shown in Fig. 20, where the abscissa is the fault fracture surface and the abscissa is the distance from the fracture surface. It can be seen from the figure that the increment of longitudinal axial force of the tunnel is basically divided by the fracture surface, and the closer it is to the fracture surface, the more obvious the increment is, in which the increment of longitudinal axial force at the left arch foot of the hanging wall reaches -373 N; At the same distance from the fault, the increment of the hanging wall is larger than that of the foot wall; The increment of longitudinal bending moment of tunnel is basically divided by the fracture surface, and the closer it is to the fracture surface, the more obvious it is. The increment of longitudinal bending moment at the inverted arch of footwall reaches 0.2 Nm, and the increment of footwall is larger than that of footwall at the same distance from the fault.

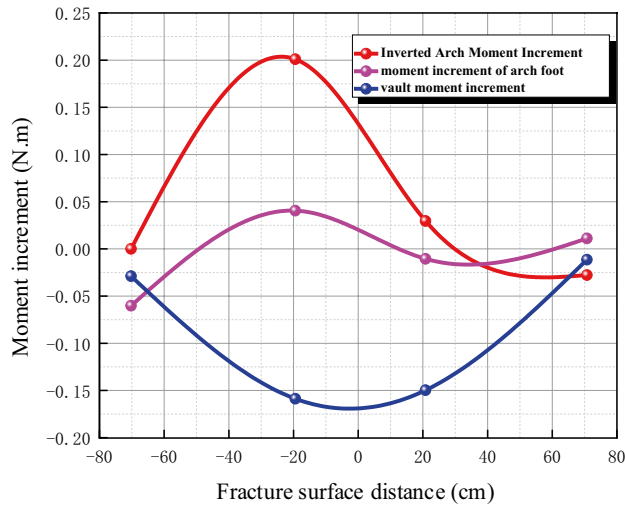
Figure 20. Relationship between Moment Increment and Fracture Surface Distance.

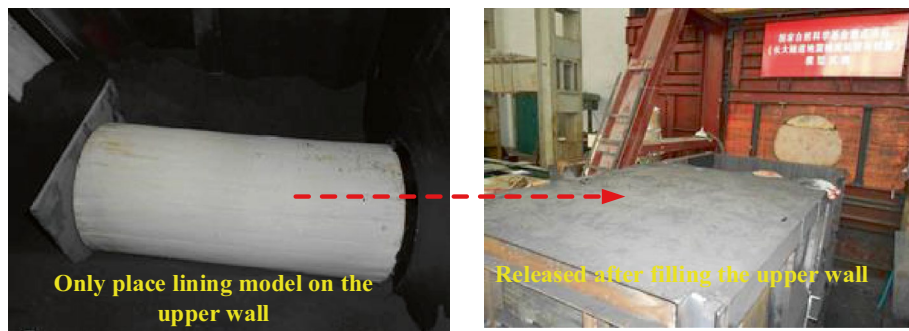
Figure 25. Comparative test of tunnel without crossing fault.

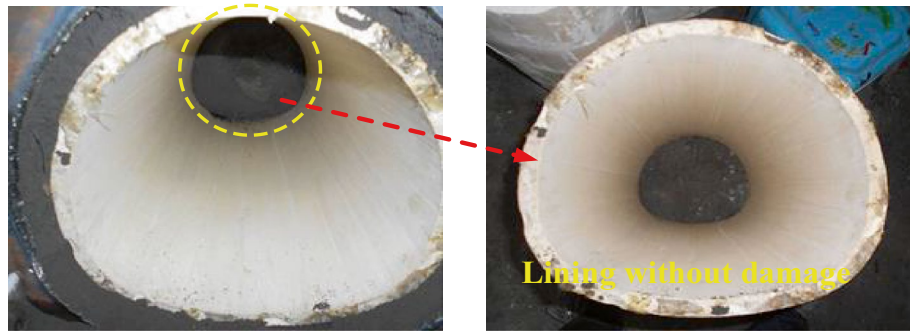
Figure 26. Lining without damage.

The damage of surrounding rock and lining structure after the test is shown in Fig. 26. After the hanging wall is staggered, the lining does not appear any cracks, and the structure is intact, which is completely different from the structural damage characteristics of the previous test. From the comparison of the two groups of tests, it is found that the main reason for the longitudinal through cracks in the basic test is the shearing and squeezing action of the fracture surface when the fault is dislocated, and the instantaneous reaction force generated after the fault touches the bottom has little effect, which is not enough to cause the lining to crack. However, if the lining has cracked under the action of the fault, the instantaneous reaction force may aggravate the damage of the tunnel lining.

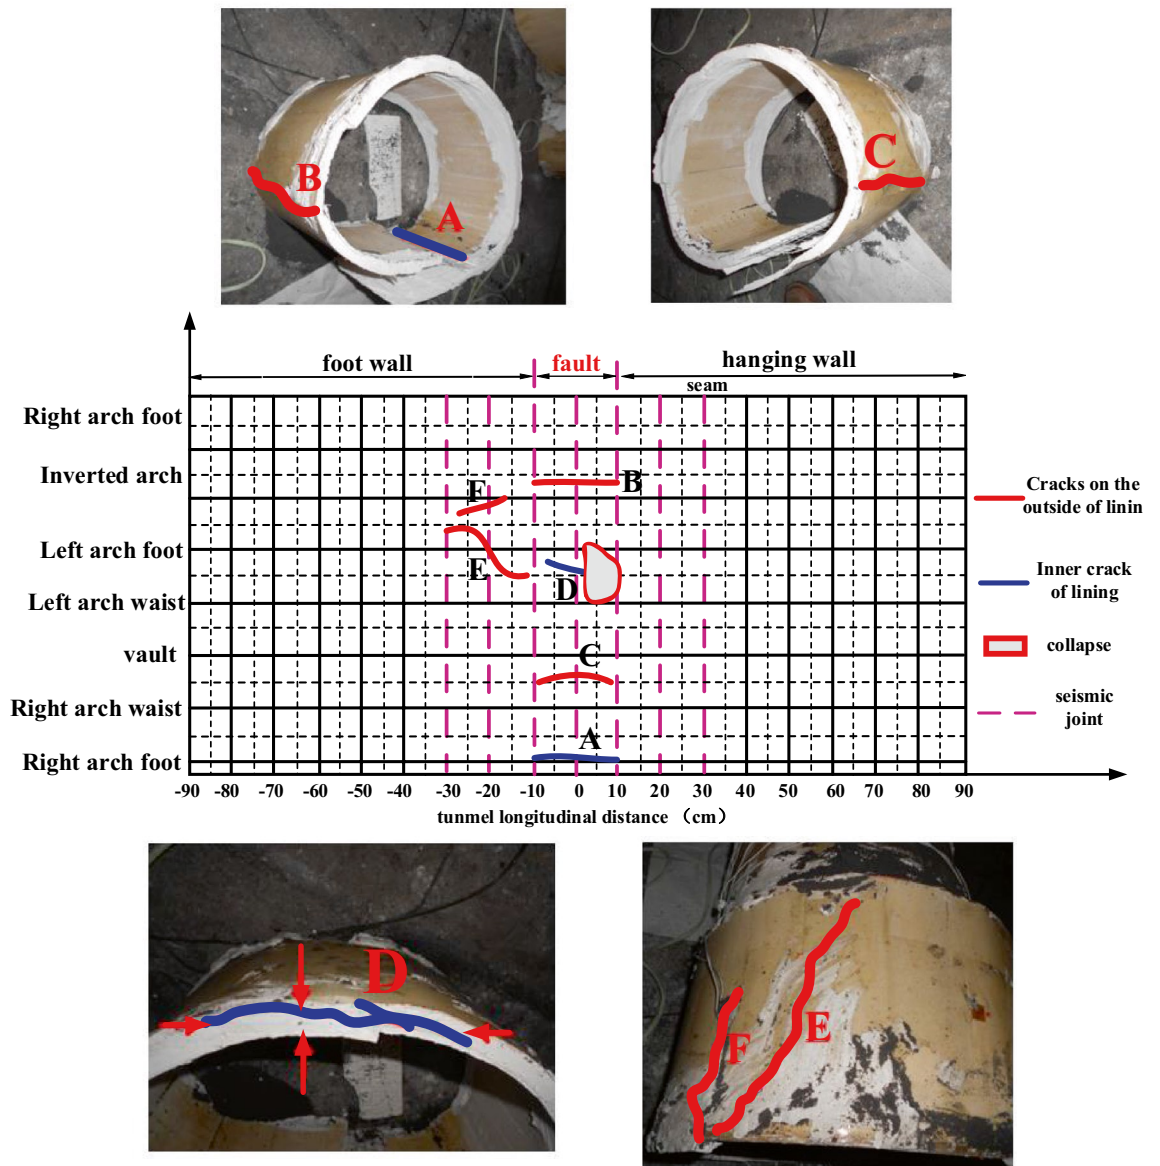
Figure 27. Crack Development and Failure.

The spring arranged under the upper plate can effectively simulate the repeated dislocation process of the upper and lower plates, and the stiffness of the spring directly affects the displacement and vibration time of repeated dislocation. In order to achieve the best test effect, reduce the spring stiffness and test the dislocation of the box with small stiffness. After the test, the damage of surrounding rock and lining structure is shown in the Fig. 27. From the failure form, after replacing the spring with small stiffness, the failure characteristics of the lining after fault dislocation are basically similar to those of the spring with large stiffness, and there are longitudinal through cracks at the inverted arch and arch foot, but the damage degree is slightly lighter than the former, that is to say, the spring becomes softer because of its stiffness, and its buffering ability to impact load is enhanced. At the same time, however, the test shows that the use of small stiffness spring will lead to the situation that the upper plate can not rebound effectively, and the mutual dislocation of the upper and lower plates is not obvious, with less reciprocating dislocation times, small displacement and short time, which can not achieve good test results.
