Deformation characteristics and mechanism of Mala paleo-landslide during the Miaowei reservoir initial impoundment period

Zhijie Mai[✉], Xi Hu, Lianke Li & Jiacheng Hou

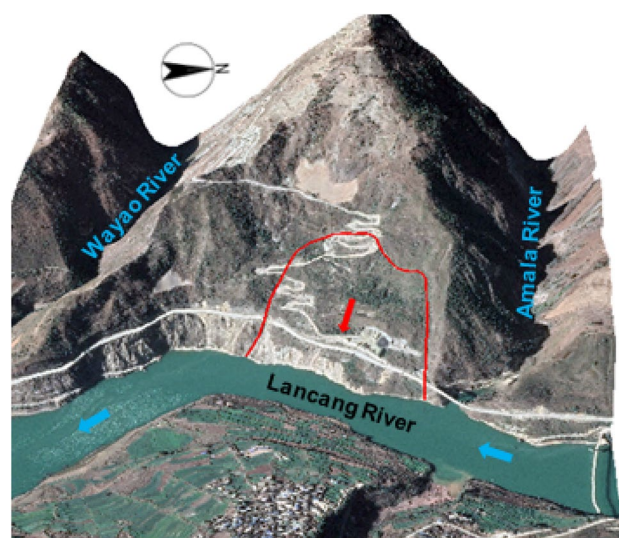
Figure 1. Mala paleo-landslide.

As shown in Fig. 1, the upstream of the Mala landslide is the Amara River, and the downstream is the Wayao River. The elevation of the landslide area ranges from 1380 to 1560 m, extending approximately 420 m in the downstream direction. The thickness of the sliding body varies from 10 to 75 m, with a total volume of approximately $4.3 \times 10^6 \text{ m}^3$. Below an elevation of 1440 m, the terrain becomes steeper, with slopes ranging from 40° to 60° . In the section of the landslide with elevations ranging from 1440 to 1650 m, the terrain is relatively gentle, and the slope typically ranges from 20° to 35° . On the right bank of the reservoir, there are two roads passing through the lower and middle parts of the landslide.

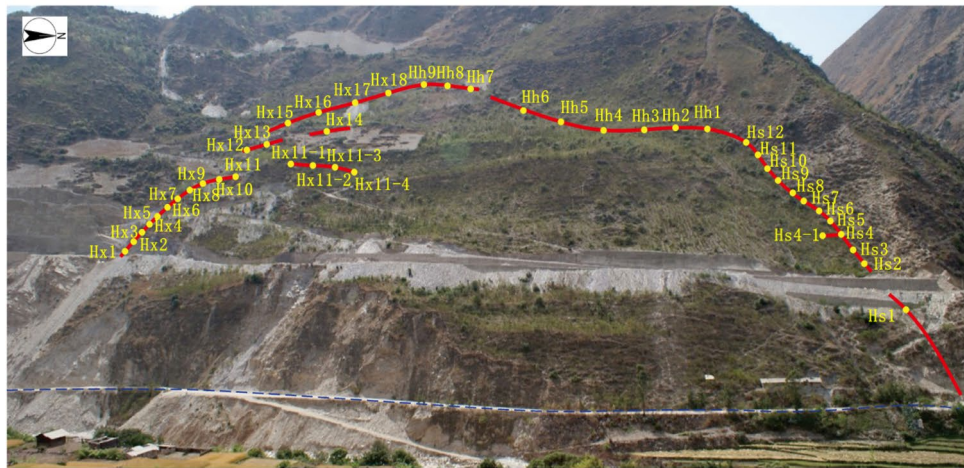
Figure 3. Ground deformation feature.

Since the impoundment began on April 21, 2017, the water level in the reservoir rose from an elevation of 1372.7–1392.8 m by June 2017. As a result, the front edge slope of the sliding mass (near the downstream side) has caused a certain range of bank collapse (Fig. 3b 1# collapse). In the mid to late July of 2017, the reservoir water level stabilized at an elevation of around 1401 m, several small-scale collapses occurred at the front edge (Fig. 3b 2# collapse). Surface cracks began to appear successively from the front edge to the rear edge of the sliding mass, with the development of surface cracks primarily concentrated along the perimeter of the ancient landslide. In December 2017, the cracks at the front edge had partially connected, extending for approximately 100 m with an opening width of about 5–15 cm. By March 2018, a total of 42 cracks had been identified during on-site investigations. Except for Hs3 and Hx11, which were shear cracks, all others were tension cracks. The field survey results indicated that the average opening width of these slope cracks ranged from 10 to 20 cm, reaching up to 30 centim in some local areas. Essentially, the perimeter cracks within the sliding mass were interconnected. Please refer to Fig. 3 for the on-site survey results of cracks within the landslide area.

Taking into consideration Fig. 3, we will proceed to analyze the average width, extension direction, and characteristics of the sliding mass within the landslide area through investigations of cracks both upstream, at the rear, and downstream of the sliding mass. The details are as follows:

(a) Crack location distribution

(b) Characteristics of landslide deformation

The trace lines of the upstream cracks (Hs1–Hs12) closely align with the landslide boundary. Among these, cracks Hs4, Hs6, Hs9, and Hs11 were the first to appear on the upstream side of the landslide boundary, with an average width exceeding 10 cm. Other cracks are distributed on both sides of these four cracks, indicating that the formation of the other cracks occurred as a result of increased deformation under the gravitational pull of the sliding mass. Furthermore, the overall trend of the cracks extends from Hs11 towards Hs4, suggesting that the deformation direction of the upstream rock (or soil) mass leans towards the downstream direction.

The number of rear cracks (Hh1–Hh9) is relatively smaller, but the cracks tend to be wider and longer in extension. Cracks Hh1–Hh6 intersect with the upstream cracks, and Hh7–Hh9 intersect with the downstream cracks. Among these, cracks Hh1 and Hh3–Hh6 formed earlier than Hh2, with an average width exceeding 10 cm. The overall trend of these cracks extends from Hs6 towards Hs1, which is similar to the deformation trend of the upstream cracks. The average width of cracks Hh7–Hh9 varies, and the width of these cracks gradually decreases from Hh7 to Hh9, indicating that the extension direction of the cracks is from Hh7 to Hh9.

The downstream cracks (Hx1–Hx5 and Hx15–Hx18) are in proximity to the landslide boundary, while the remaining cracks deviate from it. The cracks in the Hx1–Hx5 and Hx15–Hx18 formed relatively early, with an average width exceeding 10 cm. Crack Hx11 tends to intersect with Hx11–4 and shows a trend of extending towards the central part of the landslide. This is due to relative displacement occurring within the landslide during the impoundment process, leading to the formation of a secondary sliding mass (Fig. 3b). Based on the

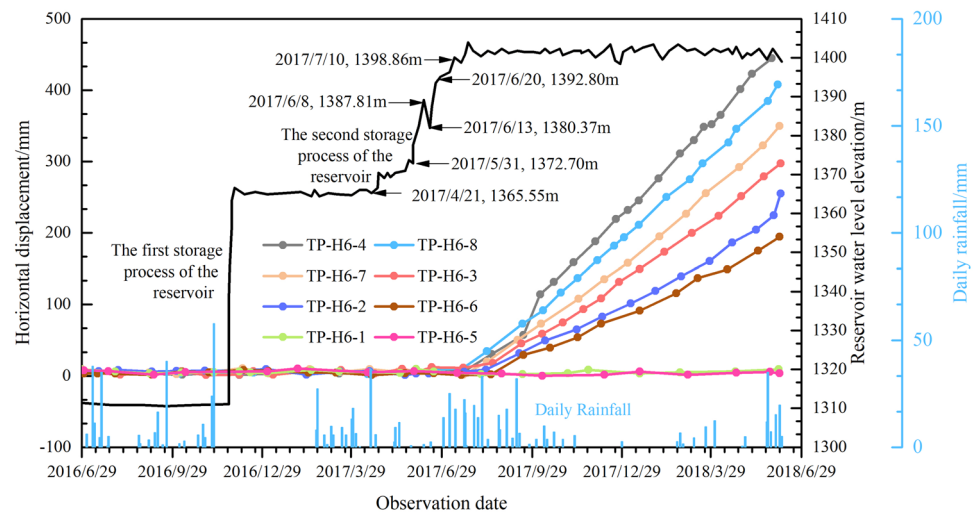
Figure 5. Deformation curve of Mala landslide surface displacement monitoring.

Consequently, deformations began to emerge at each monitoring point. The deformation curves at each monitoring point generally exhibited an exponential pattern. From mid-June 2017 to mid-August 2017, the deformation rates were relatively slow. Starting from mid-August 2017, the deformation at each monitoring point accelerated, and later, the deformation rates became relatively stable, approaching uniform deformation (Fig. 5).

From June 8, 2017, to June 13, 2017, there was a sudden drop in the reservoir water level, and there were no significant changes in the deformation curves at various monitoring points. Additionally, the deformation curves at these monitoring points did not exhibit any significant abrupt changes due to rainfall (Fig. 5). This suggests that the sudden rise in water level is an important factor in triggering the formation of Mala landslide after excluding the two factors of falling water levels and rainfall. Furthermore, according to Fig. 5, there was no significant change in surface deformation displacement during the impoundment process (from April 21, 2017 to July 15, 2017). Instead, after the reservoir water level stabilized at 1401 m, there was a noticeable increase in surface deformation displacement (after July 15, 2017). This indicates that the deformation of the landslide exhibits a certain degree of hysteresis.

Furthermore, the deformation conditions at various monitoring points exhibit synchronicity, with deformation occurring almost simultaneously. Moreover, the deformation trends are consistent, with deformation magnitudes showing the following pattern: landslide front (TP-H6-4, TP-H6-8) > central part of the landslide body (TP-H6-7, TP-H6-3) > landslide rear (TP-H6-2, TP-H6-6). This aligns with the results obtained from surface surveys.

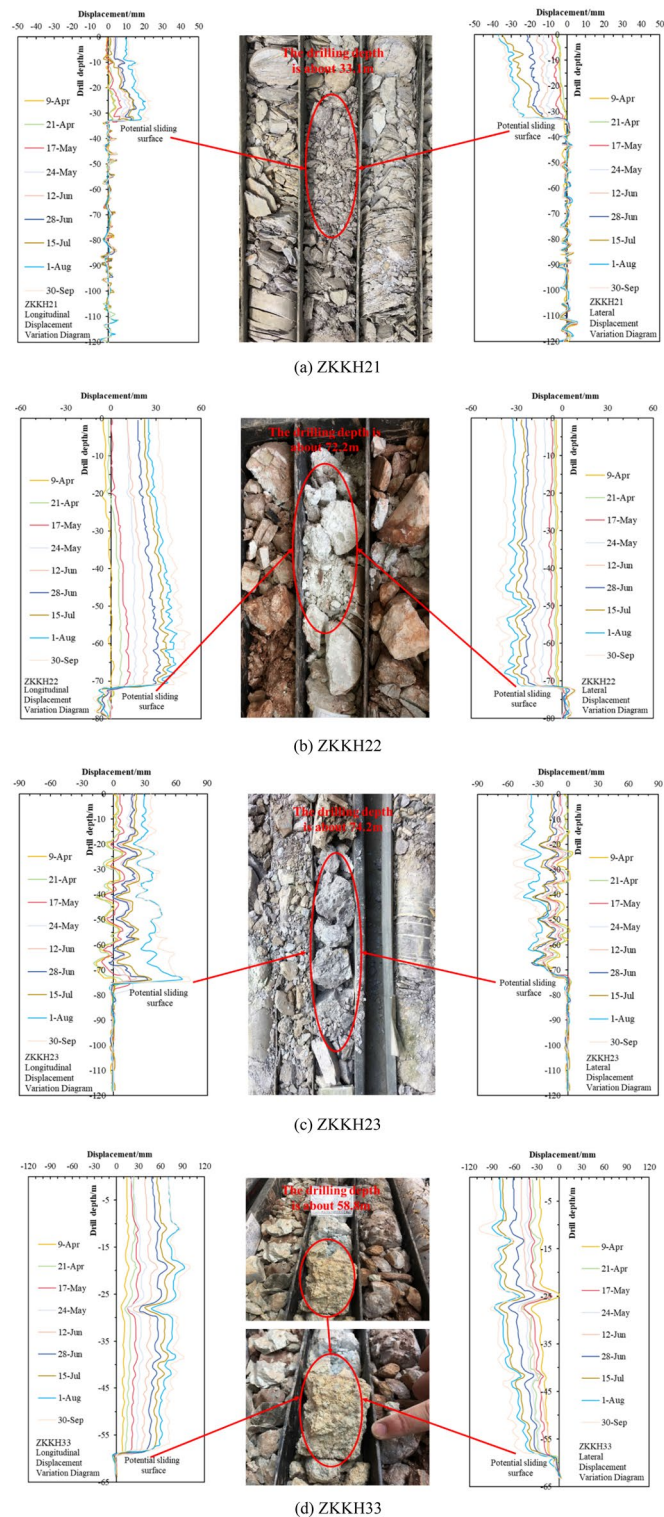
Figure 6. Deep displacement variation and slip zone detail diagram.

The deep-seated displacement monitoring includes a total of eight boreholes with the following designations: ZKKH21–ZKKH24, ZKKH31–ZKKH34, as illustrated in Fig. 6. Eliminating the influence of bending deformations in the inclinometer pipes themselves, the data from each monitoring point exhibit similar trends. To gain a more detailed understanding of displacement variations in the rear, central, and front sections of the landslide, the profile composed of ZKH21–ZKH22–ZKH23–ZKH33 was chosen to conduct an analysis of the deep-seated displacement characteristics within the landslide body.

In the displacement curve for ZKKH21, the deformation near the bottom of the borehole exhibits minimal displacement. However, there is a significant displacement surge between depths of 32.5 m and 33.4 m and the changed curves are continuous and flat, which aligns with the characteristics of shear displacement. And according to the core from the ZKKH21 borehole, at a depth of 33.1 m, there is a weak interlayer (Fig. 6a), it is estimated that the depth of the sliding surface is approximately at a depth of 33.1 m.

In the displacement curves for ZKKH22 and ZKKH23, the monitoring curves at depths of 72.0 m and 74.0 m, respectively, exhibit characteristics consistent with shear displacement. The core samples from the ZKKH22 and ZKKH23 boreholes reveal that, at depths of 72.2 m and 74.2 m, the cores are fragmented and show significant weathering, with the gravel displaying a notable degree of rounding (Fig. 6b,c). Combining this information, it is inferred that the slip surface is located at a depth of 72.2 m (ZKKH22) and 74.2 m (ZKKH23).

In the displacement curve for ZKKH33, there is a noticeable surge in displacement at a depth of 58.0 m, and below this depth, there are no significant indications of deformation. Moreover, based on the core samples obtained from borehole ZKKH33, at a depth of 58.8 m, the core samples exhibit strongly weathering (Fig. 6d), closely resembling the exposed sliding surface at the upstream landslide shear outlet. Combining the information, it can be inferred that the location at a depth of 58.8 m corresponds to the sliding surface.

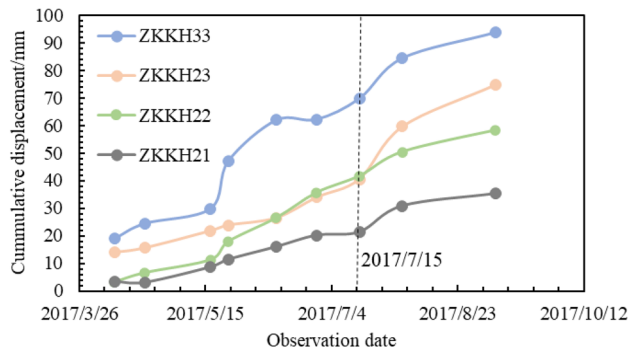
Figure 7. Deep cumulative displacement.

In deep-seated displacements, the monitoring displacement curves of individual point exhibit a generally consistent trend, indicating that the mass above the sliding surface is experiencing overall sliding and is in a state of overall creep deformation. Furthermore, the cumulative monitoring displacement data for ZKKH21, ZKKH22, ZKKH23, and ZKKH33, as shown in Fig. 7, follows a trend consistent with the surface deformation. The displacement is more pronounced at the landslide front (ZKKH33), followed by the central portion of the landslide (ZKKH22 and ZKKH23), and lastly, the rear part of the landslide (ZKKH21). This indicates that the Mala landslide is a retrogressive type landslide, aligning well with the deformation characteristics observed during the ground deformation survey. It is worth noting that since July 15, 2017, there has been a noticeable increase in deep cumulative displacement (Fig. 5). This indicates that, following the stabilization of the reservoir water level at around 1401 m, the groundwater level is gradually stabilizing. The change of groundwater level is an important factor in the deformation and displacement of the landslide.

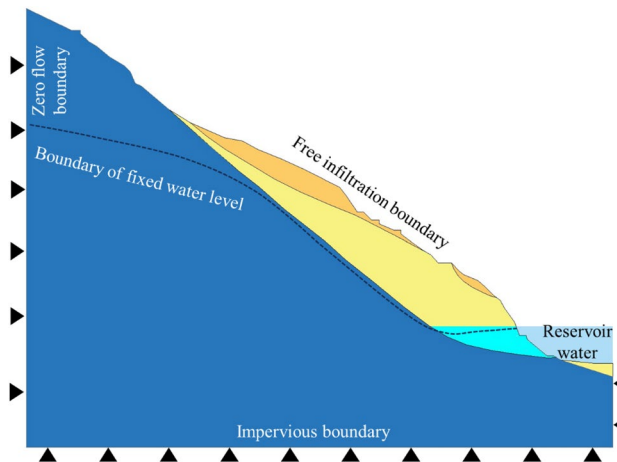
Figure 8. Schematic diagram of boundary setting.

The boundary conditions for the model are determined based on hydrogeological considerations (Fig. 8). It is assumed that both the sliding mass and bedrock are composed of homogeneous materials. Fixed constraints are applied at the bottom, while normal constraints are applied at the left and right ends. The upper surface is treated as a free infiltration boundary, and the lower surface is considered impermeable. Zero flow boundaries are applied on both sides above the water level, and given head boundaries are established below the water level, set

at the water head at each respective location. Specifically, the water head on the left boundary is set to the initial groundwater level, and on the right boundary, there's a variable head boundary due to changes in the reservoir water level. Calculations are based on the natural state of the slope before reservoir filling, with the reservoir water level during the filling period applied as a boundary condition on the slope surface.

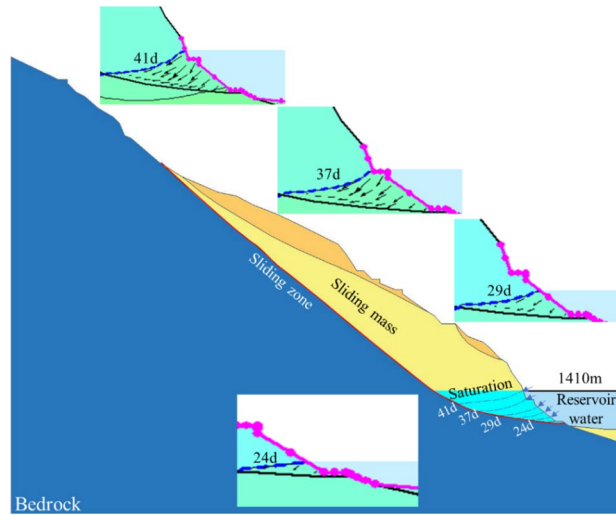
Figure 9. The variation of infiltration line with the increase of reservoir water level.

According to the analysis of numerical simulation results, it is observed that as the reservoir water level rises, the infiltration line within the slope ascends, and the infiltration line exhibits a concave shape towards the interior of the slope (Fig. 9). During the rising of the reservoir water level, the water level within the slope lags behind the reservoir water level, resulting in a water level difference. Water infiltrates into the slope, generating dynamic water infiltration pressure and pore static water pressure directed towards the interior of the slope. Therefore, it can be concluded that during the reservoir level increase, the mechanical behavior of the Mala landslide involves a combination of the infiltration force generated by dynamic water pressure and the buoyant force produced by pore static water pressure. However, due to the influence of the sliding surface morphology (featuring an anti-slide segment), the buoyancy-induced reduction in weight is more significant than the underground water infiltration pressure, making buoyancy the primary factor.

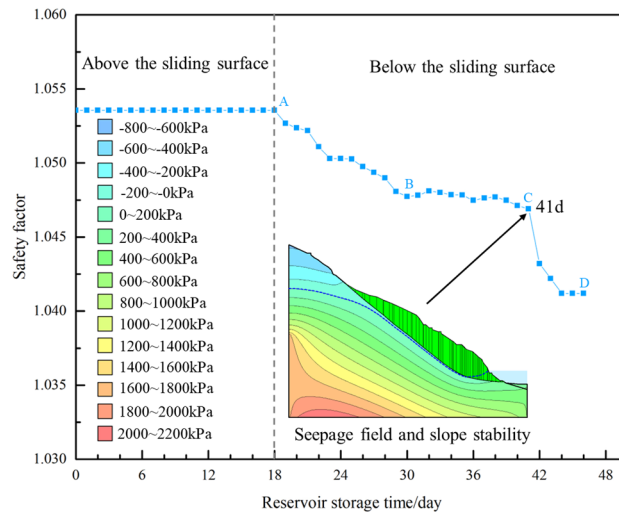
Figure 10. Safety factor variation curve.

Furthermore, according to the analysis of previous deformation and displacement monitoring data and seepage characteristics, this landslide exhibits a typical reservoir-induced delayed response with the relationship reservoir water level fluctuation rate (v) being greater than the permeability coefficient (c) of the sliding mass¹⁰. During the first 17 days of impoundment, as the reservoir water level was lower than the sliding surface, it had minimal impact on the stability of the landslide. However, starting from the 18th day, as the reservoir water level exceeded the sliding surface, the stability of the landslide began to decrease (Fig. 10 (A → B)). As the water level continued to rise, the decline in stability showed a slight slowdown (Fig. 10 (B → C)). When the reservoir water level reached its highest operational point, during the transition of groundwater seepage from a transient to a steady state, the buoyancy-induced reduction in weight further increased, leading to a continued reduction in the landslide’s stability, reaching its lowest point (Fig. 10 (C → D)).

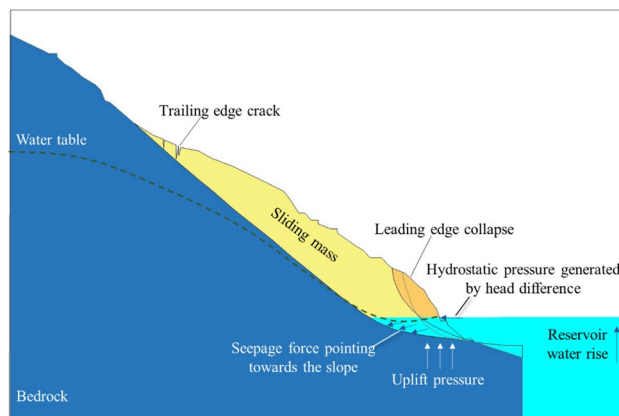
Figure 11. Deformation mechanism.

Based on a comprehensive assessment of the engineering geological conditions, deformation characteristics, displacement monitoring, and stability analysis of the Mala landslide, it is concluded that the condition of the leading-edge free surface is relatively favorable. As shown in Fig. 11, under the rising reservoir water level conditions, localized collapsing and sliding deformation occur in the front part of the landslide. This sliding at the front creates new frontal conditions, leading to stress redistribution within the slope and the gradual appearance of tension cracks at the rear of the slope. As the reservoir level continues to rise, the water level within the slope lags behind the reservoir water level, resulting in a water level difference. Water infiltrates into the slope, generating dynamic water infiltration pressure and pore static water pressure, with the buoyant force produced by pore static pressure being the dominant factor^{10,11}. When the reservoir water level rises to 1401 m, on one

hand, there is the application of static water pressure on the slope mass, leading to a reduction in the effective self-weight of the front part of the sliding mass¹². On the other hand, due to the immersion effect of the reservoir water, the param of the anti-slide segment also decrease. Finally, the significant decrease in anti-slip force of the sliding mass leads to deformation and instability of the landslide.
