# Use of the multi-cup denture for a severely resorbed maxilla: a clinical report

R. Vasant<sup>1</sup> and G. S. Bassi<sup>2</sup>

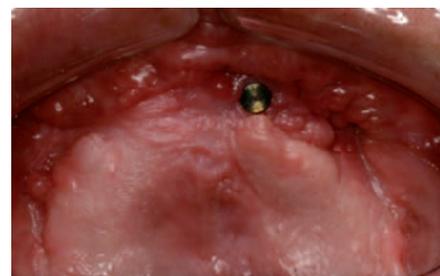
Fig. 1 Occlusal view of maxilla

iliac crest and calvarium. Furthermore, a soft tissue graft had been taken from the inner labial mucosa of the upper lip and 14 implants had been removed, with the remaining ones not fully integrated and in unfavourable positions for restoration. The patient was left with a severely resorbed maxilla (Fig. 1). It can be seen that denture stomatitis was present. In addition there was significant alteration of the sulcus anatomy with an almost complete lack of sulcus and the alveolar ridge was severely resorbed and uneven in contour. The lower arch, however, was reasonably well aligned and partially dentate. There were two implant retained crowns replacing the lower left premolars and the remaining natural teeth were moderately restored. There was evidence of tooth surface loss on the incisal edges of the lower anteriors. The occlusal vertical dimension appeared to be satisfactory. The incisors were in a Class I relationship, with group function on right and left lateral excursion.

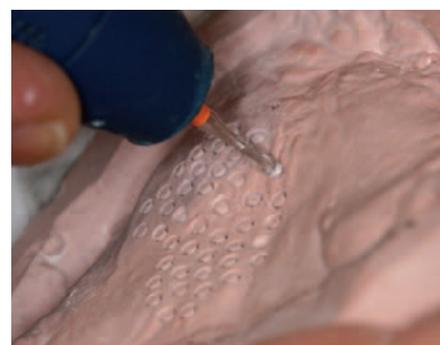
Fig. 2 Drilling of trephine holes into master cast

Following the conventional prosthodontic stages of primary impressions, secondary impressions and jaw registration, a tooth try-in on a cold-cure acrylic resin primary base was carried out. Once patient and clinician were happy with the tooth arrangement, the try-in was disinfected and returned to the laboratory. The master cast was then prepared by drilling trephine holes perpendicularly into it (Fig. 2). These

were placed approximately 1.5 mm apart, were 1 mm deep and had a diameter of 2 mm. The entire alveolar ridge and palatal denture supporting areas were prepared in this way, leaving 2 mm at the denture borders and frenal attachment sites.

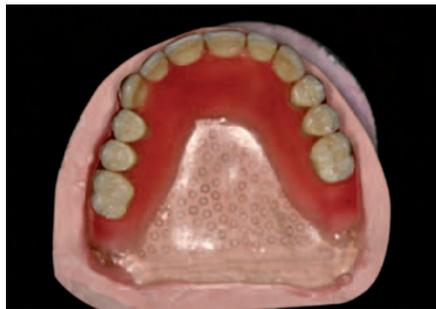
Fig. 3 Sealed down primary base

The primary base was then sealed down on the master cast with wax in the conventional way (Fig. 3). The denture was then flaked and the wax boiled out in the normal manner (Figs 4 and 5).

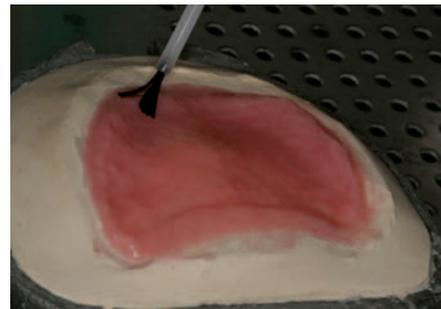
Fig. 8 Adhesive being applied

Heat-cured acrylic resin dough was packed over the teeth in the conventional way and covered with a thin plastic sheet (Fig. 7). After one hour in the press at two bar pressure, the flask was opened. Molloplast B adhesive was applied to the surface of the partially cured acrylic resin, then pressed over the surface of the master cast (Figs 8 and 9).

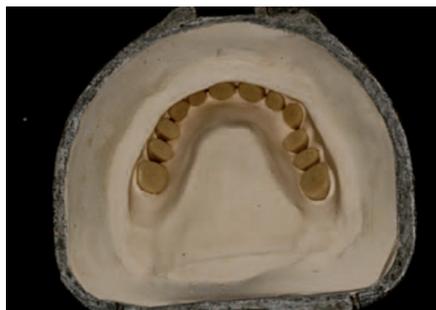
Fig. 4 Acrylic teeth in opposing half of flask following wax elimination

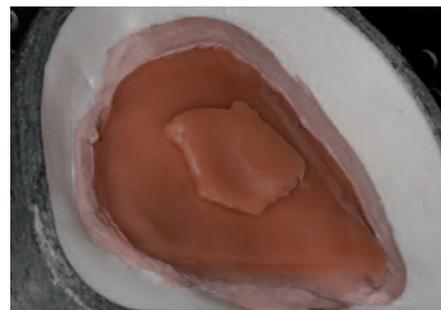
Fig. 9 Molloplast B being placed over the trephine holes on the master cast

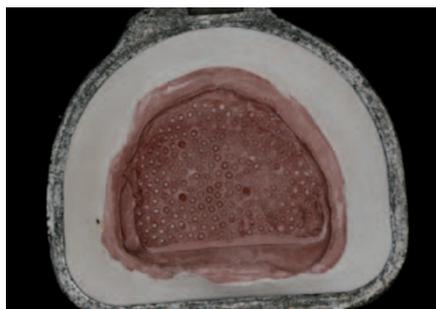
Fig. 5 Master cast following the boiling out procedure

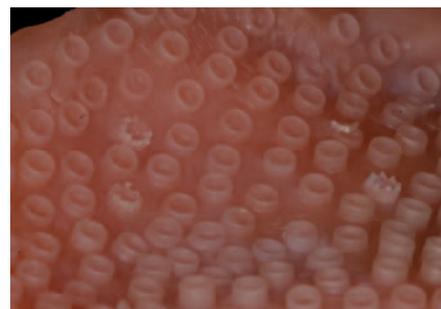
Fig. 10 Close-up of intaglio surface showing tiny suction cups

The flask was closed together and the acrylic allowed to fully cure using standard laboratory protocols. The flask was opened carefully, taking care not to tear the Molloplast B (Fig. 10). The acrylic resin was finished and polished in the conventional manner, again taking care not to damage the Molloplast B (Fig. 11).

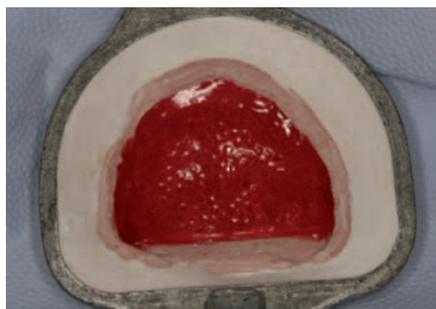
Fig. 6 Application of wax spacer

At this stage, a new 1.5 mm thick wax spacer was placed over the entire fitting surface of the cast (Fig. 6). This prevented the acrylic resin dough from entering the trephine holes and allowed sufficient space for the addition of Molloplast B at a later stage.

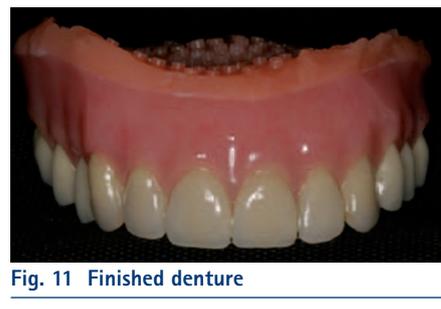
Fig. 11 Finished denture

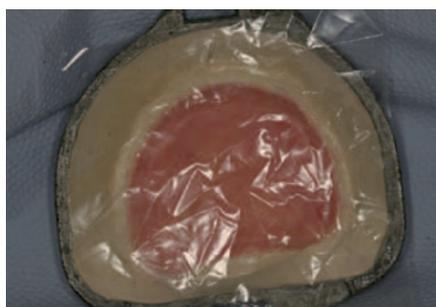
Fig. 7 Acrylic resin dough packed over the teeth

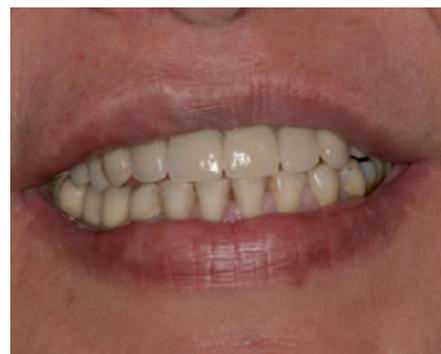
Fig. 12 Patient wearing finished denture

The denture was then fitted (Fig. 12). The patient found it very comfortable to wear and reported increased retention compared to her previous conventional prosthesis. This is in line with a previously published report.<sup>2</sup> The patient was to be followed up for any deleterious soft tissue changes. However, in the previously published case report,<sup>2</sup> no soft tissue changes were recorded. The patient did not seek any further treatment 12 months after the maxillary denture was fitted.
