Management of a fractured incisor using a stratified composite technique

Case report

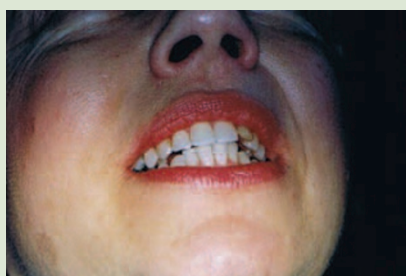
Fig. 1 Pre-op clinical appearance

From the clinical appearance (Figs 1-2), the tooth was set in an anterior position to avoid the over-erupted lower incisor (32). This may be a result of the original restoration.

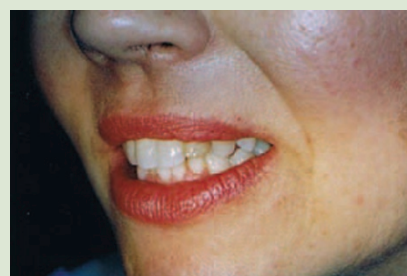
Fig. 2 Discoloured malpositioned

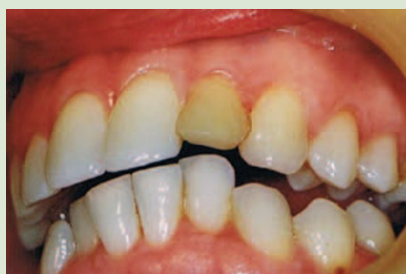
The 22 had been restored with a composite which was largely discoloured. The aesthetics of this restoration were unacceptable (Fig. 3).

Fig. 3 Excessive proclination

The treatment proposed was to replace this restoration with a nano-composite (Filtek XT™). A stratified lamellar composite build up was proposed using three shades (A2B, A1E, WE).

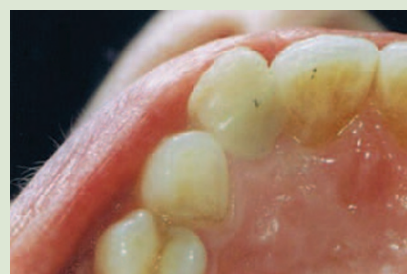
Fig. 4 Palatal form with temporary composite (mirror view)

Initially a temporary palatal composite was placed (Fig. 4). The occlusion was then reassessed and a putty record taken of the

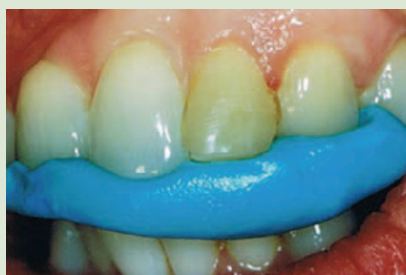
Fig. 5 Putty record of palatal contour

palatal surface (Fig. 5). This temporary composite was not bonded to the tooth.

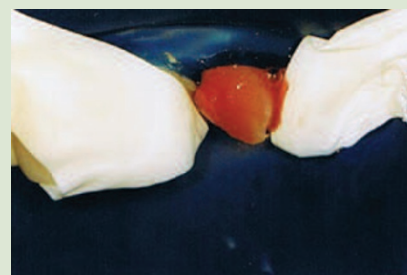
Fig. 6 Isolation and etching (Rubber dam and PTFE tape)

Under local anaesthetic infiltration, the tooth was isolated using a medium rubber dam (Fig. 6). The adjacent teeth were protected with PTFE tape and the temporary composite removed. The enamel was bevelled buccally and all remnants of the original restoration removed.

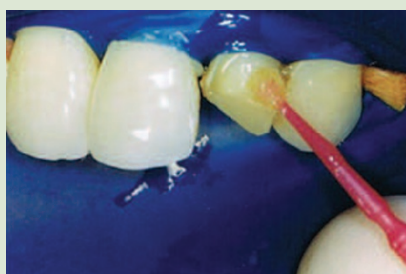
Fig. 7 Application of prime and bond (Adper L-POP™)

A single step etch/bond system was used, Adper L-POP™ (Fig. 7). This is presented as a single use system which is mixed and applied to the tooth (15s) and allowed to gently air dry (3s) to enable the solvent to evaporate. The resin is then light cured (10s). This was repeated twice.

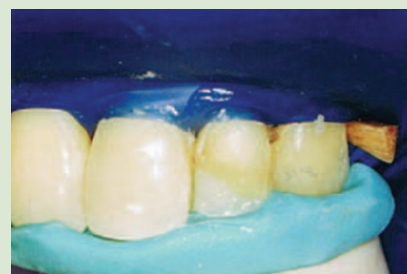
Fig. 8 Palatal composite layer

The putty record was then replaced (Fig. 8), and the first layer of composite placed to restore the palatal surface (Shade WE). The approximal surfaces were also restored at this stage and light cured (20s).

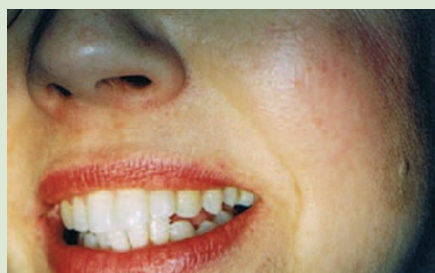
Fig. 9 Initial post-op view

Review appointments indicated that the restoration was well tolerated by the soft tissues and there were no detected adverse occlusal features. The nano-composite was able to retain its polish (Figs 9-11).

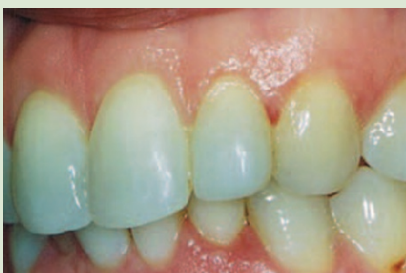
Fig. 10 Two weeks post-op

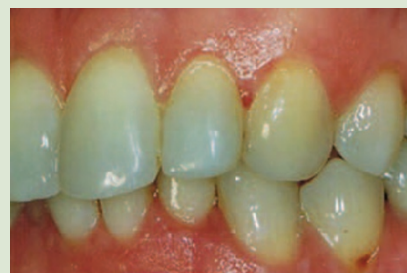
Fig. 11 Eight weeks post-op
