## Evolution process and failure mechanism of a large expressway roadside landslide

Site investigation, deformation monitoring, laboratory test, and theoretical calculations were used to analyze the evolution details of a large expressway roadside landslide during the start-up sliding process. The monitoring results show that the initial deformation and failure occurred on the protective wall at the slope toe, then gradually developed to the upper part of the slope, and finally led to tensile cracks at the slope trailing edge. Accelerated deformation of the slope support structures, such as the protective wall at the slope toe, the anti-slide pile, and the anchor cable, were observed during the continuous extreme rainfall. The infiltrated rainwater can change the weight, the osmotic pressure, the anti-sliding force, the sliding force of the sliding mass, and further soften the fully weathered tuff soil and reduce its strength, resulting in the landslide occurrence. Block the slope surface runoff is an effective measure to reduce the landslide risk. The current analysis will be helpful to the prevention, control, and emergency disposal of similar landslides.

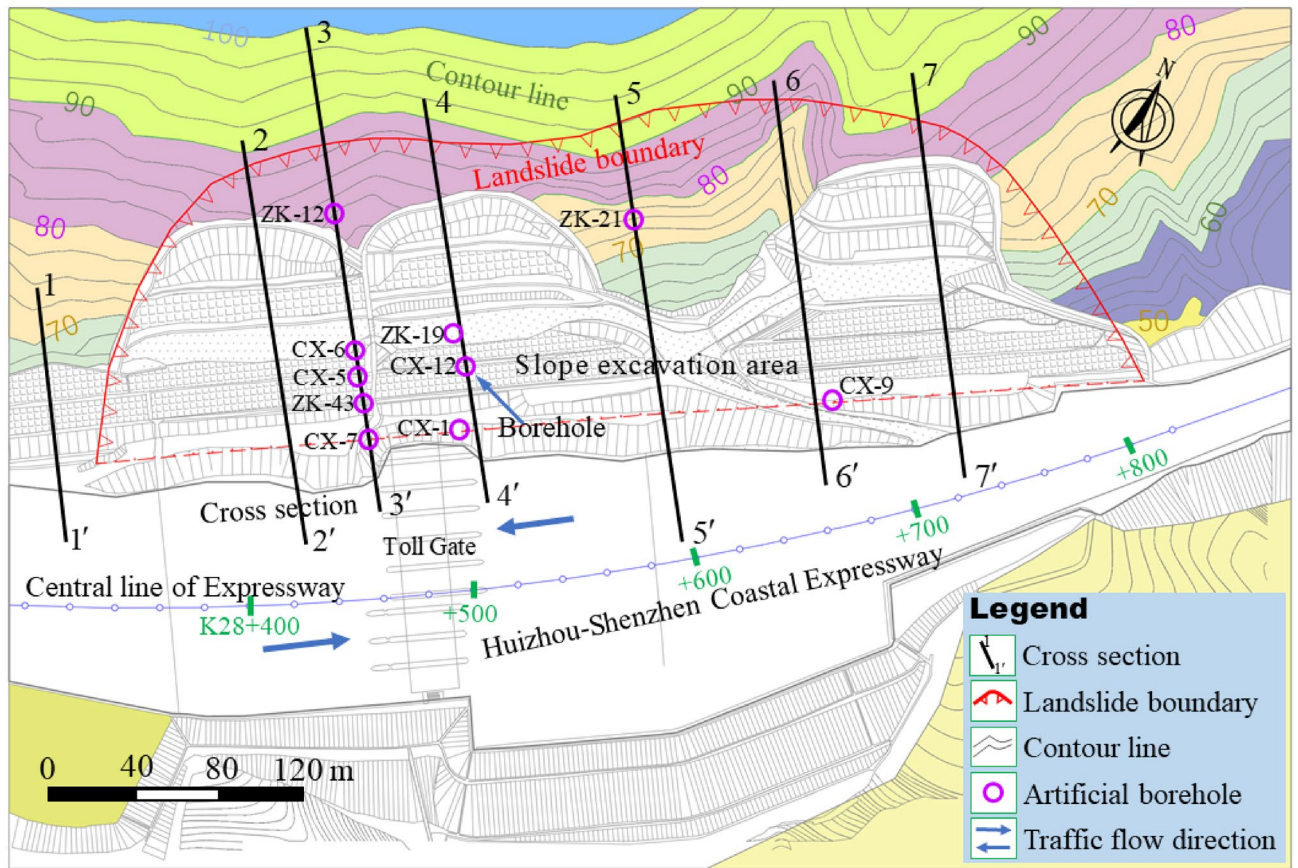
**Figure 6.** The distribution of the observation cross sections and part of boreholes.

On the same cross sections (e.g., cross section 3-3, 4-4), with the increase of slope elevation, the slip surface depth gradually increases, indicating that the sliding boundary is outside the borehole investigation scope. Therefore, the landslide boundary in Fig. 6 is an estimated boundary (determined according to the tension crack location), and the actual landslide boundary may be larger.
