## Role of tool marks inside spherical mitigation pit fabricated by micro-milling on repairing quality of damaged $\text{KH}_2\text{PO}_4$ crystal

Repairing initial slight damage site into stable structures by engineering techniques is the leading strategy to mitigate the damage growth on large-size components used in laser-driven fusion facilities. For  $\text{KH}_2\text{PO}_4$  crystals, serving as frequency converter and optoelectronic switch-Pockels cell, micro-milling has been proven the most promising method to fabricate these stable structures. However, tool marks inside repairing pit would be unavoidably introduced due to the wearing of milling cutter in actual repairing process. Here we quantitatively investigate the effect of tool marks on repairing quality of damaged crystal components by simulating its induced light intensification and testing the laser-induced damage threshold. We found that due to the formation of focusing hot spots and interference ripples, the light intensity is strongly enhanced with the presence of tool marks, especially for those on rear surfaces. Besides, the negative effect of tool marks is mark density dependent and multiple tool marks would

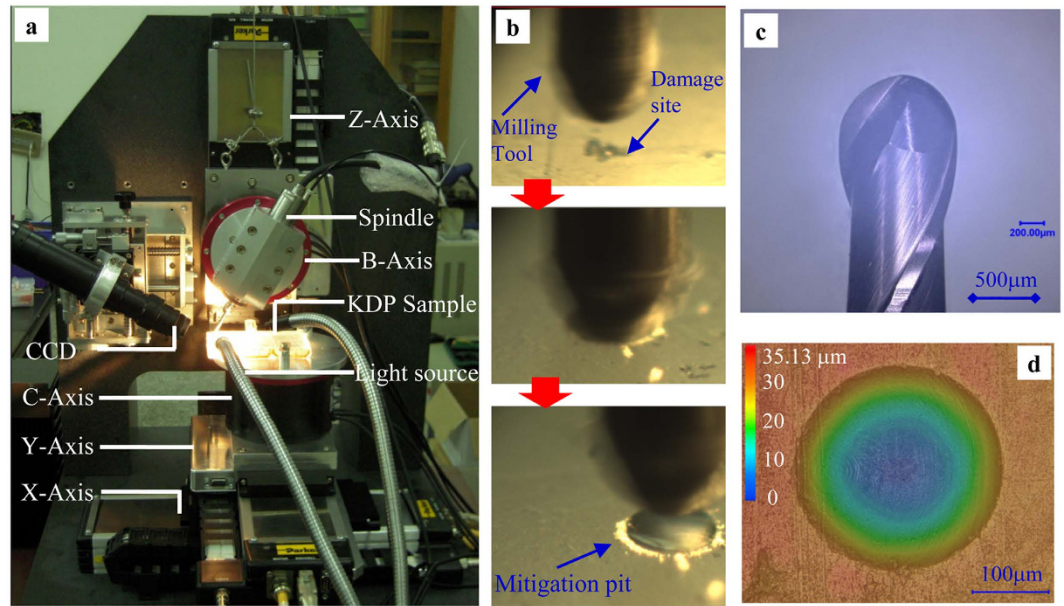
**Figure 1. Micro-milling set-up developed for repairing the damage sites on KDP crystal surfaces.**

(a) Overall configuration of the miniature five-axis milling set-up. (b) The repairing process to replace the initial surface damage with a spherical mitigation pit. The initial damage site is illuminated by a cold light source and identified by a CCD camera. (c) The double-edged ball-end milling tool adopted in the repairing process. (d) The typical spherical mitigation pit without internal tool marks fabricated by micro-milling.

**Repairing damage sites on KDP surfaces by micro-milling.** In the laser fusion projects, several types of specialized micro-machining set-ups have been developed to repair the unstable damage sites on high-precision crystal surfaces<sup>12,20–22</sup>. In order to improve the laser damage resistance of KDP crystal, we have designed and finished the construction of a miniature five-axis micro-milling set-up to fast repair the initial damaged crystal surfaces. The overall configuration and details of the milling set-up are exhibited in Fig. 1. The set-up integrates one high-speed spindle, two revolving axes (C- and B-Axis) and three linear axes (X-, Y- and Z-Axis) to achieve precision identification, positioning and repairing of the surface damage sites. The full description of the micro-milling machine can be found in ref. 23. As shown in Fig. 1b, the initial damage site is firstly detected by a CCD camera and positioned right beneath the milling tool. Then, the tiny tool, which is firmly embedded inside the spindle and rotated at high speed of 70,000 RPM, vertically feeds downward to a sufficient cutting depth, enabling the damage site to be completely removed. The remaining structure on the repaired surface is determined by the geometry of the milling tool. Figure 1c presents the double-edged cemented carbide milling tool with a radius of 500 μm, which is prepared by the NS TOOL Co., LTD (Type MSB 230) in Tokyo, Japan. The ideal fabricated spherical mitigation pit without any tool marks is shown in Fig. 1d with 240 μm width and 30 μm depth.

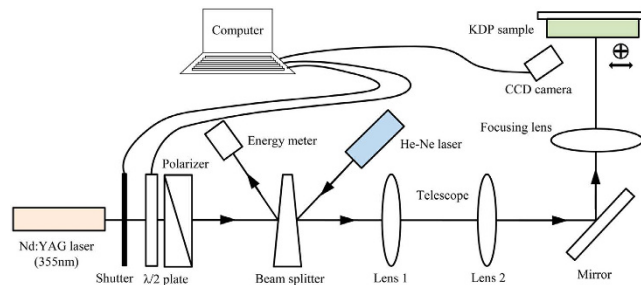
**Figure 3.** Schematic of laser damage setup for determining the LIDTs of KDP crystals.

The experimental set up for testing the LIDTs of KDP samples with various surface features is depicted in Fig. 3. The adopted Nd:YAG SAGA laser, operating at  $355\ \text{nm}$  wavelength,  $10\ \text{Hz}$  repetition rate and  $6.4\ \text{ns}$  pulse duration, is capable to output laser pulses with single longitudinal mode and approximate Gaussian spatial distribution. The  $355\ \text{nm}$ -wavelength is chosen to be consistent with that used in the simulation and actual laser fusion facilities. The switching action of laser pulses is controlled by a mechanical shutter. The combination of a wave plate and polarizer is installed following the shutter to adjust the variable laser fluence. Besides, depending on a wedged splitter, a fraction of pulse energy is detected by energy meter and a He-Ne laser is employed to calibrate the incident light. A CCD camera is placed against the KDP sample to monitor *in situ* the changes of surface morphology after each laser pulse. The LIDTs of various KDP surfaces are measured based on R-on-1 testing strategy<sup>21</sup>, and the detailed implementation for determining the LIDTs are described in Supplementary Fig. S1 online. It is worth noting that the laser damage experiments in this work are just designed for testing the repaired

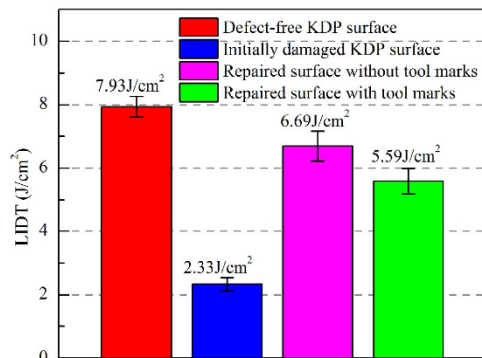
**Figure 7. Comparison of the experimentally tested LIDTs for KDP crystals with damage-free surfaces, initially damaged surfaces, and repaired surfaces with and without tool marks.** The LIDT is determined by testing 10 spots and the error bar is the standard deviation of the tested data.

The tested LIDTs of KDP crystal with different surface features are exhibited in Fig. 7. It is shown that the LIDT of diamond turned defect-free surface is  $7.93 \text{ J/cm}^2$ . However, the growth threshold of initial damaged surface is only  $2.33 \text{ J/cm}^2$ , which implies that once the damage occurs, the damaged surface is susceptible to suffer damage growth under the irradiation of subsequent laser pulse even with very low fluence. The LIDT of ideally repaired mitigation pit with no tool mark comes out to be  $6.69 \text{ J/cm}^2$ . It means that replacing the initial damage site with a spherical mitigation pit by micro-milling can successfully retrieve the damage resistance of previously damaged crystal surfaces. However, with the presence of tool marks inside mitigation pit, the LIDT of repaired KDP surface decreases to  $5.59 \text{ J/cm}^2$ , which is only 83.6% of that for ideally repaired spherical mitigation pit. The electromagnetic energy density is related to electric field  $\mathbf{E}$ ,  $1/2 \epsilon_0 \eta^2 |\mathbf{E}|^2$ , through the refractive index  $\eta$  and vacuum permittivity  $\epsilon_0$ <sup>37</sup>. As known, the light intensity is linearly proportional to  $|\mathbf{E}|^2$ . So, for a given pulse width, the laser fluence threshold LIDT is solely dependent on the light intensity. Based on this, since the tested LIDT for repaired KDP surface with tool marks decreases to 83.6% of that for ideally repaired surface, it is
