Effect of hydrogen embrittlement on mechanical characteristics of DLC-coating for hydrogen valves of FCEVs

Diamond-like carbon (DLC) coating is a surface coating technology with excellent hydrogen permeation resistance and wear resistance. However, it is difficult to completely prevent hydrogen permeation, and when hydrogen penetrates into the coating layer, the DLC coating is adversely affected. Therefore, we investigated the effect of hydrogen embrittlement on the adhesion strength and wear resistance of the DLC coating layer. As the results of the research, the surface roughness of the DLC coating was increased by a maximum of 3.8 times with hydrogen charging, and the delamination ratio of the DLC coating reached about 58%. In addition, the Lc3, which refers to the adhesion strength corresponding to the complete delamination of the DLC coating, was decreased by a maximum of 2.0 N due to hydrogen permeation. In addition, the wear resistance decreased due to hydrogen permeation, and the exposed width of the substrate due to wear increased by more than 4 times. It was also determined that hydrogen blistering or hydrogen-induced cracking occurred at the interface between the DLC co

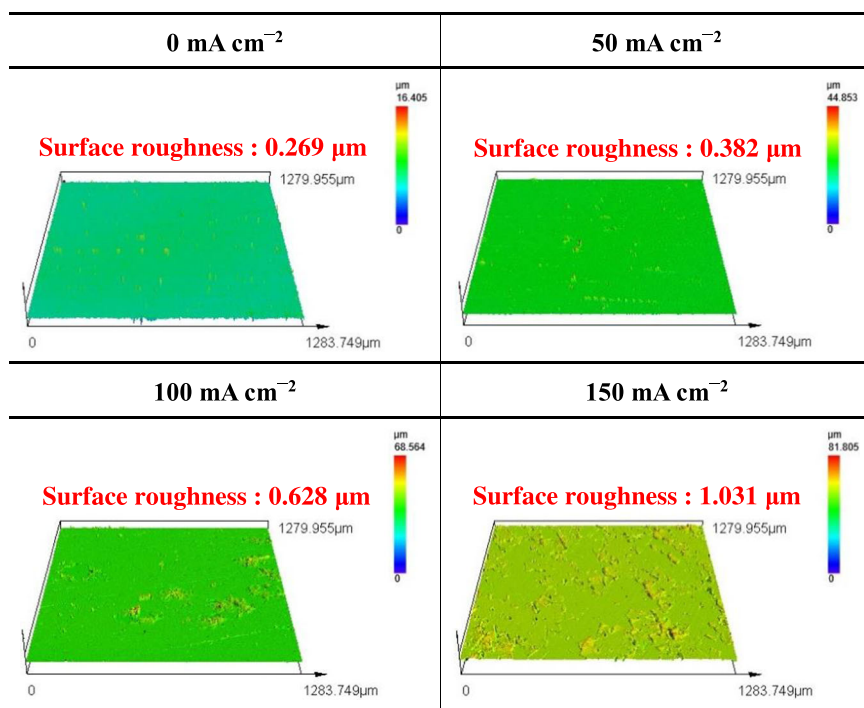
Fig. 2 | The variation of surface roughness by hydrogen charging. 3D images and surface roughness analysis of damaged surface after hydrogen charging (0, 50, 100, 150 mA cm⁻²) for DLC coated 316 L stainless steel.

Figure 2 depicts the surface roughness measurement results of the DLC coating after the hydrogen charging experiments. Many researchers have conducted electrochemical hydrogen charging and high-pressure hydrogen gaseous experiments to investigate the hydrogen embrittlement of materials exposed to hydrogen environments^{29,30}. In addition, the current density corresponding to the actual environments was investigated by comparing the experimental methods. In most research, however, electrochemical hydrogen charging and high-pressure gaseous experiments presented different characteristics depending on the material^{31,32}. In practice, the hydrogen gas pressure of approximately 24 bar reaches the hydrogen valve, which is the target of this study. However, it is difficult to determine the current density corresponding to 24 bar in evaluating the durability of the valve. This research also is an accelerated experiment to investigate damage to DLC coatings in the actual operating environments of hydrogen valves. After hydrogen charging experiment, the seven points of damaged specimen were measured using a 3D confocal laser microscope, and after excluding the maximum and minimum values, a value approximated to the average and a 3D image were used. The measurements revealed the surface roughness of the DLC coating without hydrogen charging to be about 0.269 μm . However, under the experimental conditions of the applied current density of 50 mA cm^{-2} , 100 mA cm^{-2} , and 150 mA cm^{-2} , the surface

roughness was found to be about 0.382 μm, 0.628 μm, and 1.031 μm, respectively. In addition, the surface roughness of the DLC coating increased by up to 3.8 times as the applied current density used for the hydrogen charging increased. This is considered to be due to damage and delamination of the DLC coating by hydrogen permeation.

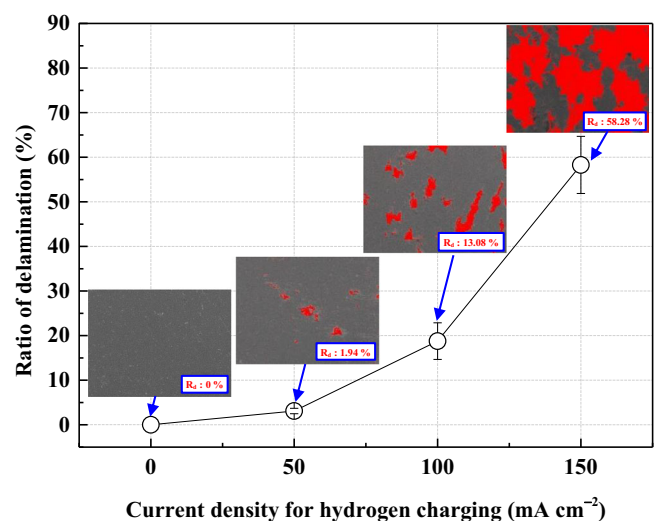
Fig. 5 | The variation of delamination ratio (R_d). Delamination ratio and optical images of damaged DLC coating layer after hydrogen charging (0, 50, 100, 150 mA cm⁻²) for DLC coated 316 L stainless steel.

Figure 5 reveals the delamination ratio of the DLC coating layer after the hydrogen charging, using Image J software. As a result of the calculations, the delamination ratio of the DLC coating with the applied current density of 50 mA cm⁻², 100 mA cm⁻², and 150 mA cm⁻² was 1.94%, 13.08%, and 58.28%, respectively. At an applied current density of 150 mA cm⁻², the delamination ratio was the largest when compared with the other applied current density. In general, the DLC coating layer exhibits excellent hydrogen permeation resistance. However, the delamination of the DLC coating is accelerated because the hydrogen permeation resistance is rapidly reduced from the start point of damage and delamination with regard to the

coating layer. Delaminated DLC coatings can migrate into a fuel cell and cause electrolyte degradation. In severe cases, they can block hydrogen gas piping and valves, making it impossible to supply hydrogen gas to the fuel cell and thereby hindering the operation of the cell. These results may be caused more significantly by hydrogen embrittlement or friction/wear of the material itself, not just the coating. Nevertheless, DLC coatings were chosen for this research because of their relatively high resistance to hydrogen embrittlement and wear. In addition, the DLC coating is considered to have excellent performance as a thin film and will not block the passage of hydrogen gas. Correspondingly, the initial damage and delamination of DLC coatings must be avoided to prevent hydrogen embrittlement.

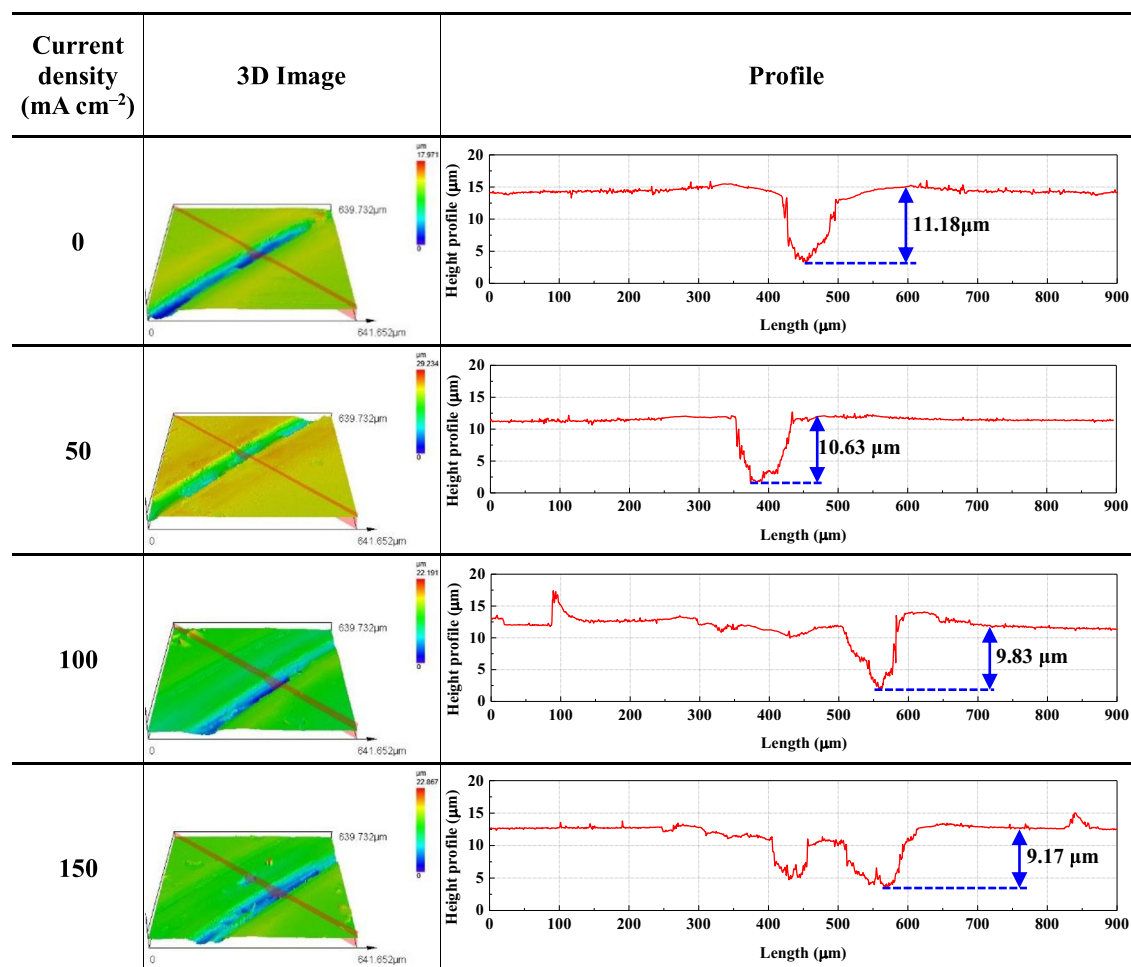
Fig. 8 | The variation of wear track by hydrogen charging. 3D images and profile analysis after friction experiment with hydrogen charging (0, 50, 100, 150 mA cm^{-2}) of DLC-coated 316 L stainless steel.

Figures 8 and 9 present 3D images of the wear tracks and the measurement results of the depth and width of the wear damage observed using a 3D confocal laser microscope. In general, wear products (wear debris, wear particles, etc.) are generated by the work hardening and phase transformation of the contact surface that occurs during friction experiments, which accumulate at the edge of the wear track to form a ridge⁵¹. This shape is one of the main factors that accelerate wear damage, as plasticized parts are peeled off by frictional wear⁵². However, in the case of the DLC coating used in this research, a ridge shape caused by the wear products was not observed. This is thought to be because the surface is not plasticized due to the wear

characteristics of the DLC coating, and as a result, no wear products are formed. In addition, the frictional heat is relatively low, so the tendency toward abrasive wear was more dominant than that toward adhesive wear^{53,54}. As demonstrated in Fig. 9a, the wear depth of the DLC coating without hydrogen charging presented a wear depth of about $11.18 \mu\text{m}$, while the increasing applied current density of 50 mA cm^{-2} , 100 mA cm^{-2} , and 150 mA cm^{-2} resulted in wear depths of $10.63 \mu\text{m}$, $9.83 \mu\text{m}$, and $9.17 \mu\text{m}$, respectively. As the result, the wear depth presented a decreasing trend as the applied current density increased. In this research, to improve the adhesion strength of the DLC coating on the stainless steel, a chromium buffer layer of 60 nm in thickness was first deposited on the stainless steel and then the DLC coating was deposited, meaning that the adhesion strength of the coating was relatively excellent. In general, the coating layer is worn by shear force during friction experiments⁵⁵. In particular, when the DLC coating thickness is reduced by wear, the compressive residual stress and adhesion strength of the coating are both reduced^{56,57}. At the same time, when a shear force stronger than the compressive residual stress and adhesion strength of the coating is applied, the interface destruction between the coating and substrate is accelerated, resulting in damage and delamination of the coating⁵⁸. According to A. A. Voevodin et al., when a contact load is applied to the coating layer with the wear resistance, the strongest shear force is distributed at the interface between the coating and substrate⁵⁹. When the coating thickness is relatively thin, the shear force and frictional heat act more strongly on the substrate to plastically deform it, ultimately causing the adhesion failure of the coating^{60–63}. Therefore, when a strong shear force is applied while a certain adhesion strength is retained due to the wear of the coating, the coating is peeled off and the buffer layer or substrate is

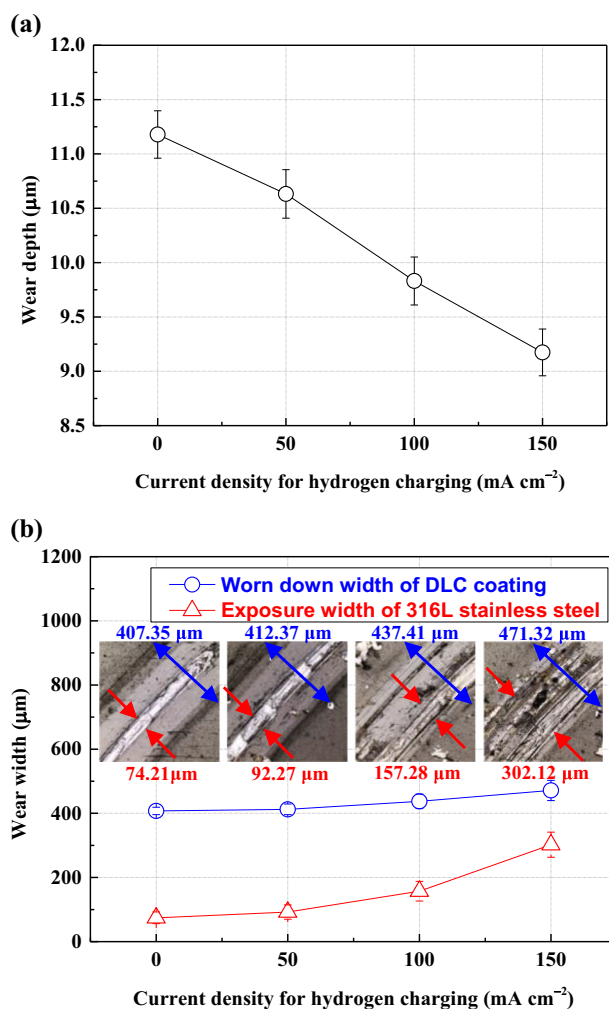
Fig. 9 | The variation of wear degree by hydrogen charging. Wear depth, width, and surface roughness after friction experiment with hydrogen charging (0, 50, 100, 150 mA cm⁻²) of DLC-coated 316 L stainless steel. **a** Wear depth. **b** Wear width.

plasticized and eventually detached, resulting in adhesive wear⁶⁴. This tendency is reflected in the results of this research. However, as described in Fig. 9b, the wear width exhibited a tendency to increase with an increasing applied current density. In particular, the exposed width of the 316 L stainless steel presented a relatively large increase with an increasing applied current density. The exposed width of the substrate at the applied current density of 0 mA cm⁻² and 150 mA cm⁻² was 74.21 μm and 302.12 μm, respectively, which indicated a more than 4 times increase. This is thought to be because the adhesion strength of DLC coating layer and the chromium buffer layer is locally lowered by hydrogen permeation. As a result, the exposed width of the substrate is increased due to partial or complete delamination of the coating by wear damage in a relatively wide range. These results are considered to be due to the following causes. First, the adhesion strength of the DLC coating layer and the chromium buffer layer is locally lowered by hydrogen permeation. Afterward, the coating is partially or completely peeled off by friction to increase the exposed width of the substrate.
