Study on fracture development and progressive failure characteristics of downstream dam-type expansion tailings reservoir

Hongyue Zhang¹, Jiaxu Jin^{1,2,3✉} & Yihong Xu^{4,5}

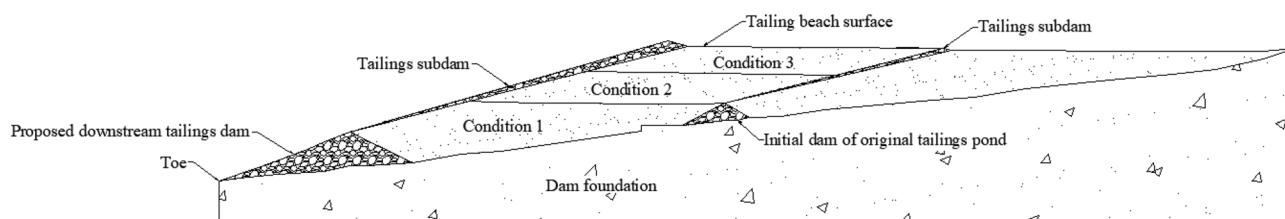
Figure 3. Test models of three working conditions.

In this experiment, three working conditions of a tailings reservoir in Yunnan after expansion were simulated: (1) the tailings beach surface of the new reservoir area reaches the top of the initial dam of the original reservoir pond (Condition 1), (2) the tailings beach surface of the new reservoir area rises to the midpoint of the sub-dam in the original reservoir area (Condition 2), and (3) the beach surface of the new reservoir area comes to the top of the sub-dam in the original reservoir area (Condition 3). After forming the tailings dam model, the dam body surface was compacted with a baffle. The schematic diagram of the working conditions is shown in Fig. 3. Under three working conditions, the tailings are accumulated layer by layer and each layer was compacted in order to simulate the actual working conditions. The load was increased by lifting the test device and for each time, the lifting angle was 1° and the static time was 3 min. The industrial camera recorded in real-time images during the lifting process. The raw tailings were used as the test material, with a dry density of 1.92 g/cm³ and a moisture content of 12.3%. The particle composition is shown in Table 1.

In this study, the FLAC3D software was used to simulate the three working conditions of the expansion tailings pond, and the diagram of the working condition is shown in Fig. 3. The three principal stresses of the composite shear-tension failure criterion in FLAC3D meet:

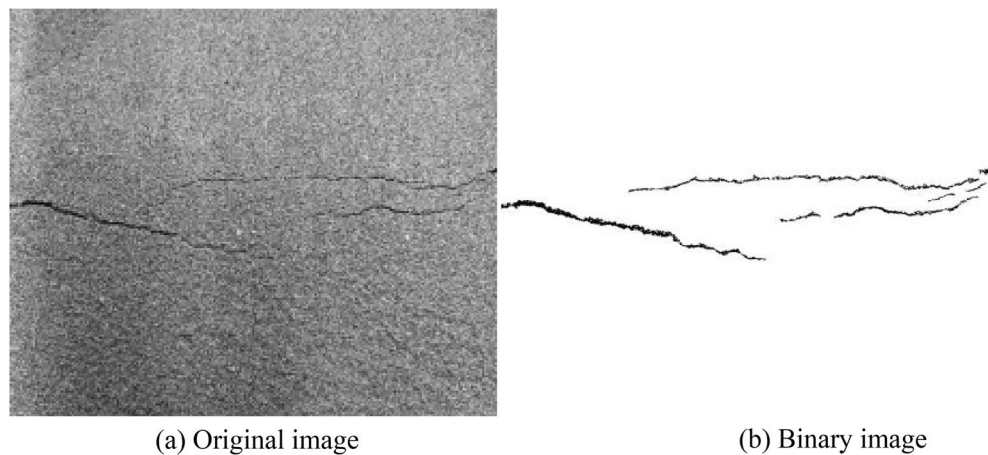
Figure 4. Binarization of tailing sand fracture image.

Quantitative analysis of fractures. The obtained images were grayed and threshold values were segmented by MATLAB software, as shown in Fig. 4. The fracture network can be identified and the geometric characteristics of the fracture can be calculated by the "regionprop" function of MATLAB software. In this experiment, the maximum long axis length and the maximum short axis length of the tailings fracture (the maximum long axis and the short axis length of the ellipse with the same standard second-order central distance in the region) were calculated. Since MATLAB software calculated the geometric characteristics of cracks in the image based on pixels, Photoshop software was used to process the image into a binary image with the same resolution of 220 dpi \times 220 dpi before the calculation, so the width of a pixel was 0.11 mm.

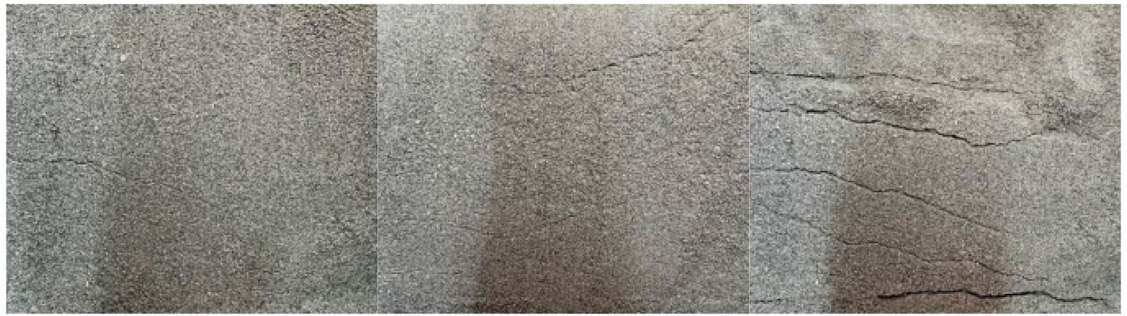
(a) Condition 1: Fracture development in the original reservoir area

Figure 5. Fracture development map under three working conditions.

Fracture development law in the reservoir area. Figure 5 (although the binary image can clearly reflect the development characteristics of fractures, it will cover the differential settlement in the new and original reservoir areas, so the binary image is not used) represents fracture development images under three working conditions. In condition 1, the new reservoir area was covered by sliding tailings when the original reservoir dam was destroyed, and the fracture development of the new reservoir area were not observed. In condition 3, the new and original tailings became a whole, so there was no fracture development in the original reservoir area.

According to the fracture development diagrams of three working conditions, with the increase of the inclination angle of the device, the gravity component of the tailings at the top of the dam increased gradually along the slope direction, and the primary cracks began to appear in the reservoir area. The length, width, and the number of primary cracks were not the same under different working conditions. Under Condition 1, the primary cracks in the original reservoir area initiated at the top of the dam. The cracks grew from the outer boundary to the reservoir area but the further development of cracks was not obvious. With the increase of load, the primary cracks further developed and penetrated the top of the sub-dam. At the same time, the sub-cracks were derived from the stress concentration of the primary cracks, and the sub-cracks grew vertically from the primary cracks to the outer slope of the sub-dam. After the further development of the sub-cracks, the secondary cracks were formed on the outer slope of the sub-dam, which were approximately parallel to the primary cracks. With the emergence of secondary cracks, a small range of landslides occurred on the outer slope of the sub-dam. As the inclination angle continued to increase, collapse failure took place at the top of the sub-dam where the primary fractures were initiated. In the Condition 1, the fracture development and the failure form of the original reservoir area are 'concave' while in the Condition 2, it shows the opposite 'convex' shape. The author believes that the tailings level in the new reservoir area is low, which cannot provide an effective support for the original reservoir area. With the generation of primary and secondary cracks on the surface of the dam body, the retrogressive failure begins to appear. The failure surface is distributed in a 'concave' shape. The collapsed sliding body extends to the reservoir area in a step shape, which eventually leads to the overall failure of the reservoir area. With the increase of the accumulation of tailings in the new reservoir area, an effective pressure slope is formed at the original reservoir area, and the failure form of the reservoir area is transformed into push failure, so the fracture development form and the failure surface are 'convex'.

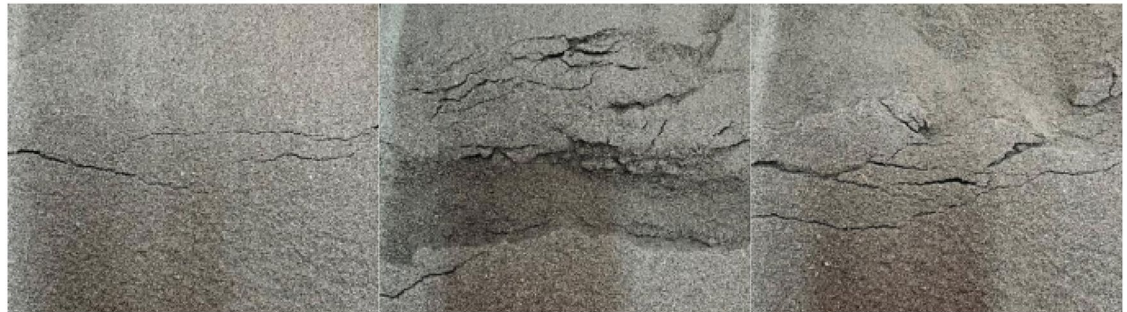
(b) Condition 2: Fracture development in the new reservoir area

Under the Condition 2, the new reservoir area generated cracks before the original reservoir area, and the location and development direction of primary cracks were consistent with those of the original reservoir area under the Condition 1. But differently, the primary cracks in the new reservoir area under this condition were distributed in parallel with multiple branches and almost connected through the whole dam crest. With the

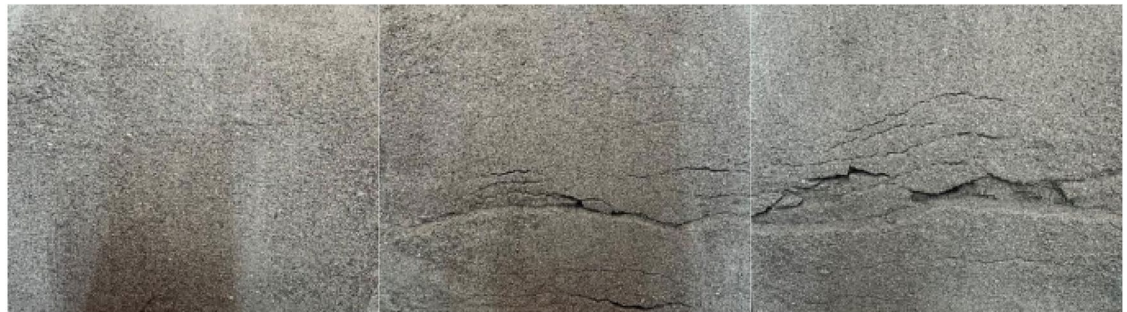
(c) Condition 2: Fracture development in the original reservoir area

increase of the overlying load, the secondary cracks were distributed in a multi-level parallel manner on the slope outside the dam. The generation of primary cracks, sub-cracks, and secondary cracks in the original reservoir in the Condition 2 was roughly the same as that in the original reservoir under the Condition 1. The difference was that the width of primary cracks continued to increase with the increase of load, and the tailings at the edge of cracks deteriorated and collapsed, but the overall sub-dam remained stable. Under the Condition 3, due to the increase in tailings accumulation height, the local collapse failure began to occur after the initiation of primary

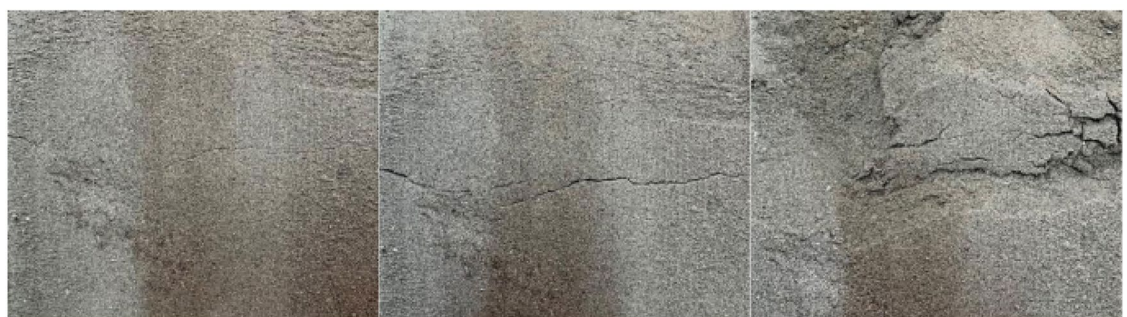
(d) Condition 3: Fracture development in the new reservoir area

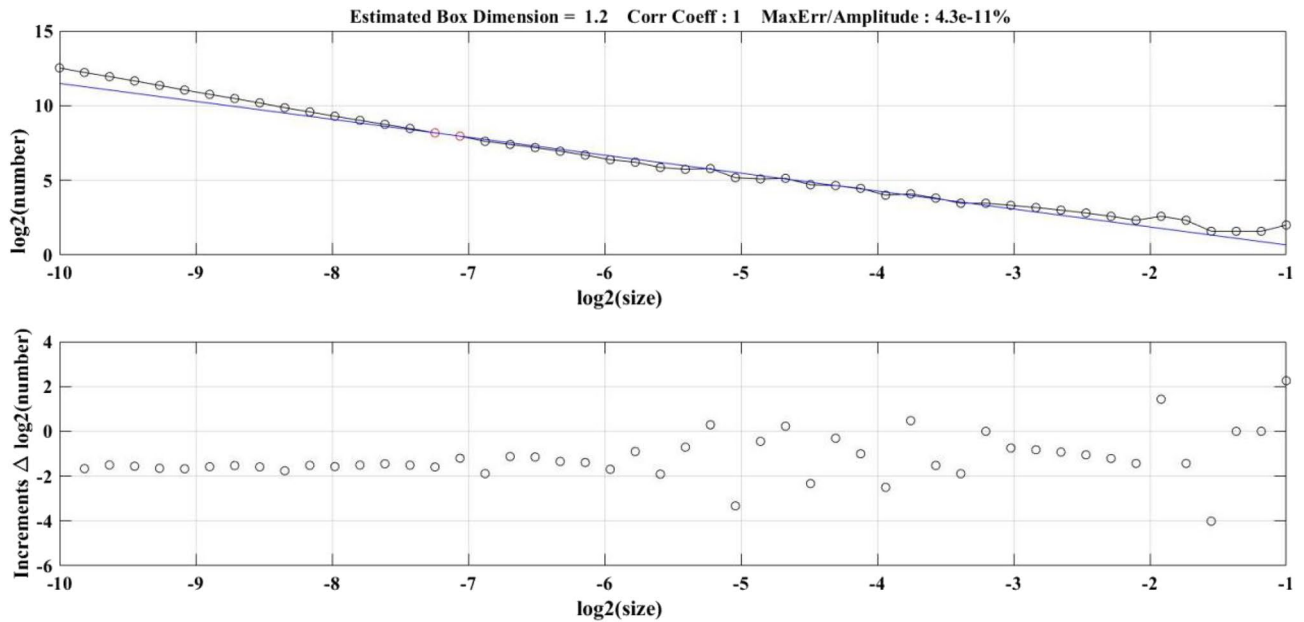
Figure 6. Condition 1: $\log N_\delta(F)$ and $\log \delta$ logarithm images of primary fractures in the original reservoir area.

Figure 6 shows $\log N_\delta(F)$ and $\log \delta$ logarithmic images of primary fractures in the original reservoir area, and the least square method was used to fit them. The fractal dimension of fractures in the original reservoir area was 1.2, the correlation coefficient R^2 was close to 1, and the maximum error was $4.3e-11\%$, which showed that the fractures in the original reservoir area have obvious statistical self-similarity. Figure 7 shows the variation of fracture fractal dimension with the increase of dam height in the new and original reservoir areas under three conditions (the original reservoir dam height is from 5 to 12 cm and the new reservoir dam height is from 12 to 20 cm). When the primary fractures appeared in the new and original reservoir areas under three conditions, the fracture fractal dimension was close to 1, indicating that the shape of primary fractures was similar to a straight line, and with the further development of fractures, the sub-fractures and secondary fractures led to an increase of fractal dimension. Under the Condition 2, the fracture development of the original reservoir area was later than that of the Condition 1, and the fracture development was more regular. This paper analyzed the back pressure slope formed at the original reservoir area with the gradual accumulation of tailings in the new reservoir area, which enhanced the stability of the original reservoir area.

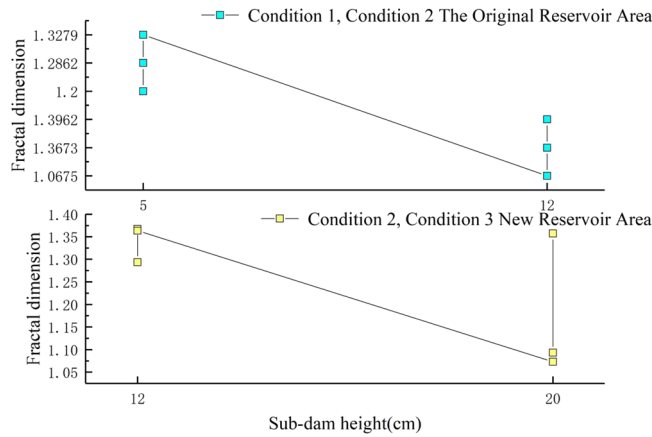
Figure 7. Fractal dimension of new and original reservoir fractures under three working conditions.

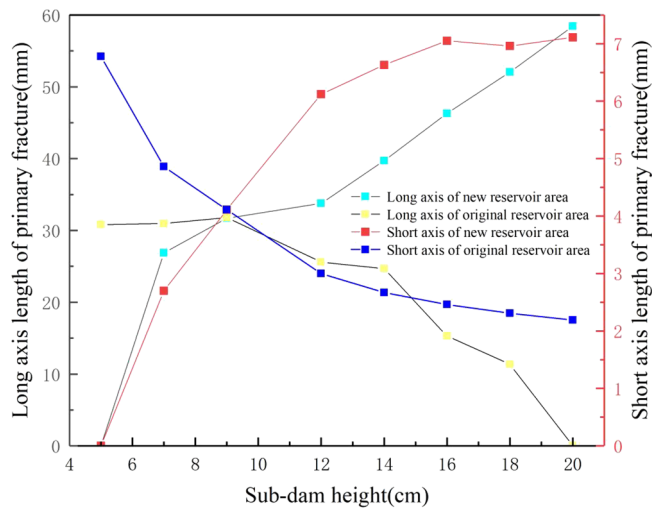
Figure 8. Accumulation height of the new reservoir area and geometric characteristics of primary fractures in the new and original reservoir areas.

reservoir area, five groups of tailings accumulation heights in different new reservoir areas were added under three typical working conditions, and each group was tested three times. The average length of primary fractures and short axis length calculated by MATLAB software were taken. The stacking height of the new reservoir area and the geometric characteristics of the primary fractures in the new and original reservoir areas are shown in Fig. 8. With the increase of the accumulation height of the new reservoir area, the length of the long and short axes of the primary fractures in the new reservoir area showed an overall increasing trend, and the increase rate of the short axis was significantly higher than that of the long axis. The increase rate of the long axis was 117.4%, and that of the short axis was 163.3%, indicating that with the accumulation of tailings, the length and width of the primary fractures in the new reservoir area significantly increased, and the increase rate of the width was higher. The long and short axes of primary fractures in the original reservoir area showed a decreasing trend. The long axis decreased from 30.81 to 11.37 mm, with a decrease of 63.1%. The short axis decreased from 6.78 to 2.19, with a decrease of 67.7%. There was little difference in the decrease rate. The decreasing trend of the long and short axes of the primary cracks in the original reservoir area can be verified with the "back pressure slope protection" below. It is precisely the increased height of the accumulated tailings in the new reservoir area that inhibits the initiation and development of the cracks in the original reservoir area. However, corresponding reinforcement measures were not taken in the new reservoir area. With the accumulation of tailings, the trend of fracture development is more intense. Therefore, it is suggested that the tailings reservoir with downstream dam expansion should be used to reinforce the dam body in the new reservoir area, which can effectively improve the stability of the tailings reservoir.

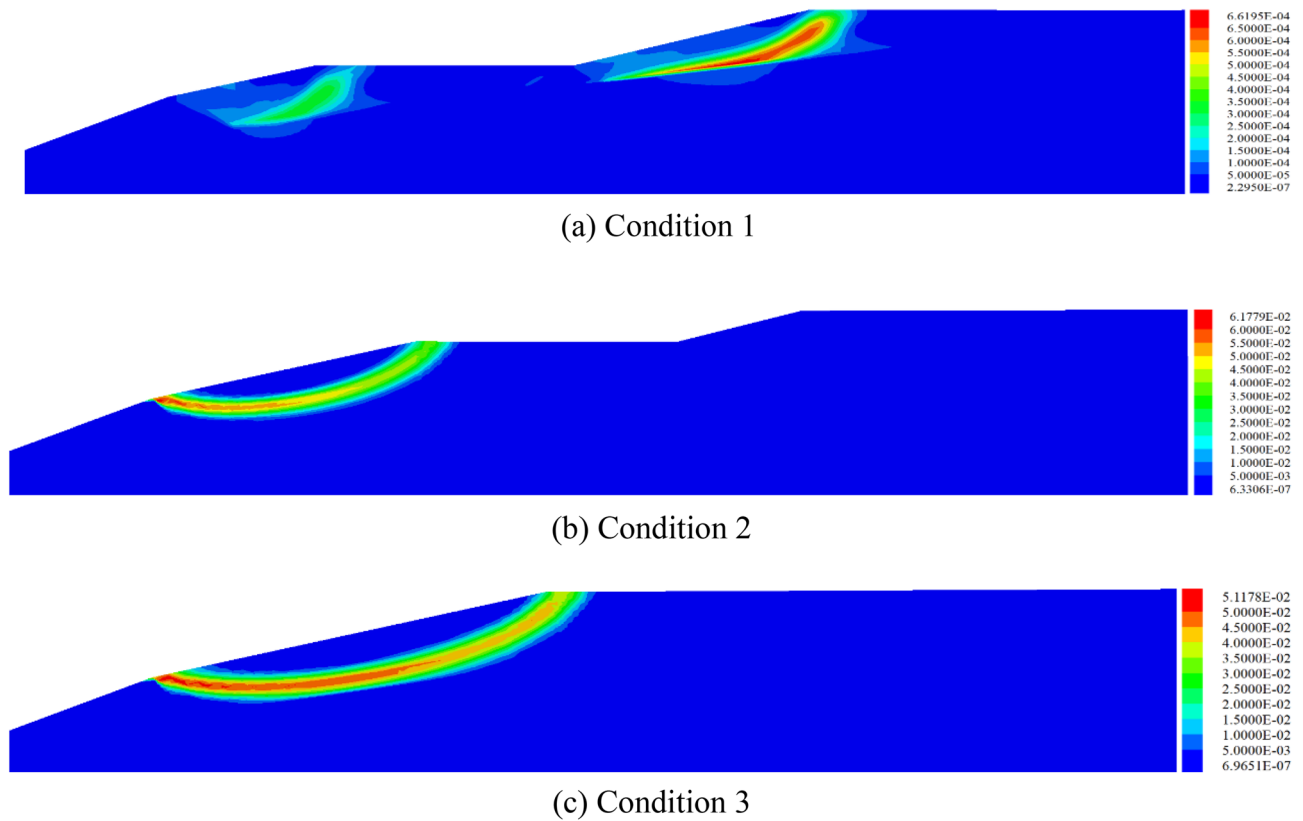
Figure 10. Distribution of the maximum shear stress in the reservoir area.

Tension-shear failure. Combined with the distribution characteristics of maximum shear stress and tensile plastic zone in reservoir area in Fig. 10, the progressive failure of the tailing dam can be characterized as: (1)

the maximum shear stress is generated at the slope toe or the initial dam crest, (2) and then extends to the crest of the sub-dam in the form of a curve, and (3) finally forms the failure shear surface by connecting with the primary fracture in the tensile plastic zone at the crest. From the maximum shear stress distribution, it can also be seen that under Condition 1, the instability failure of the reservoir area is the result of combined action of shear and tension failure. With the accumulation of tailings in the new reservoir area, the shear failure of the reservoir area will gradually become the dominant type. This is because, in the early stage of tailings discharge, the height of the reservoir area is low, the slope toe is small, and the anti-sliding force of the tailings in the reservoir is much larger
