# Case study on long-term deformation monitoring and numerical simulation of layered rock slopes on both sides of Wudongde dam reservoir area

**Keywords** Slope deformation monitoring, High steep layered slope, Numerical analysis, Long-term stability

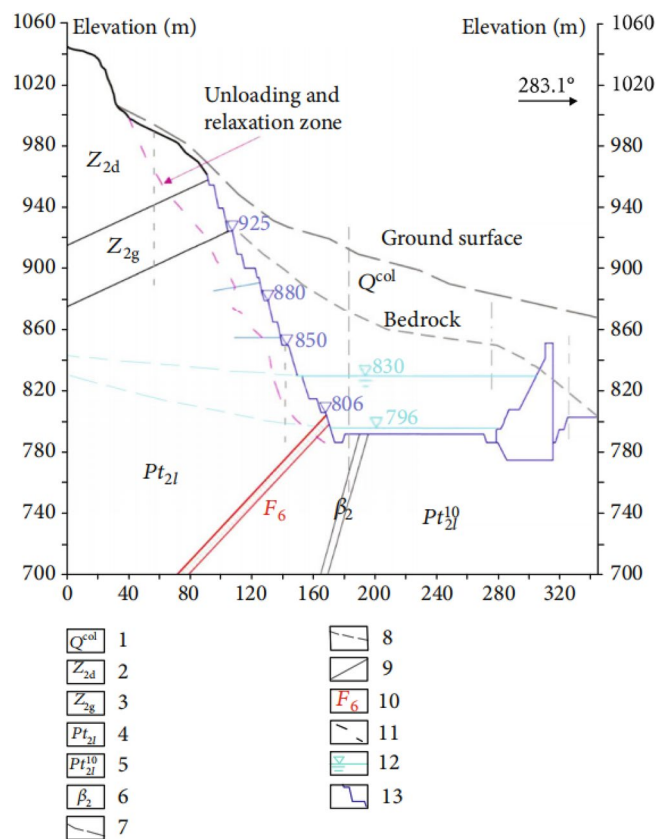
**Figure 1.** Typical engineering geological section of the left side slope. 1: collapse accumulation 2: gray to light gray thick gray dolomite of the Dengue Formation; 3: gray thin-layered dolomite sandwich and ultra-thin shale of the Guanyin Rock Formation; 4: gray thin-layered dolomite (specifically, the strata of the Falling Snow Formation downstream of the Huashangou Fault on the left bank); 5: gray rock with thin lime layer 6: gabbro 7: original topography 8: bedrock surface 9: lithologic boundary 10: faults and number; 11. Lower limit of artificial side slope slack zone 12: Groundwater table line 13: Design excavation line.

The part of the left side slope of the spillway outlet of Wudongde Hydropower Station with elevation greater than 1070 m is the natural exposed rocky slope side slope, with elevation 1070–1850 m as a steep slope, with an average inclination of 55°. The area below 1070 m elevation is an artificial excavation area, and the side slope before excavation is the gentle slope formed by Huaquan Gou deposit, with inclination of 10°–35°. The artificial side slope structure is transverse side slope, the highest elevation line is about 1070 m. The excavation elevation of the water cushion pond foundation corridor is 786.5 m, and the excavation height of the artificial side slope is about 183.5 m. The excavation of the first phase of the flood cave outlet started in June 2012 and ended in March 2014, mainly excavated to an elevation of 850 m. The excavation of the second phase started from March 2015 to May 2016, mainly excavated to the elevation of 830 m. The third phase excavation project from December 2016 to April 2017, mainly for the remaining part of the water cushion pond, tail channel and drainage channel, has been excavated to the bottom elevation 806 m, local excavation to elevation 796 m. In June 2017, the artificial side slope blasting excavation was completed, and the flood cave water cushion pond storage began. The typical excavation geologic profile of the slope on the left side of the spillway tunnel exit is shown in Fig. 1.

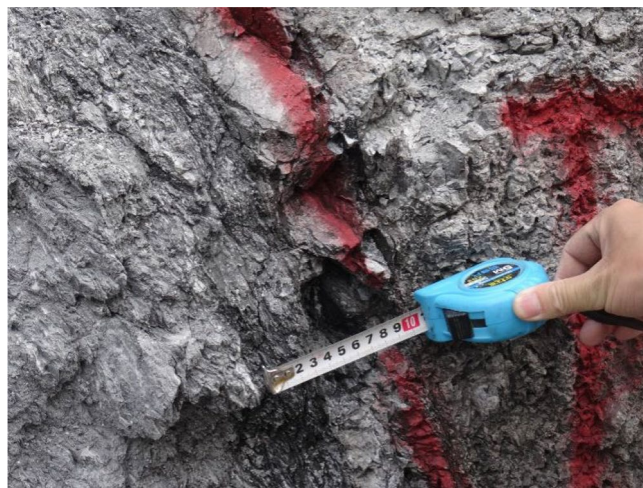
**Figure 4.** Rock cracks during slope excavation.

The main engineering geological defects exposed during the excavation of the slope included blockwork, fractures outside the slope, the Huashangu fault (F6), and poor rock masses. A total of 33 cracks were found on this slope, of which only 6 were rock deformation cracks (see Fig. 4), which were found in late April 2014 and mid-June 2016, respectively. These rock deformation cracks are all located in the local ridge-like prominence above the opening line downstream of the F6 fault, with rough fracture surface, extension length of about 10 m, crack opening width less than 4 cm, and depth less than 0.4 m, all extending into the subsurface rock mass. The causes are mainly related to the slope relaxation and deformation. The remaining 27 cracks are all shotcrete cracks, mainly distributed on the stripped slope and engineered slope surface near the F6 fault, with rough crack surfaces, visible extension lengths less than 12 m, crack opening widths less than 4 cm, and maximum visible depths less than 0.1 m. They are only exposed to the shotcrete, but do not extend into the rock mass. The reasons are mainly related to the shrinkage of concrete, temperature changes and other factors.

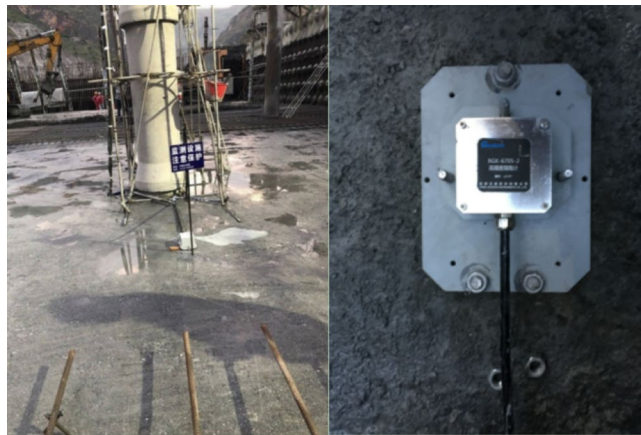
**Figure 5.** Displacement monitoring device.

During the construction of the left bank slope, there were two cases of steep increase in rock deformation and surface deformation, which aroused great concern. It is necessary to grasp the deformation of the slope and the force of the support structure during the period through on-site monitoring, effectively determine the deformation law and characteristics of the slope, analyze the factors that cause the change of the monitoring volume, so as to dynamically guide the program development, excavation construction and support. The project slope deformation monitoring adopts the multi-point displacement meter of model YT-DG-0600 series produced by Changsha Yito Monitoring Instruments Co., Ltd. Each set of equipment consists of multiple displacement meters, installation base, extension transfer rod, anchor head, etc. The resolution is 0.01 mm. The device has high accuracy and stability, and can be used for long-term observation by manual reading or automatic collection. The displacement meter shell of this project is made of stainless steel, waterproof and moisture-proof, and can resist high water pressure, and can be equipped with stainless steel mounting accessories, which can be used for long-term health monitoring under corrosive or other harsh environments, and the appearance of the displacement equipment is shown in Fig. 5.

This project adopts a multi-point displacement meter composed of a multi-branch displacement meter, an installation base, a lengthened transfer rod and an anchor head, which are respectively installed in the parts of the mountains on both sides that need to be monitored to monitor the apparent displacement of the slope. The position of the monitoring point is appropriately adjusted according to the actual conditions of the site; the data are collected once every 30 days, and the transmission module connects the server to transmit the displacement monitoring data to the data acquisition center. Terminal data query, data analysis, when the deformation rate

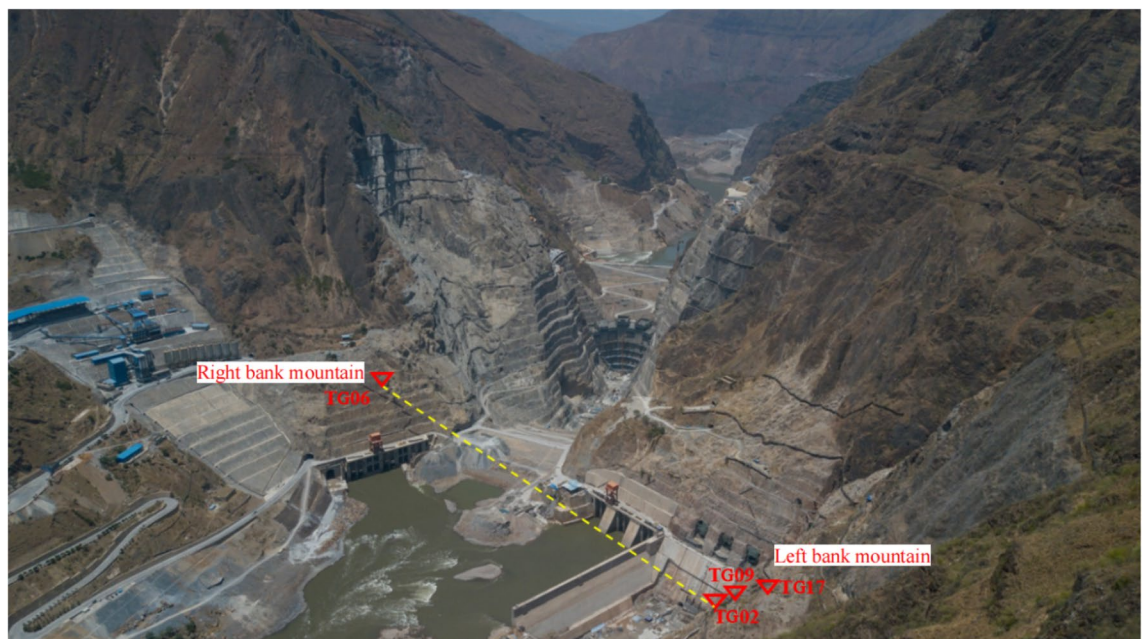
**Figure 6.** Distribution of mountain valley deformation monitoring points on both sides of water cushion pond in flood tunnel.

While the Wudongde Hydropower Station is under construction, from June 2015 to March 2019, the construction unit established displacement monitoring points in the area with an elevation of more than 1070 m on both sides of the outlet of the spillway tunnel (for the unexcavated natural mountain part), numbered TG06, TG02, TG09 and TG17, respectively, to monitor the valley deformation in the reservoir area through the mountain displacement. The arrangement of the mountain displacement monitoring points on both sides of the spillway tunnel is as follows: the right bank elevation of the survey point TG06 is 1088 m, the left bank survey point TG02 is 1088 m, the left bank survey point TG09 is 1175 m, and the left bank survey point TG17 is 1235 m. Due to the different construction environment and conditions, the installation and recording time of the valley deformation monitoring points on the left and right sides are different. The data are recorded manually, and the recording interval is about 30 days. Affected by the site construction progress and other factors, the TG17 monitoring site was installed in 2015, and TG06, TG02 and TG09 were installed in 2016, so the time span of the data is inconsistent. The layout of monitoring points for the natural slope of the mountains on both sides of the Wudongde dam is shown in Fig. 6. Since 2013, six deformation monitoring sections have been arranged on the left side of the artificially excavated slope at the outlet of the spillway tunnel, 17 sets of multi-point displacement meters (numbered at the beginning of M) have been arranged and implemented to monitor rock mass deformation, and 16 apparent monitoring piers (numbered as TP or TN) have been arranged and implemented. Seventeen sets of borehole multi-point displacement meters are uniformly distributed in the lower reaches of F<sub>6</sub> fault, among which 11 sets are arranged between F<sub>6</sub> fault and the trailing edge slope of 850 m concrete system, and 6 sets are arranged in 850 concrete system trailing edge slope. Fourteen apparent monitoring piers are uniformly distributed in the lower reaches of F<sub>6</sub> fault, 11 between F<sub>6</sub> fault and the trailing edge slope of 850 m concrete system, and 3 between 850 concrete system trailing edge slope. However, due to the influence of on-site construction and other factors, as of July 2019, only 11 sets of multi-point displacement meters and 14 sets of apparent monitoring piers have been effective. The arrangement of effective monitoring points on the left bank slope of the Wudongde dam spillway tunnel is shown in Fig. 7.

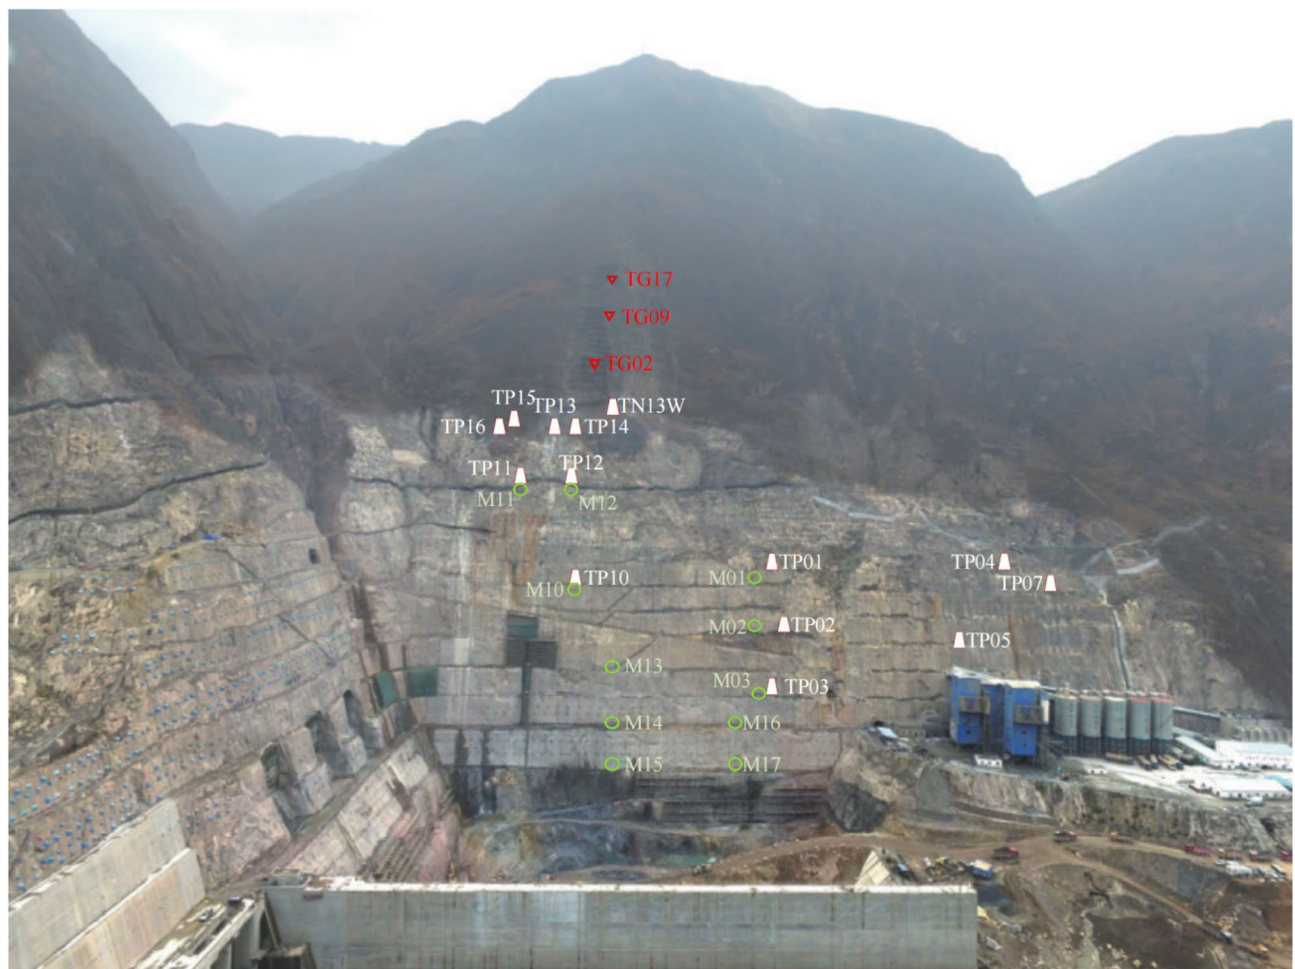
**Figure 7.** Distribution of effective monitoring points on the left bank slope.

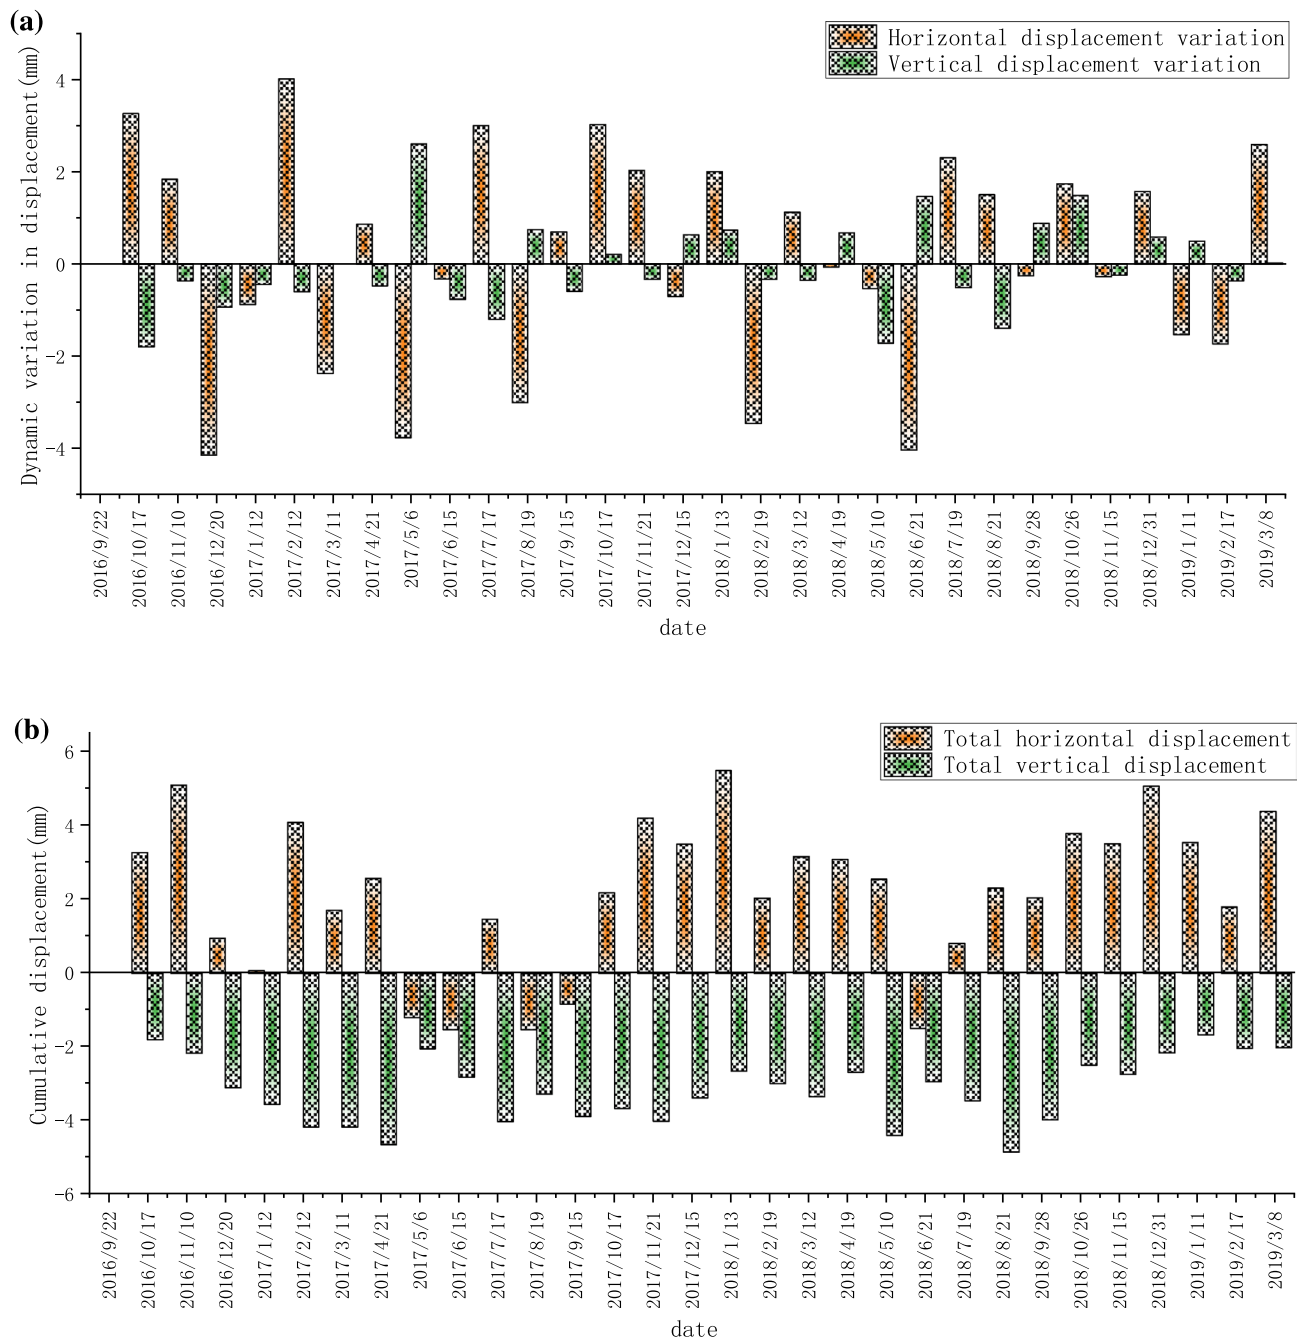
**Figure 8.** Data recording at the monitoring point TG06 located on the right bank: **(a)** Monthly displacement; **(b)** Monthly cumulative displacement.

Due to the overall displacement value of the slope on both sides of the spillway cave water cushion pool is small, the time interval of all the monitoring points to record data is about 30 days (1 month). The right bank was monitored from October 2016. The monthly dynamic variation and cumulative deformation of TG06 are shown in Fig. 8a,b, respectively, where positive horizontal displacement indicates deformation toward the valley frontage

and positive vertical displacement indicates deformation toward the valley bottom. From the monitoring data, it can be seen that both the total horizontal displacement and the total vertical displacement fluctuate to some extent, but their trends are stable, and there is no obvious deformation in both horizontal and vertical directions of the right bank mountain, and the maximum accumulated deformation in the horizontal direction is about 5.5 mm, and the maximum accumulated deformation in the vertical direction is about 3.8 mm (toward the top of the mountain), and the monthly dynamic changes also mainly vary smoothly above and below the zero value.

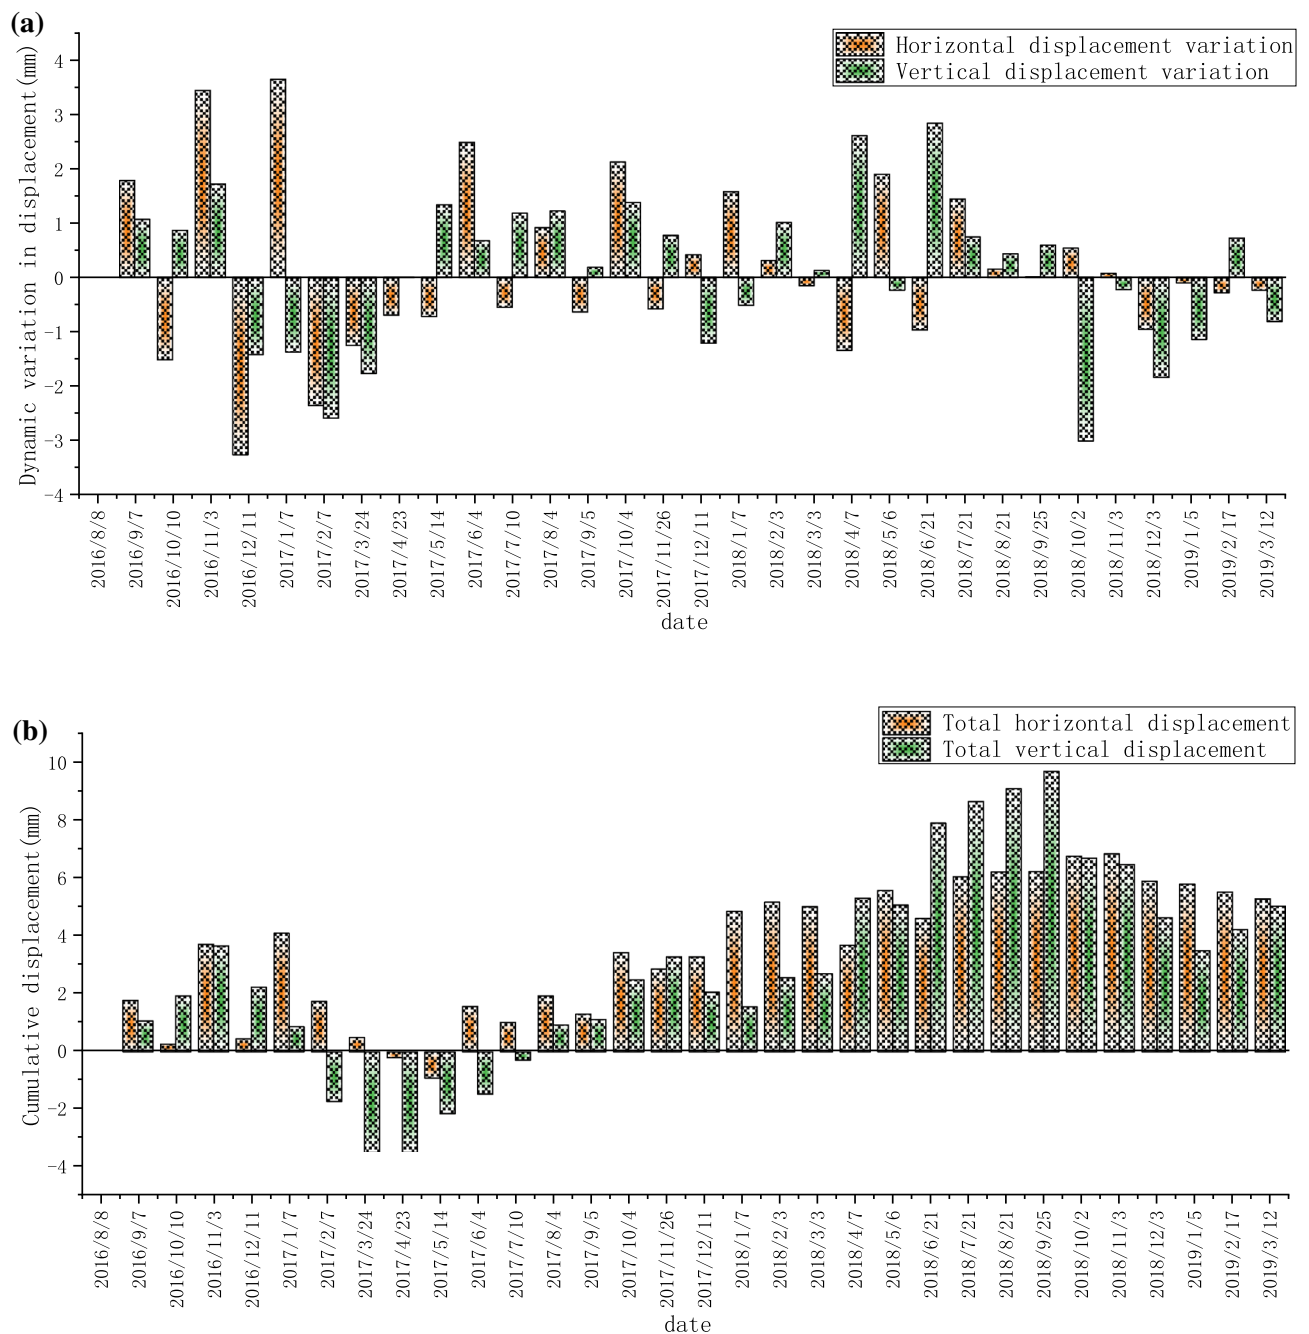
**Figure 10.** Data recording at the monitoring point TG09 on the left bank: (a) Monthly displacement; (b) Monthly cumulative displacement.

The left bank has been monitored since June 2015, and the monthly dynamic and cumulative displacement data of TG02 are shown in Fig. 9a,b, respectively. The monthly dynamic displacement and cumulative displacement data of TG09 are shown in Fig. 10a,b, respectively. The monthly dynamic displacement and cumulative displacement data of TG17 are shown in Fig. 11a,b, respectively. Due to the complexity of the geological environment and the construction site, the displacement data of the three monitoring points do not reflect an obvious consistent response law, and whether in the horizontal or vertical direction, the occurrence time of the maximum displacement is different. The cumulative deformation of the three monitoring points on the left bank is summarized in one data chart, of which only TG17 is in normal operation from June 21, 2015 to September 7, 2016. The horizontal and vertical displacements are shown in Fig. 12a,b, respectively.

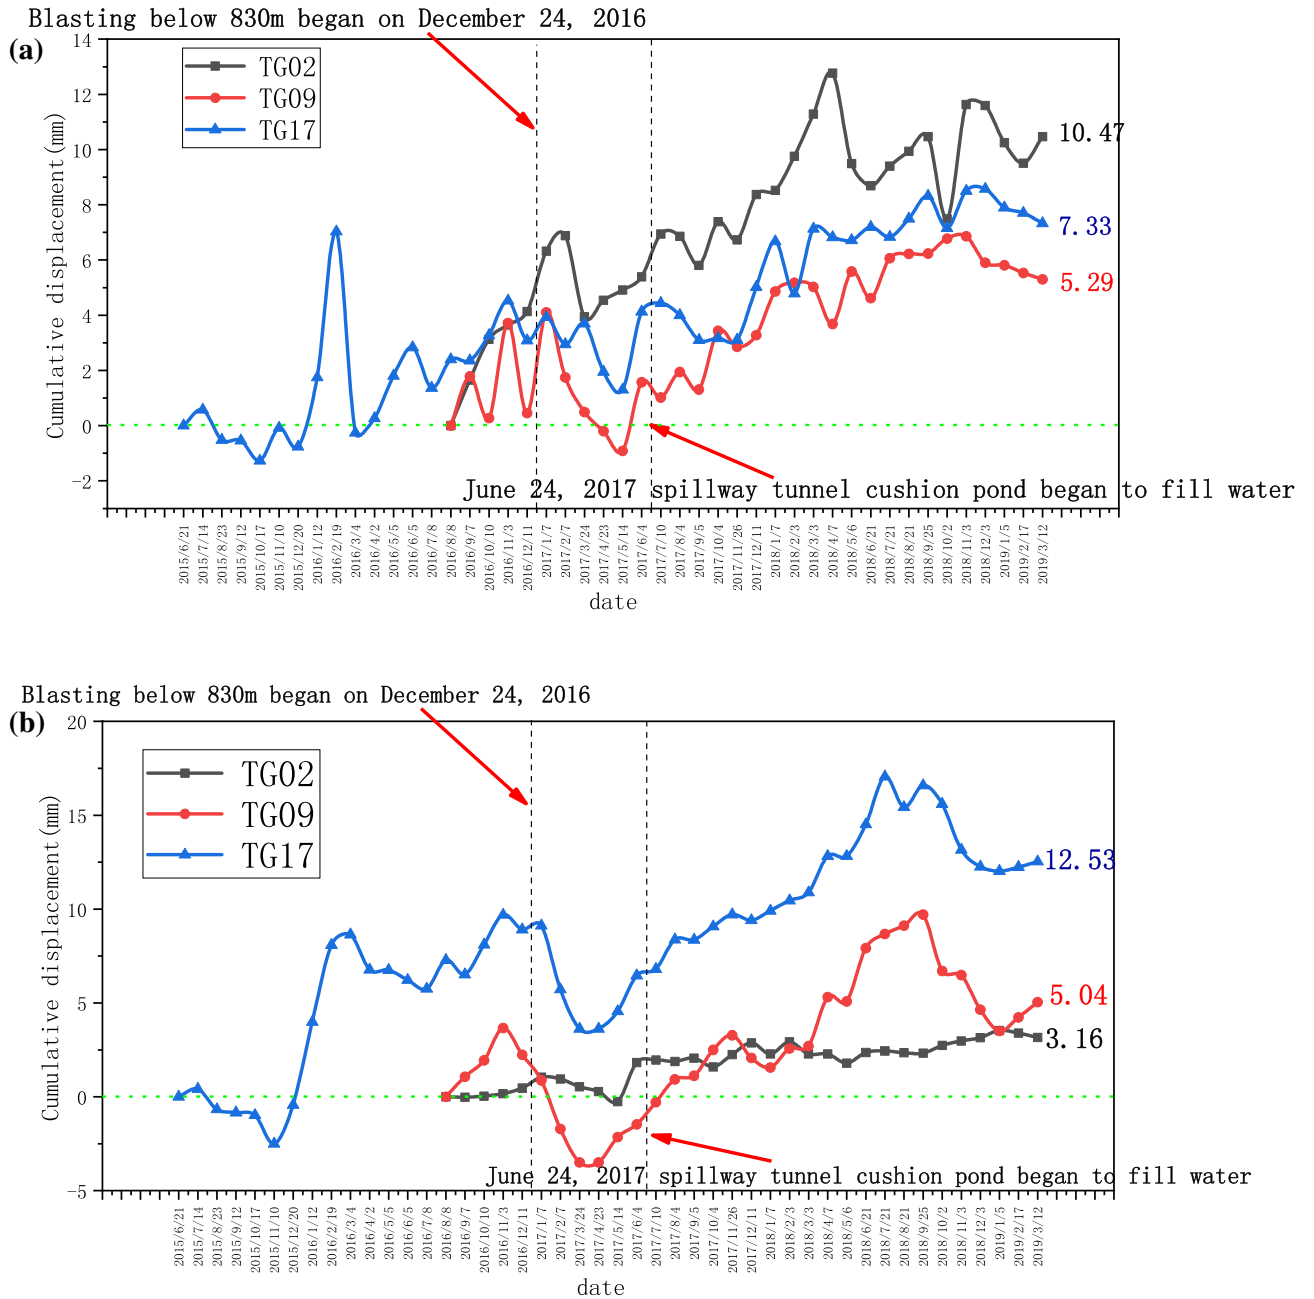
**Figure 12.** Comparison of cumulative displacement changes of TG02, TG09 and TG17 at monitoring points on the left bank: (a) Cumulative displacement in horizontal direction; (b) Vertical cumulative displacement.

The accumulated deformation in the horizontal direction was most significant at the minimum elevation of TG02 (1088 m) and the accumulated deformation in the vertical direction was most significant at the maximum elevation of TG17 (1235 m). By observing the changes of horizontal and vertical cumulative deformation, it is found that after the water cushion pool of the spillway tunnel starts to fill with water, it has more influence on the

deformation of the mountain than that of the blasting construction. For the horizontal direction, the cumulative deformation did not produce significant abrupt changes at the three monitoring sites after the blasting construction started on December 24, 2016; however, the cumulative deformation of G09 and G17 increased abruptly after the water filling started on June 24, 2017. For the cumulative deformation in vertical direction, the trend of abruptness increase after water filling is more obvious. This law corroborates with the laws expressed in other literature<sup>37–39</sup>, and a reasonable explanation is that the rise of water level causes the shift of fracture water pressure in the geotechnical body at the bottom of the slope, which in turn affects the stability of the bank slope. It is also noteworthy that the high and steep slopes in the study area exhibit significant stratification, while the seepage characteristics of the Layered geotechnical slope differ from those of the homogeneous slope. The integrity of the geological body will become poor after stratification, and the parting interfaces, joints, and fracture zones between different geotechnical units will easily become channels for groundwater and rainwater seepage from inducing landslides and collapses<sup>16,40</sup>. After the flood cave water cushion pond is filled with water, the high and steep layered slope may lead to a wide range of fluctuation of safety factor under the joint action of pond water, groundwater and rainwater, when the mountain is more prone to deformation. The law that the fluctuation of the water level of an impoundment aggravates the contraction and deformation of the valley has also been confirmed in additional engineering cases<sup>26,27,41</sup>. The famous Vajont dam landslide is entirely caused by the impoundment of the reservoir, which occurred in the third year after the impoundment of the reservoir<sup>25</sup>. However, some scholars<sup>42</sup> proposed that when the valley amplitude deformation at the top of the water cushion pool is less than 50 mm, the safety of the seamless structure water cushion pool can be controlled, and water storage can reduce the influence of valley amplitude deformation on the adverse stress of the water cushion pool structure.

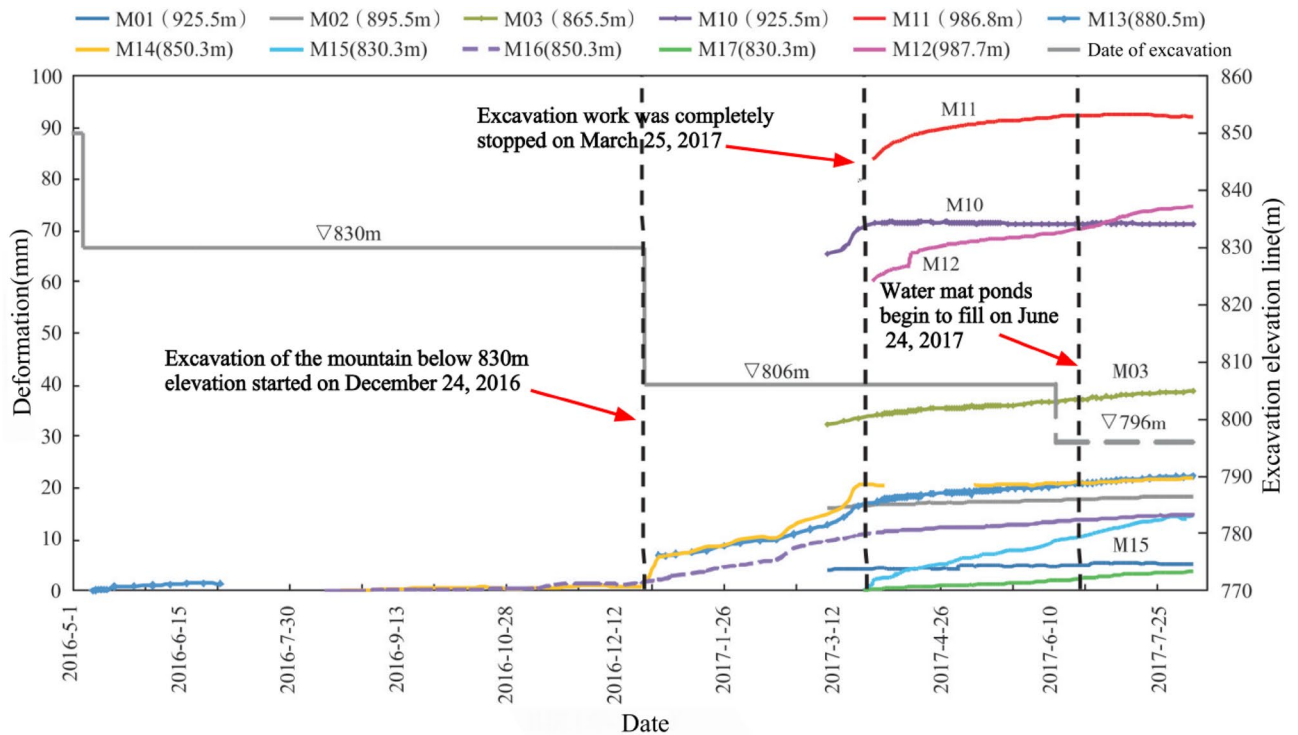
**Figure 14.** Relation curve between hole deformation and excavation process of multi-point displacement meter.

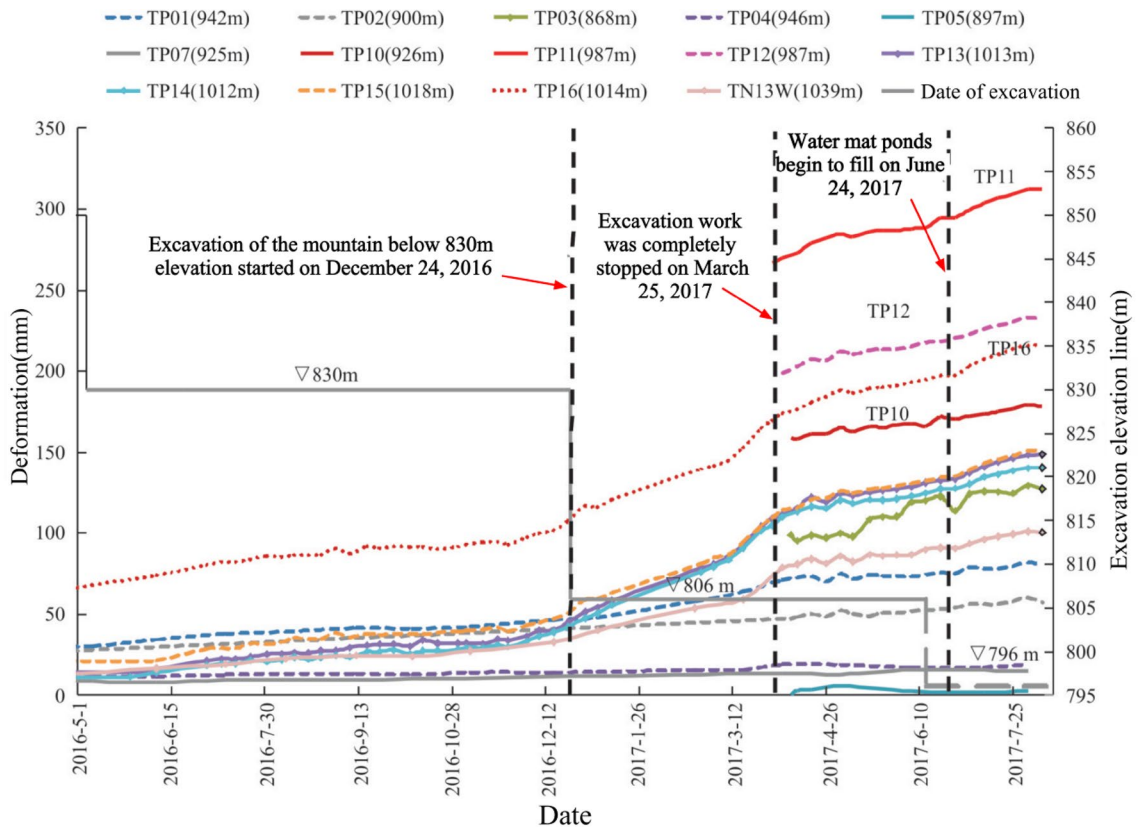
**Figure 15.** Relationship between total deformation of surface monitoring and excavation process.

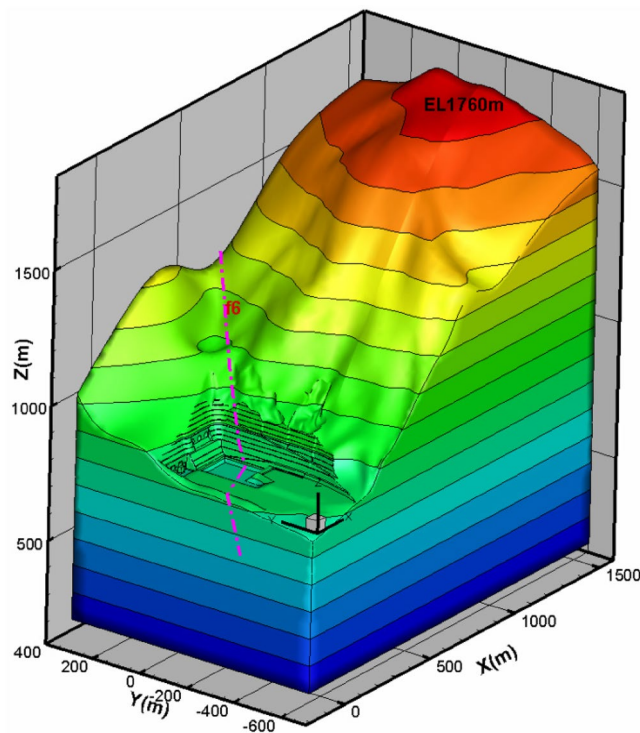
**Figure 17.** Three-dimensional numerical model of the left bank slope of the spillway tunnel.

Due to the deformation generated by self-weight, long-term creep, and excavation, rebound deformation, i.e. deformation toward the river valley, will occur. Taking the slope with large deformation (mountains on the left) as the object of study, which is located at the left hand side of the exit of the spillway tunnel, a three-dimensional layered geological generalized model of the whole left bank slope was established by FLAC<sup>3D</sup> software according to the preliminary detailed engineering survey, combined with topographic and geological data, and the numerical model of the whole hill is shown in Fig. 17, and the boundary conditions of the model are set: three-way constraint at the bottom, horizontal constraint on several sides of the model directional constraints. After the model is established, the self-weight condition (i.e., the applied gravity field) will produce deformation to simulate the valley deformation (horizontal direction) generated by the slope in the actual project. If there is rainfall and earthquake on the applied physical field, of course, they will also affect the model deformation, but this situation needs to be analyzed additionally and are not considered in this paper. This paper considers the natural self-weight deformation and excavation rebound deformation under the action of long-term gravity field.

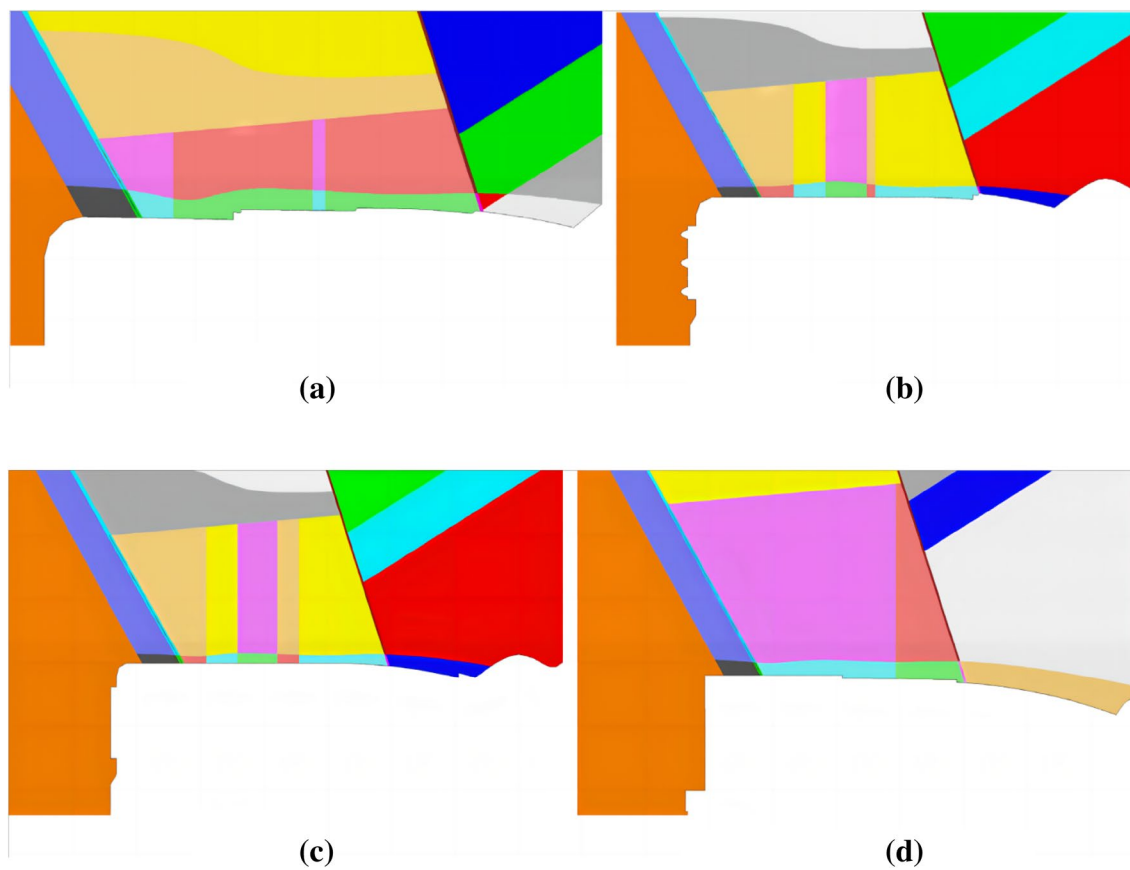
**Figure 19.** Horizontal section diagram of numerical calculation model of layered slope: (a) Elevation 895m; (b) Elevation 865m; (c) Elevation 850m; (d) Elevation 828m.

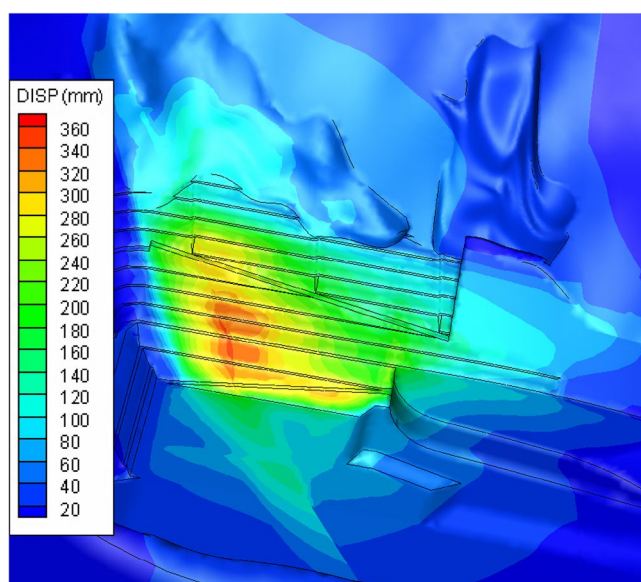
**Figure 20.** Total displacement cloud of slope.

The network cloud diagram of the overall total displacement of the slope is shown in Fig. 20. The depth of the plastic zone of the slope is 40–50 m, and the rock body of the slope shows a downward deformation trend toward the outside of the slope. When FLAC<sup>3D</sup> software performs iterative calculation, the rock mass strength is continuously reduced until the slope is in an unstable state, and the calculation does not converge at this time, and the reduction coefficient at this time is the slope stability coefficient. In addition, the iterative reduction process of shear strength can be used to analyze the progressive failure process of slope. Combined with the characteristics of the finite difference procedure, according to the convergence criterion of the characteristic points and the displacement trend, it is determined that the safety coefficient of the slope is about 1.3, which meets the construction safety standard. During the construction process on site, the manual excavation causes the shallow surface of the slope to be affected to a certain extent and produces the unloading relaxation effect, and the shallow surface displacement is larger and shows a gradually decreasing trend. Because F6 is at the reverse slope, the bottom of the upper slope is "reverse" structure, and the slip force of the upper slope forms an obtuse

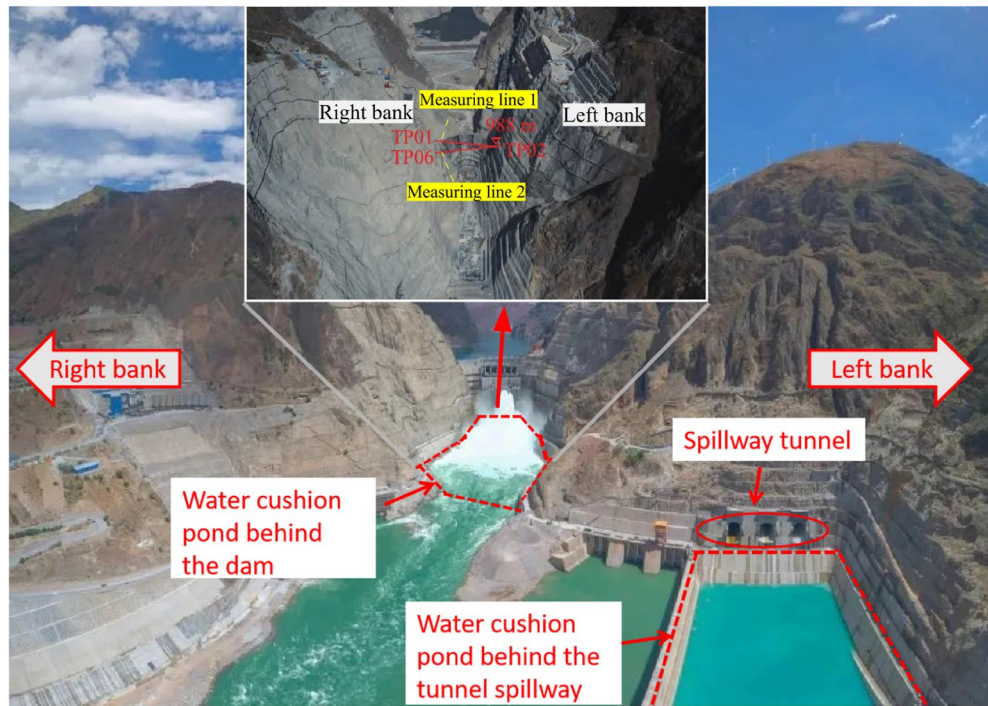
Figure 21. Location of water cushion ponds on the back side of the dam.

The horizontal spacing between the left and right sides of the hill of the water cushion pond at the outlet of the flood cave is too large, which is not conducive to numerical modeling, and it is difficult to accurately estimate the deformation and displacement of the slopes of the river valley on the left and right sides of the water cushion pond of the flood cave by only relying on the monitoring points. Meanwhile, the horizontal spacing between the side slopes on both sides of the water cushion pond at the back side of the dam is small, as shown in Fig. 21. The construction organization also arranged three sets of displacement monitoring points at the left and right ends of the vertical surface of the central course of Jinsha River. Combining the numerical simulation method with the field deformation monitoring, the deformation of the high side slopes on both sides of the water cushion pond behind the dam was compared and analyzed. The displacement diagram of the established numerical simulation model along the X direction is shown in Fig. 22a and b; the superposition of the absolute values of the slope deformation of the left bank and the right bank sloping toward the valley (i.e., the forward direction) is the valley deformation. In the numerical simulation of the water cushion pond behind the dam, the creep time is set through the creep command after the elastic–plastic calculation, and the creep time is referred to the real monitoring time on site. In this case, a total of 31 months between June 2016 and March 2019 were the actual monitoring time of the actual displacement on both sides, and 19,100 time steps were experienced in the elastic–plastic calculation using FLAC<sup>3D</sup> software. At this time, the creep simulation calculation time is about 31 months, which can correspond to the actual deformation time of the water cushion pond slope behind the dam.

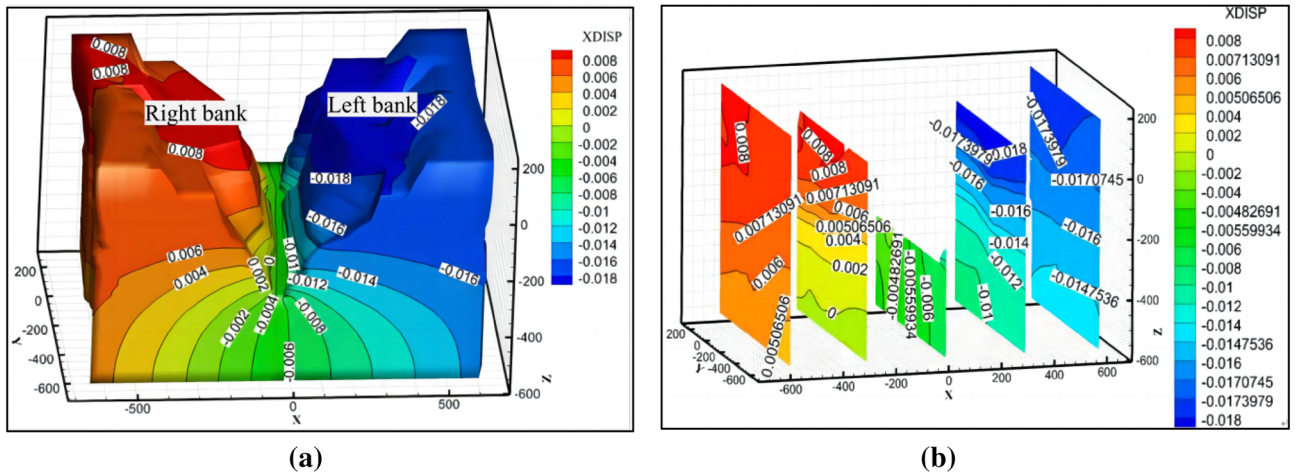
Figure 22. Numerical calculation model of water cushion pond on the back side of the dam: (a) Cloud image of model displacement in the X direction; (b) Sectional-plane cloud image of displacement contour line in the X direction of the model.

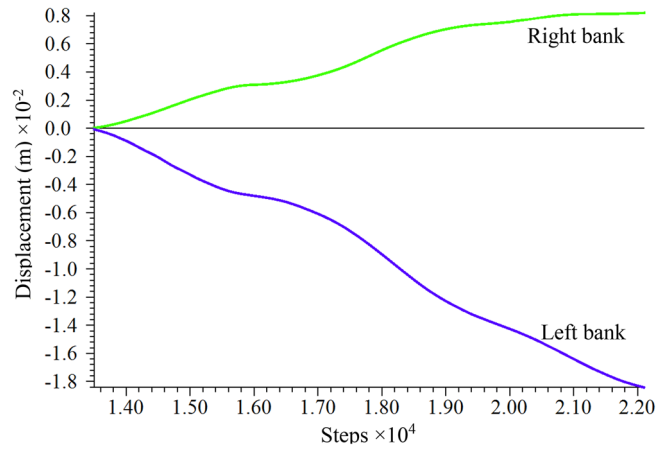
**Figure 23.** Horizontal displacement curve of 990 m elevation on the left and right bank.

Comparing the calculated values of horizontal deformation of the left and right bank measurement points (990 m) obtained from numerical simulation, as shown in Fig. 23, the right bank deformed toward the valley with positive displacement values, and the left bank also deformed toward the valley with negative displacement values. The absolute values of the two deformations were superimposed toward the valley direction to obtain the change curve of the calculated values of valley deformation and compared with the measured values of the two measurement lines (measurement line 1 and measurement line 2) monitored by the water cushion pool behind the dam at the same elevation position, as shown in Fig. 24. Where the valley deformation, positive

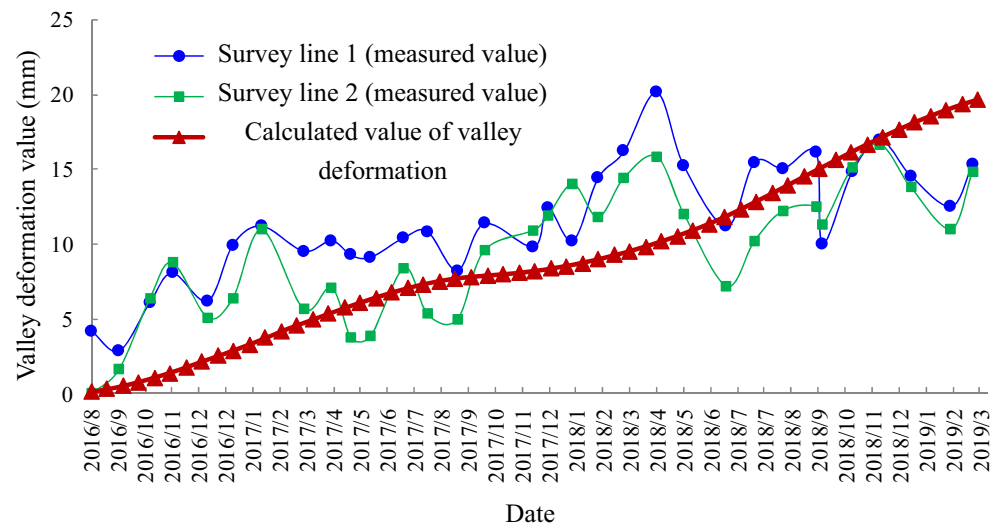
**Figure 24.** Comparison of field measurements and calculated valley deformation values (990 m post-dam water cushion pool elevation).

values are contraction and negative values are expansion. The comparison shows that there is a certain volatility in the field monitoring of valley deformation data; however, the overall rising trend of displacement of both measurement lines is consistent with the change of simulation results. The valley deformation, both numerically calculated and measured, did not exceed 20 mm. The absolute values at 900 m above sea level behind the dam were superimposed to obtain the variation curve of the calculated values of the valley and compared with the measured values of the valley measurement line 3 at the site elevation of 907 m, as shown in Fig. 25. Since the on-site monitoring of Line 3 started in December 2017, while the calculation time for the set of calculated values of valley deformation started in September 2016, a comparative analysis of the same period is not possible, but it is possible to compare the trends of both. Since December 2017, the calculated values have similar trends to the actual measured values in the field. Comparatively accurate comparison of the valleyward shrinkage deformation at 990 m and 900 m elevation shows that the FLAC<sup>3D</sup> simulation results and the actual engineering situation can be well corroborated with each other.

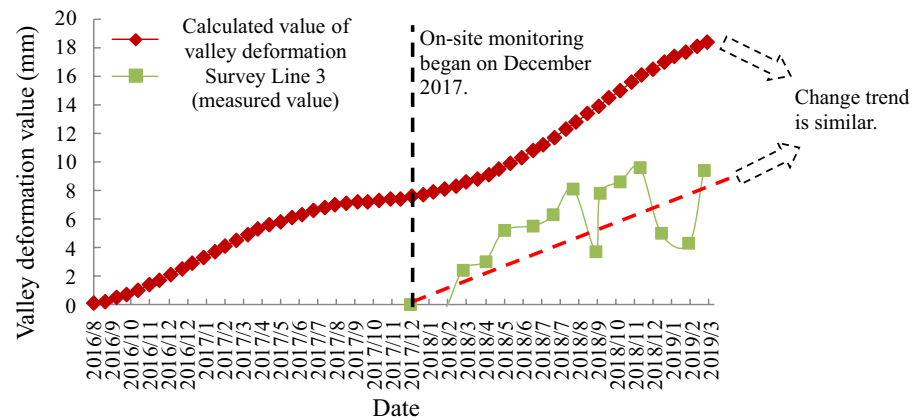
**Figure 25.** Comparison of field measured values and calculated values of valley deformation (post-dam water cushion pool elevation 900 m).

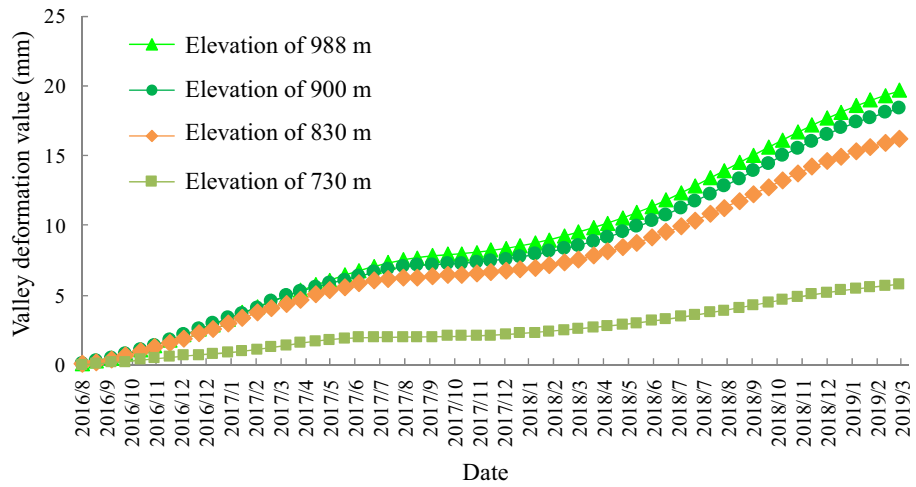
**Figure 26.** Calculated values of valley deformation at different elevations.

By superimposing the calculated values of valley deformation on both sides of the reservoir behind the dam at different elevations (upper 990 m, upper 900 m, lower 830 m, lower 730 m), the valley deformation curves at each elevation can be obtained as shown in Fig. 26. The valley shrinkage pattern of each elevation is similar, showing a slow increasing trend. 830 m and above height valley shrinkage deformation is not much different,

but the difference with 730 m height valley shrinkage deformation is obvious. The valley deformation at altitude 990 m is the largest, close to 20 mm, and the valley contraction at the bottom 730 m is the smallest, only 5 mm.

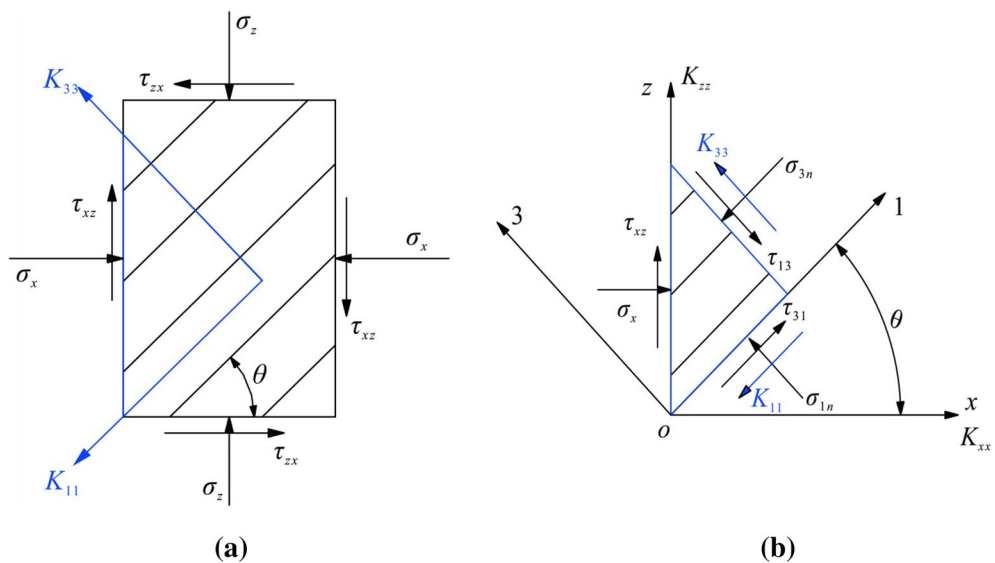
**Figure 27.** Equivalent continuous medium mechanical model of a typical layered rock mass: **(a)** Stress state of layered rock.  $\sigma_x$  is horizontal positive stress;  $\sigma_z$  is vertical positive stress;  $\tau_{zx}$ , zx-directional shear stress;  $\tau_{xz}$  indicates xz-directional shear stress;  $\theta$  is the dip angle of the layered structure face;  $K_{11}$  and  $K_{33}$  are equivalent permeability coefficients along and perpendicular to the direction of the layered structure face, respectively; **(b)** Equilibrium state of layered rock unit.  $\sigma_{1n}$  is normal shear stress;  $\sigma_{3n}$  is horizontal tangential stress;  $\tau_{31}$  indicates tangential shear stress;  $\tau_{13}$  indicates normal shear stress;  $K_{xx}$  is horizontal permeability factor and  $K_{zz}$  is vertical permeability factor.  $xOz$  is the overall coordinate system and  $1O3$  is the local coordinate system.

direction along the laminae and in the direction of the vertical laminae. Based on the classification of rock mass in the study area, the layered rock mass is simplified to the equivalent continuum mechanical model. Figure 27a shows the stress state of typical stratified rock mass, and Fig. 27b shows the equilibrium state of stratified rock mass elements.
