# Case study on long-term deformation monitoring and numerical simulation of layered rock slopes on both sides of Wudongde dam reservoir area

**Keywords** Slope deformation monitoring, High steep layered slope, Numerical analysis, Long-term stability

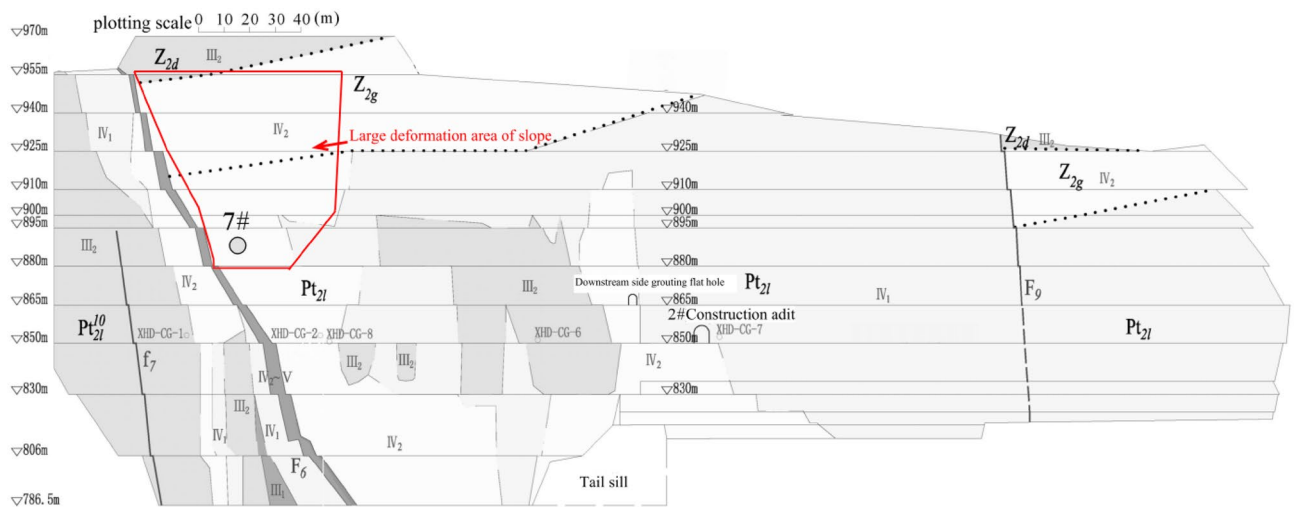
**Figure 28.** Rock quality of the left side slope of the water pad pond of the spillway tunnel<sup>34</sup>.

With reference to the preliminary detailed geological investigation and related literature<sup>34,35</sup>, it can be determined that the construction operation behaviors such as excavation and blasting are more disturbing to the slope. The rock body on the downstream side of the F6 fault on the left side of the spillway tunnel water pad pond is mainly type IV<sub>2</sub> with poor quality, and this type of rock body accounts for 32.6% of the whole slope (see Fig. 28). The parts of the slope with larger deformation are marked with red lines (corresponding to the red circle part of Fig. 13). The area with larger deformation on the slope surface has higher consistency with the area with larger deformation of the rock mass, and the larger deformation in this area is related to the F6 fault, which is mainly generated by the unloading relaxation of the rock mass caused by the excavation in this area. At an elevation of 891.6 m on the downstream side immediately adjacent to the F6 fault, physical exploration was conducted using anchor holes (hole numbered 7 in Fig. 28), and the relaxation depth was found to be about 16.4 m. The acoustic wave velocity in the relaxation zone was 2600–3200 m/s, and the acoustic wave velocity in the non-relaxation zone was 3100–5000 m/s. In order to verify the relaxation depth of rock unloading relaxation caused by excavation, a multi-point displacement meter was set in physical exploration hole number 7. In order to verify the relaxation depth of rock unloading caused by excavation, the rock deformation measured by setting multi-point displacement meter in hole 7 of physical exploration is shown in Fig. 29, and the distance marked in the figure refers to the distance from each monitoring point of displacement meter to the deep anchorage head. It can be seen that the maximum deformation after the excavation is completed is about 73 mm. 16.4 m is the depth of loosening and unloading determined in the exploration hole No. 7, which confirms the existence of rock unloading phenomenon in this area and determines that the depth of loosening and unloading is within the range of 0–20 m of rock deformation. Due to the unloading relaxation caused by excavation and other factors, as well as the poor quality of the rocks in this area downstream of the F6 fracture, large tensile deformation and surface deformation occurred in the rocks near section 4–4 of the first phase downstream of the F6 fracture.

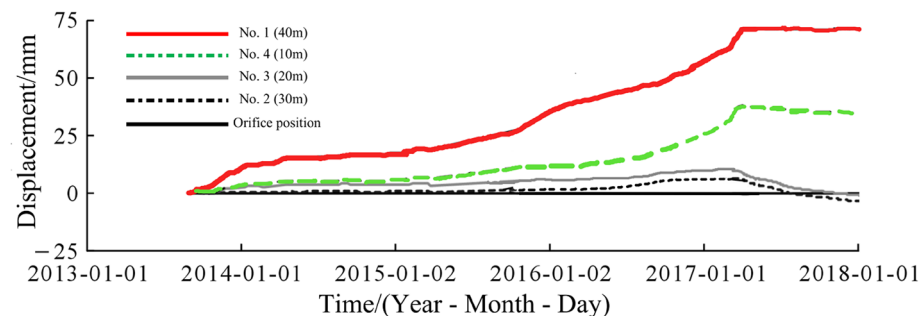
**Figure 29.** Rock deformation measured by multi-point displacement meter in borehole No. 7<sup>34</sup>.

deformation. When the slope is stable, it will stay in the gestation stage or development stage of damage development, and it is not easy to further develop to the final stage of large-scale, progressive and large deformation, similar to the change of multi-point displacement meter data in Probe Hole 7 (see Fig. 29), which will converge when it grows to a certain value. If the deformation remains uncontrollable after the release of strain energy, the displacement will develop freely and the sliding surface will gradually multiply to completion, i.e., it will enter the irreversible state, thus the slope will lead to the overall damage. At present, the whole of Wudongde hand-excavated slope is in the stage of convergence of deformation, and no coherent and unified sliding surface is formed inside.
