## **OPEN** A pre-failure narrow concrete cracks dataset for engineering DATA DESCRIPTOR structures damage classification and segmentation

Karolina Tomaszkiewicz 🗈 🖂 & Tomasz Owerko

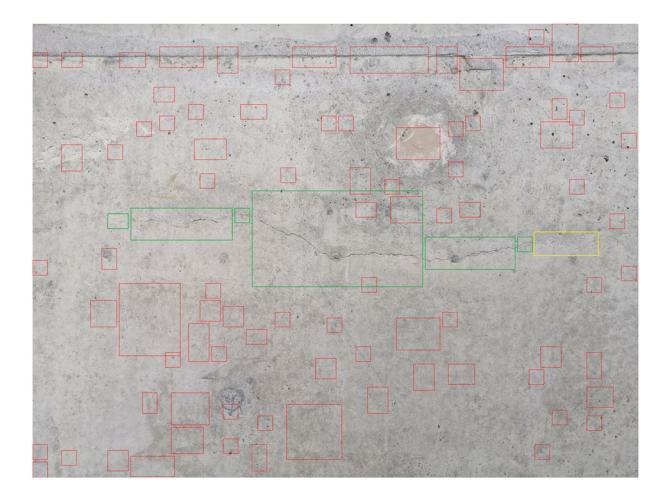
**Fig. 1** Limitations of using the network trained on the KrakN dataset for the case of narrow cracks. Green rectangle - cracks correctly detected, red rectangle - detection of a cracks by the network in a place where they do not actually occur, yellow rectangle - a crack not detected by the network, despite the fact that it occurs in that place.

The authors also conducted an experiment using weights of the network trained on narrow cracks<sup>21</sup> using images from the KrakN<sup>18</sup> dataset. The solution's effectiveness was verified on one of the images, which was later used to build a dataset for the narrow cracks. It was shown that the solution's based on automatic methods

and an undifferentiated dataset (i.e. KrakN<sup>18</sup> including images of only one pillar) does not support the bridge engineer's work. The number of incorrect identifications - as shown in Fig. 1 - does not allow the use a network trained in this way to support the inspection process.

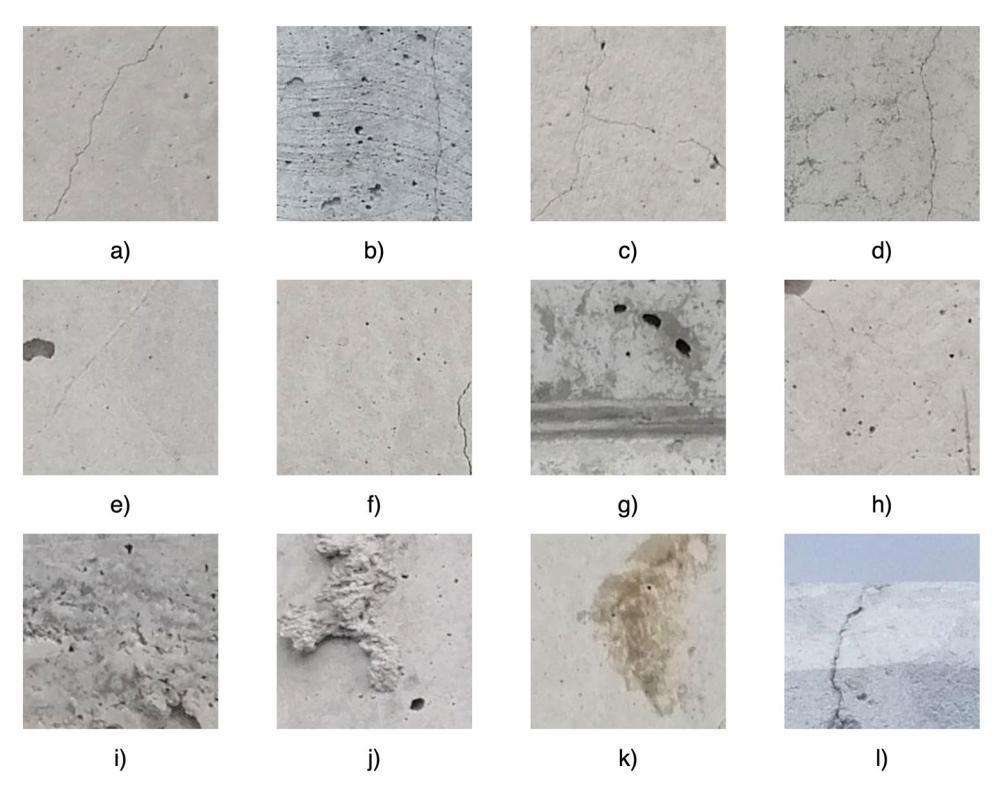
Fig. 2 Examples of characteristic damage or complex concrete surface finish present in the dataset.

It should be noticed that a characteristic feature of this dataset is the very complicated nature of the concrete surface finish, including, for example, the presence of formwork marks (Fig. 2g), concrete troweling marks (Fig. 2b), dirt (Fig. 2h,k), and mechanical damage of the concrete surface (Fig. 2e). As the Authors' experience has shown<sup>19</sup>, these damages can potentially be recognized as cracks and provide additional difficulties for damage detection by machine learning algorithms. However, they are very common and they occur independently of the work contractor (that is, their occurrence is unavoidable) therefore, from a practical point of view, they must be taken into account in the final solution. In the dataset presented here, the cracks can be located in different areas on the image, i.e. they do not necessarily occur in the central part of the image (Fig. 2f). In addition, the dataset also includes different colors of the concrete surface (e.g., Fig. 2b,c,d,k,l), bugholes (Fig. 2b,e,g,j) and background obstructions (Fig. 2l).

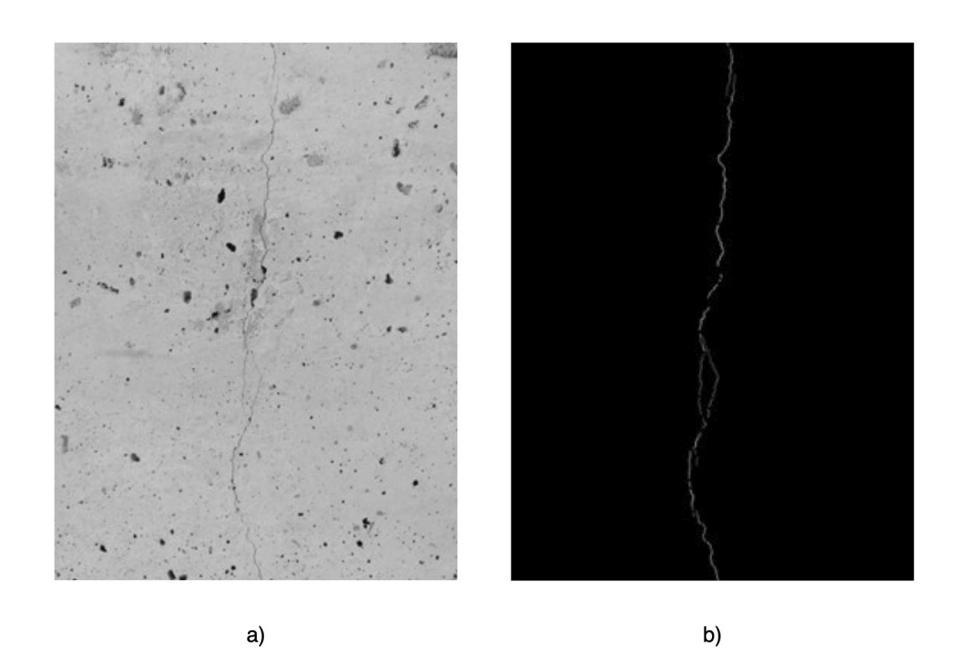
Fig. 3 Example of full-resolution images before sub-image division (a) original image (b) segmentation mask.

A mask was prepared for each image in GIMP by manually selecting the pixels representing the damage by an experienced engineer. A detailed description of the annotation process is presented in the subsection "*Validation of correct class assignments to pixels*". Each mask was exported to a .png file. An example of the image and its corresponding mask is shown in Fig. 3. The image-mask pairs were then divided into sub-images according to the defined sub-image size (i.e.,  $224 \times 224$  px), without overlapping sub-images. In order to eliminate errors related to the export of the mask from GIMP (i.e., with the possibility of having in the mask, in addition to pixel values of 0 and 255, also values close to 0 and 255, such as 1, 4, 253), a thresholding operation was performed for each mask sub-image to receive a binary image. The sub-images of images and masks prepared in this way were used to create a segmentation dataset. An example image and its corresponding mask after dividing into sub-images is shown in Fig. 4.

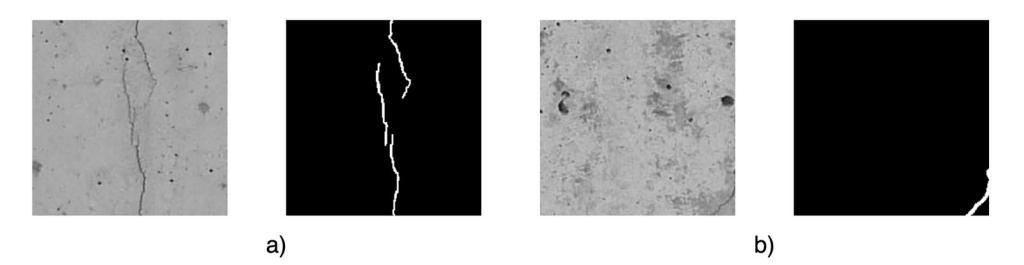
Fig. 4 Examples of images and their segmentation masks after sub-image division (a) Crack in the center of the image (b) Crack in the corner of the image.

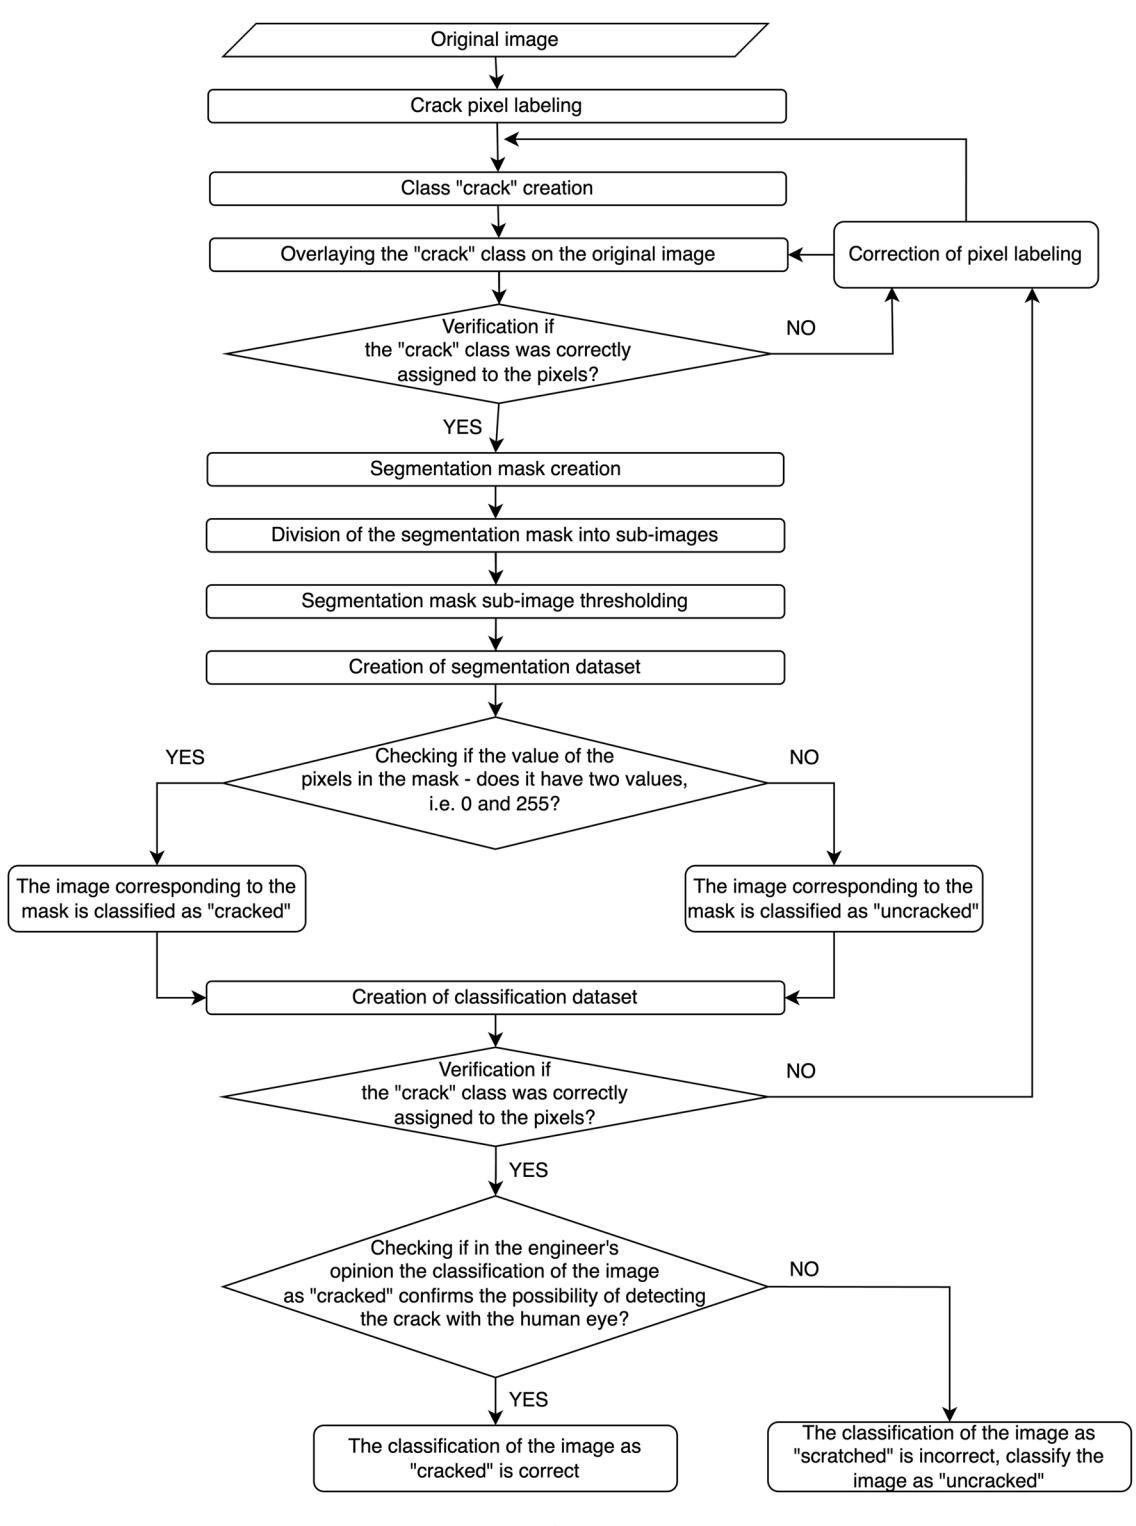
Fig. 5 Schema of creating segmentation and classification dataset.

The classification dataset was created based on the segmentation dataset. The adopted approach was that the image for which there are pixels indicating crack in the mask is automatically classified as "Cracked" and "Uncracked" for images in which there are no crack pixels in the mask. It is important to note that after the process of automatic classification of the image assignment to each class, the correctness of the algorithm was manually verified in the context of the proper image assignment to each class. For details of this classification validation, see the subsection "Validation at the stage of creating the classification dataset". A schematic representation of the dataset creation process is shown in Fig. 5.

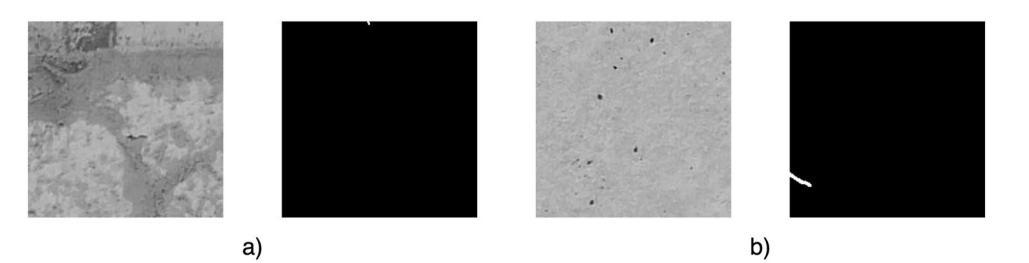
Fig. 7 Examples of manual verification of correct class assignment (**a**) final section of crack (**b**) crack with very small width.

- a) There is a final section of crack on the image (Fig. 7a) on the segmentation mask, the percentage of crack pixels is small compared to the background pixels. In the engineer's opinion, such a small section of crack would not be detectable in the image. In this case, the decision was made to change the classification of this kind of image to "Uncracked".

- b) The crack is larger than in the case of a) (Fig. 7b) in terms of the pixel percentage of the crack compared to the background on the segmentation mask but has such a small width, that it is difficult to see with the human eye and the classification as a crack without having the context of the whole crack's progression. In the engineer's opinion, having the role of classifying such an image (without having the support of a segmentation mask), it would not be possible to recognize a crack on it. For the purpose of image classification, it was decided to change the classification of such an image to "Uncracked".

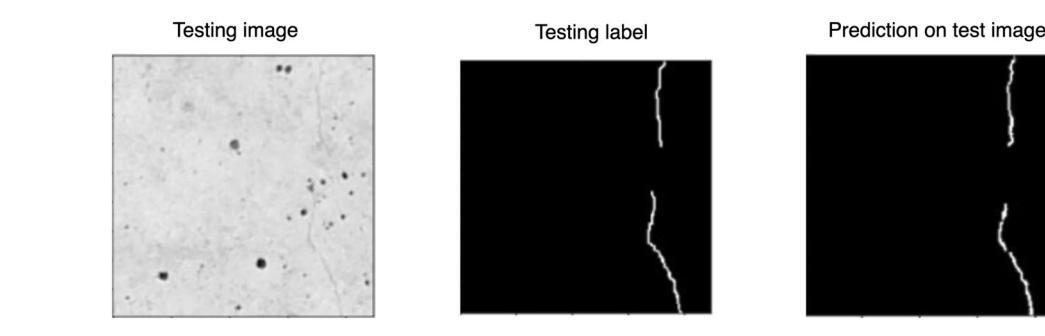
Fig. 8 Results of the Authors' dataset-based prototype solution.

**Validation the possibility of using dataset for machine learning-based solutions.** In order to verify the standard of dataset delivery (including image size, dataset size) and to verify that this dataset is valuable for machine learning, the authors built a prototype solution. A U-Net model was trained from scratch on a subset of 791 images of size  $224 \times 224$  px. The solution showed satisfactory results for pixel classification in detecting narrow cracks, as shown in Figs. 8, 9.

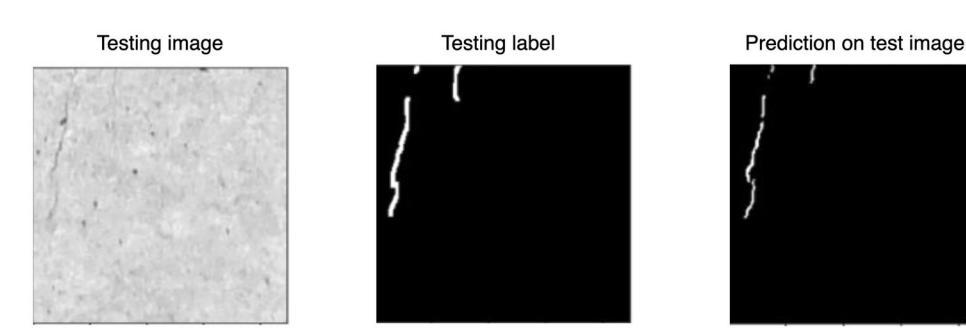
Fig. 9 Results of the Authors' dataset-based prototype solution.
