# SCIENTIFIC REPORTS

## Microcrack healing in non-ferrous metal tubes through eddy current pulse treatment

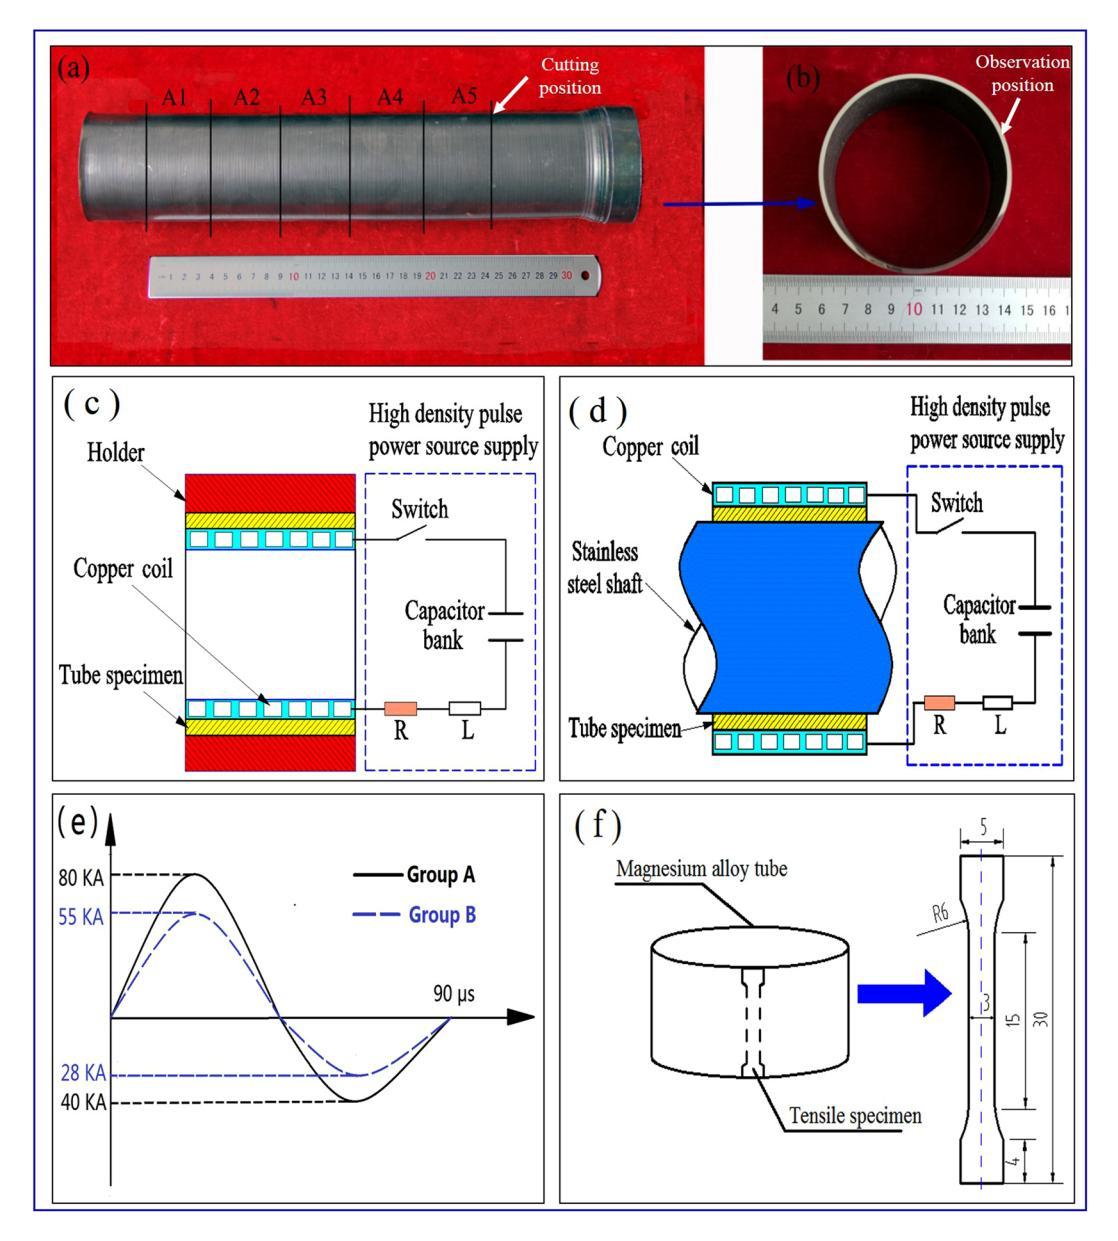
**Figure 1.** (a) Mg alloy as-spun tube. (b) specimen cut from as-spun tube. (c,d) the schematic diagrams in outward-discharging scheme (c) and inward-discharging scheme (d) under ECPT. (e) the exciting current waveforms in group A and B. (f) schematic of tensile specimen (unit: mm).

The tubes used in this study were made of as-cast magnesium alloy containing high extent of rare earth (RE) elements, which were prepared through the power spinning process<sup>21,22</sup>, as shown in Fig. 1a. The chemical composition of the RE magnesium alloy is listed in Table 1. The as-spun tube blank of Mg alloy was 72.3 mm in inner diameter and 8.0 mm in wall thickness. After power spinning at about 450 °C with the total thickness reduction of 77% in five passes, the as-spun tubes were thinned to  $1.7 \pm 0.10$  mm in thickness and elongated to more than 300 mm in length. Two as-spun Mg alloy tubes were fabricated for two groups of ECPT experiments. The tube specimens for ECPT were cut from the middle area of as-spun tubes through wire electrical discharge machining (WEDM) and machined to 30 mm in length, as shown in Fig. 1b.

After the morphologies of cross sections of as-spun tubes were recorded, the high density eddy current pulse treatment (ECPT) was applied to the tube specimens under ambient temperature. Both the outward-discharging (or outward) scheme and inward-discharging (or inward) scheme for ECPT were adopted, in which the tube specimens were fixed outside and inside the copper coil respectively, as shown in Fig. 1c,d. The device for ECPT had a high density pulse power source supply including a capacitor bank with the maximum discharging voltage of 15 KV, which could provide the total energy storage of about 50 kJ. The circular copper coil was connected with the power source supply, whose surface was covered by an insulation layer. The copper coils in both the ECPT schemes were about 50 mm in length, which were longer than the tube specimens in order to cover the tube specimen completely. In the outward-discharging scheme, a stainless steel holder was fixed outside the tube specimen to restrict its radial expansion (see Fig. 1c). In the inward-discharging scheme, the stainless steel shaft was fixed inside the tube specimen to restrict its radial contraction (see Fig. 1d). When the switch was on, the capacitor bank rapidly discharged and high density pulse current occurred in the copper coil, which could induce high density eddy current within the tube specimen. Table 2 shows the processing conditions of ECPT on the tube specimens in group A and B, which were cut from the two as-spun tubes, respectively. The tube specimens A1 - A4 were applied by ECPT in outward scheme with 0, 5, 10, 15 cycles at 6 KV discharging voltage of capacitor bank respectively, while the tube specimen A5 was applied by ECPT in inward scheme with 15 cycles at 6 KV discharging voltage in contrast to tube specimen A4. Similarly, the tube specimens B1 - B4 were applied by ECPT in inward scheme with 0, 5, 10 and 15 cycles at 9 KV discharging voltage of capacitor bank respectively, while the tube specimen B5 was applied by ECPT in outward scheme with 15 cycles at 9 KV discharging voltage in comparison with tube specimen B4. Here, each cycle of ECPT denoted a discharge process of capacitor bank. In the discharging experiments, the exciting current within the copper coil was measured through a current sensor, which exhibited attenuating sine waves, as shown in Fig. 1e. The tube specimens were cooled in air at the time interval of 30 seconds between every two cycles of discharge treatments in order to prevent the thermal accumulation. Before the ECPT, the cross sections of tube specimens were mechanically polished, and the morphologies of cross sections were observed by scanning electron microscopy (SEM) on Quanta 200FEG, as depicted in Fig. 1b. After the SEM observation on the initial cross section of as-spun tube specimen, the tube specimens were taken out and then treated by the ECPT cycles. In the ECPT experiment, the coil was placed inside the tube specimen in outward scheme (see in Fig. 1c) and outside the tube specimen in inward scheme (see Fig. 1d). After every five cycles of ECPT, the tube specimens were taken out for SEM observation on the cross section of tube specimen end. The specimens before and after ECPT were also observed through TEM (Transmission Electron Microscopy) analysis on Talos F200X. After the ECPT experiments, the mechanical properties of tube specimens were tested

on an Instron 5569 test machine with a drawing speed of 0.8 mm/min under ambient temperature. The tensile specimens were cut from the tube specimens along the axial direction, as illustrated in Fig. 1f. Ten specimens cut from the same tube specimen were tested as a group.

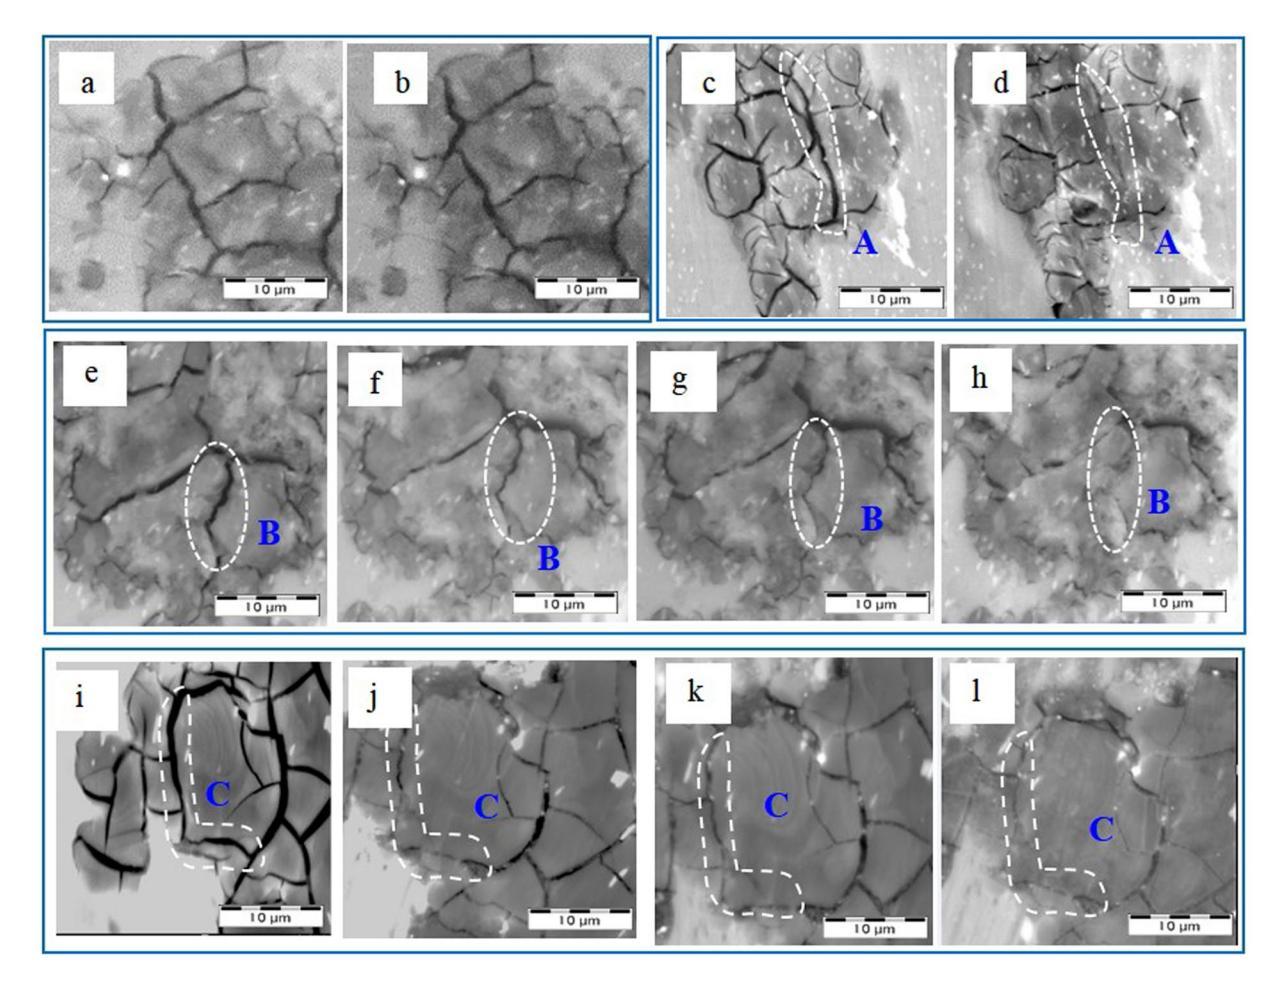
**Figure 2.** SEM images of cross sections of tube specimens (**a**,**b**) A2 before and after 5 ECPT (outward scheme); (**c**,**d**) A3 before and after 10 ECPT(outward scheme); (**e**-**h**) as-spun and after 5, 10,15 ECPT of A4 (outward scheme); (**i**-**l**) as-spun and after 5, 10,15 ECPT of A5 (inward scheme).

After spinning deformation, amounts of microcracks were observed on the cross sections of tube specimens both in group A and B since the RE-containing Mg alloy exhibited higher strength at the expense of ductility. Figure 2 shows the morphologies of microcracks on the cross sections of tube specimens before and after the ECPT. The A2-A4 were subject to the ECPT in the outward-discharging scheme. As shown in Fig. 2a,b, there was no obvious change in the morphologies of microcracks on the cross section of specimen A2 before and after 5 cycles ECPT. However, when subjected to ECPT for 10 cycles, the microcracks on the cross section of tube specimen A3 started to close in local areas, as illustrated in Fig. 2c,d, respectively. The microcracks were narrowed and even completely closed in region A, and the microcracks in neighboring areas also exhibited a healing tendency by degrees. The similar situation occurred when the specimen A4 was subject to ECPT for 15 cycles. In order to study the evolution of the microcracks during the ECPT, the cross section of tube specimen A4 was observed after every fifth cycle treatment, as shown in Fig. 2e–h. The SEM images taken from region B depicted the gradual narrowing and closing of microcracks on the cross section of microcracks in tube specimen A5 in the inward-discharging scheme with 6KV discharge voltage exhibited similar tendency in outward-discharging scheme. As illustrated in Fig. 2i–l, the microcracks in region C were gradually narrowed and finally closed as the ECPT cycles increased.

From the SEM pictures of microcrack evolution, it should be noted that the microcrack closure was not so evident in tube specimen A4 after first 5 cycles of ECPT (see Fig. 2e,f), while more microcracks tended to be closed in tube specimen A5 (see Fig. 2i,j). As mentioned above, the tube specimen A4 and A5 were applied by ECPT under same discharging voltage 6 KV, which means that the energy consumptions of ECPT in the two schemes were very close. Actually, the simulation results of eddy current density distribution in Fig. 5d suggests that the eddy current densities of tube specimens in inward-discharging schemes with discharging voltage of 6 KV was a little higher than that in outward scheme. In addition, the relative positions of copper coil and tube specimen in outward and inward schemes were different. The distribution of Lorentz force on the surfaces of tube specimens in outward scheme and inward-discharging scheme at 6 KV are illustrated in Fig. 7a,b, respectively. According to the Faraday Law of electromagnetic induction<sup>25</sup>, the electromagnetic field could induce the Lorentz force, which was an inward radial force in the specimen A5 (in inward scheme) and an outward radial force in the specimen A4 (in outward scheme) during the ECPT. The inward radial force would squeeze the material towards the center of tube specimen, while the outward radial force would expand the material outwards. Furthermore, both the tube specimen A4 and A5 were tightly fixed during ECPT to prevent axial deformation, so the sidewall of tube specimen should be squeezed by Lorentz force, which would push the two sides of microcracks closer. Clearly, this squeezing force should be one of the driving forces for microcrack healing.

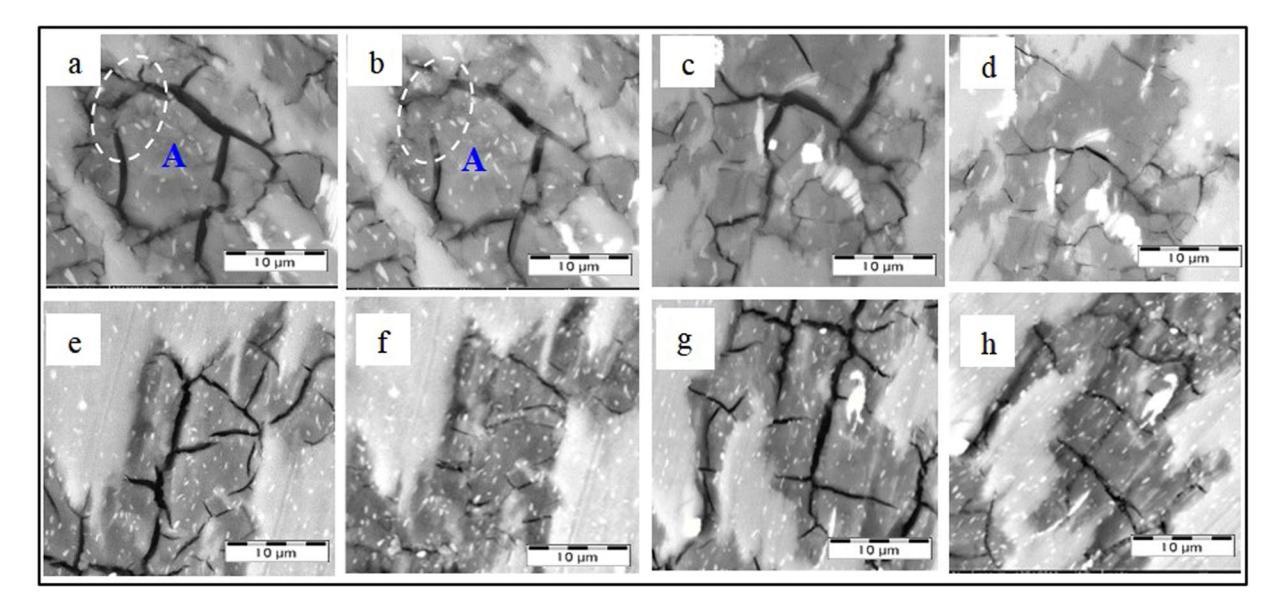
**Figure 3.** SEM images of cross section of tube specimens: (**a**,**b**) B2 before and after 5 ECPT (inward scheme); (**c**,**d**) B3 before and after 10 ECPT (inward scheme); (**e**,**f**) B4 before and after 15 ECPT (inward scheme); (**g**,**h**) B5 before and after 15 ECPT (outward scheme).

Compared to the tube specimens in group A subjected to outward-discharging treatment, the microcrack morphologies of tube specimens in group B subjected to inward discharging treatment showed similar evolution tendency. After 5 cycles of ECPT with the inward-discharging scheme at 9 KV, it can be seen from Fig. 3a,b that some local areas of microcracks in tube specimen B2, such as region A, became closed. When the ECPT increased to 10 cycles, most of the microcracks in tube specimens B3 were basically closed or pronouncedly narrowed, as shown in Fig. 3c,d. After 15 cycles of ECPT, almost all the microcracks were healed, as shown in Fig. 3e,f. For tube specimen B5 treated with 15 cycles of ECPT by the outward-discharging scheme at 9 KV, crack healing was also clearly observed, while the healing degree seems less than that for tube specimen B4 in the inward-discharging scheme.

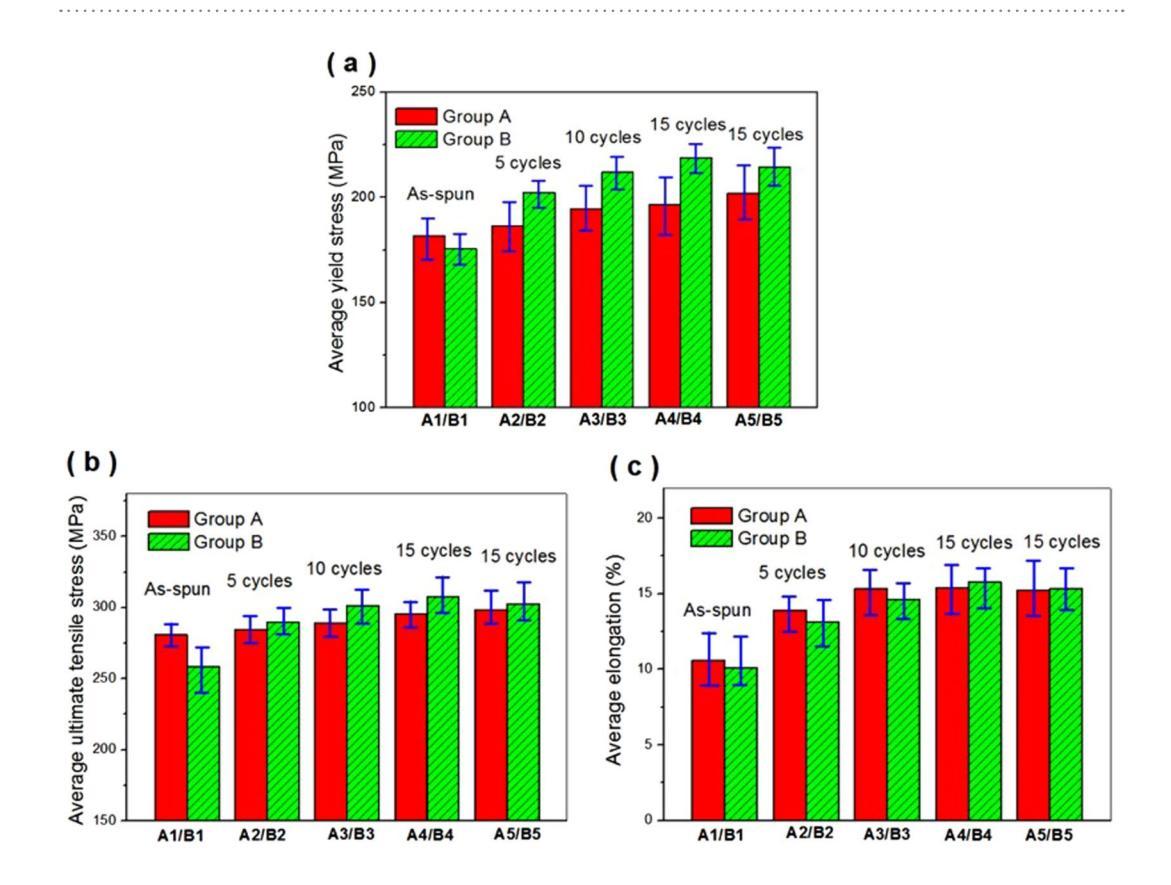
**Figure 4.** Uniaxial tensile experiment results of group A and B: (a) average yield stress, (b) average ultimate tensile stress, (c) average elongation.

The microcrack healing in the tube specimens may lead to the change of mechanical properties, so the mechanical properties of tube specimens were tested through uniaxial tensile experiment. Figure 4 shows the yield strength, ultimate tensile strength and elongation of tube specimens in group A and B, respectively, before and after the ECPT. The average yield strength of as-spun specimens in group A1 was 170.83 MPa, and the average yield strength of groups A2, A3 and A4 reached 182.37 MPa, 194.01 MPa and 199.13 MPa after 5, 10 and 15 cycles of ECPT respectively, increasing by 6.75%, 13.86% and 16.56% respectively (see Fig. 4a). It indicates

that the average yield stresses gradually increased with the increasing cycles of ECPT, while it was not so significant when the ECPT reached more than 10 cycles. Also, the ECPT improved the ultimate tensile stress of as-spun tubes with increasing ECPT cycles, and the average values of group A2, A3 and A4 increased by 5.23%, 10.66%, 12.76%, respectively, compared to that of initial as-spun tubes A1 (280.91 MPa), as illustrated in Fig. 4b. The average elongation of group A1 was 10.37%, while the average elongation of group A2, A3, A4 reached 12.68%, 15.03% and 15.87%, enhanced by 22.26%, 44.94% and 53.04%, respectively. Clearly, the elongation was significantly improved with increasing treatment cycles. Therefore, the mechanical properties were gradually promoted with the increasing cycles of ECPT, but it became less remarkable as the ECPT surpassed 10 cycles in outward-discharging scheme. In order to compare the strengthening effect of ECPT with outward-discharging scheme at 6 KV, the specimen A5 was subjected to ECPT with 15 cycles using inward-discharging scheme under the same discharging voltage, and the average yield strength, ultimate tensile strength and elongation of specimen A5 increased to 202.12 MPa, 298.47 MPa, 16.11% respectively, which were slightly higher than those of specimen A4 (193.96 MPa, 294.24 MPa, 15.24%) subjected to ECPT with 15 cycles using outward-discharging scheme.

For the specimens in group B, the average yield strength of B2, B3 and B4 increased to 199.55 MPa, 212.41 MPa and 215.23 MPa (see Fig. 4a), respectively, which rose by 12.94%, 22.26% and 23.89%, respectively, compared to specimens B1 (173.73 MPa). The average ultimate tensile strength of initial specimen B1 was 263.02 MPa, which increased by 10.79%, 15.44% and 20.02%, respectively, after 5, 10 and 15 cycles of ECPT (see Fig. 4b). The average elongation of B2, B3 and B4 increased by 31.37%, 50.84% and 62.77%, respectively, compared to specimen B1 (10.03%). When subject to ECPT at 9 KV, the specimen B5 treated by 15 cycles using outward-discharging scheme had the average yield strength (215 MPa), ultimate tensile strength (311.33 MPa) and elongation (15.35%), respectively, which were slightly smaller than the values of the specimen B4 treated by 15 cycles using inward-discharging scheme (see Fig. 4a–c). Therefore, it can be noted that the specimens treated with inward-discharging scheme exhibited better mechanical performance than those with outward-discharging scheme.

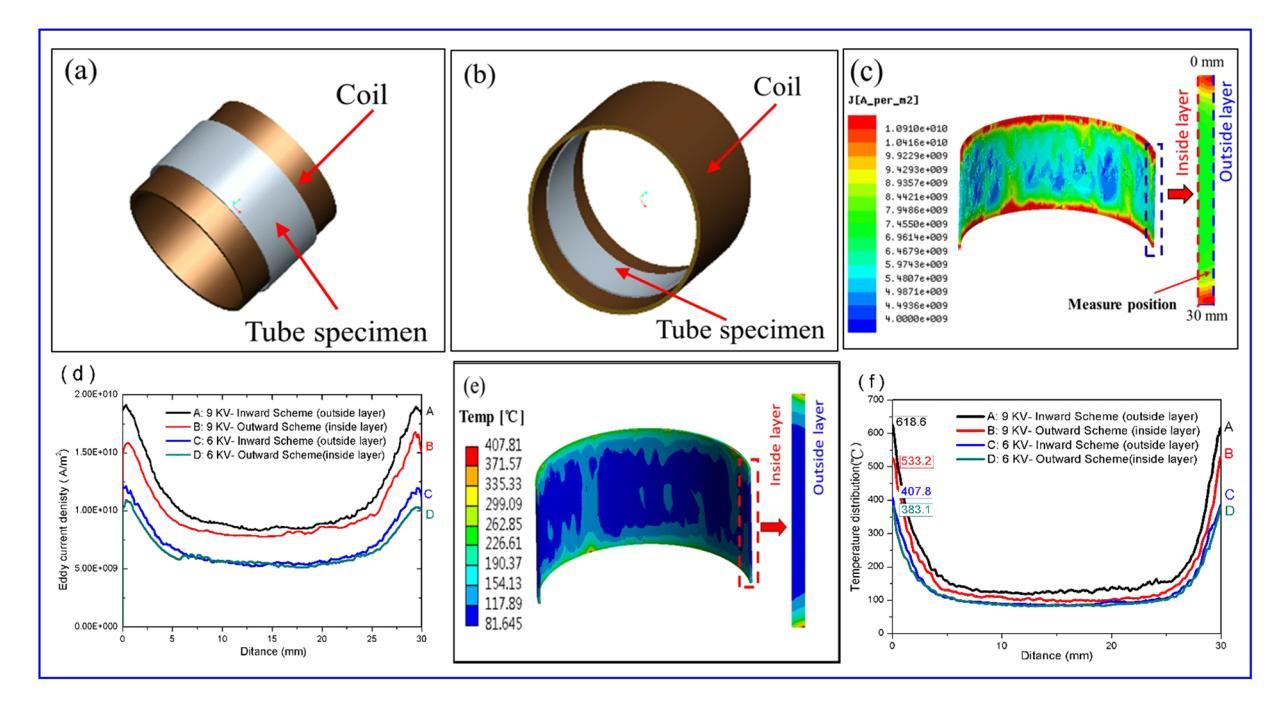
**Figure 5.** FEM results of ECPT ( $t = 90 \ \mu$ s): (**a**) model in outward scheme, (**b**) model in inward scheme; (**c**) distribution of eddy current density induced within the tube specimens in inward scheme A at 6 KV; (**d**) current density distributions on the axial section in different schemes at different voltages; (**e**) temperature distribution on the axial section in inward scheme at 6 KV; (**f**) temperature distribution in the inside layer in outward scheme at different voltages.

In order to quantitatively analyze the influence of the ECPT in different schemes, the FE (Finite Element) simulation was performed using the commercial FE software ANSYS platform. As shown in Fig. 5a,b, the copper coils were fixed inside and outside the tube samples, respectively, which were similar to the ECPT experiments in outward-discharging scheme and inward-discharging scheme. The copper coils in the ECPT experiments were fabricated by coiling the copper wire with square section, and only small gaps existed between neighboring copper wires, so the copper coil was simplified as a cylindrical tube in the FE models, which could reduce the complexity of FE simulation. According to the exciting current waveforms in group A and B (see Fig. 1e), the corresponding approximate formulas of the exciting currents  $80e^{-15400t}sin(700t)$  KV and  $120e^{-15400t}sin(700t)$  KV, where t was discharging time, were obtained by the fitting method. The fixed supports were applied on the outer surface of tube specimen in outward-discharging scheme and inner surface of tube specimen in inward-discharging scheme at 6 KV, the distribution

of eddy current density induced within the tube specimens at  $t = 90 \ \mu s$  is shown in Fig. 5c. The distribution of eddy current density on the axial section of different specimens at  $t = 90 \ \mu s$  is shown in Fig. 5d, wherein the curves A, C represent the eddy current densities in the outside layer of axial section in inward-discharging scheme and B, D represent the eddy current densities in the inside layer of axial section in outward-discharging scheme. The highest eddy current density occurred in the outside layer in inward-discharging scheme and the inside layer in outward-discharging scheme, respectively, since the two layers were more close to the copper coil in their corresponding ECPT schemes. It indicates that the eddy current density was smaller in the middle zone and greater at both the ends of tube specimens because the tube specimen was shorter than the copper coil in this study. The density distribution of curve C was a little higher than the curve D at 6 KV discharging voltage, which was due to higher magnetic flux density inside the copper coil than outside<sup>23</sup>. When the discharging schemes increased to 9 KV, both the eddy current densities in outward-discharging and inward-discharging schemes increased pronouncedly, and the eddy current in inward-discharging scheme (see curve A) was higher than that in outward-discharging scheme (see curve B).

The temperature distribution at t = 90  $\mu$ s on the axial section of the tube specimen in inward-discharging scheme at 6 KV is illustrated in Fig. 5e. The maximum temperature appeared at the both ends of axial section as a result of the highest eddy current density over there. The temperature distribution in the inside layer of axial section in outward-discharging scheme and the outer layer in inward-discharging scheme was compared in Fig. 5f. The result indicates that the maximum temperature increased with the increase of eddy current density, so the maximum temperature in inward-discharging scheme due to the difference of eddy current density in the two schemes, and higher discharging voltage led to higher maximum temperature on the axial section of tube specimens.

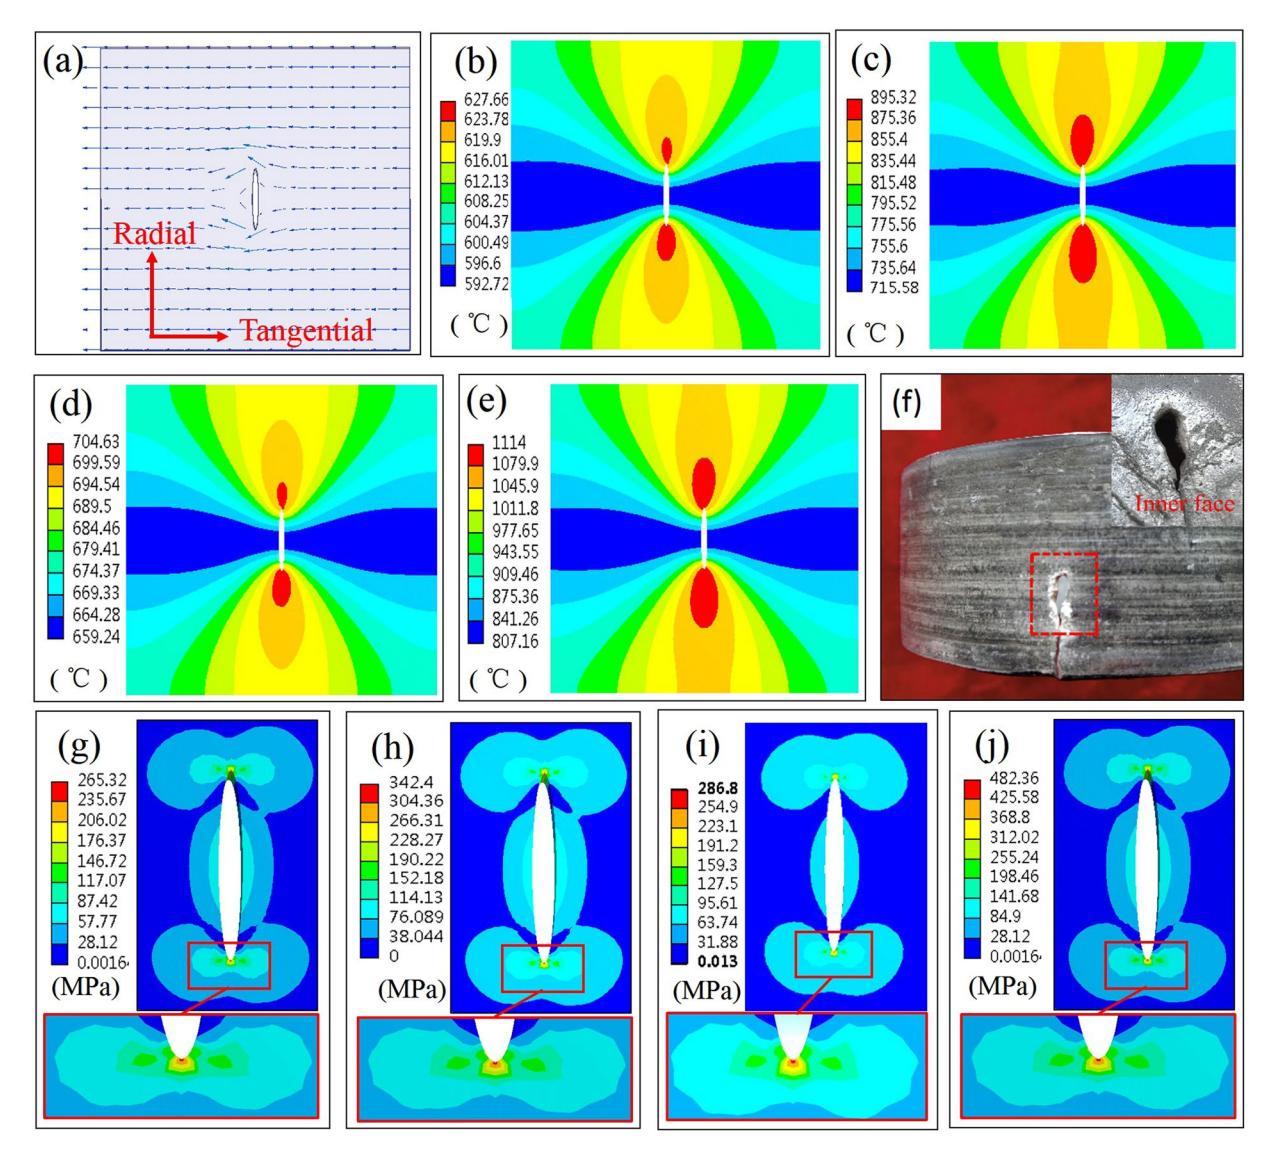
**Figure 6.** Simulation results of ECPT ( $t=90\mu s$ ): (a) eddy current distribution; (b–e) temperature distribution around the microcrack in outward scheme at 6KV (b), 9KV(c) and in inward scheme at 6 KV (d), 9 KV (e); (f) tube specimen after ECPT at 11 KV; (g–j) equivalent stress distribution in outward scheme at 6 KV (g), 9 KV (h) and in inward scheme at 6 KV (i), 9 KV (j).

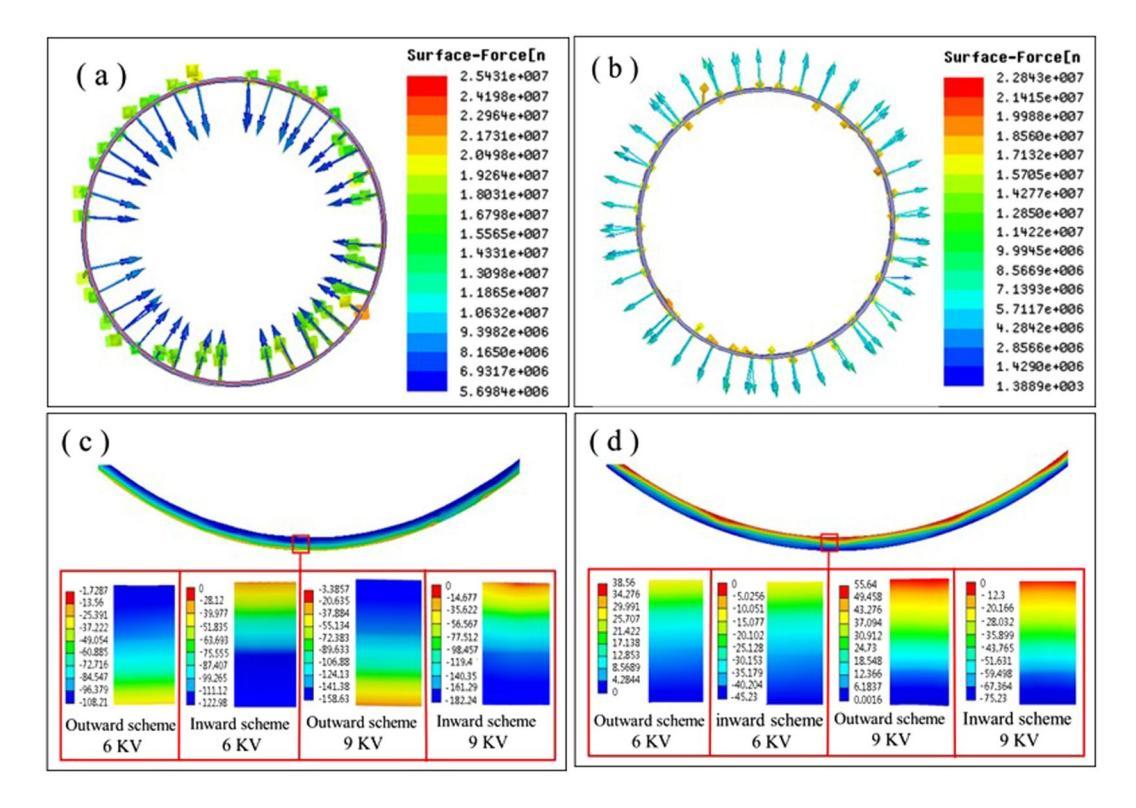
**Figure 7.** (**a**,**b**) Lorentz force distribution on the surface of tube wall in outward-discharging scheme (**a**) and inward-discharging scheme (**b**) at 6 KV. (**c**) radial stress distribution on the cross section in different discharging schemes with different voltages. (**d**) tangential stress distribution on the cross section in different schemes with different voltages.

increase in the tube specimens. The distribution of radial stress and tangential stress on the cross section, which were caused by the Lorentz force, was illustrated in Fig. 7c,d, respectively. The maximum radial stress and tangential stress in outward scheme appeared in the inner layer of cross section, while the maximum values in inward scheme occurred in the outer layer of cross section. The maximum radial stress in inward scheme was a little higher than in outward scheme, and the radial stress was much higher than tangential stress at the same position. The radial stress squeezed both sides of tangential microcrack closer during the ECPT and more cycles of ECPT repeated this process, resulting in the improvement of microcrack healing degree. The increase of exciting current increased the radial stress, which could enhance the squeezing action on the two sides of microcracks, leading to better healing effect and mechanical performance. In inward scheme, the tangential stress may stretch the two sides of radial microcracks owing to the outward Lorentz force in the outward scheme. Therefore, the better healing effect and mechanical performance occurring in inward scheme than in outward scheme should be partly ascribed to different directions of the tangential stress, which was caused by the Lorentz force as well as

the FEA results show that when the tube specimen was subjected to the ECPT at 6 KV, the maximum tangential component of thermal stress reached 234.17 MPa, which was much higher than the tangential stress caused by the Loretz force (38.56 MPa), as shown in Fig. 7d. Although the distribution of microcracks in as-spun tube specimens was more complex (see Figs 2 and 3), both the thermal stress and Lorentz force could contribute to the healing of microcracks in tube specimens under enough cycles of ECPT, as indicated in the ECPT experiments.

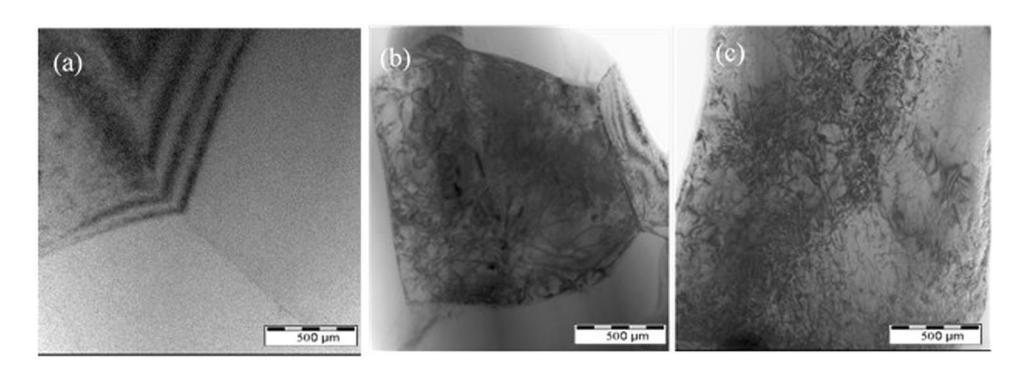
Figure 8. TEM images of A1, A4 and A5 after ECPT.

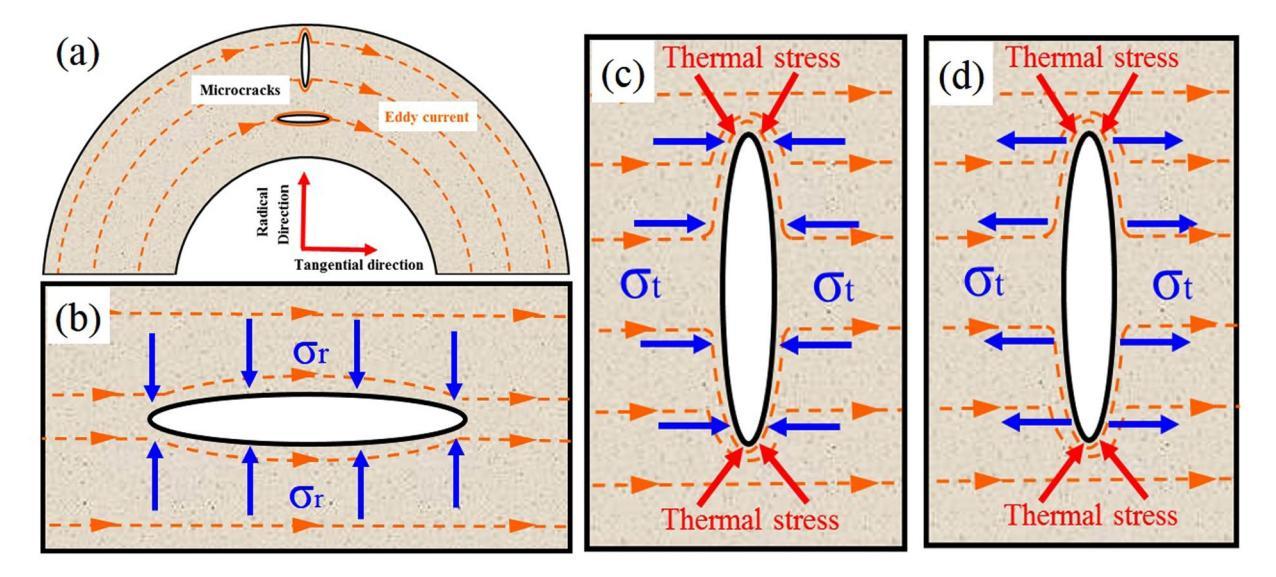
**Figure 9.** (a) The radial and tangential microcracks on the cross section. (b) The stress distribution around the tangential microcrack. (c,d) The stress distribution around the radial microcrack in inward scheme and outward scheme.

All in all, the mechanisms of microcrack healing during ECPT could be attributed to the thermal stress caused by the detouring of eddy current and the Lorentz force. Here, the radial microcrack and tangential microcrack will be discussed respectively. For the microcrack along the tangential direction shown in Fig. 9b, the radial stress caused by the Lorentz force  $\sigma_r$  squeezed the two sides of microcrack. However, the detouring of eddy current around the microcrack was not so pronounced, and the thermal accumulation in the vicinity of microcrack was relatively weak, so the thermal stress around the microcrack was too small to heal microcracks compared to the radial stress  $\sigma_r$ . When the microcrack was distributed along the radial direction, the detouring of eddy current around the microcrack was quite evident and the thermal accumulation in the vicinity of microcrack was relatively remarkable. Besides, the tangential stress  $\sigma_t$  caused by the Lorentz force in outward and inward scheme was orientated along opposite directions: it compressed the two sides of microcrack in inward scheme and streched the two sides of microcrack in outward scheme (see in Fig. 9c,d). So in inward scheme, the microcrack along the radial direction could be successively healed under the combination of thermal stress and tangential compressive stress induced by the Lorentz force, as shown in Fig. 9c. But in outward scheme, it can be seen from the Fig. 9d that the tangential stress  $\sigma_t$  was smaller than the tangential component of thermal stress, the microcrack could also be healed step by step. For instance,
