# Experimental analysis of control technology and deformation failure mechanism of inclined coal seam roadway using non-contact DIC technique

#### Engineering background

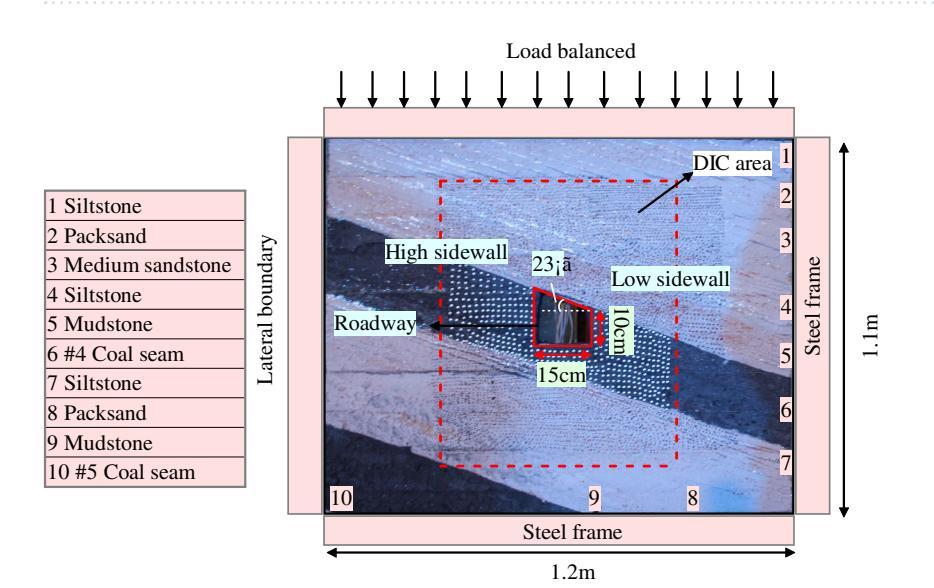
Figure 3. Physical simulation test system.

**Test setup.** In order to control the deformation of asymmetric roadway surrounding rock in inclined coal seam and mine inclined coal seam safely and efficiently, a large-scale variable angle model test (length × width × height =  $1.2 \text{ m} \times 0.12 \text{ m} \times 1.1 \text{ m}$ ) apparatus is assembled to reveal the deformation failure mechanism of roadway surrounding rock without support (see Fig. 3). In this study, in order to simulate the effect of in-situ stress, uniform load was applied on the top of the model to trigger the failure of surrounding rock after excavation (Jia and Tang 2008; Lee et al. 2010). Simplifications adopted in the model tests are given as follows: (1) The cross-section of right angle trapezoidal roadway in the inclined coal seam with the dip angle of  $23^{\circ}$  in Shitanjing No.2 Mining Area is used; (2) No support system is considered, in order to reveal the source of roadway deformation and failure; (3) The influence of roadway excavation process is not considered.

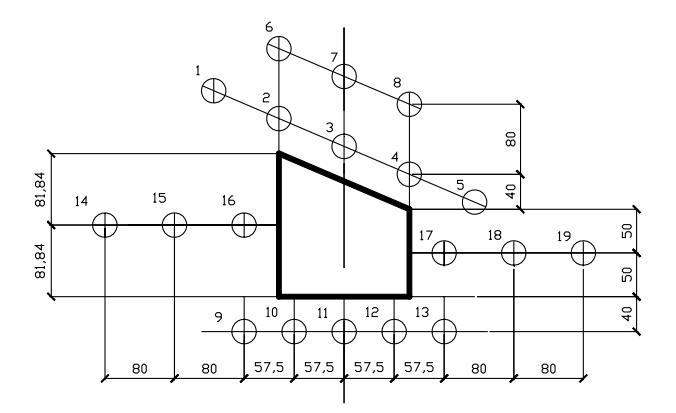
Figure 4. Layout of stress measuring points of roadway surrounding rock (mm).

According to the deformation and failure characteristics of inclined coal seam roadway in the actual project, and throughout the backfilling process, a total of 19 stress force sensors are embedded in the rock mass around the roadway (the roof, two sidewalls, floor and four sharp corners of the roadway) as schematically presented in Fig. 4 to measure the variation of rock stress during the roadway excavation and the surcharge loading process. The error of the stress sensor is 0.5% in the full range of measurement; whether the stress sensor fits closely with similar model materials and the installation method of the stress sensor may affect its measurement accuracy.

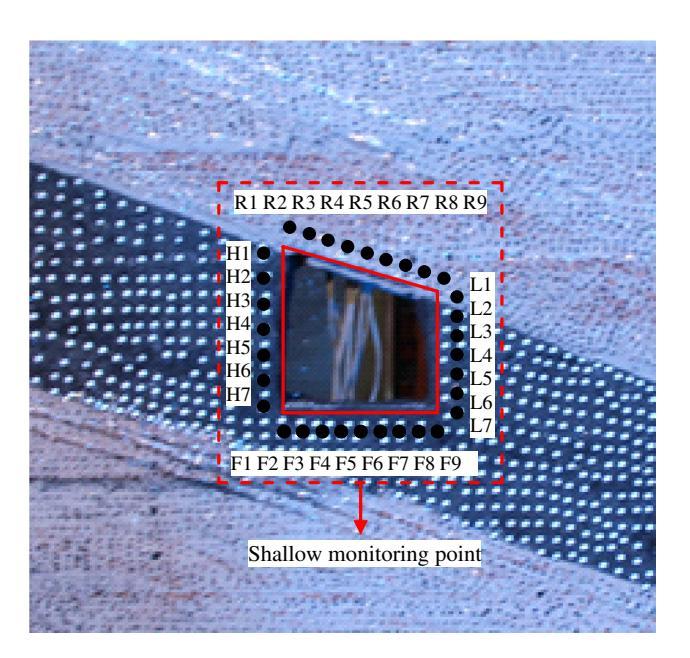
Figure 5. Layout of displacement measuring points of roadway surrounding rock.

In a similar physical simulation test, since most traditional measurement methods have low acquisition density, large discreteness, and low measurement efficiency, it results in a large measurement error<sup>29</sup> (Chen et al. 2016). Therefore, this paper uses a test method to monitor the displacement and deformation failure characteristics of roadway surface—Digital Image Correlation (DIC), which has the advantages of non-contact, robustness, and full-field measurement and can overcome the weakness of traditional measurement methods<sup>30</sup>. DIC is introduced into the deformation measurement of a similar model, which has short monitoring time intervals and high precision. It can realize the high precision test of large range and detail parts of rock strata simultaneously, complete the continuous dynamic monitoring of similar material models,

and obtain the deformation characteristics of the model in a small time scale. It provides rich monitoring information for the comprehensive study of the deformation and failure law of roadway surrounding rock to accurately grasp the dynamic process and local information of rock deformation, movement, failure, and collapse 31-35. The resolution of the two CCD digital cameras is  $2648 \times 2448$  pixels. Sub pixel accuracy can be achieved using 3D-DIC software (GOM-Aramis, version 8, related solutions). In this experiment, the photographing format is  $1.2 \times 1.1$  m, and the magnification is 3.383 pixel / mm, and the accuracy of DIC displacement measurement is expected to be 0.0296 mm, and the layout of displacement monitoring points and DIC measurement system are shown in Figs. 5, 6. For geotechnical problems, the strain level measured by DIC is usually much higher than the typical measurement error range. The materials and scale dimensions of similar model tests are carefully designed. However, it is still difficult to avoid the development of plane strain, which may damage the plane strain conditions and affect the measurement results of DIC. At the same time, eight fixed control marks are placed on a similar model frame, and DIC can be used to eliminate the rigid body displacement to correct some measurement errors in the post-DIC treatment. Because the test object is a large plane similar model, the test focuses on the structural deformation of the model, focusing on the phenomena and laws presented in the test. Therefore, in this study, the use of DIC technology is helpful to measure the displacement and strain field around the roadway surrounding rock.

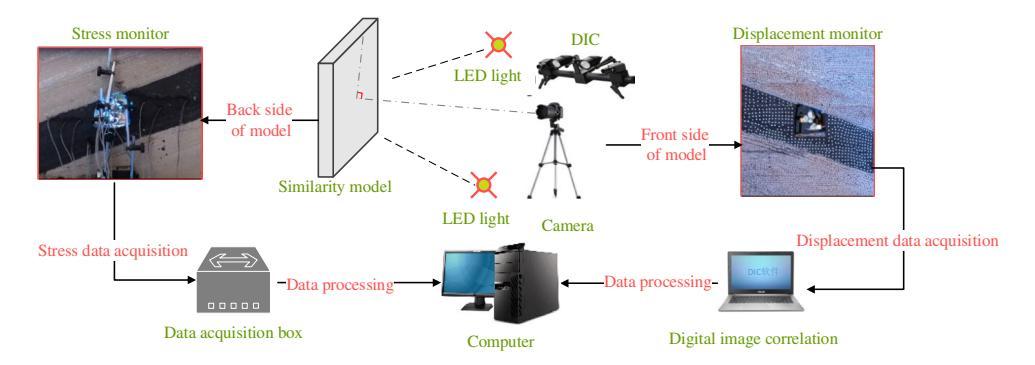
Figure 6. Flow chart of roadway deformation monitoring.

**Test procedures.** The mixture of sand, calcium carbonate and plaster powder was mixed evenly with water, and then it was layered and filled into the model test apparatus to make the physical similarity model, in which the layered thickness was controlled at 1–3 cm. The stress sensor is embedded in the corresponding position.

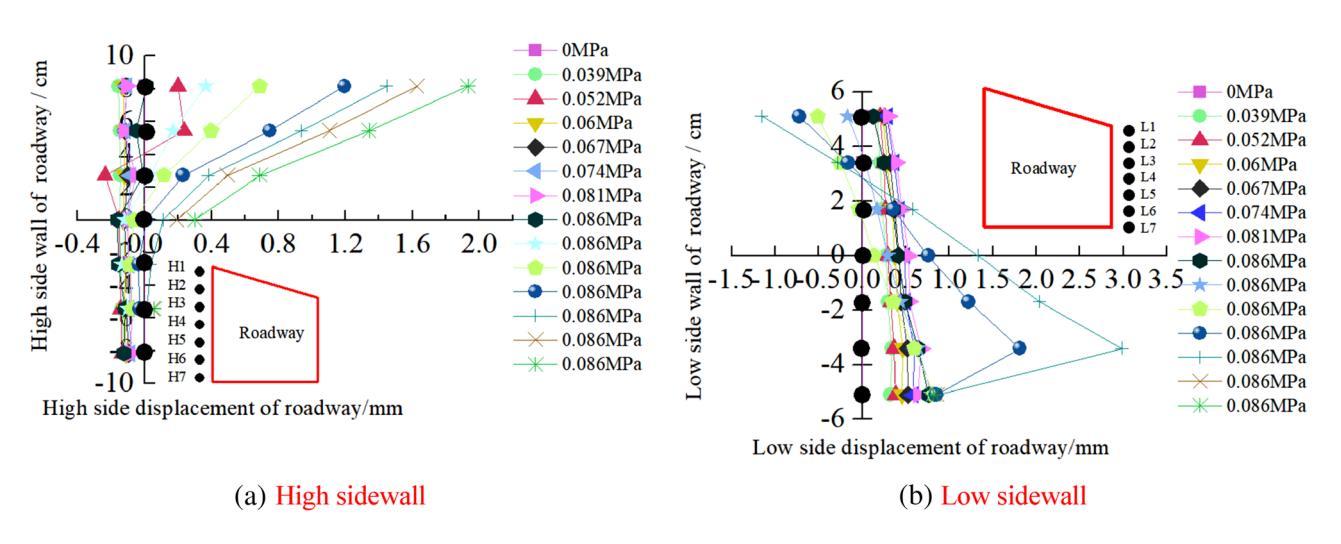
Figure 7. Evolution of surrounding rock on shallow surface of two sidewalls of roadway with loading.

Figure 7 shows the evolution of the surrounding rock on the shallow surface of the two sides of roadway with loading. It can be seen from the figure that under low load, the displacement of surrounding rock of the two sidewalls of roadway is small, and the surrounding rock of the two sidewalls of roadway is in the compaction stage. When loading to 0.063 MPa, the upper displacement of the two sidewalls of roadway began to increase, and the surrounding rock of the two sidewalls of roadway was bulging into the roadway. Combined with the displacement nephogram Fig. 8 of all the measured points on the two sidewalls of roadway is large, and the upper side of the two sidewalls of the surrounding rocks of the two sidewalls of severely bugles. With the increase of the distance from the surrounding rock in the roadway to the sidewall, the deformation is smaller, indicating that the deep surrounding rock of roadway is in the compaction stage and is relatively stable. With the continuous increase of load, the roadway's two sidewalls seriously bulge, and the maximum

displacement of the high sidewall and the low sidewall is 1.934 mm and 2.98 mm, respectively. There is no data for the last loading of the low sidewall measuring point of the roadway, indicating that the surrounding rock of the roadway's low sidewall surface is spalling and the measuring point is damaged. As shown in Fig. 19d, the surface damage of the roadway's low sidewall is more significant than that of the high sidewall surface, which shows asymmetric characteristics.

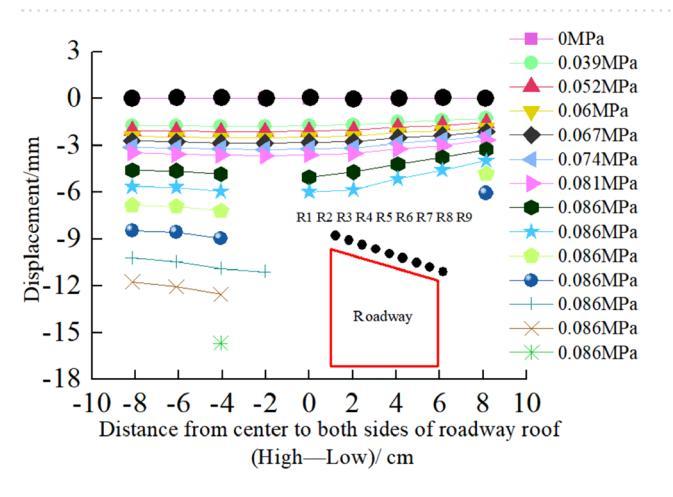
Figure 9. Evolution of surrounding rock separation layer on shallow surface of roadway roof with loading.

Figure 9 is the evolution figure of the surrounding rock separation layer loading on the shallow surface of roadway roof. It can be seen from the figure that under the action of lower load, the displacement of each measuring point of roof has little difference, and the subsidence trend is similar, which indicates that the roadway roof has good integrity at this time. When the load reaches 0.063 MPa, the subsidence of each measuring point of roof increases sharply, especially the subsidence of the middle measuring point of roof is the largest, and its value is far greater than that of the other measuring points. With the continuous increase of the load, there is no data for the middle measuring point and the low sidewall measuring point of roof, indicating that the roof is separated from the layer and caving, and the deformation of the low sidewall and the middle surrounding rock of roof is large, which leads to the damage of the measuring point. At this time, the deformation of the middle and low sidewall of roadway roof is greater than that of the high sidewall, showing asymmetric characteristics, as shown in Fig. 19d. Combined with the displacement nephogram Fig. 10 of all measuring points on the roof surface of roadway, it can be seen that the deformation of surrounding rock in the middle of roadway roof is the largest at the early stage of loading. With the increase of load, the position of the maximum deformation of roadway roof is transferred from

the high sidewall to the low sidewall, and the separation of surrounding rock of roadway roof begins to extend from the shallow part to the deep part. Finally, the deformation of the low sidewall and the low sidewall angle of roof is greater than that of the high sidewall.

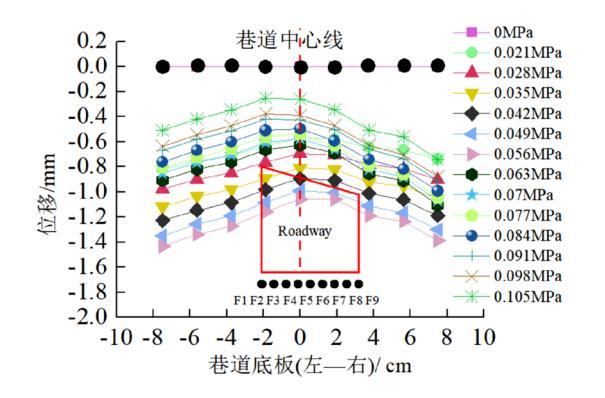
Figure 11. Evolution of floor heave of roadway with loading.

Figure 11 is the evolution figure of floor heave with loading at shallow measuring points on the roadway floor's surface. It can be seen from the figure that under low load, the displacement of floor surrounding rock is small and is in the compaction stage. When the load is 0.063 MPa, the displacement of the surface measuring point on the low sidewall of the roadway floor is larger than that on the high sidewall, resulting in the subsidence of the low sidewall of roadway floor, the bulging of the high sidewall of floor, and the dislocation of the floor. As shown in Fig. 19a, b large crack appears on the floor's high sidewall, and a slight floor heave occurs on the roadway floor, shows asymmetric characteristics. Combined with the displacement nephogram Fig. 12 of all the measuring points in the floor, it can be seen that the deformation trend of the surrounding rock in the deep part of the roadway floor is consistent with that in the shallow part, and the larger the depth of the surrounding rock in the roadway floor is, the smaller the displacement is.

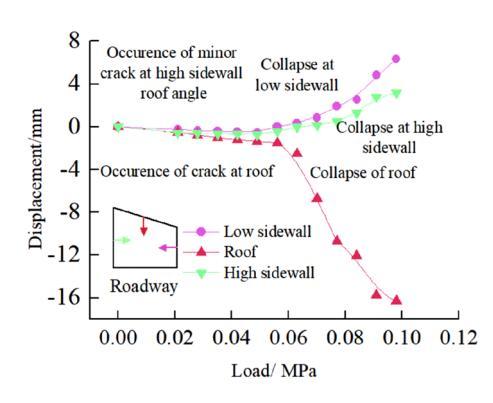
Figure 13. Variation of internal displacement of roadway with load.

*Internal displacement of roadway.* The correlations between internal displacement of roadway and loading are plotted in Fig. 13. It can be seen that when the loading is at a low level (i.e. less than 0.063 MPa), both the internal displacement of roadway are insignificant. When the load increases beyond 0.063 MPa, the displacement at roof and two sidewalls increase rapidly, whereas the deformation of the two sidewalls of the roadway is more serious than that of the roof and the displacement of low sidewall is larger than that of high sidewall. The asymmetric displacement could be caused by dip angle of coal seam and section type of roadway.

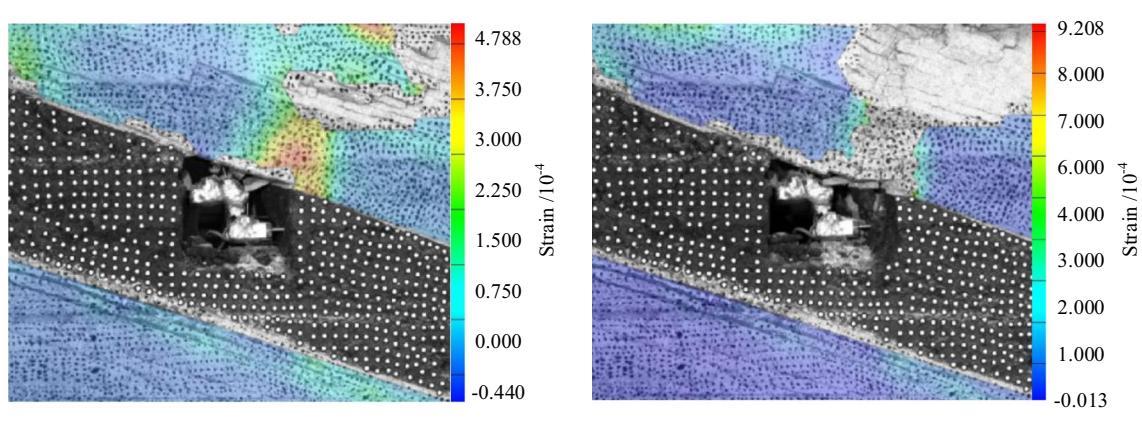
**Strain analysis of roadway surface.** Figure 14 shows the roadway's strain nephogram when the load reaches 0.07 MPa and the final failure surface of the roadway. It can be seen from the figure that when the load reaches 0.07 MPa, the strain of the roof of roadway is concentrated in the low sidewall, showing an asymmetric "Beret" type. Finally, the surface of the low sidewall of roadway roof is peeled off, the measuring point is invalid,

and the asymmetric delamination collapse occurs. In this study, DIC technology explains the "Beret" of the surrounding rock above the roadway roof. The strain profile of type an asymmetric deformation reveals the process of asymmetric deformation and the failure of inclined strata.

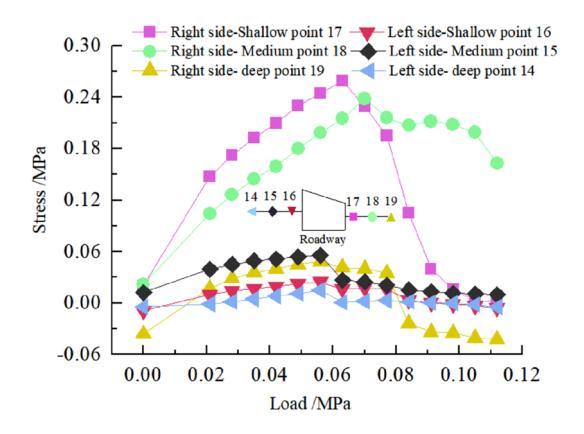
Figure 15 shows the variation curve of surrounding rock stress of two sidewalls of roadway with loading. It can be seen from the figure that in the 0–0.063 MPa loading stage, the stress of 17 and 18 measuring points in the low sidewall of roadway increases rapidly, and the stress concentration occurs, while the stress of 19 measuring points in the low sidewall of roadway and all measuring points in the high sidewall of roadway increases steadily. When the load reaches 0.063 MPa, the stress concentration of roadway low-sidewall measuring point 17 reached the maximum, and the stress concentration coefficient was 4.1. The stress distribution of roadway high-sidewall measuring points 15 and 14 also reached the maximum, without stress concentration, and the stress value of high-sidewall measuring point 15 was the maximum. In the 0.063-0.112 MPa loading stage, the stress of 17 measuring points in the low sidewall of the roadway decreased sharply. Simultaneously, the stress of 18 measuring points in the roadway's low sidewall continued to increase to the maximum and then began to decrease, indicating that the stress concentration in the low sidewall of roadway transferred from the shallow to the deep. The stress of the high sidewall of roadway began to decrease slightly and finally stabilized. Overall, the stress of the low sidewall of roadway is greater than that of the high sidewall, showing asymmetric characteristics. The maximum stress of roadway's low sidewall appears in the shallow part of the roadway side, and the maximum stress of the high sidewall appears in the middle of the roadway side. The measuring point's stress value in the deep part of the two sidewalls of roadway is the smallest.

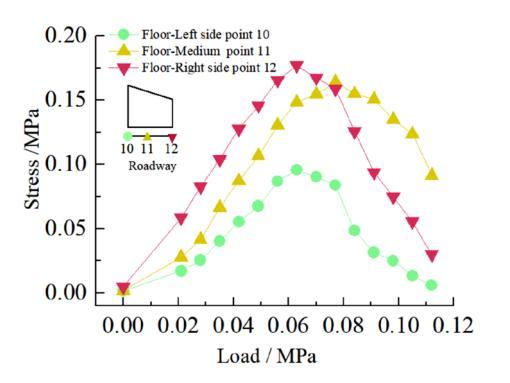
Figure 17. Curve of roadway floor stress with load.

Figure 17 shows the variation curve of surrounding rock stress of roadway floor with loading. It can be seen from the figure that under the action of load, the stress of each measuring point of roadway floor

increases rapidly, and the stress concentration occurs. When the load reaches 0.063 MPa, the stress concentration of each measuring point in the roadway floor reaches the maximu, and the stress concentration factors of roadway floor low sidewall, middle and high sidewall measuring points are 2.8, 2.1 and 1.5, respectively. From this, it can be seen that the stress concentration of the low sidewall of floor is the largest, followed by the middle of roadway, and the minimum is the high sidewall of roadway, indicating that the stress distribution of the roadway floor is asymmetric.

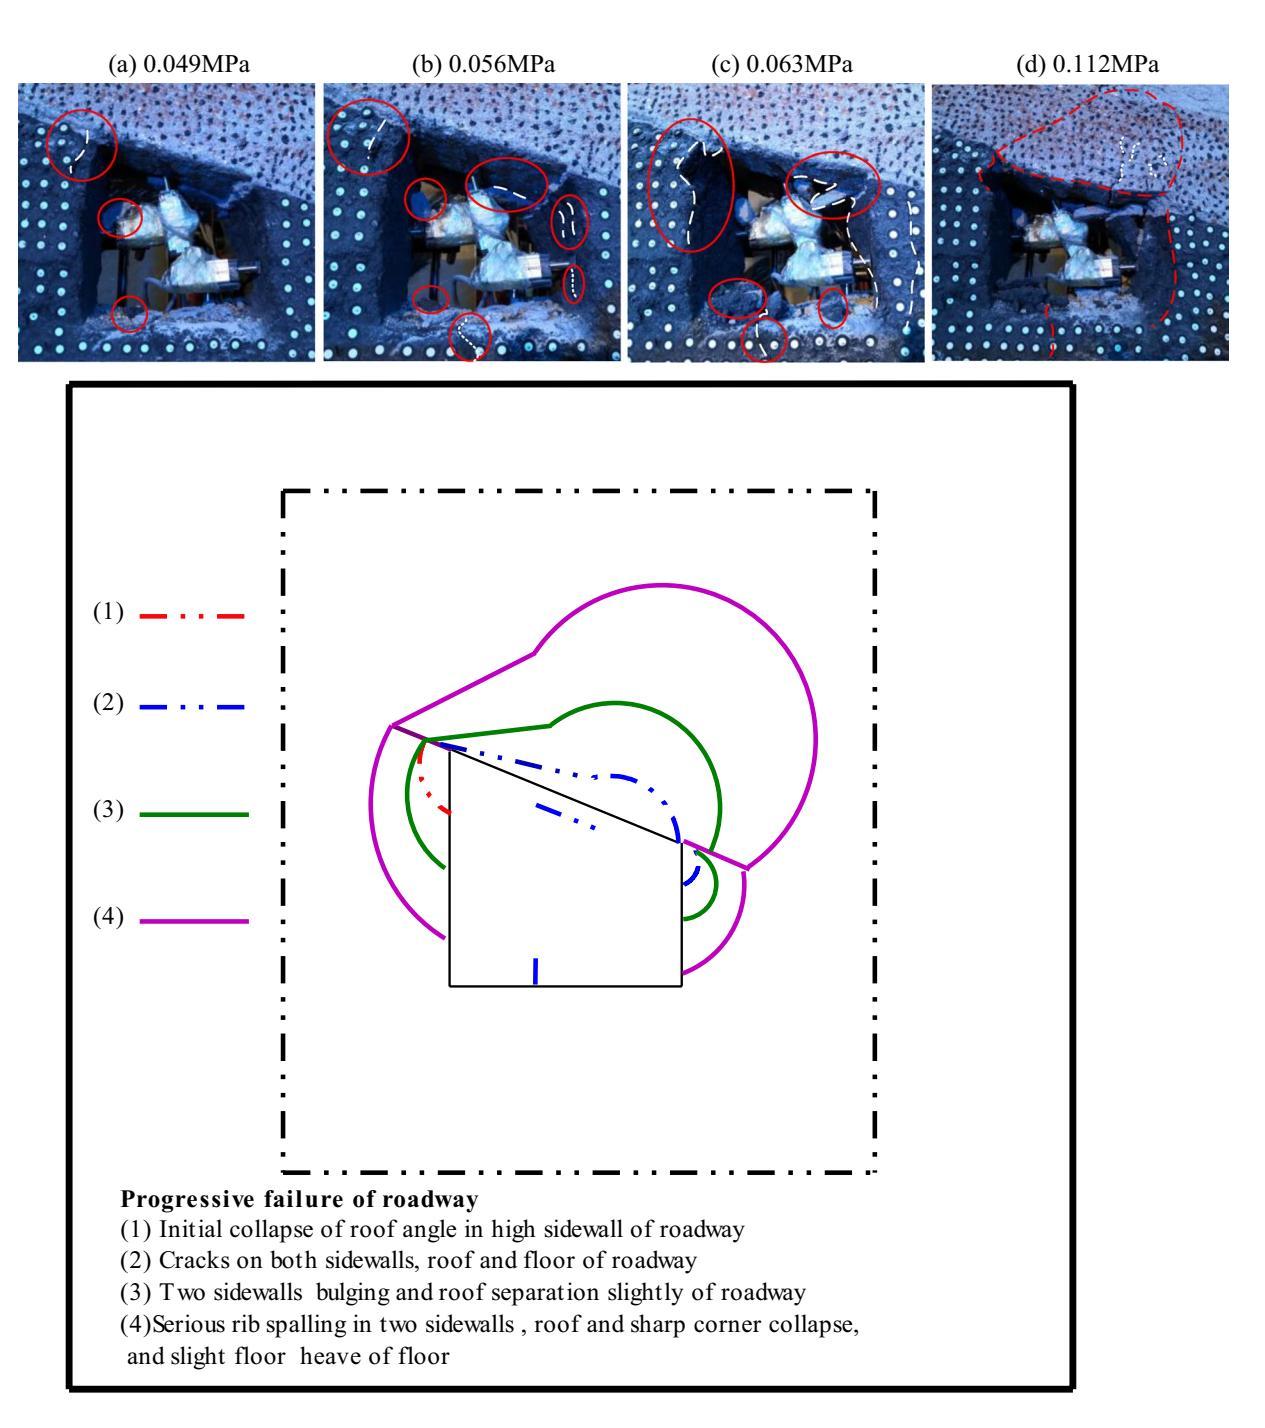
Figure 19. Cyclic failure of roadway.

**Deformation and failure characteristics of roadway surrounding rock.** The deformation and failure characteristics of the roadway surrounding rock are the most direct embodiment of its failure. With the increasing external load, the roadway's surrounding rock begins to deform slightly, and then cracks, crack propagation, local fracture, and overall failure occur, as shown in Fig. 19.

- (1) When the load reaches 0.049 MPa, the stress concentration of the roof angle of roadway's high sidewall reaches the maximum value, and the stress concentration coefficient is 3.1. The first fine cracks appear on the surface of the roof angle of the high sidewall of roadway. The fine cracks' length is 20–40 mm, and the roof angle of the high sidewall occurs local collapse, as shown in Fig. 19a.
- (2) When the load reaches 0.056 MPa, the stress of roof angle of the high sidewall of roadway begins to decrease, and the stress concentration shifts to the roof angle of the low side. The stress concentration on

the roadway roof's high sidewall reaches the maximum value, and the stress concentration coefficient is 3.4. A large crack appears on the internal sidewall of roadway roof. The stress in the middle of roadway's high sidewall reaches the maximum, and there is no stress concentration. However, due to the influence of the roof sharp angles' stress concentration, there are fine cracks on the upper side of the roadway's high sidewall. The stress of the roadway's low sidewall and floor surrounding rock increases, and the stress concentration appears. The stress concentration of the roadway floor low sidewall is greater than that of the roadway's high sidewall. At this time, two large cracks appear in the roadway's low sidewall, and a crack appears in the roadway floor high sidewall, as shown in Fig. 19b.

(3) When the load was 0.063 MPa, the roof angle of the roadway's high sidewall collapsed greatly, and the stress concentration at the roof angle of low sidewall of roadway reached the maximum value with the stress concentration coefficient of 1.57. The roof angle of the low sidewall of roadway collapsed locally. The stress of roadway roof and high sidewall began to decrease, the roadway roof separated from the layer, and a large main crack and many small cracks appeared in the high sidewall. The stress concentration of the shallow surrounding rock of the roadway's low sidewall reached the maximum value, with the stress

concentration coefficient of 4.1. The roadway's low sidewall slightly bulged, and a crack appeared on the surface of the roadway's low sidewall. The stress concentration at the roadway floor's low sidewall reached the maximum value, with the stress concentration coefficient of 2.7, as shown in Fig. 19c.

(4) When the load was 0.112 MPa, it is that the roadway's plastic deformation occurs at this time and the stress concentration of the surrounding rock of the low sidewall of roadway transfers to the deep surrounding rock of the low sidewall. Continuous loading until the roadway is completely destroyed, the two angles of roadway roof collapse and the failure of roof angle of the low sidewall of roadway is greater than that of the high sidewall. The roof of roadway floor deepened, and slight floor heave occurred, but the stress at the two corners of the roadway floor changed little and was relatively stable. Finally, only one crack appeared at the low sidewall angle of floor surface. The two sidewalls of roadway are seriously fragmented. The upper side of the roadway's high sidewall is partially collapsed, and the low sidewall of roadway is bulging, all of which are collapsed. The surrounding rock of roadway surface is exfoliated, and the damage of the roadway's low sidewall is greater than that of the high sidewall, showing asymmetric characteristics, as shown in Fig. 19d.

Cyclic deformation mechanism of roadway surrounding rock. Under the action of load, the failure of the right angle trapezoidal roadway in inclined coal seam originates from the sharp corner of the roadway roof, and then the roadway roof, floor, and two sides begin to damage. The interaction of various areas of roadway surrounding rock leads to the increase of stress and the decrease of strength. The roadway surrounding rock enters a vicious cycle of deformation until the roadway presents the characteristics of asymmetric failure. Since the section type of inclined coal seam roadway is a right-angle trapezoid, the stress concentration is easy to occur at the sharp angle of the roadway roof, and the stress concentration at the sharp angle of the high sidewall of the roof first reaches the maximum value, resulting in cracks. With the increase of load, the roof's stress concentration, two sidewalls, and roadway floor also reached the maximum. At this time, cracks appeared in the roof's internal sidewall, the high sidewall of the floor and the two sidewalls, and then the roof was slightly separated, the two sidewalls bulged, and the floor of roadway was slightly heaved. As the load continues to increase, the stress concentration of the roadway's low sidewall transfers to the deep, and the failure of the surrounding rock of the low sidewall of the roadway extends from the shallow to the deep. At this time, the two sidewalls of roadway appear spalling and slight collapse, and the failure of the low sidewall of roadway is greater than that of the high sidewall, which leads to the decrease of the support capacity of roadway, increases the span of roadway, and aggravates the separation of the roof. The deformation of the roof increases the pressure of the two sidewalls and intensifies the two sides' failure. As the connection part, the corner continues to deteriorate the stress state. Finally, the two sidewalls' failure extends to the deep part, which deteriorates the roof's stress conditions. The roof rapidly collapses from the floor, showing an asymmetric "Beret" type of caving arch failure. That is, the roadway has two sidewalls, two sharp angles of the roof, and the roof falls into a vicious cycle that increases each other's stress, weakens the material, and intensifies the failure. This cycle continues until the roadway is completely unstable.

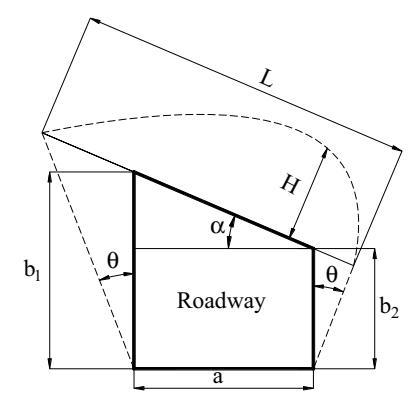
Figure 20. Loose ring of roadway roof.

Due to the influence of dip angle on the roof of inclined coal seam roadway, the stress distribution of the two sidewalls shows asymmetric characteristics, which leads to the asymmetric "Beret" type caving arch of the roof loose circle of the roadway (as shown in Fig. 20). According to Pu's theory, the range of roof loose circle *H* is shown in Eq. (2):

where *H* is the range of roof loose circle;  $\alpha$  is the dip angle of rock stratum, is 23°; *a* is the width of roadway, and its value is 3 m; *b*<sub>1</sub> the height of high sidewall of roadway, and its value is 4.91 m; *b*<sub>2</sub> is the height of low side of roadway, and its value is 3 m; *f* is the Pu's coefficient of roof rock, and its value is 2.3;  $\varphi$  is the internal friction angle of the rock mass in the two sidewalls, and its value is 28°; *c* is cohesion, and its value is1.4; The calculation results show that the range of roadway roof loose circle is 1.93 m.

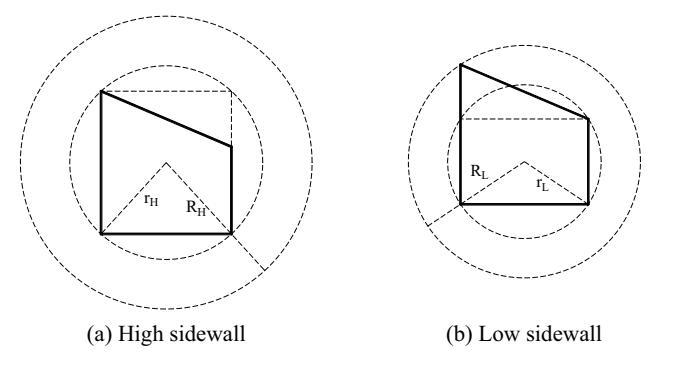
Figure 21. Loose circle of two sidewalls of roadway.

Due to the plastic zone of the two sidewalls of the right angle trapezoidal roadway in inclined coal seam is asymmetric, the section form is simplified to different circular roadways (as shown in Fig. 21). According to the elastic–plastic mechanics, the range of the loose circle of the high sidewall and the low sidewall of the roadway is  $R_{H}$  and  $R_{L}$ , respectively, as shown in Eqs. (4) and (5):

Where  $R_H$  and  $R_L$  are the range of loose circle of high and low sidewalls of roadway, respectively; *P* is vertical original rock stress, and its value is 10 MPa;  $\alpha$  is the dip angle of rock stratum, and its value is 23°; *a* is the width of roadway, and its value is 4.5 m;  $b_1$  the height of high sidewall of roadway, and its value is 4.91 m;  $b_2$  is the height of low side of roadway, and its value is 3 m;  $\varphi$  is the internal friction angle of the rock mass in the two sidewalls, and its value is 28°; *c* is cohesion, and its value is 1.4. The calculation results show that the range of the left side loose circle is 1.58 m, and the range of the right side loose circle is 1.1 m.

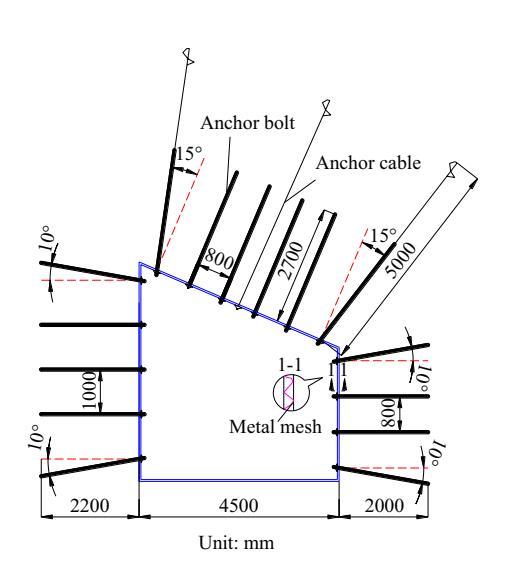
Figure 22. Support scheme of roadway.

According to the engineering analogy and experience, the length of the left side anchor bolt is 2.2 m, the length of the right side anchor bolt is 2.0 m, and the row distance between the two sides of the roadway is 0.8 m.

According to the above theory's calculation results and the asymmetric deformation and failure of the roadway and the existing support experience, and a new support scheme was developed for the roadway of No.2 Mining Srea of Shitanjing, as shown in Fig. 22. The following support systems were applied:

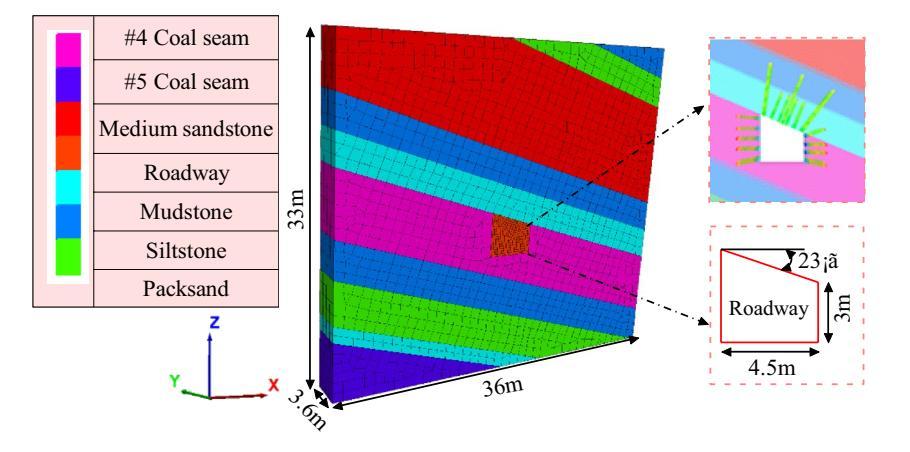
Figure 23. 3D computing model.

**Support effect of numerical simulation.** *Establishment of model.* Based on the engineering geological conditions of Shitanjing No. 2 mine, the numerical calculation model is established by using FLAC3D software. The model size is  $33 \text{ m} \times 3.6 \text{ m} \times 36 \text{ m}$ , the dip angle of the coal seam is  $23^{\circ}$ , and 10 MPa vertical stress is applied on the top surface of the model to simulate the action of in-situ stress. Considering the calculation accuracy, the

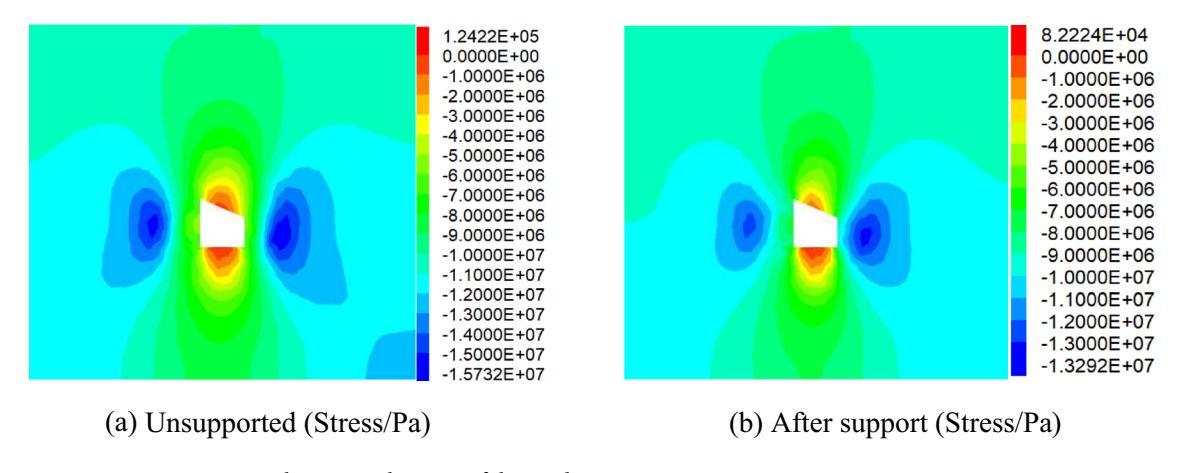
**Figure 24.** Vertical stress nephogram of the roadway.

Figure 24, 25 shows the vertical and horizontal stress nephogram of before and after roadway support. It can be seen from the figure that after roadway support, compared with that without support, the vertical stress distribution of roadway surrounding rock is uniform, which makes the original skewed stress asymmetric distribution transfer to the middle of roadway roof and floor, and the difference of stress concentration distribution between the two sides of roadway is significantly reduced. The horizontal stress

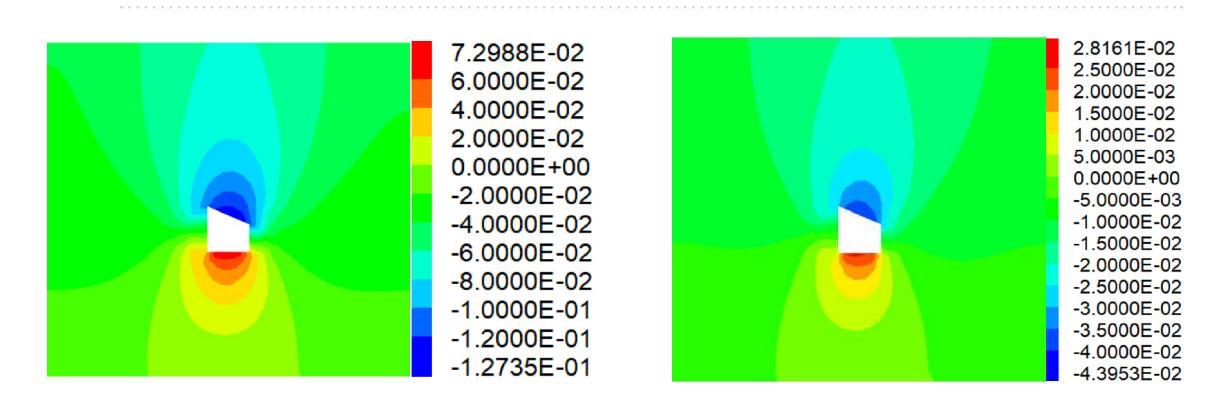
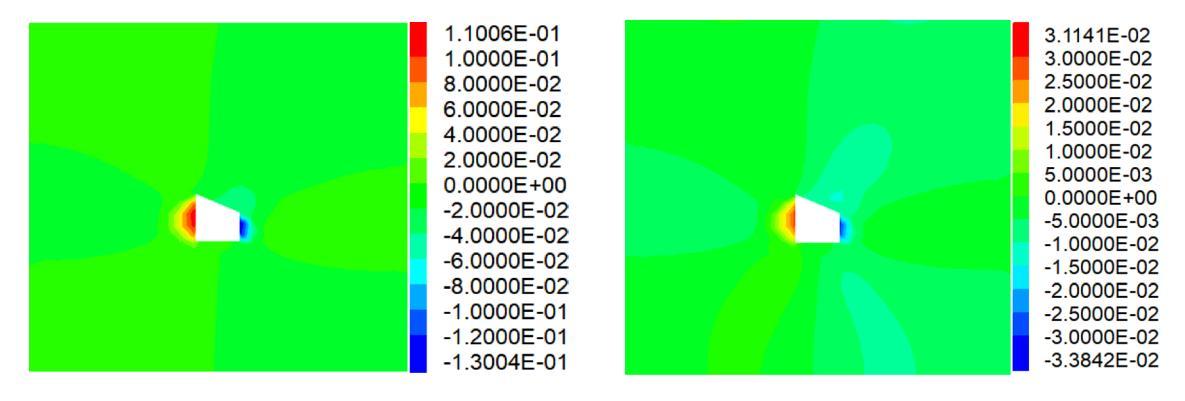
Figure 26, 27 shows the vertical and horizontal displacement nephogram of before and after roadway support. It can be seen from the figure that after roadway support, the maximum subsidence of roadway roof is reduced from 127.3 to 44.0 mm, the maximum floor heave of roadway is reduced from 73.0 to 28.2 mm, the maximum displacement of right side of roadway is reduced from 130.0 to 33.8 mm. and the maximum displacement of left side of roadway is reduced from 110.0 to 31.1 mm. It shows that the deformation of

roof, floor and two sides before and after roadway support is significantly reduced, and the asymmetric deformation of roadway is effectively controlled.

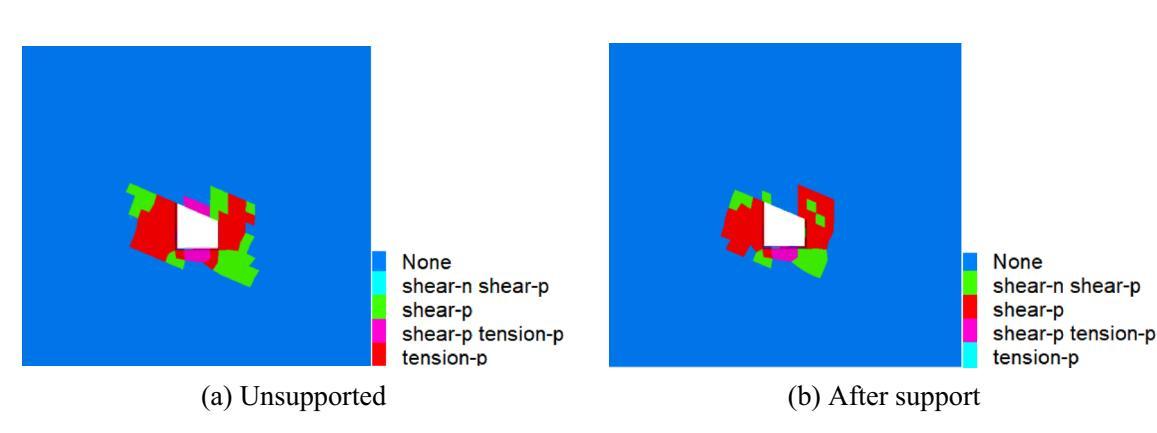
Figure 28. Plastic zone nephogram of the roadway.

Figure 28 Plastic zone nephogram of roadway surrounding rock. It can be seen from the figure that after roadway excavation, under the action of stress redistribution, the distribution of plastic zone of roadway surrounding rock presents asymmetric characteristics, that is, the range of plastic zone on the right side of roadway is larger than that on the left side, and the roadway surrounding rock presents shear failure. After roadway surrounding rock support, the distribution range of plastic zone decreases, and the plastic zone on the left and right sides is more uniform. It shows the improvement of roadway surrounding rock deformation.

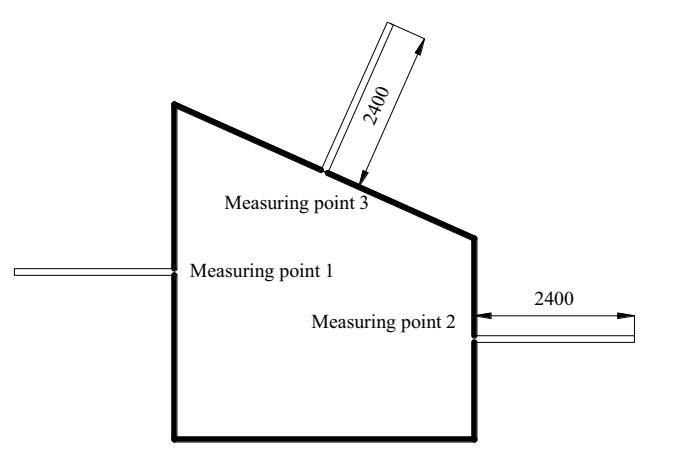
Figure 31. Layout of monitoring points of roadway loose circle (mm).

**Field measured support effect.** In order to detect the effect of asymmetric roadway support, the support scheme is applied to the mining roadway of the working face, and the monitoring station is arranged in the typical section of the surrounding rock of the roadway, and the layout of monitoring points is shown in Figs. 29, 30, and 31. The monitoring results are shown in Figs. 32, 33, 34, and 35.

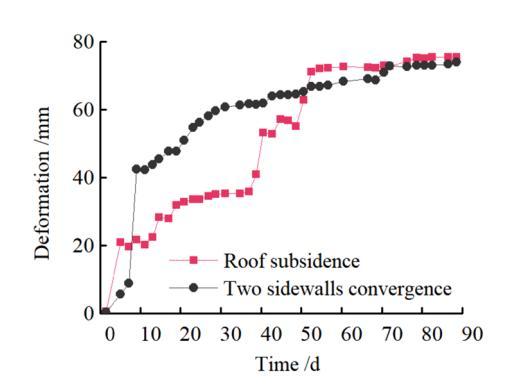
Figure 32. Deformation of Roadway.

It can be seen from Figs. 32, 33, 34, and 35, the maximum settlement of the roof is 75 mm, and basically stable after 13 days. The maximum relative convergence of the two sidewalls is 74 mm, which is basically stable after 15 days. The maximum roof separation occurred in 1.2–1.6 m. After 12 days, the roof separation stabilized, and the maximum separation was 10 mm, and its maximum separation occurred in the range of anchor bolt support. The maximum axial force of the roof anchor bolt is 35 kN. The loose circle range of the roadway roof is 1.4–1.7 m, and the loose circle range of two sidewalls is 1.2–1.5 m, which is basically consistent with the results of theoretical calculation. The subsidence of the roof, the convergence of the two sidewalls, and the stress of the anchor bolt are less than the design requirements, indicating that the asymmetric support scheme effectively controls the deformation of the surrounding rock of the roadway, improves the stability of the roadway, and the support effect is good. It can be seen that the asymmetric support technology of inclined coal seam roadway has good applicability.

- (5) The asymmetric support scheme was later verified by on-site engineering practice. Under this scheme, the maximum value of roof subsidence was 75 mm, the maximum cumulative deformation value of two side walls was 74 mm, The maximum roof separation occurred in 1.2–1.6 m, and the maximum separation was 10 mm. The maximum axial force of the roof anchor bolt is 35 kN. The loose circle range of the roadway roof is 1.4–1.7 m, and the loose circle range of two sidewalls is 1.2–1.5 m. Thus, the asymmetric support scheme successfully met the requirements for safe mining operations.
