SCIENTIFIC REPORTS

Statistical study of ductility-dip cracking induced plastic deformation in polycrystalline laser 3D printed Ni-based superalloy

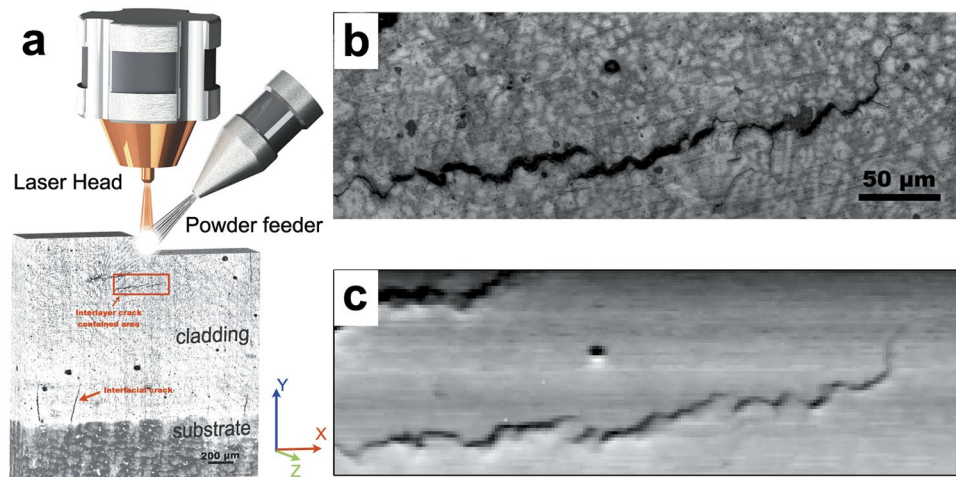
Figure 1. Schematic of 3D printing specimen preparation and microstructure characterization. **(a)** Laser 3D printing setup and a low magnification optical micrograph showing two types of cracks parallel and perpendicular to the substrate/cladding interface. **(b)** Optical microscope image of the investigated crack containing region. **(c)** Raw intensity map generated from μ XRD to show the cracks as low intensity pixels with reasonable contrast and spatial resolution.

Schematically shown in Fig. 1a, a ~0.8 mm thick thin-walled sample was prepared by laser 3D printing without strict process optimization on a 001 directionally solidified DZ125L Ni-based superalloy. For convenience, a Cartesian coordinate system **O-XYZ** was established, with **X**-axis parallel to the laser scanning direction and **Y**-axis perpendicular to the cladding-substrate interface. In 3D printing, the surface of the substrate or the last solidified layer and the feeding powder are heated above the melting point by the focused laser to form a molten pool, generating a temperature gradient from the molten pool to the other parts of the material, especially along the **Y**-direction in this thin-walled structures²⁷. As the laser spot is moved away, the molten material solidifies rapidly. Unintended cracks were observed under an optical microscope (OM) in the deposited materials without

μXRD microstructure characterization. A $400\ \mu\text{m}$ by $130\ \mu\text{m}$ area, almost identical to the one shown in the optical micrograph in Fig. 1b, was scanned using a micro-focused synchrotron polychromatic X-ray beam with a $2\ \mu\text{m}$ step size. In order to analyze the materials microstructure and its deformation mechanism, it is essential to visualize the crack, i.e. to know where the crack was relative to the X-ray beam position within the scanned area. Hence a newly developed intensity mapping approach was employed²¹. From the generated raw intensity map (Fig. 1c), the crack appears with reasonable contrast and spatial resolution, as low intensity pixels. Therefore in our following analysis, a threshold intensity value was applied, below which the diffraction patterns would be considered to originate from deeper regions within the crack.

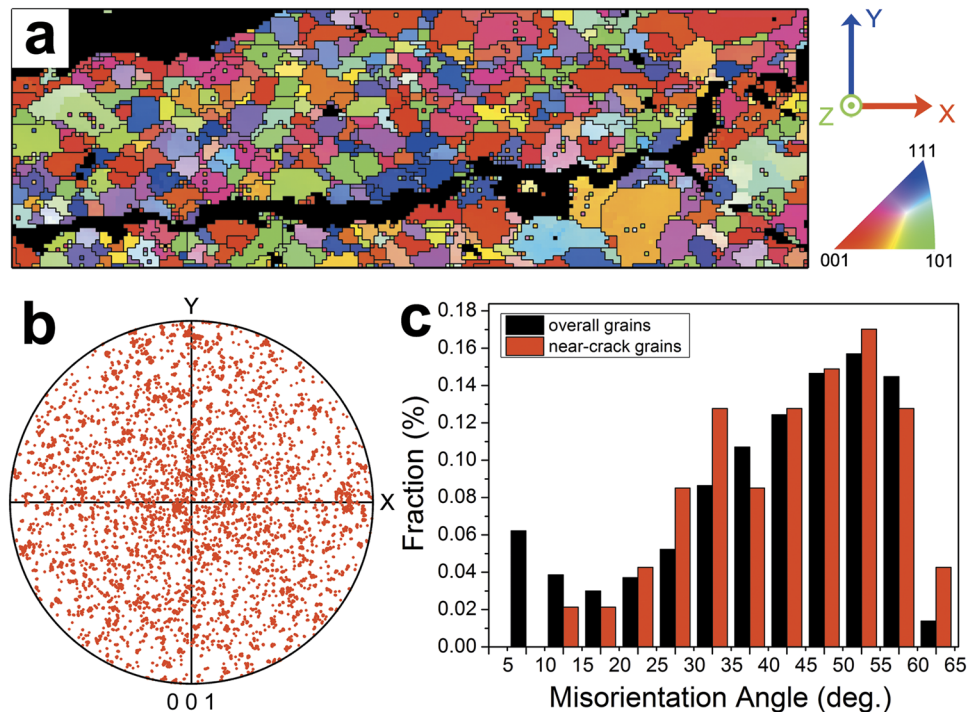
Figure 2. Crystal orientation characterization of the crack containing region. (a) The inverse pole figure map showing the crystal orientation along xx-axis. (b) The inverse pole figure showing random crystal orientation distribution in the scanned region. (c) Statistical distribution of GB misorientation for the overall scanned area and the grains adjacent to the crack, respectively.

The recorded Laue diffraction patterns were indexed using the software package XMAS²⁸, and the crystal orientation distribution was mapped in the inverse pole figure of X-axis in Fig. 2a. The crystal grain size spanned from about $5\ \mu\text{m}$ to $20\ \mu\text{m}$, and no obvious correlation could be found between grain size and distance of the grain to the crack. No deformation twinning was detected in the region investigated. From the inverse pole figure shown in Fig. 2b, it can be seen that the crystal orientation distribution in the scanned region was almost random, making this crack ideal for a statistical study of how the plastic deformation occurred during the cracking in grains in function of grain orientation. In Fig. 2c, it can be seen that the GB misorientation of the scanned area distributed mainly between 40° and 60° . By computing the misorientation angle between each pair of grains on top and at the bottom of the crack trace (the intersection of the crack plane with the cross section surface)²⁹, it is confirmed that the crack is intergranular and occurred along HAGBs. The distribution of the misorientation angles along the crack is slightly higher than that of the overall map. It should be noted that it is difficult to deduce from this map the nucleation spot and propagation direction of the crack, and no clear precipitate density gradient was observed along the crack.

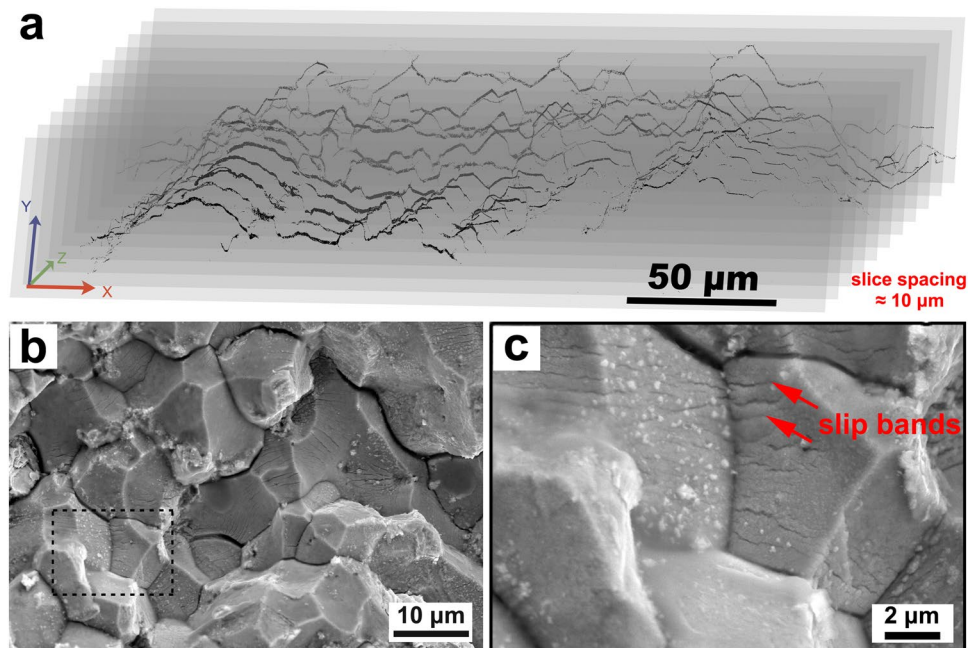
Figure 3. 3D morphological reconstruction of the crack plane and its SEM characterization. (a) Slices reconstruction of the crack with the slice-spacing of $\sim 10\ \mu\text{m}$. (b) Low magnification image of the crack plane, with sharp crystal facets. (c) The high magnification topography of the dashed area (b), exhibiting nano sized precipitates and slip bands (red arrows).

3D morphology characterization. The 3D morphology of a crack which also appeared roughly parallel with the X-axis in the stray grain region was rendered with a sequential slicing method. First of all, a mirror finish of the XY cross-sectional region that contained a visible crack was obtained using mechanical polishing, and then the surface topography was recorded in an SEM. Then the surface was further polished off by $10\ \mu\text{m}$ with a micrometer-based thickness monitoring system, before the second SEM image was taken. This procedure was repeated several times until the crack disappeared. With this method, the crack was visualized to be a corrugated plane approximately parallel to the XZ plane and perpendicular to the thermal gradient Y-direction (Fig. 3a).

Crack plane characterization. Another crack-containing sample with the same parameters was torn off along a crack for morphological characterization of the cracking plane. In the SEM image taken in secondary electron mode (Fig. 3b), the crystal grain facets confirm, once again, that the crack propagated along GBs rather than through crystal grains, agreeing well with the cross-sectional view. The magnified image in Fig. 3c revealed a large quantity of nano-sized precipitates. Due to their tiny size and small volume fraction over the total materials, diffraction signals from the precipitates appeared too weak for phase identification, while previous literatures suggested that they were probably carbides¹⁹. Persistent slip bands (PSBs) were visible in most facets of the crystal grains, marked by red arrows, indicating that the high density of dislocations in the grains next to the crack must have interacted actively with the grain boundaries and crack.

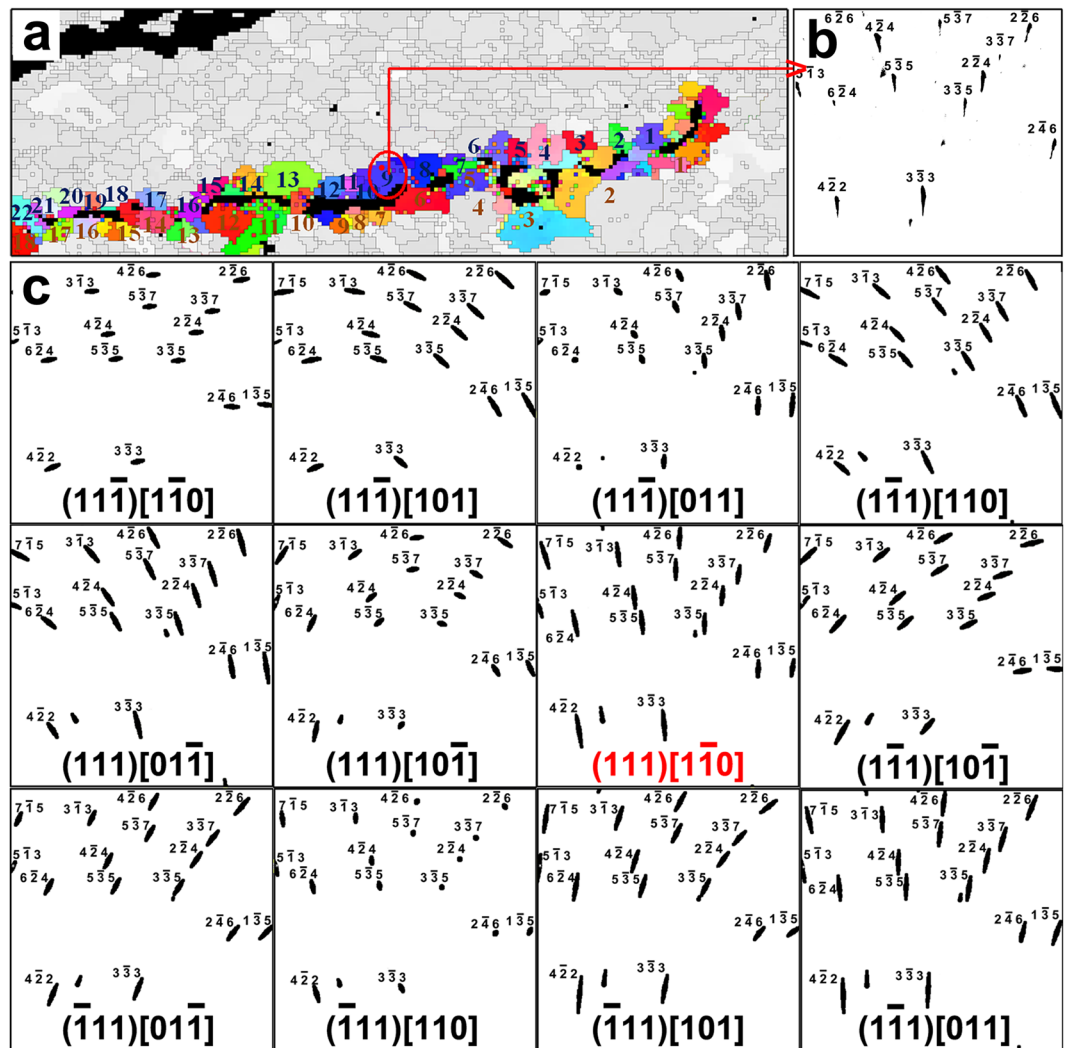
Figure 4. Deformation characterization of the crystal grains adjacent to the crack. (a) Numbered grains next to the crack, selected for plastic deformation study. (b) The Laue diffraction pattern with all reflections indexed as an example taken from Grain #9 on top of the crack. (c) Simulations of the Laue peak streaking direction corresponding to all the 12 possible $\{111\}/\langle 110 \rangle$ slip systems of face-centered cubic structure by utilizing the software package XMAS. The one highlighted in red is the best match of the simulated shapes with pattern shown in (b).

Dislocation slip system characterization. Dislocation activities were characterized for investigation of the plastic deformation occurring during cracking. A total of 40 crystal grains adjacent to the crack were selected for statistical analysis, 22 of which on the upper side and 18 on the lower side. These grains are numbered and highlighted in color in Fig. 4a. Three to five diffraction patterns in each grain were investigated, and it was concluded that the diffraction peaks were anisotropically streaked in all of them, indicating that high density of geometrically necessary dislocations (GNDs) were activated in all grains along the crack¹⁹. Moreover, different Laue patterns recorded in the same grain show almost identical peak shape, suggesting that the dislocation slip system was uniform in each grain. To determine the dislocation type and slip system active in each grain, experimental data were compared to simulated ones. As an example, the Laue diffraction pattern of Grain #9 with all reflections indexed is shown in Fig. 4b. The Laue peak streaking direction was simulated for each different dislocation types (edge and screw) and all the 12 possible $\{111\}/(110)$ slip systems of a face-centered cubic structure utilizing the software package XMAS (Fig. 4c). The simulations were based on the basic principle that different dislocation types and slip systems would induce anisotropic lattice distortion and crystal plane bending, and thus the Bragg condition will deviate from the ideal defect-free case. The simulated pattern that best match the experimental one was chosen to represent the actual active slip system. In the case of Grain #9, it is determined that edge-type $(111)/[1-10]$ GNDs were activated. The best match simulation result for Grain #9 is shown in Fig. 5a, and the streaking Laue peaks were magnified and displayed around the simulated pattern for comparison. Once the activated slip system was determined, the direction of the uniaxial stress was derived by varying the stress direction all around the three-dimensional (3D) space and calculating the Schmid factor for each particular stress

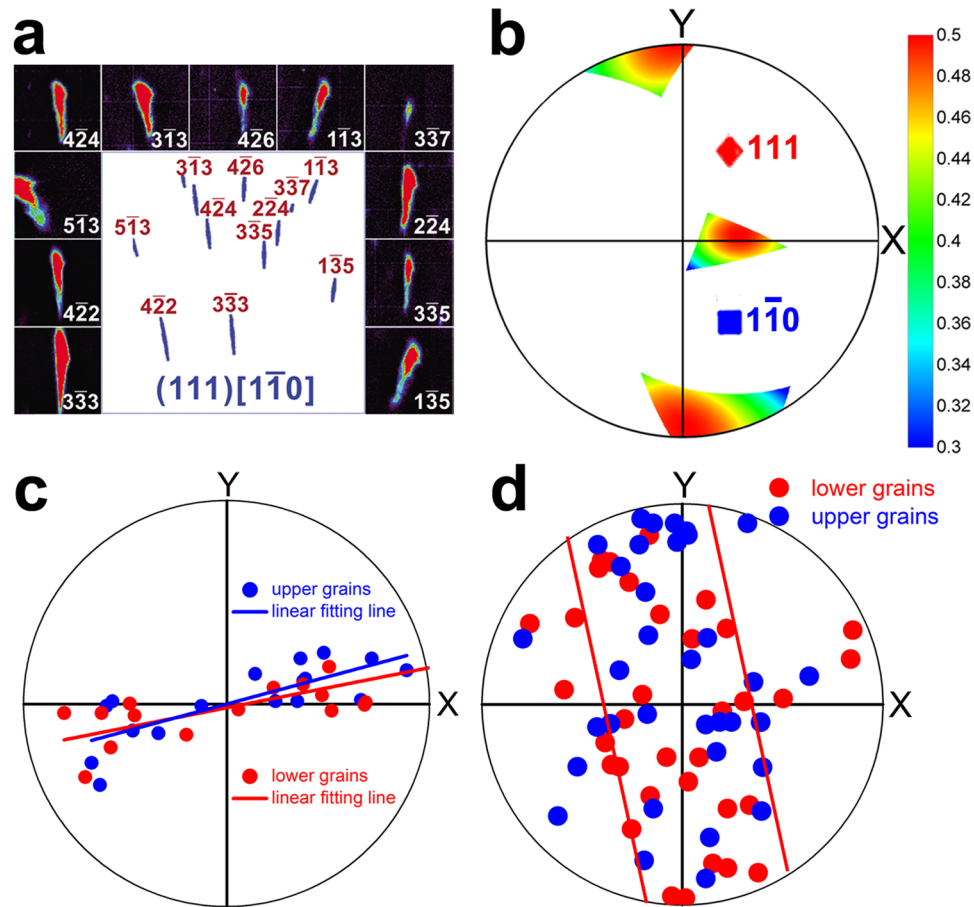
Figure 5. Statistical study of the dislocation slip systems of the crystal grains adjacent to the crack. (a) Dislocation slip system study for Grain #9. The simulated streaking Laue peaks with (111)/[1–10] GNDs are displayed surrounding the experimental observed Laue diffraction pattern. (b) The calculated Schmid factor as a function of equivalent uni-axial tensile stress direction. (c) Stereographic projection on XY plane of the dislocation line directions in investigated grains above (blue) and below (red) the crack, respectively. (d) Stereographic projection of the equivalent uni-axial tensile stress direction in each of the forty grains calculated according to Schmid's law.

direction. According to Schmid's law, the most probable stress direction corresponds to the highest Schmid factor, which means we can use the Schmid factor to find the highest resolved stress for the confirmed slip system and infer the tensile axis direction. As demonstrated in Fig. 5b, the direction of the uniaxial stress imposed on upper Grain #9 was, probably, along approximately either along *Y*- or *Z*.

The activated dislocation slip systems in all the selected forty crystal grains were characterized, and it was found that in all these grains the GNDs were edge-type dislocations. The dislocation line direction in each grain was projected onto the *XY* plane and plotted in Fig. 5c. Each blue dot in the figure represent the dislocation line direction in a grain on top of the crack, while the red dots represent those from the grains at the bottom. Interestingly, the blue and red points fall into the same line that approximately coincide with the average crack plane, indicating that the dislocation line direction in each individual grain was almost parallel to the crack plane according to the nearly horizontal 3D morphology of the cracking. Considering the characteristic relationship in edge dislocations, the slip planes and slip directions (Burgers vectors) in all these grains appeared normal to the dislocation trace. Similarly, the uniaxial force directions were also plotted in a stereographic projection. For most of the crystal grains investigated, the force direction projection distributed within the range indicated by the red lines in Fig. 5d.

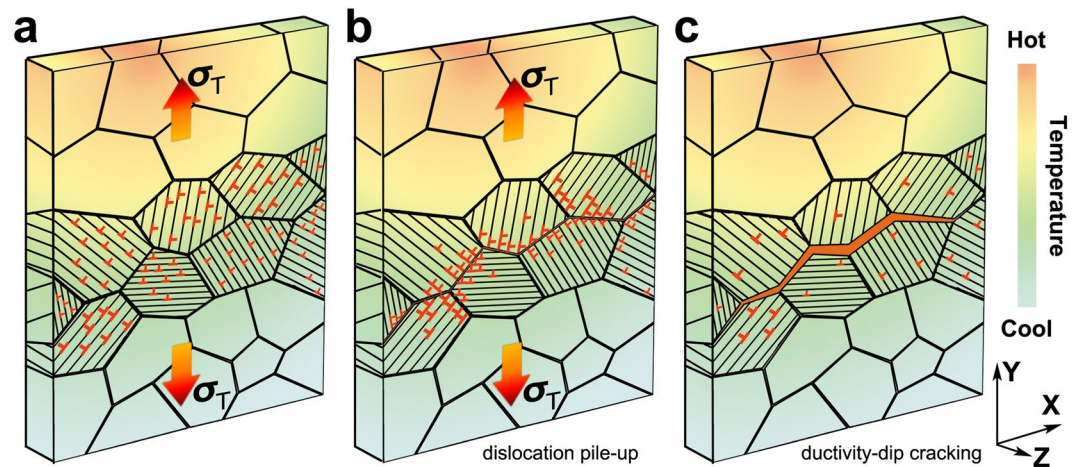
Figure 6. Possible schematic of the crack formation mechanism induced by thermal stress. (a) Sample under thermal stresses in the possible directions induced by temperature gradient, with dislocations activated mainly in the XZ plane. (b) Dislocations pile-up at the GBs, resulting in high deformation locally. (c) Void and crack formation caused by elevated local distortion.

From the experimental results, a qualitative explanation of dislocations activation, dislocation piled up, and crack formation at the GBs emerges and is demonstrated schematically in Fig. 6. First of all, it must be emphasized

that the crack formation temperature has to be lower than the melting temperature, thus the crack forms after solidification. On the other hand, elevated temperature is still necessary to generate thermal gradient and thermal stress, and also reduce the material ductility. Once the tensile thermal stress, roughly perpendicular to the XZ plane, reaches the yield stress of the crystal grain, GNDs are activated, according to Schmid's law. The dislocations slipped inside the crystal grains until they stopped and accumulated at HAGBs, where the materials microstructure becomes discontinuous. It should be mentioned that dislocations with opposite signs will propagate in the opposite direction until they meet the other side of the grain boundaries. However, according to our observation, the misorientation angles of the crystal grains adjacent to the crack are statistically higher than the average. It suggests that the dislocations are more probably blocked by the GBs with higher misorientation angles than the ones with lower misorientation angles. As the local density of dislocations at GBs increases, and perhaps with assistance from intergranular precipitates, the local strain near the GBs may exceed the material inherent ductility, resulting in void formation and eventually crack formation. From previous studies and postulates, medium homologous temperature favors crack formation, because in this temperature range the ductility of the materials is low. This statement is however difficult to be experimentally proven or rejected from our available data.
