# It's not rocket science — or is it?

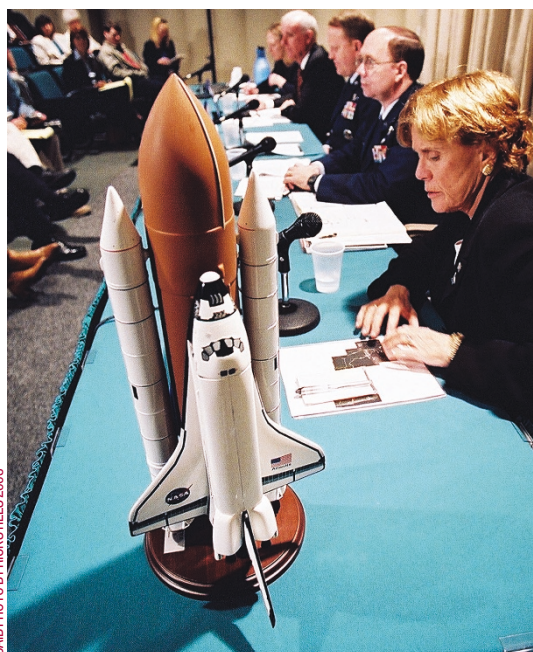
THE NASA INVESTIGATION INTO THE RECENT SHUTTLE ACCIDENT FOCUSED ON THE ORANGE FOAM THAT ENCASED THE MAIN BOOSTER ROCKET.

That would have been a reasonable judgement, but for two factors that have emerged during the investigation. One concerns the possible condition of the foam itself. The showering of it onto the shuttle during take-off, it turns out, has only been a regular occurrence since 1997, when NASA and one of its contractors decided to abandon their previous use of freon gas to apply the foam, in an attempt to help save the ozone layer. The substitute method of application seems to have left the insulating layer far less resilient than was previously the case.

Examination of another shuttle fuel casing by accident investigators has found dozens of flaws in one small area of foam, including air pockets up to 50 mm in diameter and failed bonding between foam layers. Such faults not only encourage the crumbling, but may also accommodate ice or other solid debris that is far more likely to damage the shuttle than the soft foam itself.
