Corrosion fatigue behavior of electron beam melted iron in simulated body fluid

Steffen Wackenhroth¹✉, Christof Johannes Jaime Torrent², Sebastian Herbst¹, Florian Nürnberger¹, Philipp Krooss², Christoph Ebbert³, Markus Voigt³, Guido Grundmeier³, Thomas Niendorf² and Hans Jürgen Maier¹

npj Materials Degradation (2022)6:18; <https://doi.org/10.1038/s41529-022-00226-4>

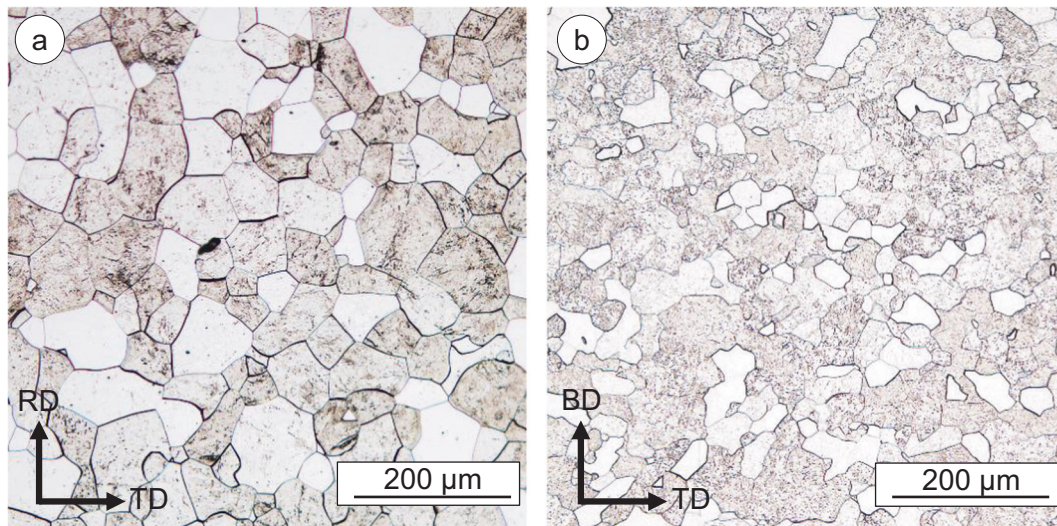
Fig. 1 Micrographs of the two material states. **a** HR iron, **b** EBM iron with rolling direction (RD), building direction (BD) and transverse direction (TD) marked in the figures.

The microstructure of the two material states was analyzed by optical microscopy (Fig. 1) and electron backscatter diffraction (EBSD) (Fig. 2). The rolling and the building direction are indicated in the vertical direction. In Figs. 1 and 2, the difference in the average grain size (27 μm for the EBM iron and 60 μm for HR iron) is obvious. For both materials, a clear ferritic microstructure is present. The slightly darker appearing grains in Fig. 1 are due to the selective etching by alcoholic nitric acid (2%). From the EBSD analysis in Fig. 2a (HR material) it becomes obvious, that the single grains show some small internal orientation deviation, i.e., the color coding in each grain varies more than in the compared EBM manufactured condition. However, the grain boundary map (not

EBM processing has a significant influence on the microstructure of pure iron. The microstructure is considerably finer compared to HR iron (cf. Fig. 1). In both cases, the grains are primarily separated by HAGB. The formation of a certain grain morphology and texture is strongly related to mechanical as well as thermal history.

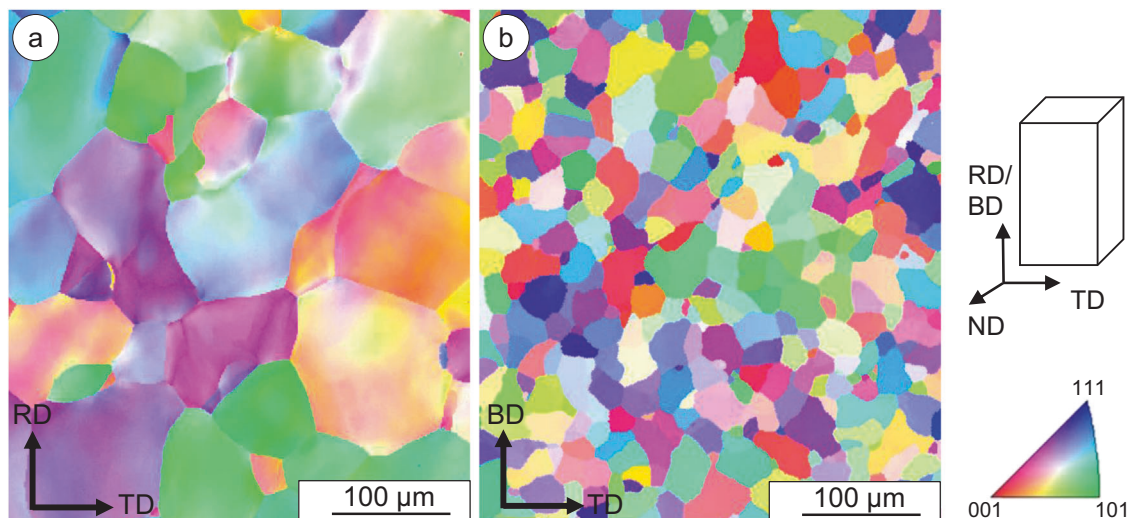
Fig. 2 EBSD orientation mappings with indication in normal direction (ND). **a** HR iron, **b** EBM iron. The rolling direction (RD), the building direction (BD) and transverse direction (TD) are marked in the figures.

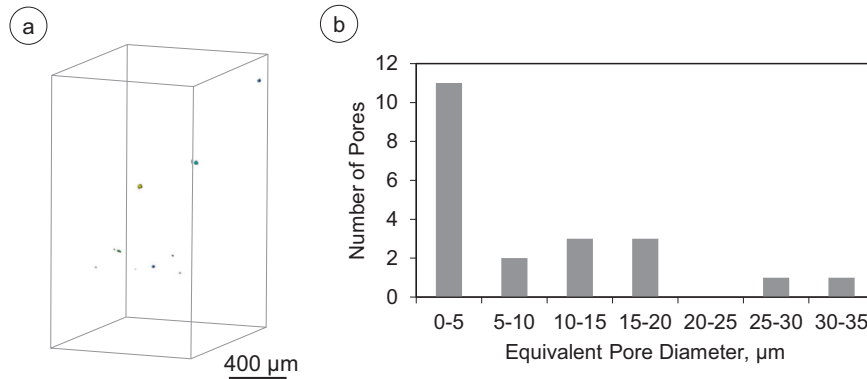
Fig. 3 Analysis of the porosity of the EBM iron. **a** μ -CT scan of a randomly selected volume in the area of the sample seed of the EBM iron with the detected defect distribution, **b** histogram of the pore distribution in the probed volume (partly recompiled from ref. ³⁷).

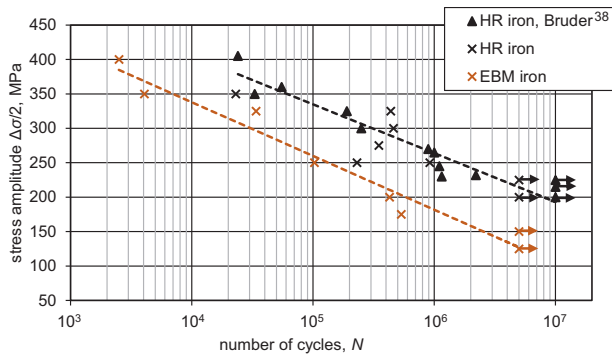
Fig. 4 S - N curves for both material states. Fatigue life in rotating bending for HR iron (with data from refs. ^{18,38}) and EBM iron.

The results of the fatigue tests are shown in Fig. 4 as S - N curves. Samples that reached the defined endurance limit of 5×10^6 cycles and had not failed are marked by an arrow. For the HR iron, single samples reached the maximum number of cycles at 225 MPa. The fatigue strengths correspond well with the results for hot rolled ARMCO iron published by Bruder for similar rotating bending tests³⁸. The S - N curve of the EBM iron is shifted on average by 75 MPa to lower values than the one obtained for the HR iron. Thus, the fatigue strength of 150 MPa is significantly lower than the values reported for EBM iron in previous studies¹⁸. This demonstrates the large effects of the process conditions in the additive manufacturing and the resulting change in microstructure. The slightly larger difference between the two lines for high

Another aspect to be considered when classifying the lower fatigue strengths of the EBM iron compared to the HR iron (Fig. 4) is related to potential defects caused by EBM processing. The maximum pore diameter found was 38.5 μm . Fatigue studies on additively manufactured material have shown that these pores, caused by process-related weaknesses such as insufficient melting of the material or gas entrapments, often act as initiation site for failure, which in turn significantly reduces the fatigue strength^{11,13,14}. Thus, the fracture surfaces of the samples were examined in detail to detect defects relevant for failure. LOF could be detected on all EBM iron fracture surfaces (Figs. 5f and 6a). On the fracture surfaces, the LOF show dimensions of up to 100 \times 400 μm . Due to the small layer thickness of these defects in the material matrix, these cannot be resolved by the $\mu\text{-CT}$ measurements. As described in the results, LOF can be exposed at the specimen surface during the manufacturing process (Fig. 6b) and thus promote crevice corrosive effects. The formation of LOF and related defects can be significantly influenced by the hatch strategy as well as the heating and related cooling rates⁵². Tammis-Williams et al. reported that the volume fraction of gas

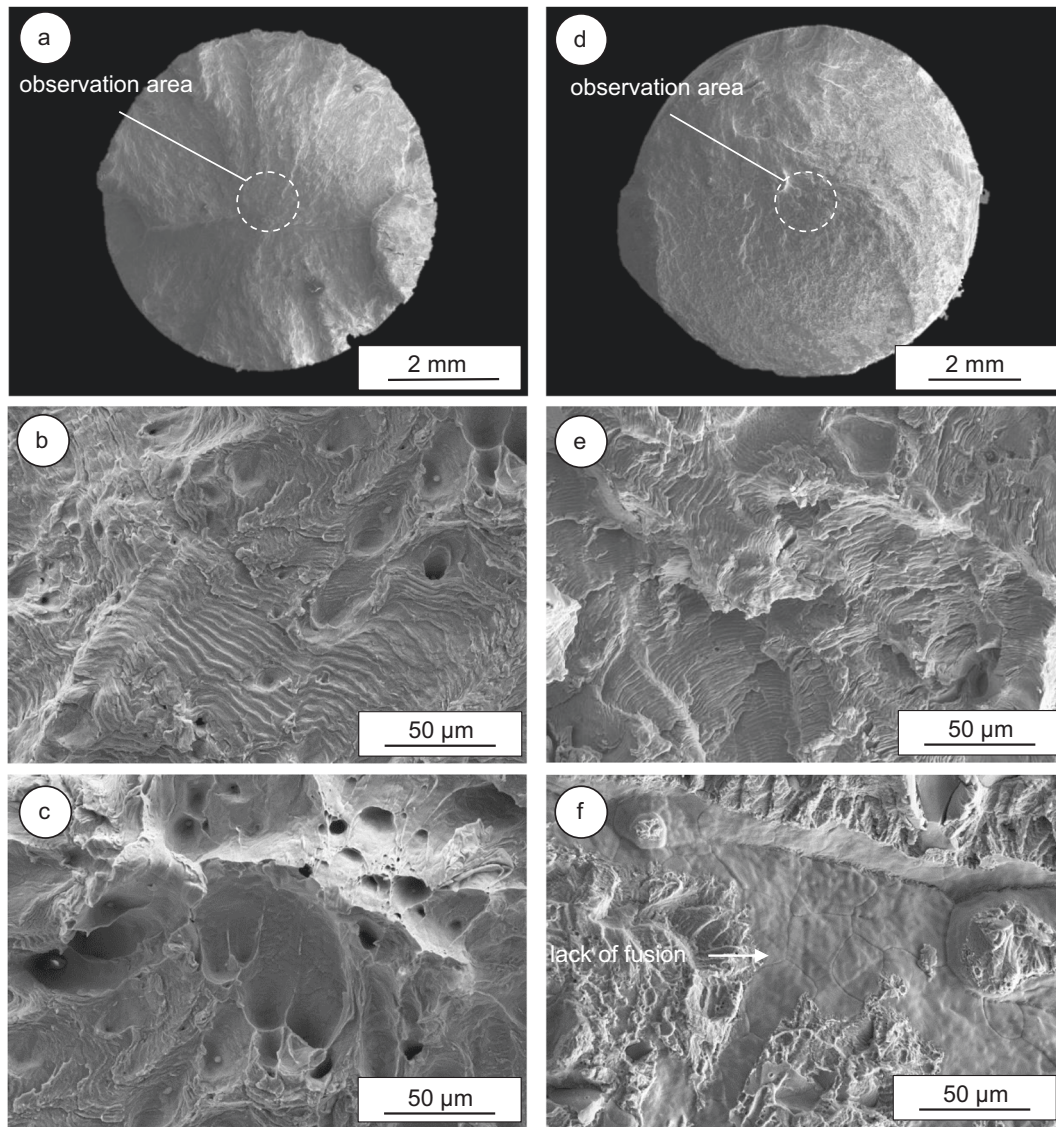
Fig. 5 Representative images of the fracture surface using secondary electron contrast mode. **a** Fatigued HR iron specimen (250 MPa, 9.1×10^5 cycles) with an overview of the entire fracture area **b** striations and **c** areas of ductile fracture; fatigued EBM iron specimen (250 MPa, 1×10^5 cycles) with **d** overview of the entire fracture area **e** striations and **f** areas with LOF.

Figure 5 depicts scanning electron images of the fracture surfaces after the fatigue tests. These images were taken from areas remote from the surface, i.e., these are areas that are unaffected by surface defects. A complete overview of the fracture areas is shown in Fig. 5a for the HR iron and in Fig. 5d for the EBM iron. The location for the detailed images is also indicated. The fatigue fracture represents about 90 % of the total fracture area for both conditions. For the HR iron, distinct striations can be seen (Fig. 5b). In addition to the areas where fatigue crack propagation is evident, there is also pronounced plastic deformation on the specimen surface due to overload failure (Fig. 5c). In contrast, the EBM iron shows areas with LOF on the fracture surface (Fig. 5f) in addition to the typical fatigue striations (Fig. 5e).

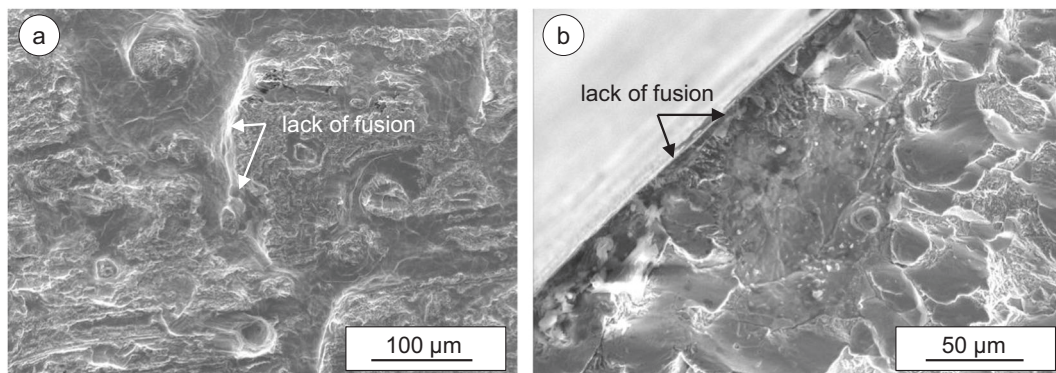
Fig. 6 Fracture surfaces with LOF defects. **a** Fatigued EBM specimen (400 MPa, 2.5×10^3 cycles) with areas of LOF, **b** fatigued EBM specimen (325 MPa, 3.4×10^4 cycles) with areas of LOF at the specimens surface.

The fracture surfaces of the EBM iron were further examined. Figure 6a shows areas where LOF could be detected. The areas where LOF is present show dimensions of up to $100 \mu\text{m} \times 400 \mu\text{m}$. These LOF-areas were independent of the area of observation. LOF usually results from gas entrapment during AM⁴¹, so that the defects are present in the inner parts of the specimens. After preparing the fatigue specimens by turning (described in detail in the "Methods" section), areas with LOF can be present in the surface layer where they can cause crack nucleation and additionally can promote crevice corrosion in the corrosion fatigue tests. Figure 6b shows an area with LOF reaching the surface of a fatigued specimen.

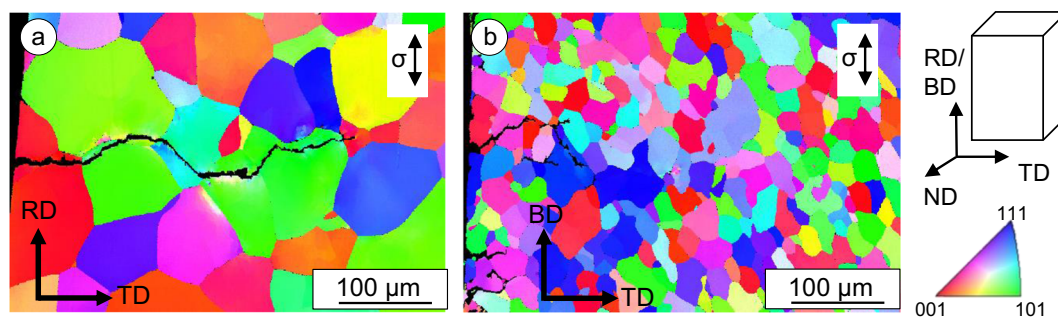
Fig. 7 EBSD orientation mappings of fatigued specimens with indication in normal direction (ND). **a** HR iron (250 MPa, 2.3×10^5 cycles) **b** EBM iron (250 MPa, 1×10^5 cycles); see main text for details; the rolling direction (RD), the building direction (BD) and transverse direction (TD) are marked in the figures.

Figure 7 shows EBSD images of fatigued HR and EBM iron specimens after failure. The samples were cut such as to reveal the crack paths of the secondary fatigue cracks. The loading direction, which is equal to the rolling (HR iron) or build direction (EBM iron) is indicated in the figure. The areas shown have a distance of $\approx 200 \mu\text{m}$ to the primary fatigue crack that led to the ultimate failure of the specimen. For the HR iron, the secondary fatigue crack with a length of about $400 \mu\text{m}$ clearly propagated in a transcrystalline manner (Fig. 7a). In the wake of the crack, slight microstructural orientation deviations are visible, indicating local plastic deformation. For the crack propagation, no change in direction can be observed within the individual grains. The EBM iron also shows transcrystalline crack propagation, but the EBSD images revealed no local changes in crystallographic orientation in the wake of the crack (Fig. 7b). This is in accordance with the brittle features seen in the SEM images (Figs. 5f and 6) and EBM iron shows several small fatigue cracks ($< 100 \mu\text{m}$) in the subsurface region of the specimen. Additionally, branching of the cracks can be observed. These fracture characteristics might indicate a

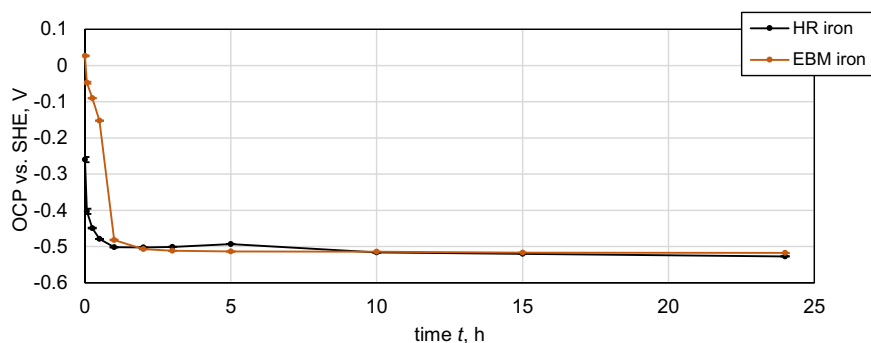
Fig. 8 OCP data. Shown for EBM iron and HR iron as a function of the immersion time in m-SBF.

The transient of the open circuit potential (OCP) for iron samples during immersion in modified simulated body fluid (m-SBF) is shown in Fig. 8. Both surfaces were etched in Nital solution for 5 s prior to the exposure to m-SBF. The transients show a substantial incubation time of about 40–50 min for the EBM sample while HR iron reaches the potential of actively corroding iron much faster. Electrochemical impedance spectroscopy (EIS) results of the samples exposed to m-SBF are shown in Fig. 9a, b in the form of Bode plots. Both samples show a time-dependent decrease of the impedance. However, the EBM processed sample shows higher initial impedance values in comparison to HR iron in agreement with the transient of the free corrosion potentials in Fig. 8. In agreement with the decreasing impedance values, the phase angle for low frequencies shifts to low values indicating a more and more dominating Ohmic resistance due to the initiation of interfacial corrosion reactions^{42–44}.

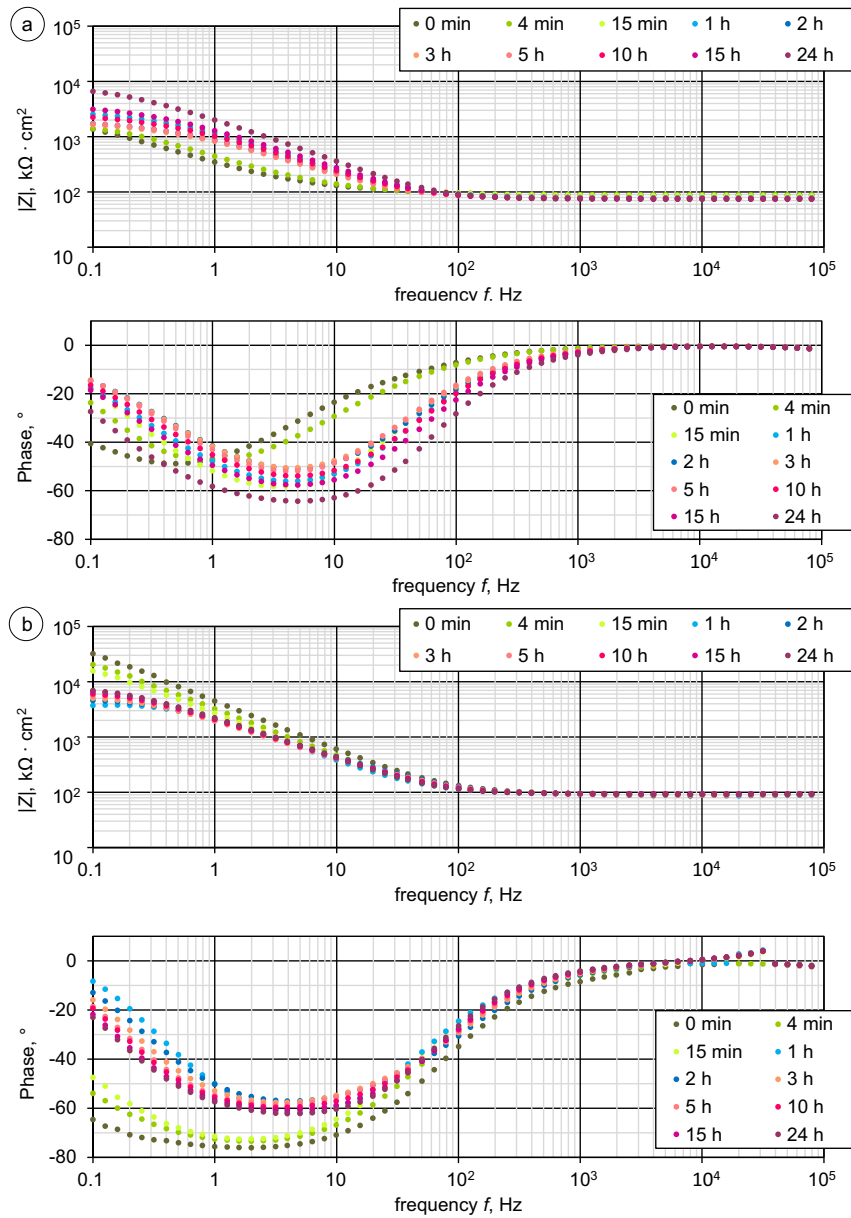
Fig. 9 Evolution of EIS data. Shown for **a** HR iron and **b** EBM iron upon immersion in m-SBF solution.

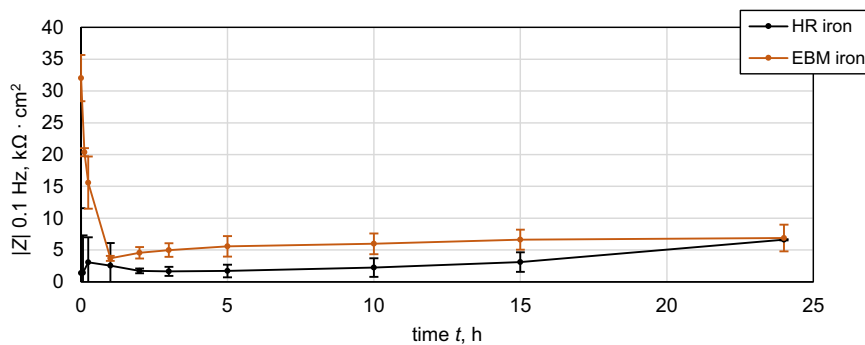
Fig. 10 Impedance values. Shown for both material states at 0.1 Hz as a function of the immersion time in m-SBF.

In Fig. 10, the change in impedance values is plotted for a frequency of 0.1 Hz. After a sharp drop in corrosion resistance in the initial phase of immersion for alloys, EBM iron shows a slightly higher corrosion resistance. However, for extended times of exposure this difference seems to diminish, most probably due to the formation of similar corrosion product layers.

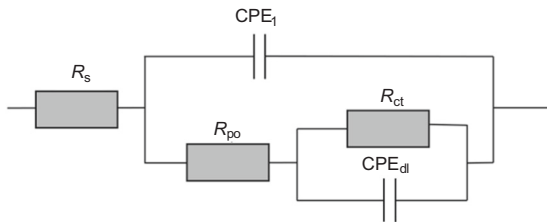
Fig. 11 Equivalent circuit of the corrosion film. Describing the covered surface of the Fe-substrates immersed in m-SBF.

For a more thorough analysis of the EIS data, the corresponding spectra were fitted using an established equivalent circuit for porous surface layer coated metals, which is also often used for modelling corrosion layer covered alloy surfaces in corrosive media^{42–44}. To take into account a non-uniform interface, the capacitance is exchanged by a constant phase element, CPE⁴². The measured spectra could be fitted well with this equivalent circuit. The equivalent circuit fitting the corrosion film is shown schematically in Fig. 11.

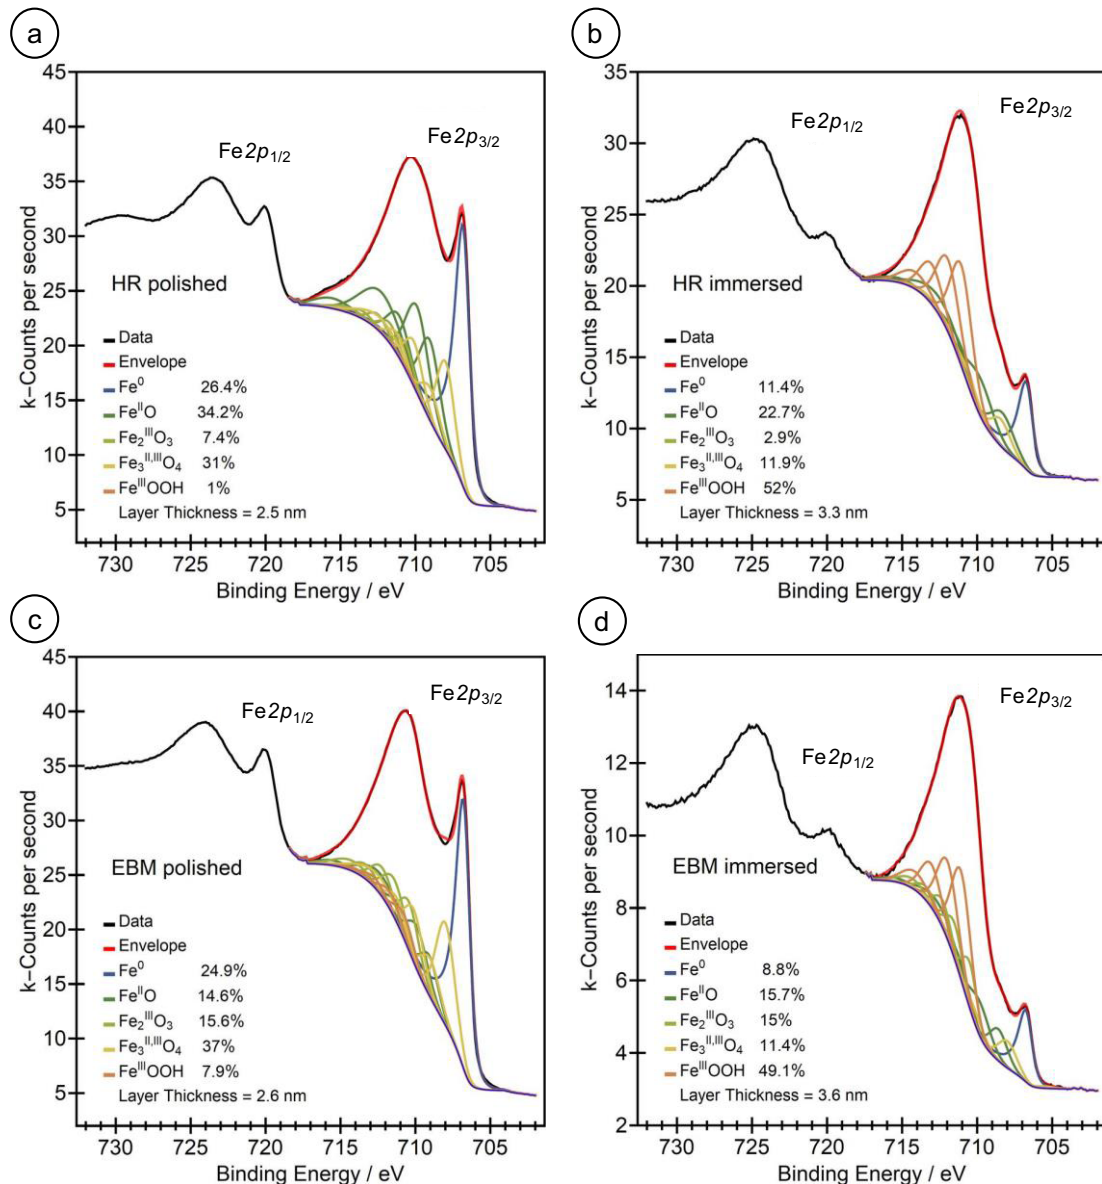
Fig. 12 Fe_{2p} element spectra of as-prepared (polished, etched) samples in comparison to the surface states after 24-h immersion in m-SBF. Shown for **a, b** HR iron and **c, d** EBM iron.

However, the analysis of the Fe2p and O1s element spectra (see Figs. 12, 13) showed a change in the contribution of oxidation states within the surface oxide film and the formation of oxyhydroxides in all cases. The fitting of the Fe2p peaks and the contribution of the underlying metallic iron could be assigned to the peak at 706.8 eV and the oxidation states of iron in the passive film were fitted to the literature^{45,46}.

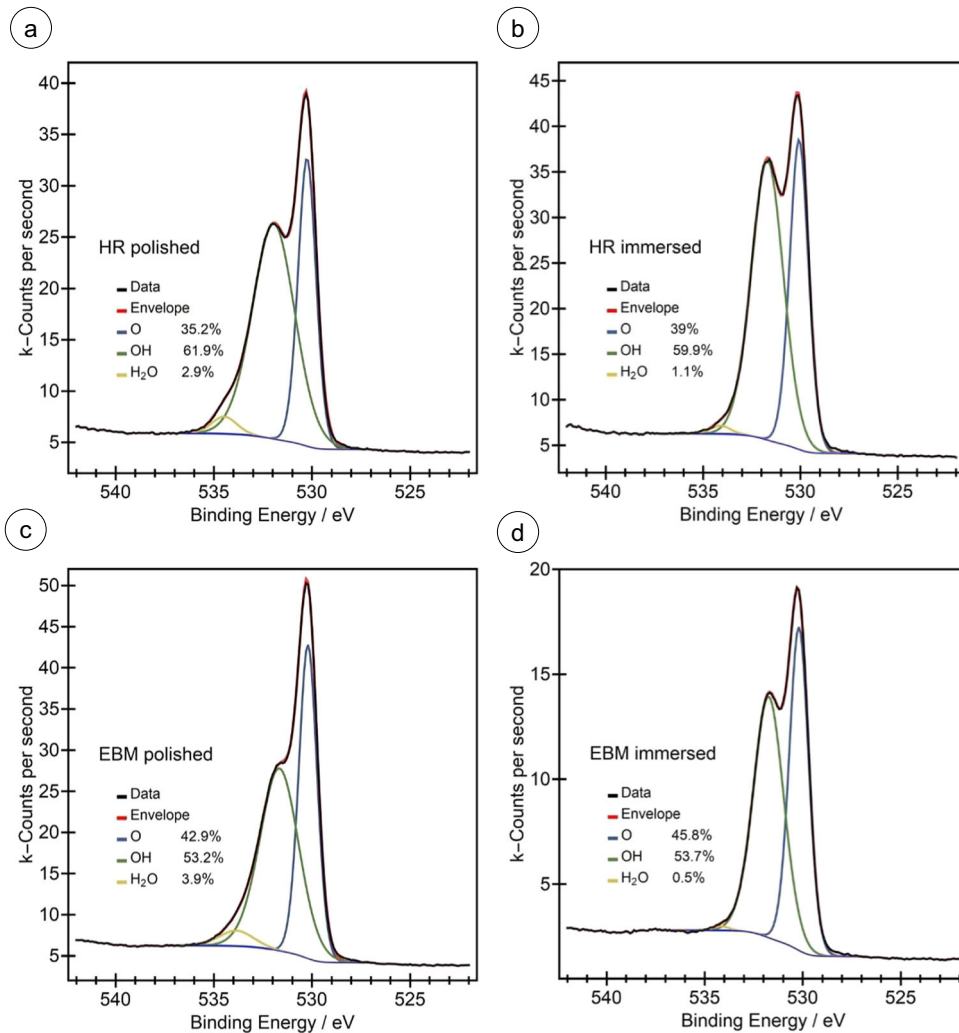
Fig. 13 O1s element spectra of as-prepared (polished, etched) samples in comparison to the surface states after 24-h immersion in m-SBF. Shown for a, b HR iron and c, d EBM iron.

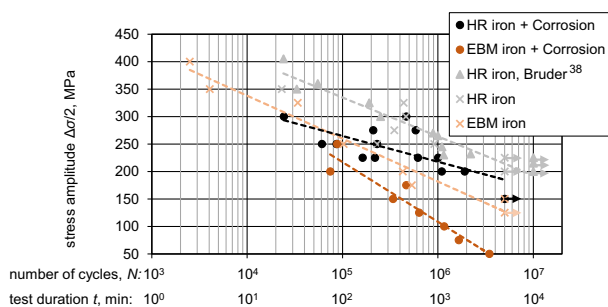
Fig. 14 S–N-curves obtained from corrosion fatigue tests conducted in m-SBF. Both material states are shown in comparison with fatigue tests under purely mechanical load (cf. Fig. 4).

The results of the fatigue tests under the superimposed corrosive influence of m-SBF are shown in Fig. 14. For comparison, the results under pure mechanical load from Fig. 4 are included. The test duration is also indicated on the x-axis. For both material conditions, the increasing corrosion effect upon lowering the stress amplitude, i.e., increasing test duration, is reflected in the significantly shorter fatigue life compared to purely mechanical fatigue testing. In the range of stress amplitudes tested, no EBM iron specimen reached the endurance limit of 5×10^6 cycles. Samples that reached the endurance limit are marked by an arrow.

In Fig. 14, there is a significant difference in the slopes of the trend lines of the corrosion fatigue tests. Especially for the EBM iron, the trend line is significantly steeper compared to HR iron. By contrast, for the fatigue tests under purely mechanical loading, the trend lines of the two material states have nearly identical slopes (cf. Fig. 4). At first glance, this contradicts the results of the corrosion studies where the EBM iron showed a higher corrosion resistance (cf. Fig. 10). However, this discrepancy can be explained by the presence of pores and LOF, which result in crevice corrosion leading to a shortening of fatigue life. Especially at a high number of cycles, these defects have an increasingly shortening effect on the fatigue life over the increasing test duration^{39,40}.

The fatigue tests in m-SBF solution showed that the fatigue strength of EBM is significantly reduced (Fig. 14). The main reason for the reduction of the fatigue strength appear to be surface defects promoting the corrosive influence of the m-SBF and the associated earlier crack initiation. The considerably stronger influence of corrosion on the fatigue behavior of EBM iron can be explained by the higher number of defects in the material. In fact, a variety of LOF-areas were detected on the fracture surfaces of the EBM iron. These defects are exposed at the surface by the turning process and the following electropolishing during manufacturing of the fatigue specimens. At the specimen's surface, these LOF are additionally opened by the applied mechanical loads, and this should promote crevice corrosion effects. The observed branching (cf. Fig. 7b) can additionally amplify these effects as this additionally impairs the electrolyte exchange with the environment. Therefore, the protective passivation film of the EBM iron cannot be formed in these areas and the crevice corrosion effects lead to significantly reduced fatigue strength of the EBM iron. In previous investigations of corrosion behavior, Chou et al. processed a Fe-30 Mn alloy via AM. Starting from a much higher open porosity of 36.3%, a significantly higher corrosion rate could be shown compared to pure iron⁵⁵. The porosities determined for the EBM iron in the current study are significantly lower (<0.01%). Thus, it can be assumed that porosity has no pronounced influence on the corrosion behavior without an applied mechanical load, which explains the higher corrosion resistance without mechanical load (cf. Fig. 10). However, in combination with a mechanical load, even the low porosities and the areas with LOF can have a significant influence on the corrosion rates and can lead to an early failure.

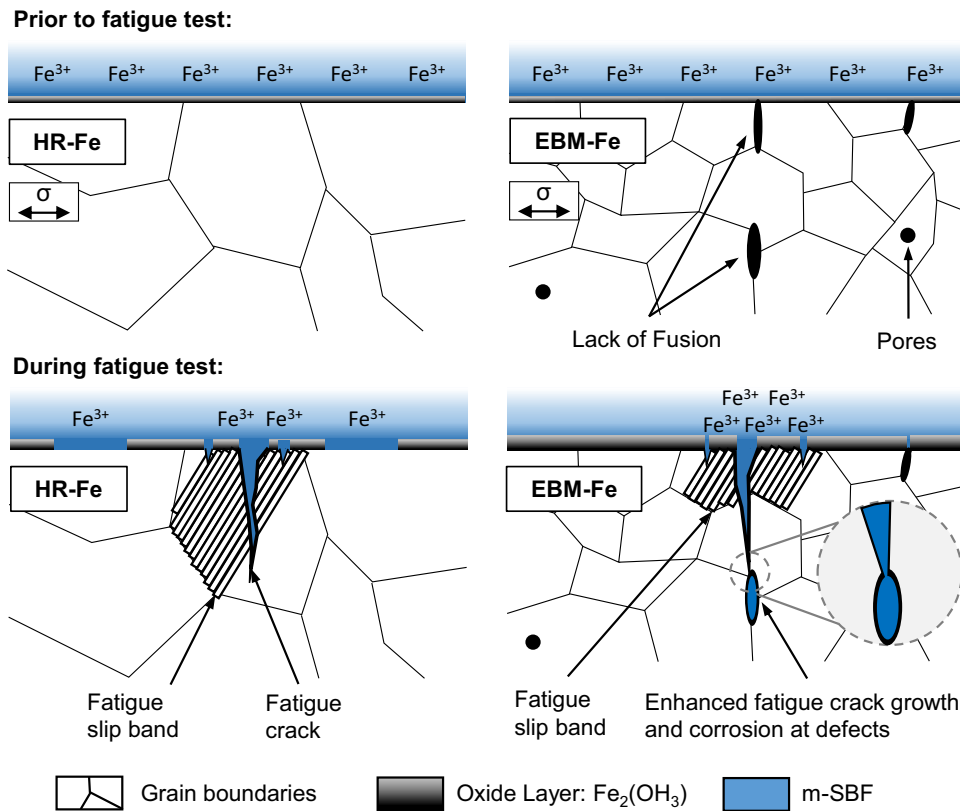
Fig. 15 Description of the corrosion fatigue behavior for both material states. Fatigue model for HR iron and EBM iron taking the microstructure and passivation in m-SBF into account.

The mechanisms during corrosion fatigue are described and summarized in the following model, which is schematically depicted in Fig. 15. For the development of the inhibiting layer of corrosion products, the model is based on the corrosion behavior of pure iron⁵⁶ and the models proposed by J. Li et al. and Z. Li et al. for magnesium alloys^{57,58}. The HR iron and the EBM iron initially differ only in terms of the size of the microstructural features and the defects. The EBM iron has the finer microstructure and single defects are present in the bulk and at the surface of the specimen. Prior to the fatigue test, an ultra-thin oxide film is present on both materials. The iron released in m-SBF is oxidized to Fe³⁺ by dissolved oxygen and later forms

oxyhydroxides and phosphates in m-SBF. During the corrosion fatigue tests, the EBM iron forms a thicker homogeneous protective layer due to the finer grain size resulting from the manufacturing process⁵⁴. Similar effects are already known for aluminum alloys or biodegradable alloys like zinc-magnesium^{59,60}.

The cyclic mechanical load in the rotating bending test results in the highest loads on the surface of the specimens. Plastic deformation in favorably oriented grains causes a continuous break-up of the inhibiting protective layer. This, in turn, leads to enhanced corrosion on the newly exposed surfaces resulting from the mechanical loading. Similar failure models that take into account the break-up of the oxide layer were described by Teoh⁶¹. By the formation of slip bands breaking through the protective layer, a rapid repassivation is prevented there and bare metal is exposed at the surface⁶¹. In the present scenario, defects present in the matrix play a key role in this process because of the locally increased stress. Thus, in the EBM material, crack nucleation and growth are more rapid as defects near the surface promote crack nucleation and at a later stage the fatigue cracks can interact with the process-induced internal defects. Thus, the presence of defects clearly outweighs the expected positive effect of a reduced grain size on fatigue life.

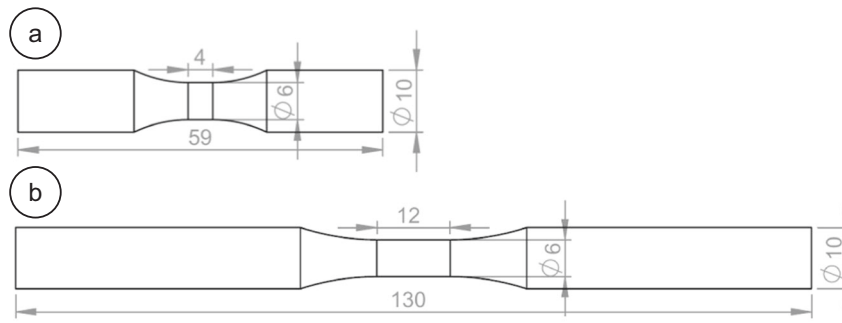
Fig. 16 Specimen geometries for fatigue testing. **a** EBM iron **b** HR iron.

50113 for rotating bending tests. The specimens were turned from the manufactured bars with a nominal diameter of 13 mm. Hence, a 3.5 mm thick layer was removed circumferentially in the gauge length (6 mm diameter) of the EBM iron specimens. Thus, all surface defects caused by the EBM processing were removed.
