Characterization of Carbon-Contaminated B₄C-Coated Optics after Chemically Selective Cleaning with Low-Pressure RF Plasma

H. Moreno Fernández¹, D. Rogler², G. Sauthier³, M. Thomasset⁴, R. Dietsch², V. Carlino⁵ & E. Pellegrin¹

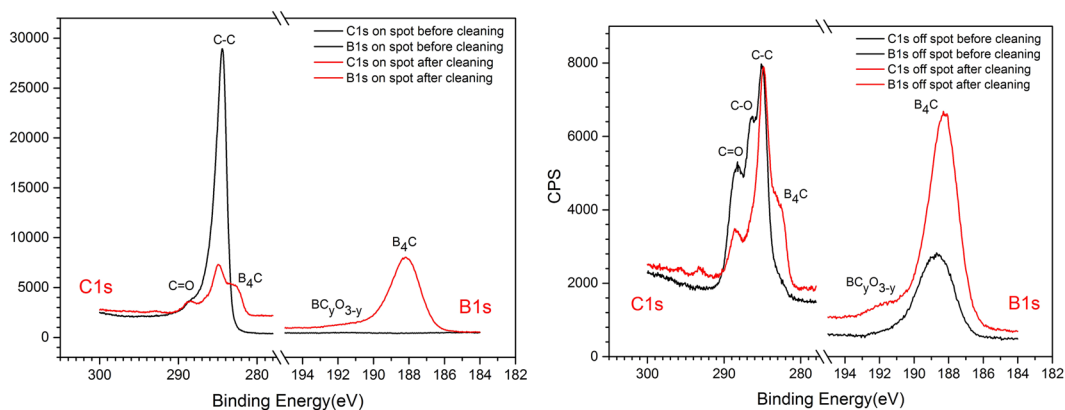
Figure 1. High-resolution C1s and B1s XPS spectra of the B₄C-coated test wafer before (black solid lines) and after O₂/Ar RF plasma cleaning (red solid lines). Left panel: XPS data taken on the amorphous carbon contamination spot. Right panel: XPS data taken off the amorphous carbon contamination spot on the bare B₄C coating.

X-ray Photoelectron Spectroscopy (XPS) analysis from B₄C-coated Si test wafer. Figure 1 shows the XPS high resolution spectra from the Si test wafers shown in Fig. S3, with the measurements being performed off as well as on the a-C spot before and after the O₂/Ar plasma cleaning. We first consider the “on spot” spectra before/after the plasma cleaning. Here, one can clearly distinguish the absence and the appearance of the B1s XPS line before and after the plasma processing, respectively, together with a significant reduction of the C1s core level line.

The cleaning efficiency becomes clear from the increase (reduction) of the B1s (C1s) lines for the “on spot” via the cleaning process, as well as from the overall similarity of the B1s and C1s lines between the “on spot” and “off spot” locations after cleaning. Taking a closer look at the spectra, one can assign the different constituents of the XPS lines as shown in Table 2. These assignments are in good agreement with the previous XPS study by Jacobsohn *et al.* and Jacques *et al.*^{11,12}

According to the XPS line assignments given in Table 2, one can interpret the high resolution spectra in such a way that the O₂/Ar plasma surface treatment leads to:

- A substantial reduction of the C-C C1s peak (“on spot” and “off spot”) as well as the C-O and the C=O peaks (“off spot”), that are all related to adventitious or purposeful surface artifacts.

- The appearance of the B-B and B-C B1s line and the associated B-C peak in the C1s spectra (“off spot” and “on spot”) being due to B and C in bulk B_4C , respectively.
- A weak B1s peak at 191.4 eV B.E. due to the occurrence of boron oxy-carbide (BOC).

On the other hand, we observe for the post-treatment spectra that the spectral fingerprint of especially the C1s XPS lines *invariably* exhibits the three peaks associated with B_4C , C-C, and C=O (with some minor shoulder at 286.6 eV due to C-O). This indicates the formation of a chemically stable interface layer at the B_4C surface that is either resilient with respect to the plasma surface interaction and/or is a direct result from the latter. Similar results from different plasma treatments will be shown in the next sections.

Summarizing the results from the O₂/Ar plasma cleaning of B₄C-coated optical surfaces, this approach gives somewhat fair results in terms of preservation of the B₄C layer thickness and morphology, but the carbon cleaning appears to be somewhat poor as evidenced by the total reflection XRR data as well as by the persistent non B₄C-related contribution in the C1s XPS spectra (see Fig. 1).

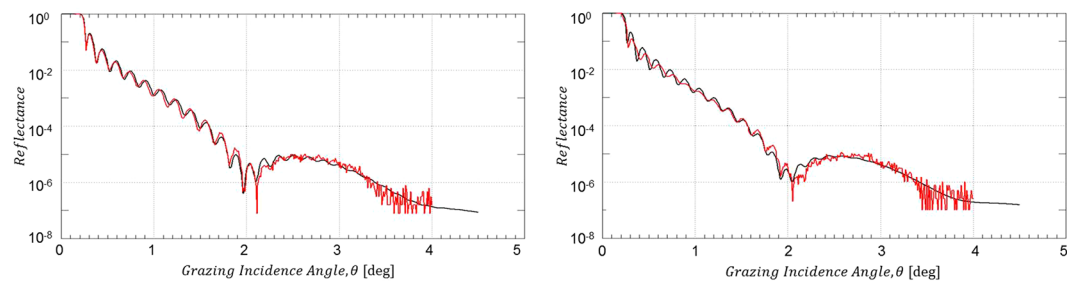
Figure 2. XRR data from B_4C -coated test mirror right after O_2/Ar plasma cleaning. Left hand side: Non a-C coated part; right hand side: Formerly a-C coated part (red solid lines: experimental XRR data; black solid lines: IMD simulation).

X-Ray Reflectometry (XRR) analysis. In order to probe the effect of the O_2/Ar plasma treatment onto the integrity of the B_4C coating and the roughness of the B_4C /air interface, we have performed XRR measurements on both the B_4C -coated test mirrors and the Si wafer test coupons. The results from both types of test specimen are depicted in Figs 2 and S14, respectively, and the parameters resulting from the IMD simulations of the experimental XRR data are given in Tables 3 and SII. All the XRR data simulation shown here include the Cr binding layer with about 2.2 nm thickness between the B_4C coating and the Si substrate. XRR results for pristine as well as air-exposed Si test wafers can be found in section 3 of the Supplementary Information.

The O_2/Ar plasma treatment of a B_4C layer on a Si test wafer after an extended exposure to atmospheric air results in the removal of the physisorbed surface contaminations together with a reduction of the B_4C layer thickness by 0.6 nm (i.e., 29.3 nm as compared to originally 29.9 nm). On the downside, the plasma treatment incurs an increase in rms surface roughness from 0.4 nm rms to 0.6 nm rms (see Table SII).

The XRR analysis from the B_4C -coated mirror in the lower part of Table 3 basically conveys the same message: A reduction of the B_4C layer thickness between 0.1 and 0.9 nm (for the formerly C-coated and non C-coated part, respectively) together with a slight increase of rms surface roughness between 0.1 and 0.2 nm.

Table 3. Results from the IMD simulations of the XRR measurements as shown in Fig. 2 (bottom rows) as well as from reference measurements of non-processed samples (top rows). (*)Surface roughness values from interference microscopy.

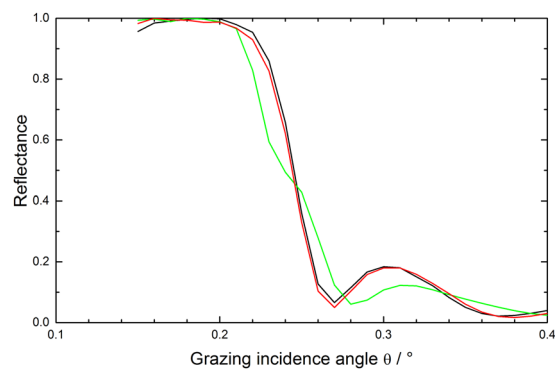
Figure 3. Comparison of XRR total reflection data at low grazing incidence angles for a pristine B₄C-coated test mirror (black line) and after a-C coating plus subsequent O₂/Ar plasma cleaning (green line: formerly a-C coated area; red line: non a-C coated area).

Additional information on the changes regarding especially the optical performance of the mirrors at Cu K α wavelength for correspondingly larger penetration depths (i.e., as compared to XPS) can be obtained by evaluating the total reflection part of the XRR data at low grazing incidence angles. In that respect, Fig. 3 gives evidence for an incomplete carbon cleaning of the mirror surface due to the deviation of the spectrum from the formerly a-C coated mirror surface (green line) at about 0.25 degree grazing incidence as compared to the spectra for the pristine and non a-C coated samples (black and red lines, respectively). Also, the further discrepancies around 0.3 degree grazing incidence corroborate the changes in B_4C layer thickness mentioned above. The results from the

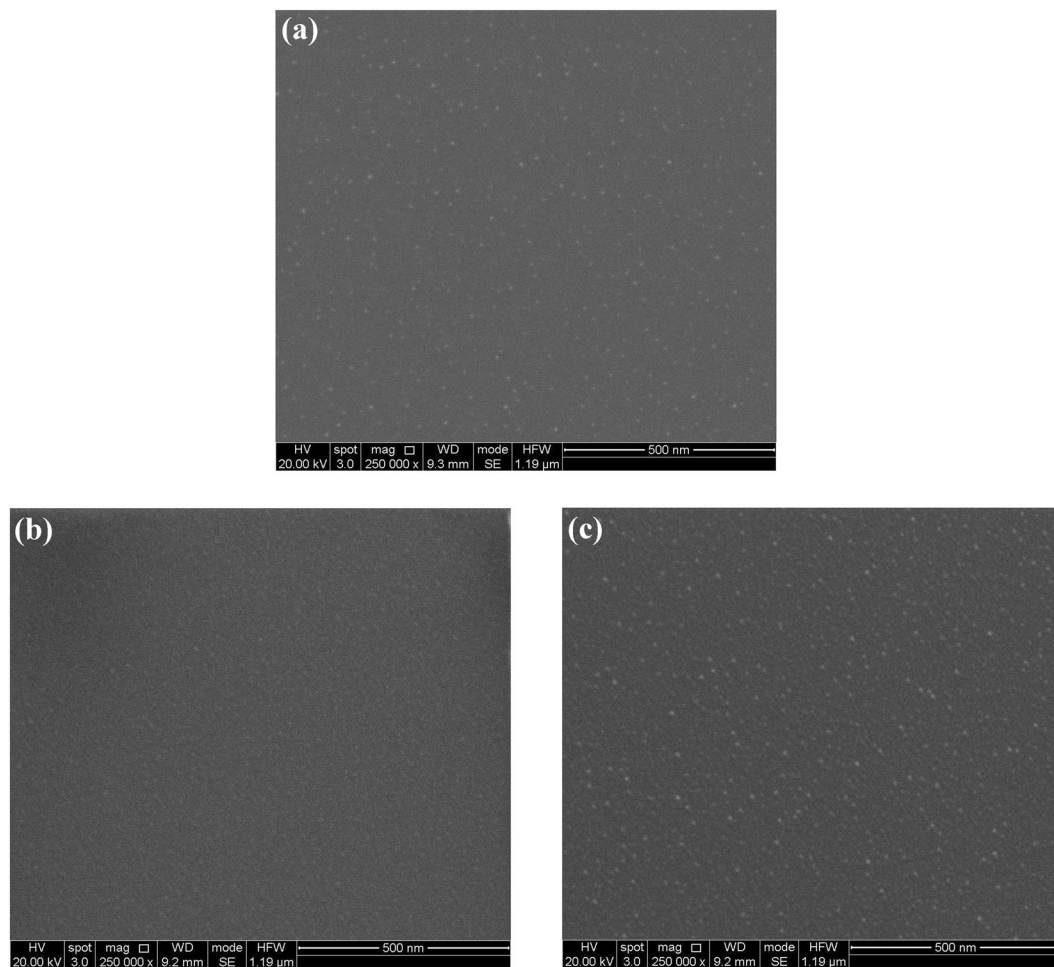
Figure 4. SEM images of B_4C -coated test wafers taken at 20 kV electron acceleration voltage with a 250 k-fold magnification: (a) Pristine B_4C -coated test wafer, (b) O_2/Ar -plasma cleaned – formerly a-C coated part, and (c) O_2/Ar -plasma cleaned – non a-C coated part.

SEM results. The B₄C surface morphology of the Si test wafers in the SEM images shown in Fig. 4 give a visual account for the slight increase in rms surface roughness mentioned above: Starting from the pristine test wafer in Fig. 4(a), one can distinguish small bright spots of about 10 nm lateral diameter that are distributed across the surface in an irregular manner. Similar “hillocks” – but of micrometric size - have been observed in other studies¹³ where they were attributed to crystalline B₄C intergrowths in a B-doped pyrolytic carbon matrix formed during the post-growth heat treatment of B₄C thin films as grown by CVD.

After a-C contamination and subsequent O₂/Ar plasma treatment of the Si test wafer, there is a clear increase regarding the density of these hillocks in the SEM image in the non a-C coated part (see Fig. 4(c)) that obviously leads to the slight increase of the surface roughness from 0.5–0.6 nm rms to 0.6 nm rms as observed in the XRR data. Regarding Fig. 4(b), the visible residual carbon interface layer (see Fig. S3) apparently leads to lower density of these hillocks as compared to the formerly non a-C coated counterpart in Fig. 4(c), as they are apparently covered by the residual carbon interface. We attribute these hillocks to the formation of boron oxy-carbides that are actually more prominent in the case of B₄C coatings treated with an Ar/H₂ plasma that will be discussed in a later section.

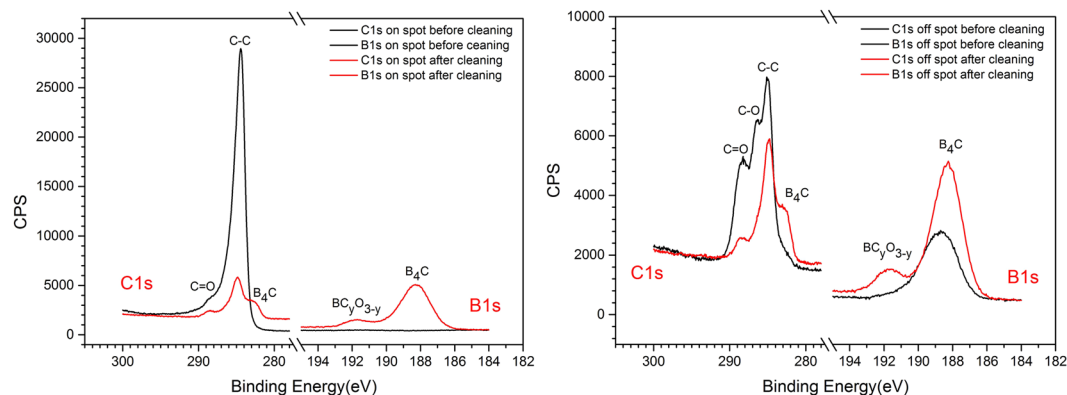
Figure 5. High-resolution C1s and B1s XPS spectra of the B_4C -coated test wafer before (black solid lines) and after H_2/Ar RF plasma cleaning (red solid lines). Left panel: XPS data taken on the amorphous carbon contamination spot. Right panel: XPS data taken off the amorphous carbon contamination spot on the bare B_4C coating.

X-ray Photoelectron Spectroscopy (XPS) analysis. The high resolution XPS spectra in Fig. 5 yield the same results as their O₂/Ar analogues in Fig. 1: An almost complete removal of the a-C contamination, including a persistent

three peak structure in the C1s XPS range. However, we note that in this specific case a significant increase of the B1s peak at 191.6 eV B.E. occurs that we relate to boron oxy-carbides.

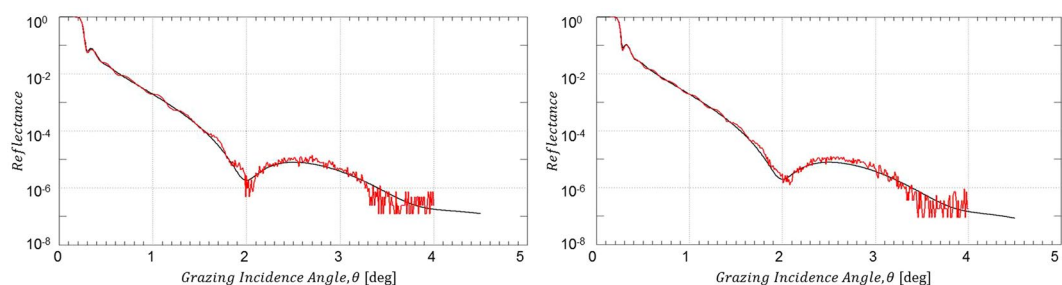
Figure 6. XRR data from B_4C -coated test mirror right after H_2/Ar plasma cleaning. Left hand side: Non a-C coated part; right hand side: Formerly a-C coated part (red solid lines: experimental XRR data; black solid lines: IMD simulation).

X-Ray Reflectometry (XRR) analysis. The significant drawbacks from the H_2/Ar plasma cleaning become most apparent from the XRR measurements presented in Fig. 6. As already obvious from these data at first glance, there is an almost complete loss of Kiessig fringes throughout the complete angular range, which applies to both the non a-C coated and the formerly a-C coated part. Taking a closer look at the results from the IMD simulations in Table 4, one can conclude that there has been a substantial reduction of the B_4C layer thickness by about 8 and 4 nm for the non a-C coated and the formerly a-C coated part, respectively, together with a large increase of the B_4C/air interface roughness beyond 3 nm rms. These latter large numbers are probably partly due to some sample non-uniformities that may well contribute to the surface roughness figures. Nevertheless, the contribution from B_4C surface roughness itself is still substantial.

Table 4. Results from the IMD simulations of the XRR measurements as shown in Fig. 6 (bottom rows) as well as from reference measurements from a non-processed sample (top row). (*) Surface roughness values from interference microscopy.

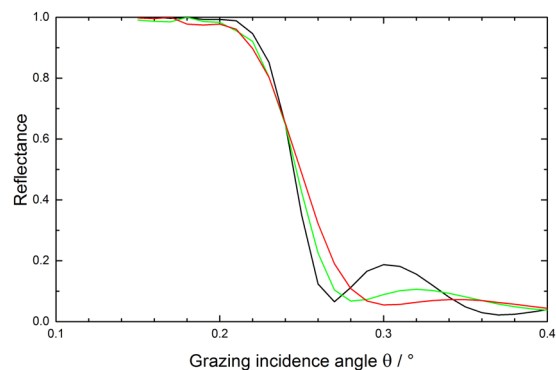
Figure 7. Comparison of XRR total reflection data at low grazing incidence angles for a pristine B_4C -coated test mirror (black line) and after a-C coating plus subsequent H_2/Ar plasma cleaning (green line: formerly a-C coated area; red line: non a-C coated area).

The total reflection data shown in Fig. 7 again indicate the structural changes for the B_4C layer at grazing incidence angles beyond 0.26 degree, while from the chemical perspective the deviation in the XRR data at about 0.25

degree indicate a satisfactory cleaning, which does not come as a surprise taking into account the loss of B_4C layer thickness mentioned above. Nevertheless, the clearly observable changes in the reflectivity edge for the plasma treated samples as compared to the pristine samples (i.e., distinct changes of the edge slope plus the occurrence of additional steps at about 0.18 degree grazing angle) indicate a severe and unacceptable change of the optical performance of the B_4C coating due to, e.g., a chemical residue from the plasma cleaning, a change of the B_4C density, and/or B_4C surface roughness.

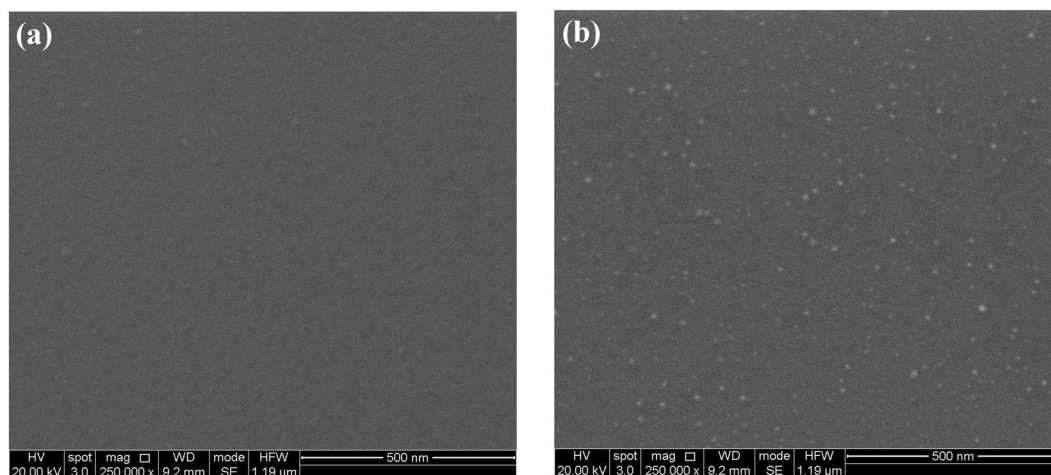
Figure 8. SEM images of B_4C -coated test wafers taken at 20 kV electron acceleration voltage with a 250 k-fold magnification after cleaning with H_2/Ar plasma: (a) Formerly a-C coated part, and (b) non a-C coated part.

SEM results. The SEM results from a H_2/Ar -cleaned B_4C -coated test coupon are depicted in Fig. 8. Comparing these results with their analogues from the O_2/Ar plasma cleaning in Fig. 4, the images taken in the formerly a-C coated part appear to be very similar (i.e., visually indicating a carbonaceous residue on the samples surface), whereas the non a-C coated part of the H_2/Ar -cleaned B_4C -coated test coupon exhibits fewer, but more distinct/larger hillocks that we attribute to the boron oxycarbides that appears more strongly in the B1s XPS line in Fig. 5 (“off spot” after cleaning). It is obviously somewhat surprising that these hillocks can still be observed after a reducing H_2/Ar plasma process, but - as mentioned above - our XPS depth profile analysis in Fig. S10 shows that the B_4C bulk material within the layers include quite some boron oxide phase that emerges to the surface during the sputtering by the Ar species within the plasma. Thus, we presume that there is a plasma-induced formation of

boron oxy-carbide hillocks that are created by the interaction of the plasma with the B_2O_3 phases and B_4C phases emerging at the sample surface.

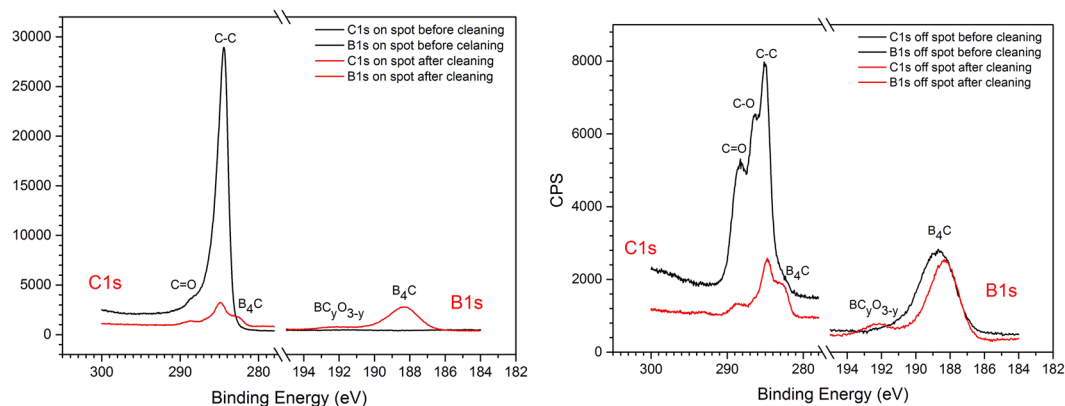
Figure 9. High-resolution C1s and B1s XPS spectra of the B_4C -coated test wafer before (black solid lines) and after pure O_2 RF plasma cleaning (red solid lines). Left panel: XPS data taken on the amorphous carbon contamination spot. Right panel: XPS data taken off the amorphous carbon contamination spot on the bare B_4C coating.

X-ray Photoelectron Spectroscopy (XPS) analysis. In Fig. 9, we show the high resolution C1s and B1s XPS spectra taken off as well as on the a-C spot before and after the pure O_2 plasma cleaning. As can be observed from the C1s spectra, there is a strong reduction of the C1s lines related to C=O, C-O, and C-C species for both the “off spot” and the “on spot” spectra due to the plasma cleaning process, whereas the B1s line to 188.3 eV B.E. related to B_4C shows up after the plasma treatment. In the case of the B1s spectra, the “off spot” spectra exhibit a shift of the B1s line to lower B.E. (plus a decrease of the line width) and the appearance of a small additional peak at about 192.2 eV, that we attribute to oxidized boron and boron oxy-carbides, respectively.

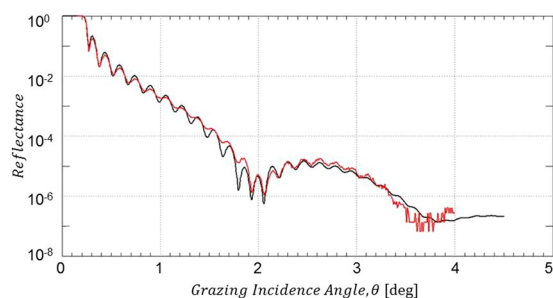
Figure 10. XRR data from B_4C -coated test mirror after cleaning with pure O_2 plasma cleaning. (red solid lines: experimental XRR data; black solid lines: IMD simulation).

X-Ray Reflectometry (XRR) analysis. The measured XRR data in Fig. 10 from the formerly fully a-C contaminated test mirror (see Fig. S5) together with the results from the IMD simulations given in Table 5 fully corroborate the results from the visual impression by the photographs in Fig. S5. As can be seen from the measured data, the Kiessig fringes throughout the full angular range are maintained and the parameters resulting from the pertinent IMD simulations yield a slight reduction of the B_4C coating thickness (i.e., 25.5 nm as compared to 26.0 nm) together with an unaltered B_4C /air interface roughness of 0.5 nm rms.

Table 5. Results from the IMD simulations of the XRR measurements as shown in Fig. 10 (bottom row) as well as from reference measurements of non-processed samples (top rows). (*) Surface roughness values from interference microscopy.

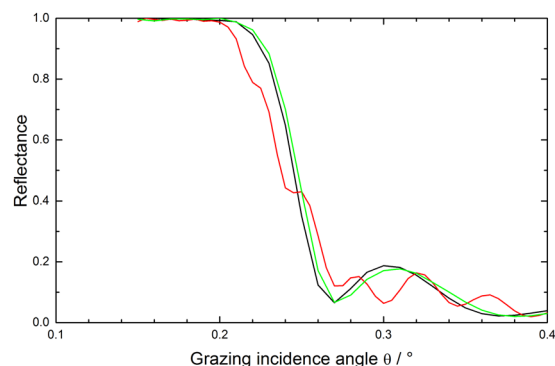
Figure 11. Comparison of XRR total reflection data at low grazing incidence angles for a pristine B₄C-coated test mirror (black line), after a-C coating (red line), and after subsequent cleaning with pure O₂ plasma (green line).

The XRR total reflection data from a B_4C -coated test mirror in Fig. 11 give further support for a full recovery of the B_4C surface at negligible losses regarding the integrity of the B_4C layer. The spectrum for the a-C coated (i.e., non plasma-cleaned) mirror surface shows the expected chemical and structural deviations in the range from 0.2 to 0.26 degree and beyond 0.26 degree, respectively, due to the additional a-C top layer. On the other hand, the spectrum of the subsequently plasma cleaned sample nicely overlaps with the spectrum from the pristine untreated clean test mirror in terms of the shape and slope of the reflectivity edge, beside a small shift regarding the edge position to slightly higher angular values. This leads to the conclusion for a full chemical and structural recovery of the test mirror from the perspective of Cu $K\alpha$ wavelengths and also applies to the optical performance of the fully processed mirror. Nevertheless, taking into account nowadays B_4C optical coating man-

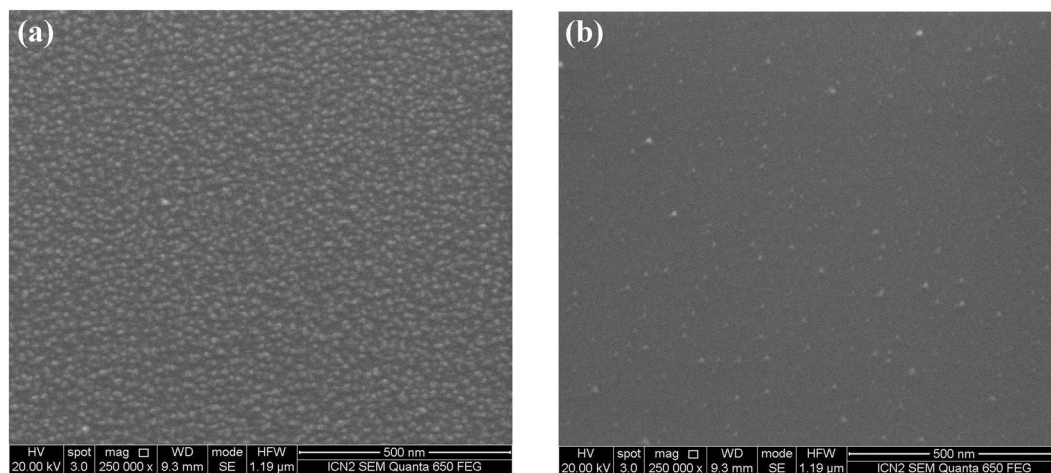
Figure 12. SEM images of B_4C -coated test wafers taken at 20 kV electron acceleration voltage with a 250k-fold magnification after cleaning with pure O_2 plasma: (a) Formerly a-C coated part, and (b) non a-C coated part.

SEM results. In Fig. 12, we show the SEM images of a fully processed B₄C-coated test coupon that has been a-C contaminated and subsequently cleaned with pure O₂ plasma. What can be immediately concluded from the images is that whereas the appearance of the non a-C coated part in Fig. 12(b) is similar to that of the B₄C reference sample in Fig. 4(a) as well as the corresponding images from the other plasma processed samples in Figs 4(c) and 8(b). In stark contrast to this, the image from the formerly a-C coated part in Fig. 12(a) exhibits a large density of small structures with diameters between 15 and 20 nm. As according to the XPS results given in Fig. 9 the surface chemistry of the formerly a-C coated part is very similar to the ones from the O₂/Ar and H₂/Ar plasma treatment (see Figs. 1 and 5, respectively), we conclude that the surface modification in Fig. 12(a) is of a pure morphological nature, without apparently alternating the surface chemical characteristics that are basically given by the aforementioned plasma-induced conversion of the B₄C and B₂O₃ bulk phases into boron oxy-carbides.
