Smart waste management perspective of COVID-19 healthy personal protective materials in concrete for decorative landscape pavements and artificial rocks

Ahmed Abd El Aal¹, Mabkhoot A. Alsaiani^{2,3}, Ahmed E. Radwan^{4✉} & Amr Fenais¹

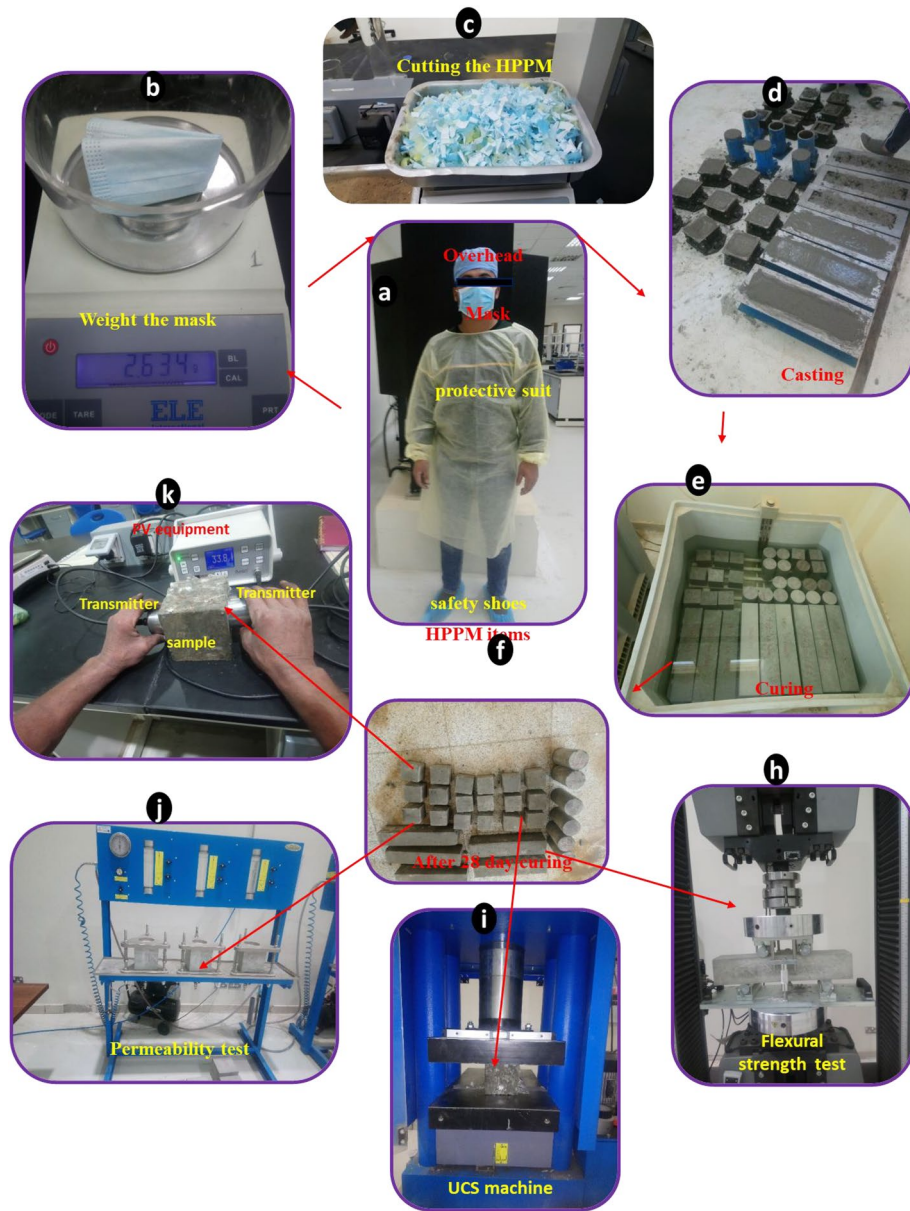
Figure 1. Experiment protocols, casting, and curing of the concrete with HPPM.

The samples mixed with cut-up HPPM were analyzed using six concrete combinations in proportions of 0% (control mix), 0.5%, 1%, 1.5%, 2%, and 2.5% by volume of concrete (three samples for each mix). This choice is in line with prior studies by^{3,7,16}. Najran cement with a specific gravity of 3.15 and a bulk density of 1250–1650 kg/m³ was utilized throughout the experiments, as well as coarse aggregates with a nominal size of 20 mm and fine aggregates with a specific gravity of 2.63, which were oven-dried for 48 h at 110 °C to remove excess moisture. Table 1 lists the cement parameters used. The physical parameters of the HPPM and fine and coarse aggregates are listed in Table 2. New and unused HPPM were utilized in this study to limit community transmission and infection risk from the coronavirus. The HPPM was cut into small pieces with a length of 1 cm and a width of 1 cm (Fig. 1).

In a reference mixer, the concrete samples were prepared according to ASTM C192M with a water/cement ratio of 0.50. No additional materials or chemical admixtures were used in this study. HPPM fibers were employed in the proportions of 0.5, 1, 1.5, 2.0, and 2.5% as an extra percentage. The concrete was mixed and placed into various molds (cubes, cylinders, and prisms) for 24 h before being demolded and cured in clean drinkable tap water. The concrete samples were cured for 28 d at room temperature from 21 to 24 °C (Fig. 1).

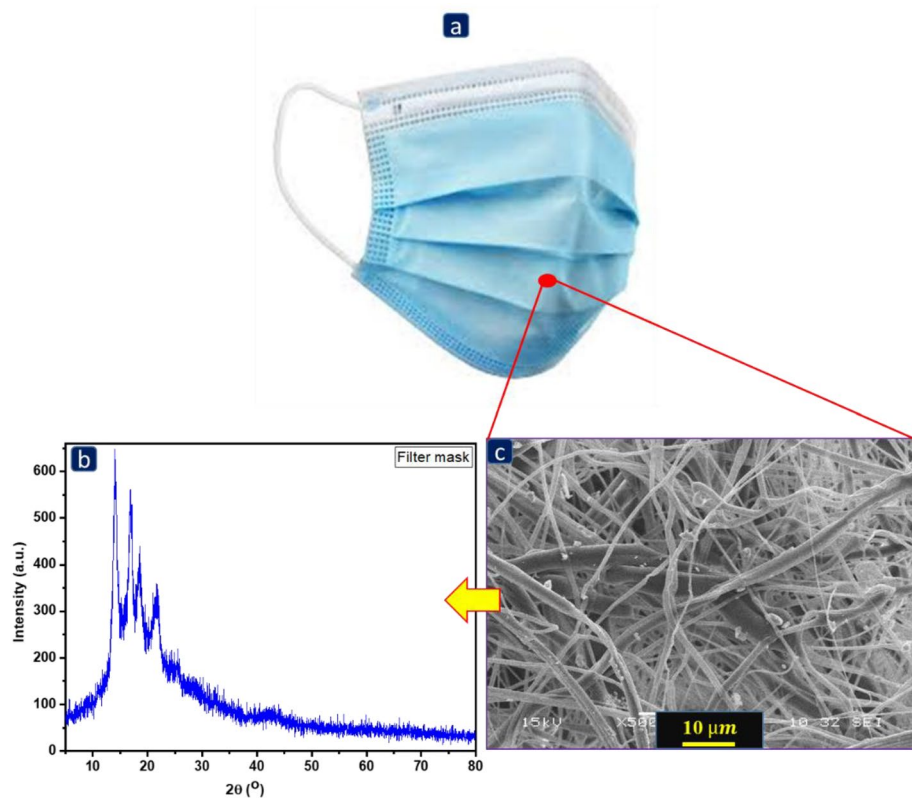
XRD and SEM of the HPPM stripes. Figure 2a,b show the facemask and HPPM fiber integrated X-ray diffraction patterns. The diffraction peaks of all fibers were obtained between 10 and 30 degrees, as shown in Fig. 2b. The peaks obtained at approximately 14°, 17°, 18.6°, 21–22°, and 28° are similar to the peaks generated by polypropylene. Any microstructural changes in HPPM were observed using SEM. The HPPM layer (polypropylene) was sliced into a 10 mm × 10 mm size and examined using a SEM (Hitachi, TM3000) at 1000× magnification. Figure 2c shows the structural changes in the polypropylene fibers, such as melting, distortion, tangling, and cracking.

Figure 2. (a) Image of single-use facemask, (b) XRD image of FM fibers, and (c) appearance of facemask layers under scanning electron microscopy at 1000 \times .

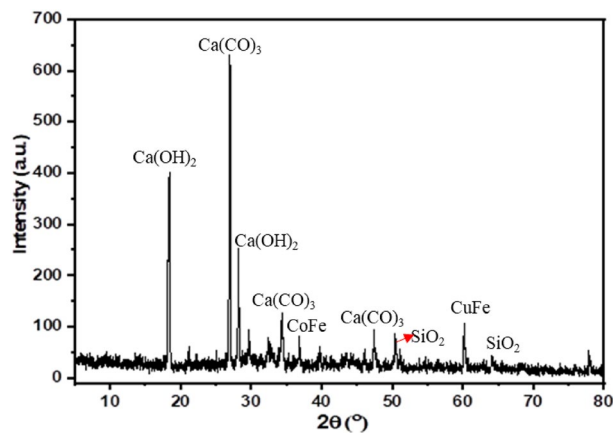
XRD results of concrete containing HPPM fibers. The specimens were studied using XRD to determine the influence of adding HPPM fibers to the concrete mixtures on the phase changes. Figure 3 shows the results of the 2% HPPM test at 28 d. The crystalline phases of portlandite $\text{Ca}(\text{OH})_2$, calcite $\text{Ca}(\text{CO})_3$, and silicon dioxide (SiO_2) are the primary peaks. The $\text{Ca}(\text{CO})_3$ and $\text{Ca}(\text{OH})_2$ levels did not change appreciably when HPPM fibers were added. Similarly, when the fibers were added, they were observed at 650 intensity. This phenomenon demonstrates that the fibers are incapable of participating in chemical processes. Furthermore, the presence of amorphous materials is indicated by the convex form between 2 theta between 16° and 36°.

Figure 3. XRD analysis of concrete with 2% HPPM after 28 days.

- XRD showed that after introducing PP fibers, neither Ca(CO)₃ nor Ca(OH)₂ was altered appreciably. This demonstrates that the fibers are incapable of participating in chemical reactions. The presence of fibers causes a considerable change in the cracking pattern of the concrete. While unreinforced concrete forms wide and long cracks, the inclusion of fibers reduces the crack width opening, cracked area, and crack propagation through the bridging activity of the fibers. Crack networks become less connected as a result of adding the fibers.

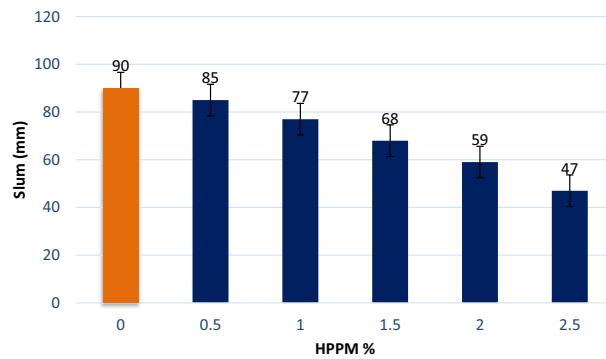
by approximately 5%, 13%, 20%, 30%, and 43%, respectively. The decreased slump could be attributed to the HPP particle heterogeneity and roughness, which could diminish the fluidity of the mixtures as well as HPPM's high absorption (8.8%), as shown in Fig. 4. Because of the high porosity of HPPM (avg. 8.8%) and high cohesiveness between the HPPM and concrete matrix²⁹, increasing the amount of HPPM resulted in lower slump values. The volume, form, and slenderness of the fibers, as well as the mix composition, influence the workability of concrete^{1,9-11}. When the fiber dose exceeds this critical amount, the likelihood of fiber clamping or balling increases, resulting in an uneven fiber distribution and a greater reduction in flowability²⁷.

Figure 4. Slump values of different percentages of HPPM.

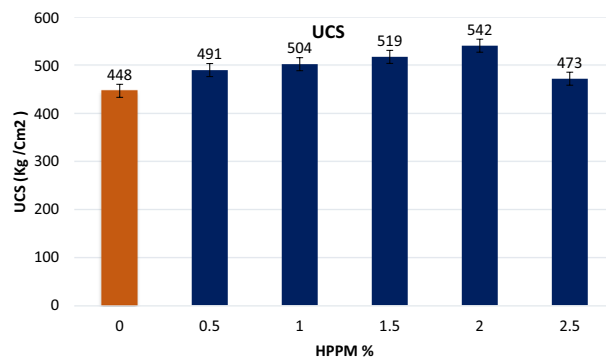
Uniaxial compressive strength (UCS). The UCS values of the samples are shown in Figure 5. The control mix in the experiment had a 28-d UCS of 448 kg/cm², but the 2% addition of shredded HPPM by volume produced the best results. For the control mix study, UCS increased steadily between 1 and 1.5 % before falling

Figure 5. Compressive strength enhanced by the addition of HPPM after 28 days.

marginally at 2.5 %. In comparison to the control sample, volume increments of 0.5, 1, 1.5, and 2% resulted in sample increases of 8.82, 11.05, 13.68, and 9.40 %, respectively (Fig. 5). The results showed that incorporating HPPM into concrete had a significant impact on the UCS of the mixture. In 2020, Xu et al.⁷ reported similar results for UCS, where the addition of different plastic fibers increased the UCS to the point where it began to fall. The improvement in UCS with the additional content of polypropylene fibers may be related to the fiber's crack restriction effect, as demonstrated in earlier investigations³⁰. According to a study by³¹, the declining trend at 2.5 % could be due to the presence of voids at 2.5 % and the existence of weakening interfacial connections between the cut-up HPPM and the cement (2017).

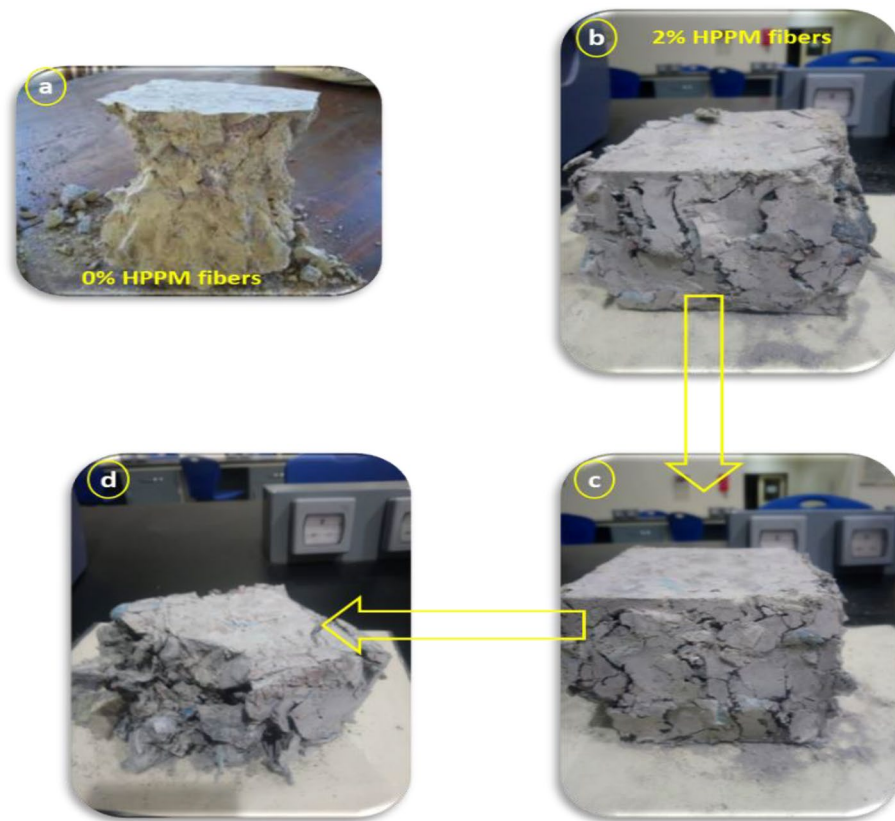
When the fiber dosage was increased from 0 to 3%, the UCS increased by 6%³². The addition of HPPM to the mixtures considerably modified the failure mode of concrete from brittle to ductile, as shown in Fig. 6. The specimens did not crush because of the bridging effect of the HPPM fibers, and they maintained their integrity until the completion of the test. It was discovered that mixtures containing HPPM had lower compressive strengths at an early age; however, after a longer curing period, they had higher compressive strengths. This suggests that the effect of bridging fibers can improve the UCS of concrete over time.

Figure 6. Failure mode of the concrete specimens without HPPM under (a) compression load (b–d), modifying the failure mode of concrete from brittle to ductile.

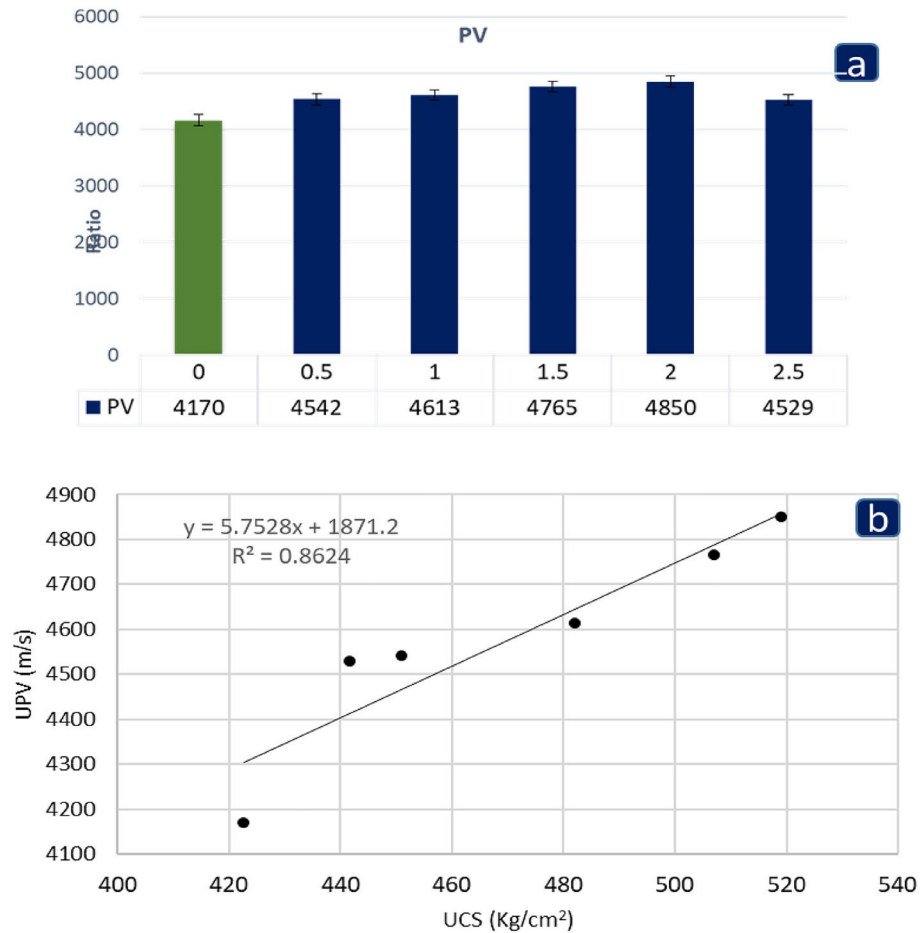
Ultrasonic pulse velocity (Pv). At 28 d, an ultrasonic test was performed on water-saturated cubic concrete specimens of 150 mm to assess the number of internal pores in the specimens. This non-destructive test uses reflected waves that radiate between probes to assess the permeability of a specimen, according to²¹. The test was performed by crossing the two faces of the specimen with two probes of the instrument. The PV test is a nondestructive method for determining the consistency and efficiency of concrete. Concrete cracks and pores are also referred to as PV³³. Non-destructive testing is a good way to assess the quality of concrete. The effects of the PV test are shown in Fig. 7a. PV grew consistently as HPPM content by volume increased until the volume crossed 2.0%, after which it declined marginally to 2.5%, as shown in Fig. 7a. Similarly, for UCS, the HPPM material with a volume of 2.0% produced the best results. According to^{34,35}, concrete with a PV result of more than 4500 m/s is considered outstanding with a high-quality rating. The quality of the concrete decreased once again at the 2.5% volume mark compared to the control specimen in the experiment; regardless, the quality of the concrete improved in all mix designs, signifying beneficial features. According to³⁶, good-quality concrete has no substantial voids or cracks in the ranges mentioned; consequently, as shown by the research of³⁷, the usage of shredded facemasks reduced the number of microcracks in the concrete, thereby enhancing the overall quality of the concrete. The absence of voids or cracks can jeopardize the structural integrity of concrete within the above-mentioned limits. Owing to an increase in void content and thus porosity with increased fiber, PV

values tend to drop beyond a fiber composition of 2.5%. According to BIS, the ultrasonic pulse velocity (UPV) values ranged between 3.8 and 4.04 km/s, indicating that the concrete quality is good³⁸. The HPPM was added to the equation, which increased the UPV values up to a particular volume fraction. However, as expected, the increased HPPM stripe content resulted in lower UPV values. This decrease in the change in velocity is thought to be due to the existence of voids and microcracks in the concrete specimens, which reduce the homogeneity at higher fiber volume fractions. For specimens containing HPPM at any %, UPV values ranging from 4200 to 4600 m/s were discovered, and they were regarded as good quality concrete.

Figure 7. (a) P-wave velocity results after 28 days and (b) the relationship between UCS and PV for concrete containing HPPM.

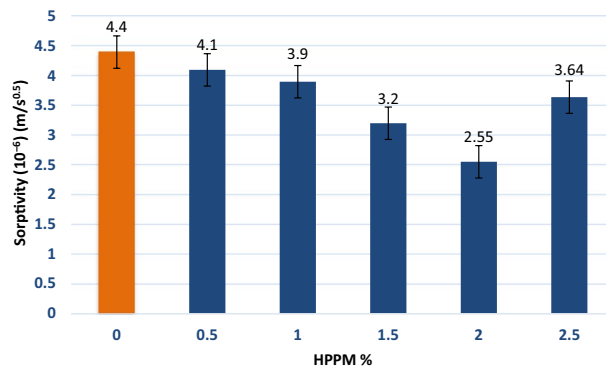
Sorptivity. The sorptivity (S) results are shown in Fig. 8. When fiber concrete is compared to ordinary concrete, S, which is a measure of concrete durability, is lower. It is possible that the loss of connection in the pore space is caused by the porosity of the HPPM fiber filling porosity³⁹. The minimum S for 2% HPPM is 2.55(106) m/s, whereas the maximum value for 2.5% HPPM is 3.46 m/s. Furthermore, all HPPM concretes had a lower S than the control mix, despite the fact that the high value for 2.5% HPPM was similar to a mix with considerable porosity. This result demonstrates the considerable reduction in the capillary and inner conductivity of the pores when HPPM fibers are used, and it confirms all of the other durability findings in this study.

Figure 8. Sorptivity enhancement by adding HPPM after 28 days.

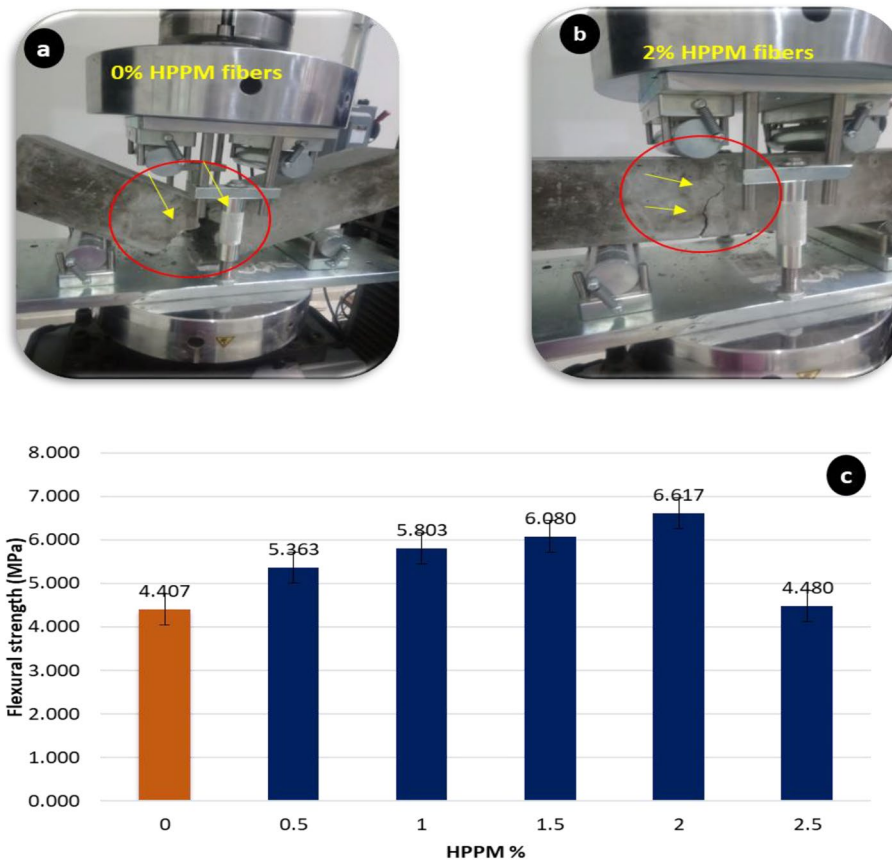
The fibers intersecting the cracks in the tension zone of the specimens caused an increase in the FS. The HPPM fibers flex to hold the crack face separation, offering a larger energy absorption capacity and stress relaxing the micro-cracked area adjacent to the crack tip (Fig. 9a,b). This could be caused by the decreased workability of concrete at larger volume fractions in the mixtures. The recorded FS values of the prismatic beams are shown in Fig. 9c.

Figure 9. (a) Fibers intersecting the cracks in the tension zone of the specimens caused an increase in flexural strength (b) enhancement the FS after 28 days after adding the 2% HPPM (c) Influence of HPPM incorporation on flexural strength.

Flexural strength. The FS of UCS and PV follows a similar pattern, with an increase up to 2% of HPPM fiber content and then a reduction as the number of fibers increases. The results shown in this graph (Fig. 9) indicate that, similar to the tensile strength, the concrete flexural strength increased as the HPPM concentration increased. In comparison to the control mix, specimens with HPPM of 0.5, 1, 1.5, 2, and 2.5% had FS of 17.8, 24, 27.5, 33.4, and 1.6%, respectively. Furthermore, HPPM plays a vital role in the development of FS, particularly after a longer water curing duration. The overall effect of HPPM appears to be geared toward increasing FS, as evidenced by the 33.4% increase in FS of concrete with 2.0% of HPPM. The decrease in FS as fiber content increases can be attributed to the fact that voids in the matrix grow as 2.5% HPPM fibers are added to the matrix. Upon applying HPPM to sustainable concrete, the FS of the sample was considerably boosted. As a result, further FS enhancements may be accomplished by introducing an HPPM with an optimized geometric shape to create a better concrete FS. The adoption of mechanically enhanced fibers with increased bond strength should

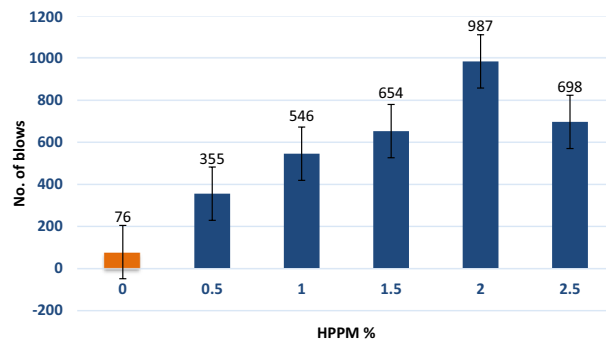
Impact strength. Regarding the number of blows required to cause the concrete specimen to collapse, the IMs of concrete was investigated for different volume fractions of HPPM fibers. PPF improves the impact resistance of concrete⁴⁰. The addition of just 1% micro PPF increased the number of blows till failure by nearly thrice⁴¹. The number of blows at first crack was assessed to be 76, 35, 546, 654, 987, and 698 percent for 0 percent, 0.5%, 1%, 1.5%, 2%, and 2.5% of HPPM, respectively, when HPPM was added to concrete mixtures. Furthermore, with 0%, 0.5%, 1%, 1.5%, 2%, and 2.5% of HPPM, the number of strikes required to destroy the sample increased 3.0, 3.3, and 4.8 times, respectively (Fig. 10). These findings are consistent with⁴², which found that the number of blows for failure increased from 76 (100%) for ordinary concrete to 355 (367.105%), 546 (618.421%), 654 (760.526%) 987(1198.68%), and 689 (818.421%) for concrete with HPPM fibers equal to 0%, 0.5%, 1%, 1.5%, 2%, and 2.5%, respectively, for concrete with HPPM fibers equal to mix control (Fig. 10).

Figure 10. Influence of HPPM incorporation on Impact resistance.

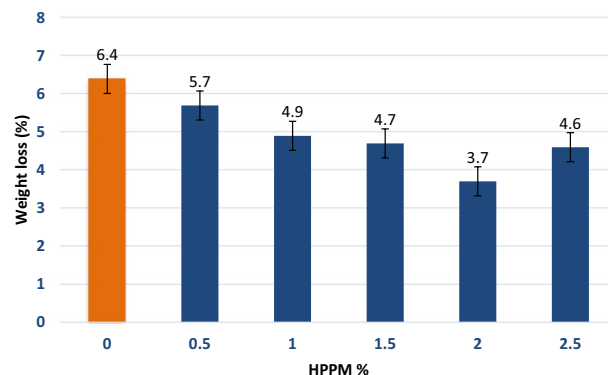
This phenomenon can be explained by the fact that incorporating HPPM fibers into concrete inhibits the creation of cracks and effectively diminishes its intrinsic cracking tendency. Furthermore, the pore-blocking effect of HPPM fibers causes the pore structures in hardened concrete to become more detached, resulting in less capillary porosity and lower water penetration of the concrete. In addition, HPPM's abrasion resistance strength improved. Regarding the resistance to abrasion damage, the HPPM fibers outperformed the control concrete (Fig. 11).

Figure 11. Abrasion resistance enhancement 28 days after adding the HPPM.

Abrasion resistance. The use of HPPM fibers improves the abrasion resistance of concrete. Horszczaruk⁴⁷ demonstrated that after including 0.9 kg/m³ of fibers, the mean depth of wear for HPPM fell from 29 to 42% compared to that of plain concrete. The increase in abrasion resistance of concretes containing fibrillated 0, 0.5, 1, 1.5, 2, and 2.5% HPPM varied from 6.4, 5.7, 4.9, 3.7, to 4.6%, depending on the water to cement ratio⁴⁸.

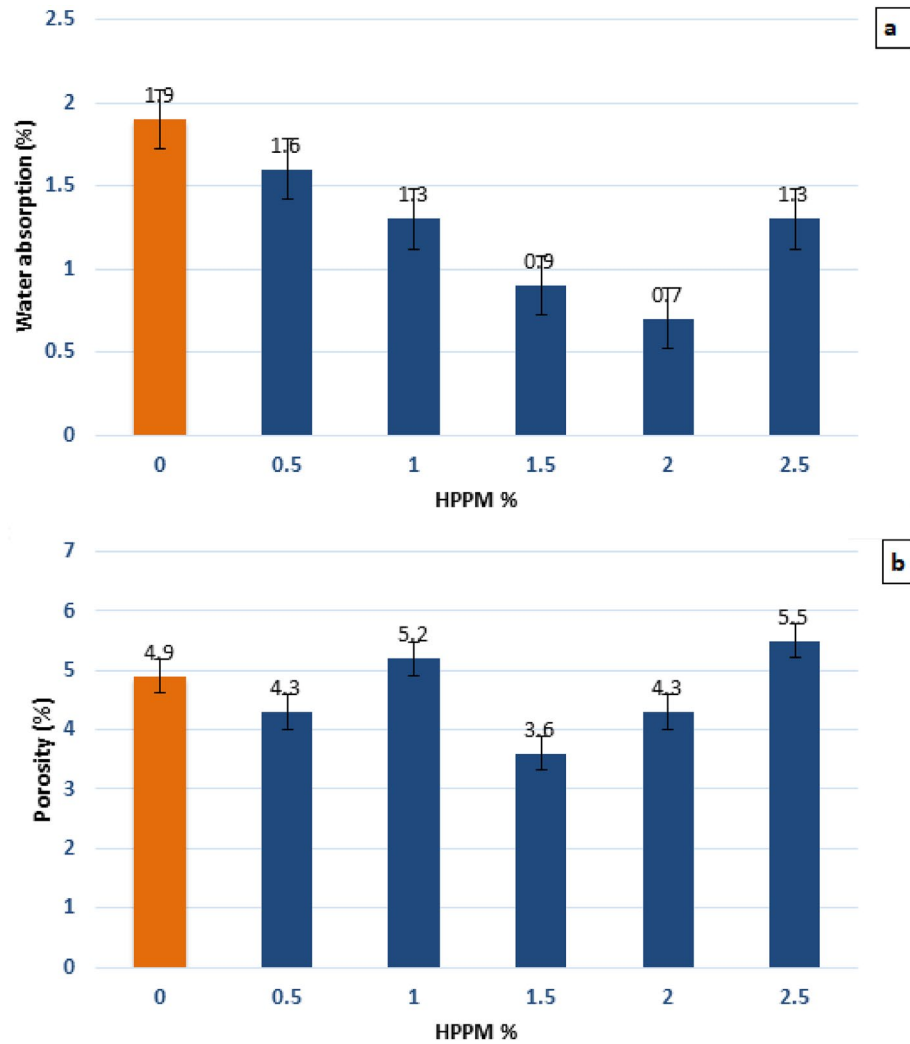
The influence of HPPM on porosity cannot be clearly measured, as shown in Fig. 12b. Workability is influenced by a number of factors, one of which is the distribution of fibers within the mixture and the level of porosity. Studies have shown that when the fiber dosage increases, the porosity increases⁵³. Porosity can decrease when the addition of fibers is confined to a lower amount, and then it can increase again with larger fiber additions, as shown previously⁵⁴. The porosities of the concrete with 0, 0.5, 1, 1.5, 2, and 2.5% HPPM were 4.9, 4.3, 5.2, 3.6, 4.3, and 5.5%, respectively, in this study. A summary of the effect of HPPM fiber incorporation on concrete porosity is provided in Fig. 12b. Adding more than 2.5% of HPPM fibers to the concrete resulted in increased transition zone thickness and n and thus a higher Sw. The increased porosity could be due to poor compaction, which could lead to more micro-cracks, unrestrained fibers, cracks, and poor fiber–matrix bonding⁵⁵.

Figure 12. Influence of HPPM on (a) water absorption (S_w) and (b) porosity (n) as reported in selected studies.

Regarding water absorption, many studies have shown that HPPM absorbs less water than plain concrete. According to⁵⁰, regular concrete absorbs 1.52% water, whereas concrete containing 1.5, 3.0, or 4.5% PPF absorbs 39, 46, or 49 % of water, respectively. Similarly, in⁵¹ the water absorption was reduced by approximately 45%, from 2.481 to 1.366%. PPFR absorbed 24.7 % less water than concrete without fibers in prior tests⁵². This could be due to the action of the fibers, limiting the number of cracks to a minimum. Fibers, however, have been shown in some tests to have a negative impact on absorbability.

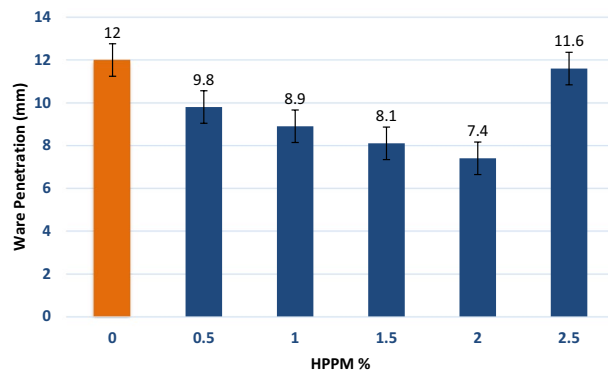
The specimen with 2% HPPM fiber content had a minimum depth of penetration of 7.4 mm, which was 38.33% less than that of the control mix. The decrease in HPPM depth of water penetration and then increase (11.6 at 2.5%) could be attributed to an increase in “ n ” as the HPPM fiber content increased. In fact, the 2% decrease in water depth is most likely attributable to pore blockage and decreased capillary porosity. This result supports the results of other durability tests presented in this study. Figure 13 shows the depth of water penetration at 28 d.

Figure 13. Depth of water penetration versus HPPM fiber content after 28 days.

Water penetration and permeability. Because of the pore blocking action of HPPM fibers, all water penetration depths for HPPM were lower than those for the control mix. These findings support the accuracy of the HPPM results.

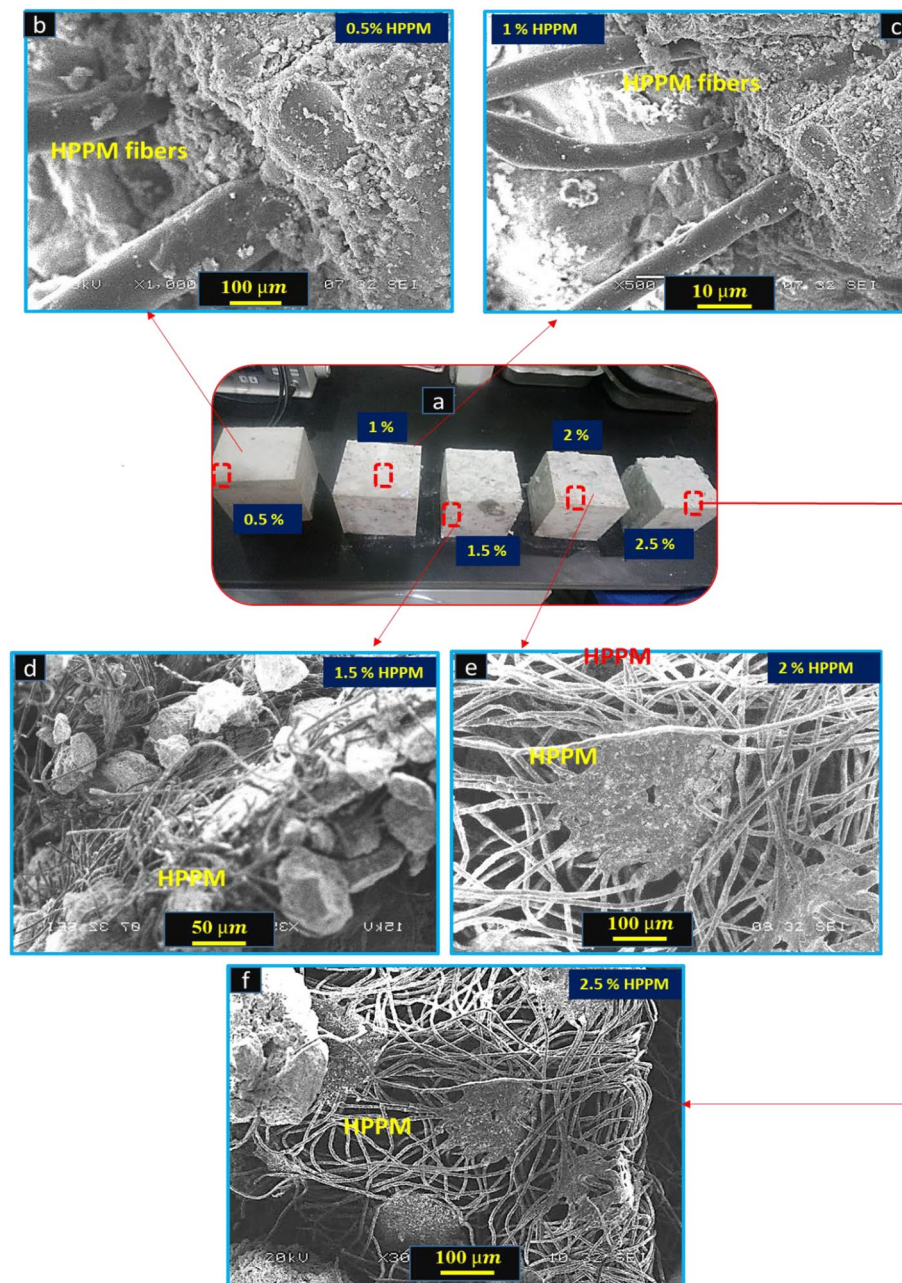
Microstructure analysis. The microstructure of the HPPM fibers with 0.5, 1, 1.5, 2, and 2.5% volume fractions were examined using SEM to evaluate the bond characteristics of the mixture. Figure 14a,b depict the HPPM fiber–matrix interface of a concrete composite that included HPPM fibers and fiber bridging following

Figure 14. SEM images of concrete with HPPM fibers. (a) Cubes with different percentages of HPPM, (b–f) 0.5, 1, 1.5, 2 and 2.5% of HPPM fibers.

The HPPM and cement matrix had a strong interfacial connection, as shown in Fig. 14e. This bonding was important for reducing the size and number of cracks, which led to a 2% increase in HPPM strength. The bridging activity of the fibers, upon which the bridging fibers partially transferred the stress across the crack, could also account for the improved flexural performance of concrete containing HPPM. Similar findings were reported by³⁰, who discovered that adding polypropylene to concrete substantially increased its flexural strength.

However, as shown in Fig. 14f, 2.5% HPPM had a higher porosity, causing the specimen to be non-homogeneous. Furthermore, the HPPM fibers have a bridging effect, which can lead to increased compressive and flexural strengths. In reality, lower permeability and capillary porosity are closely related. It may be deduced that the voids in 2.5% HPPM, which are more than those in 2% HPPM, are caused by HPPM fibers trapping air in the mixture. Furthermore, the HPPM stripes and fibers can act as a binder all over the fibers and aggregated in this micrograph, potentially causing pore blockage and decreased permeability. In reality, lower permeability and capillary porosity are closely related. The voids in 2.5% HPPM, which are more than those in 2% HPPM, are likely caused by fibers that have trapped air in the mixture.

- Microfractures propagate along concrete with HPPM, according to a concrete microstructure study. As demonstrated in SEM images, HPPM fibers (2%) play a significant role in fracture bridging. However, when the volume percentage of the fibers is higher (2.5% of HPPM), voids form and grow between the cement paste and the fiber, reducing the concrete's strength qualities. As a result, HPPM can be utilized to make sustainable concrete and produce a clean, environmentally friendly building material. In addition, the HPPM fibers employed in this study were classified as short or discontinuous, which could lead to increased UCS, FS, and abrasion resistance.

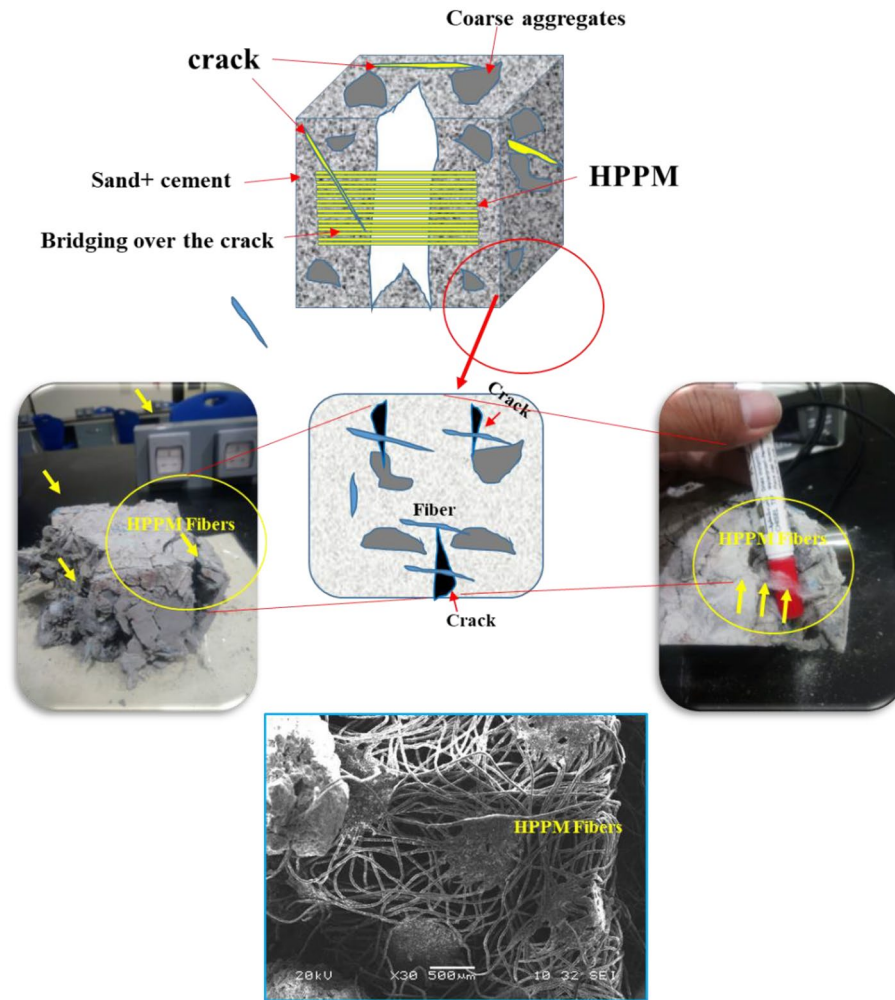
The main role of HPPM in concrete construction is shown in Fig. 15. As shown, the stresses arising from plastic shrinkage exceed the concrete strength in the initial hours of its age, when both the strength and Young's modulus are quite low. As a result, shrinkage cracks form. The formation of cracks is slowed by a high number of equally dispersed HPPM, which reduce the crack width by two orders of magnitude⁵. Of note, cracks are not detrimental to construction or serviceability if they do not exceed a particular size. When concrete transitions from a plastic to a solid state and the Young's modulus of the concrete exceeds the Young's modulus of the fibers, micro HPPMs no longer play a significant role. In this study, concrete samples with no fibers had a breaking area of 1743 mm² in the study⁶⁷, whereas those containing 0.5 and 1.0% PPF had cracking areas of 992 and 99 mm², respectively. According to this study, the presence of HPPM increases the drying shrinkage resistance of concrete.

Figure 15. Schematic representation of the mechanism of bridging formed by HPPM at 2% fibers which they acting as. Crack-bridging activity during the failure.

The use of fibers from various raw materials is efficient in controlling crack formation on exposed concrete surfaces caused by early-age drying shrinkage³⁷. Because they restricted the motions of the micro-level in concrete by bridging and stitching fine fractures, the PPF in concrete decreases the drying shrinkage and early cracking⁵. The effect of HPPM on matrix fracture behavior can be divided into two categories. First, the addition of HPPM fibers reduces the maximum stress as well as the elastic modulus of the mixtures. Second, after the grain-bridging crack face breaks, the stress can be transferred via cracks through the intersection of the fibers and cracks. Crack-bridging activity results in increased ductility in HPPM-fiber-reinforced concrete (Fig. 15).
